# **Collier House**

## **Preliminary Historic Assessment**

University of Oregon  
Campus Planning  
Campus Planning and Facilities Management

March 2025

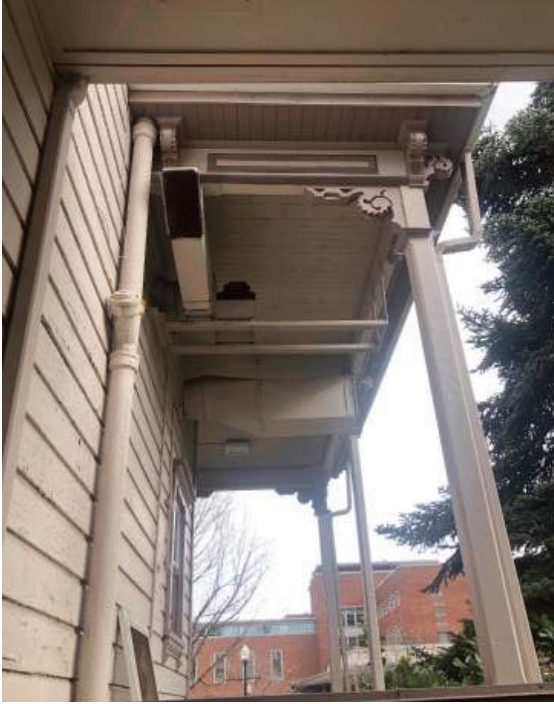
Incompatible light fixtures and HVAC equipment under porch overhang

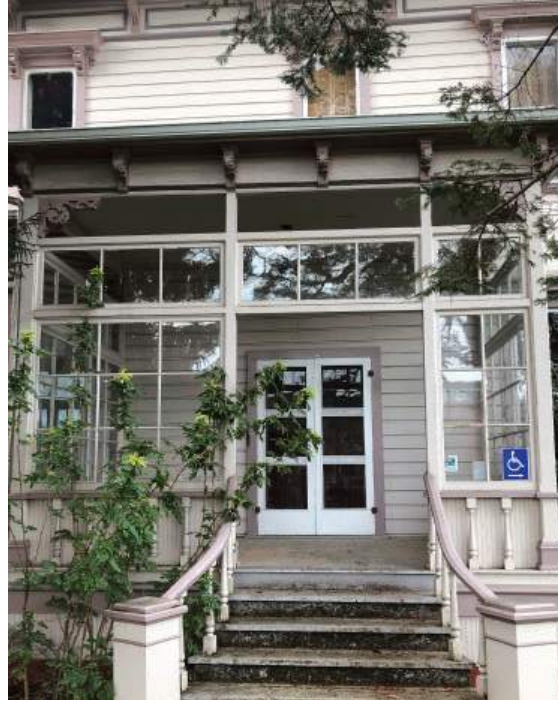
East porch glassed in (1930s)

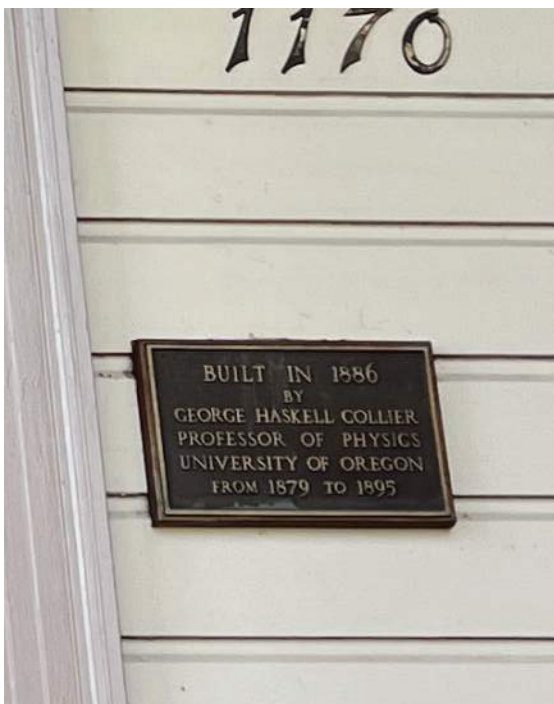
Memorial plaque adjacent to north entry
