# **Collier House**

## **Preliminary Historic Assessment**

University of Oregon  
Campus Planning  
Campus Planning and Facilities Management

July 2025

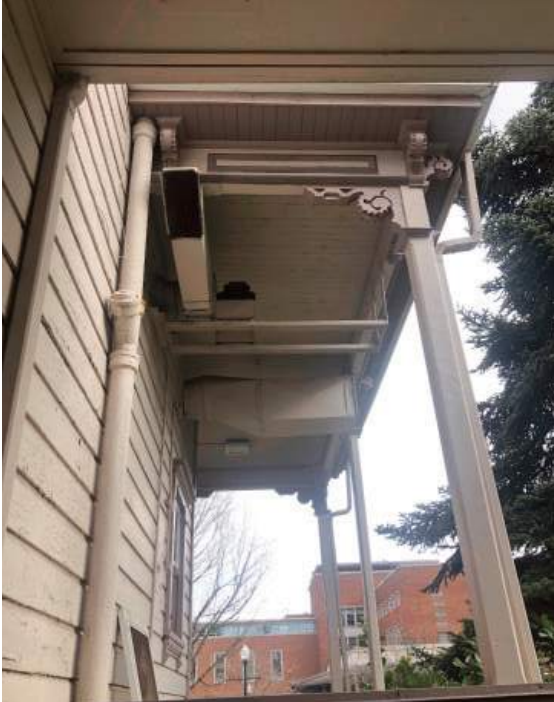
Incompatible light fixtures and HVAC equipment under porch overhang

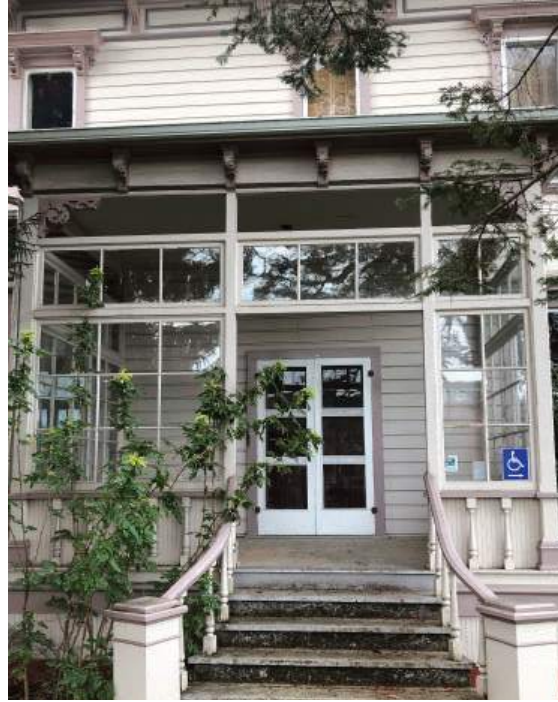
East porch glassed in (1930s)

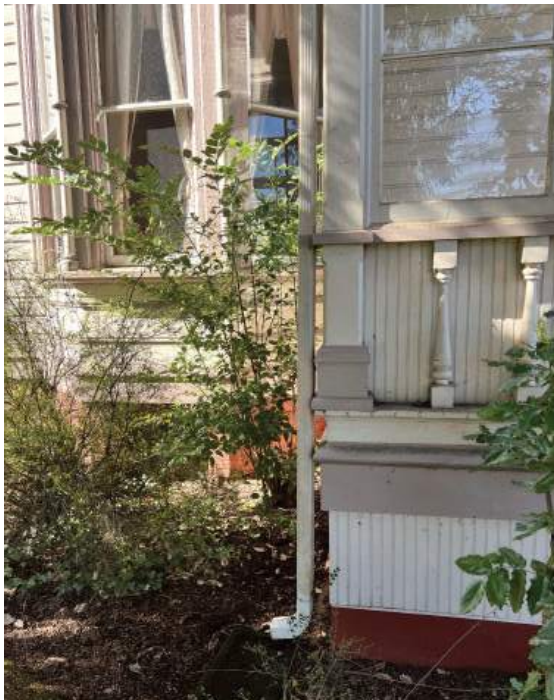
Painted foundation

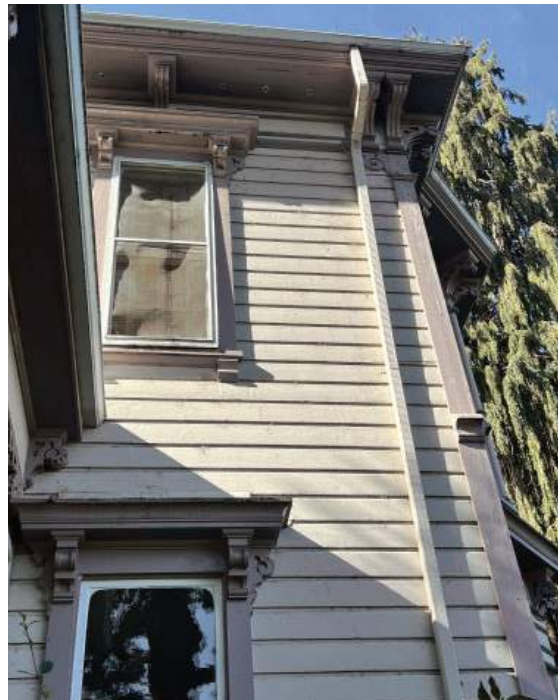
Gutter downspouts; window screens

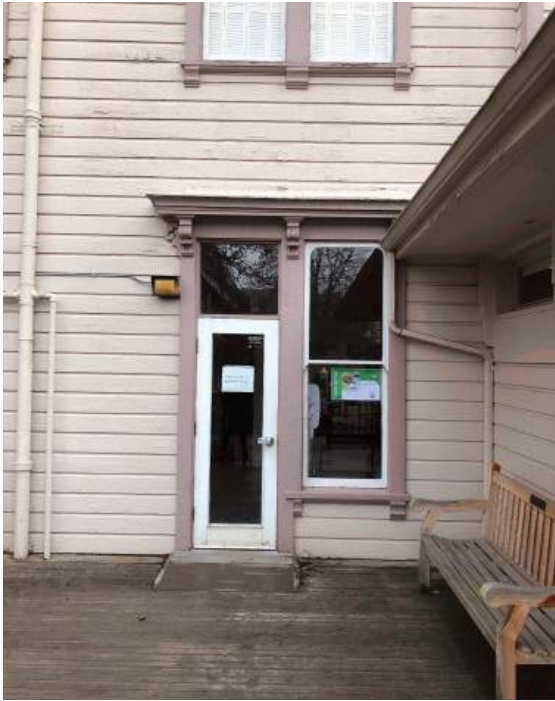
Window altered into door with single hung windows, incompatible light fixture, gutter downspouts

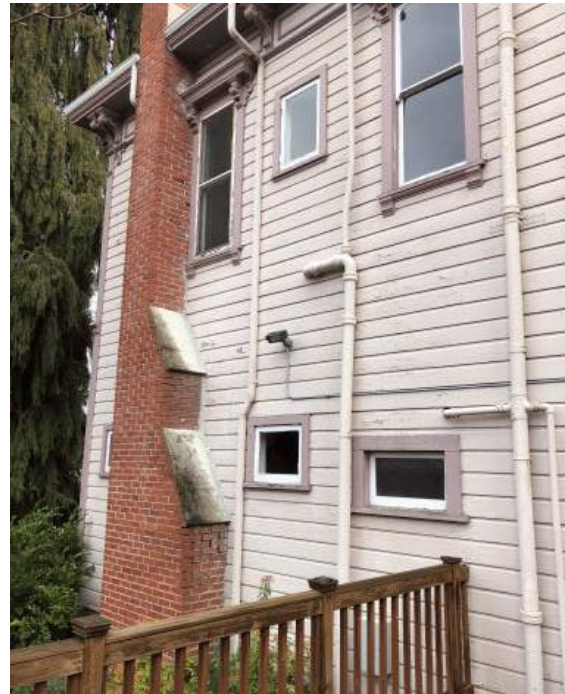
Brick chimney (1932), gutter downspouts, incompatible light fixture

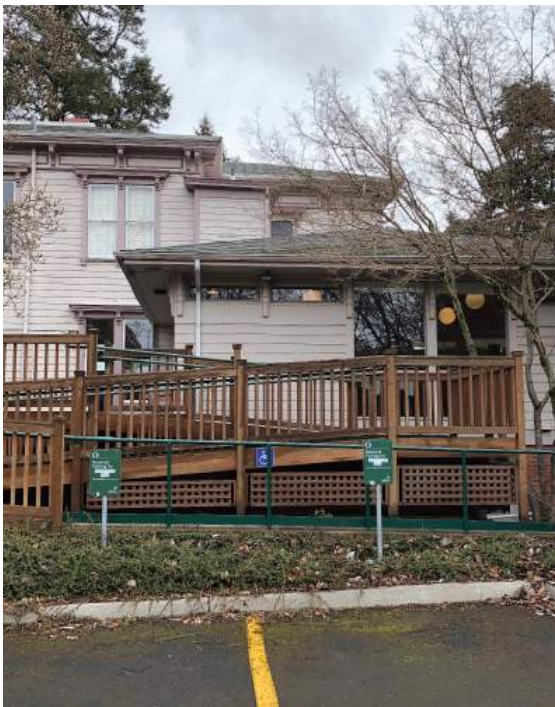
Wooden ADA ramp and deck (1999), dining room addition (1960s)

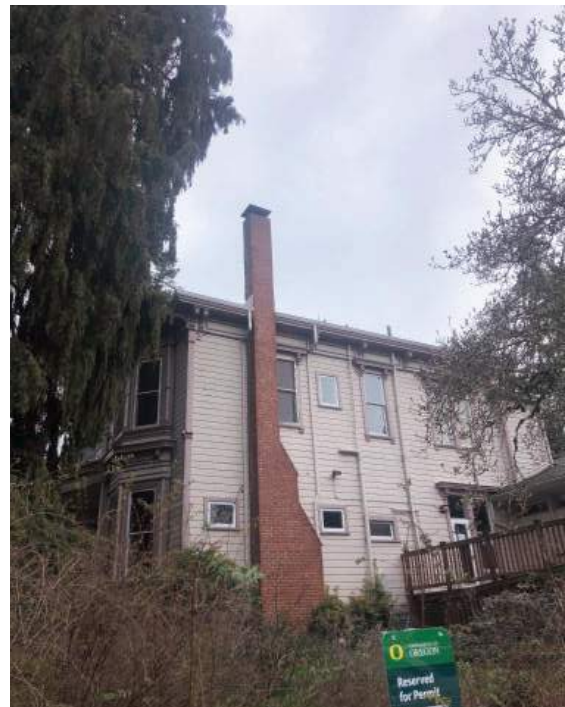
Brick chimney (1932), gutter downspouts, incompatible light fixture

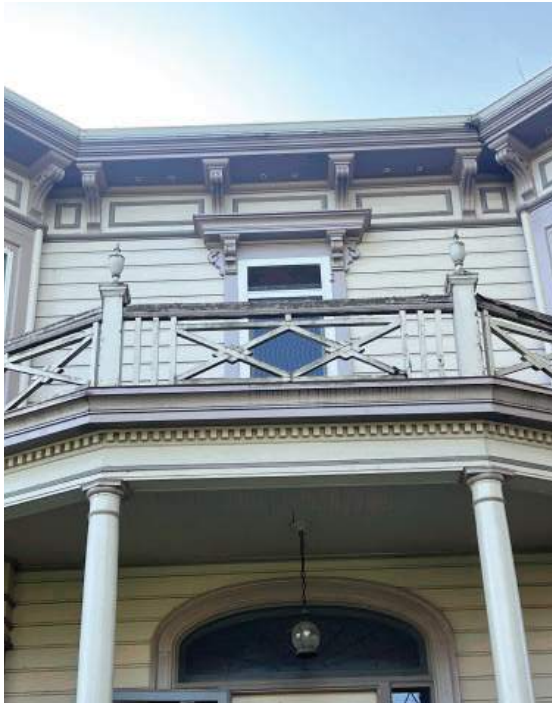
Second story balcony contains unoriginal wooden fretwork railing, balustrades, and finials; second story bracketed window crowns; decorative eave brackets

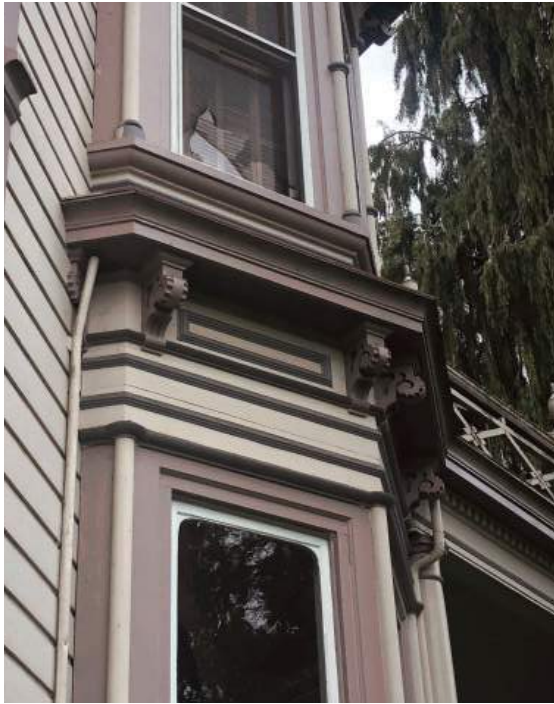
Gutter downspouts; window screens

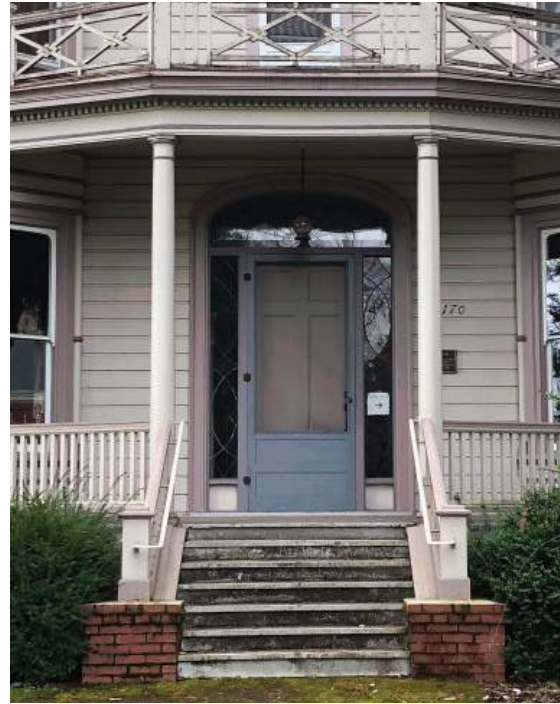
Metal stair handrail; brick base

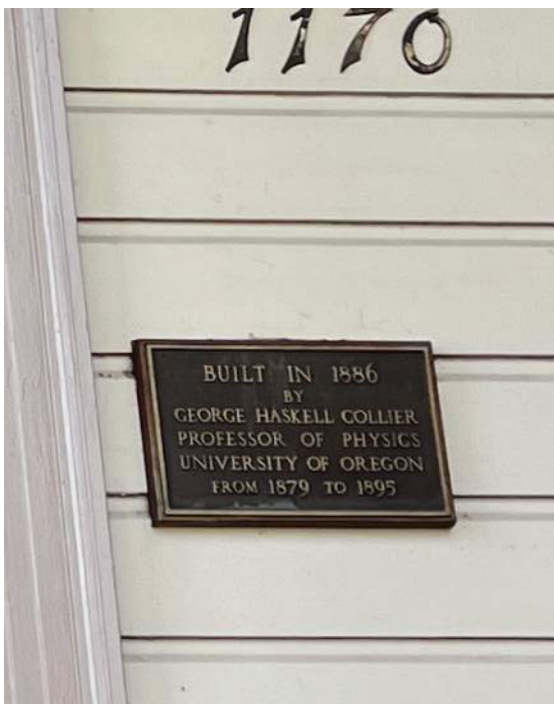
Memorial plaque adjacent to north entry

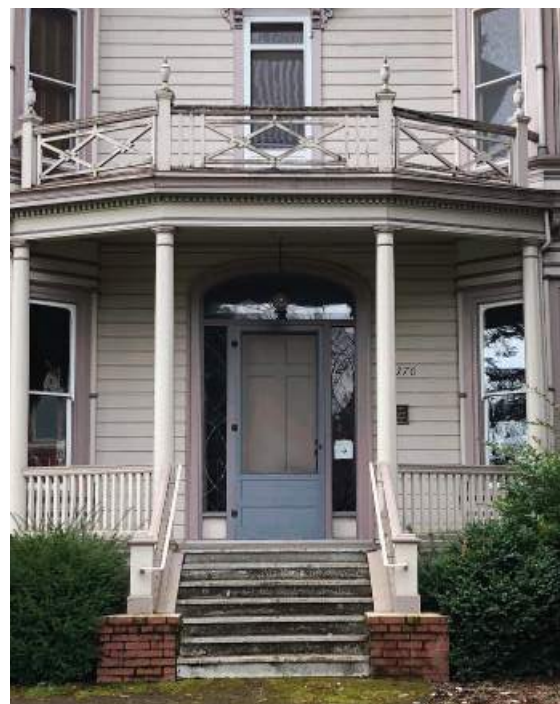
Original decorative porch brackets & post finials removed; altered landscape and pathway configuration

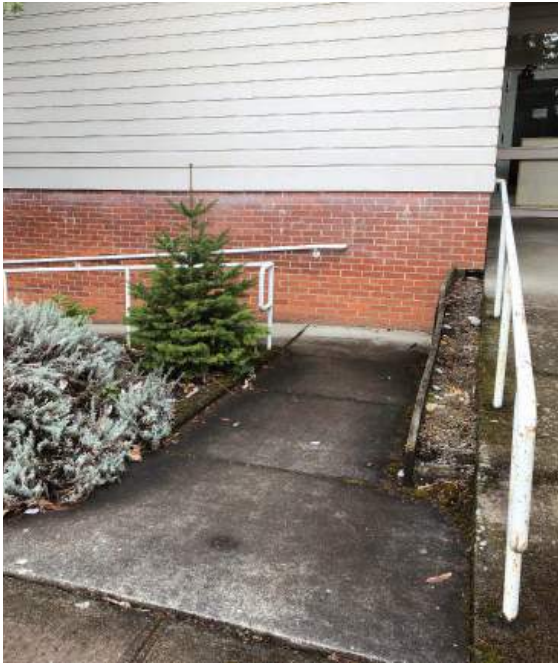
1963 addition with brick masonry foundation; exterior ramp and handrail

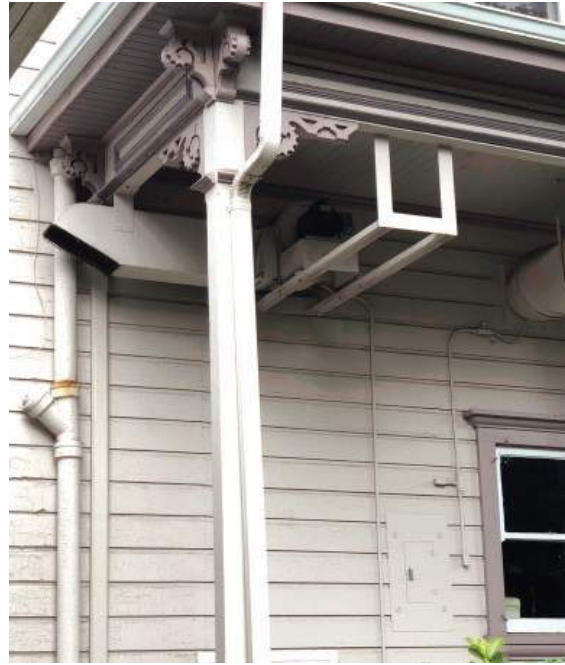
HVAC installed on east porch overhang; gutter downspout; electrical
