UNIVERSITY OF OREGON

FRIENDLY HALL ASSESSMENT

FACILITIES ASSESSMENT & FEASIBILITY STUDY

MARCH 2022

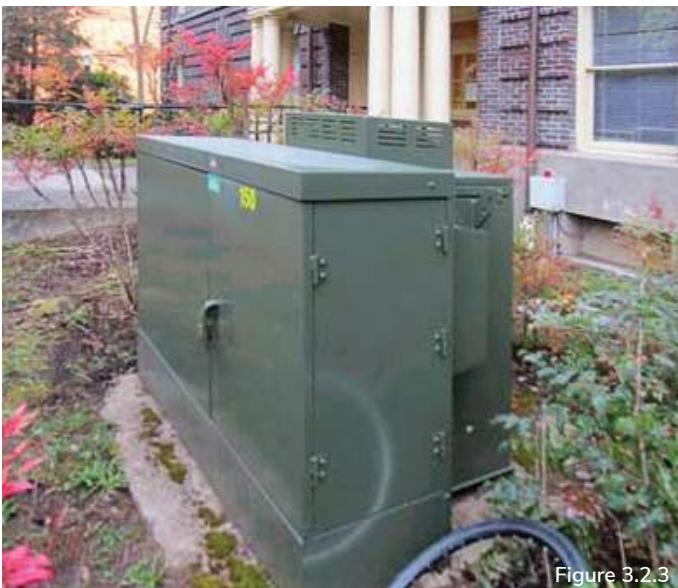
Figure 3.2.3

Friendly Hall is served by a transformer on the west side of the building. The transformer is located on a concrete pad above ground (figure 3.2.3).
