Friendly Hall

Preliminary Historic Assessment

University of Oregon
Campus Planning
Campus Planning and Facilities Management

October 2022

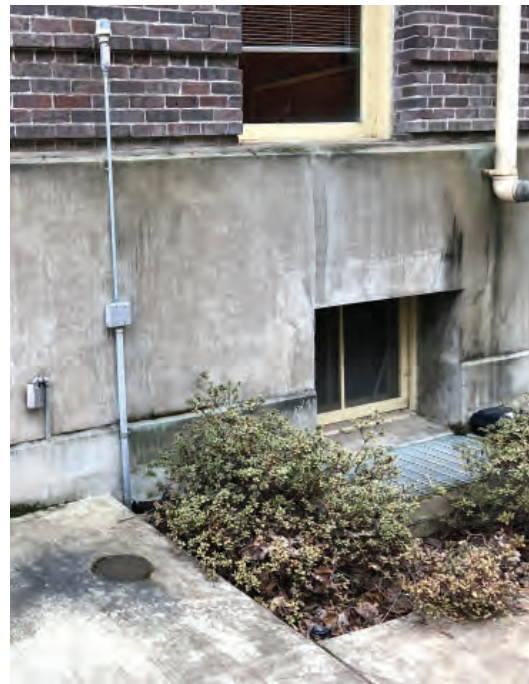
Foundation showing repairs, mechanical equipment added to facade is not original.

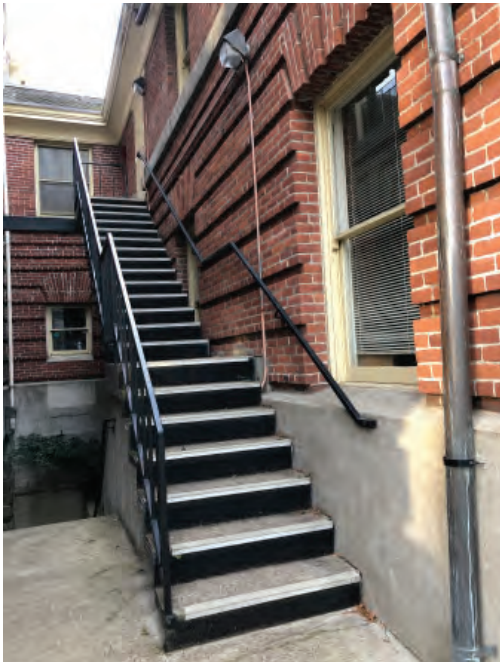
Light fixtures are not original.
Foundation differences between
basement and ground level.

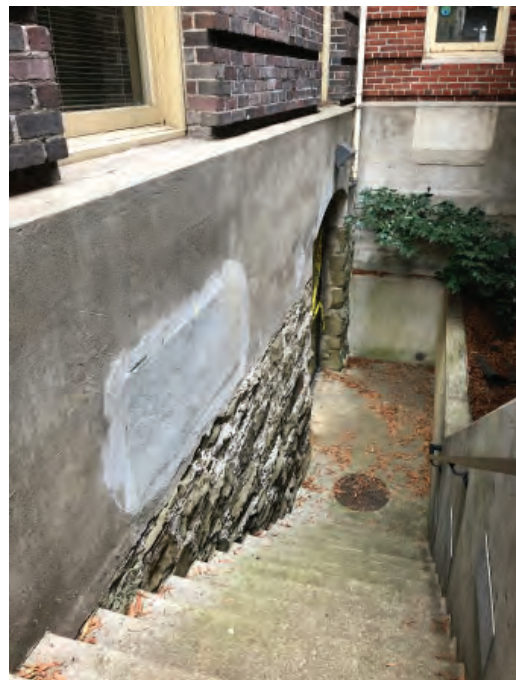
Difference between original stone
foundation and 1914 addition
foundation. 1914 addition used
different colored brick

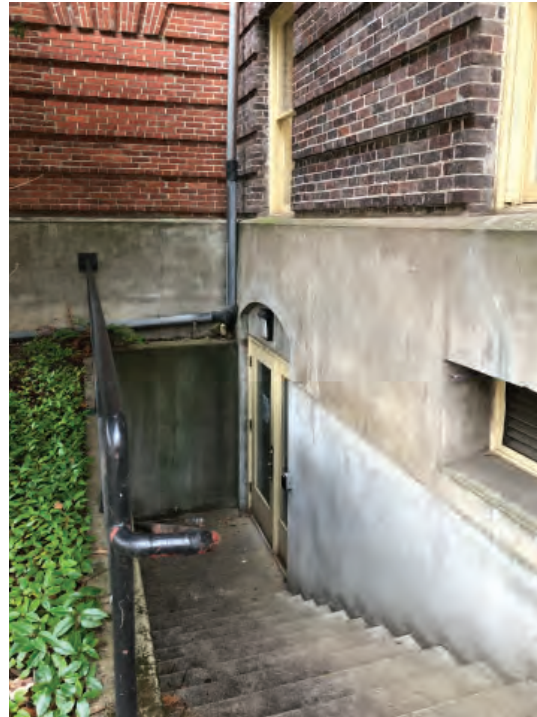
Stairwell leading down to basement shows foundation differences. Brick color differences between additions and original building.

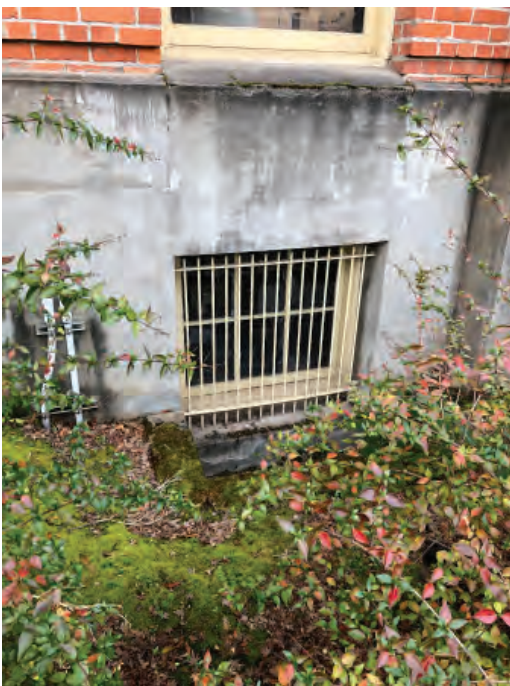
Water damage on window sills; basement windows with bars that are not original.

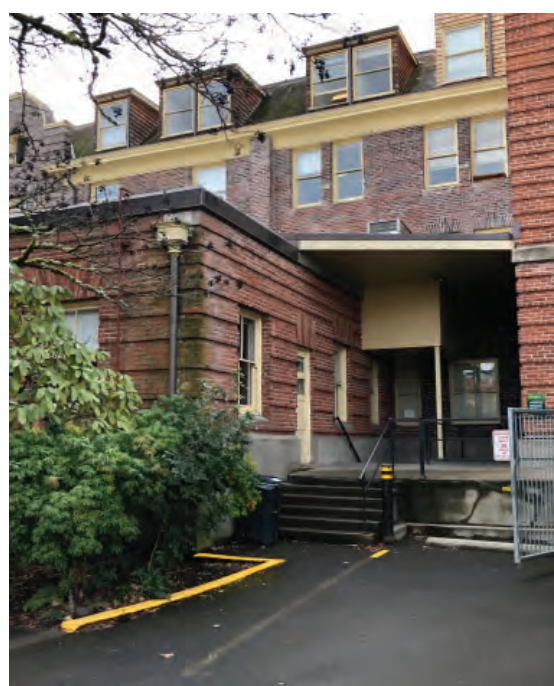
Dormers added to east facade. Overhang above the stairs and entrance is not original.

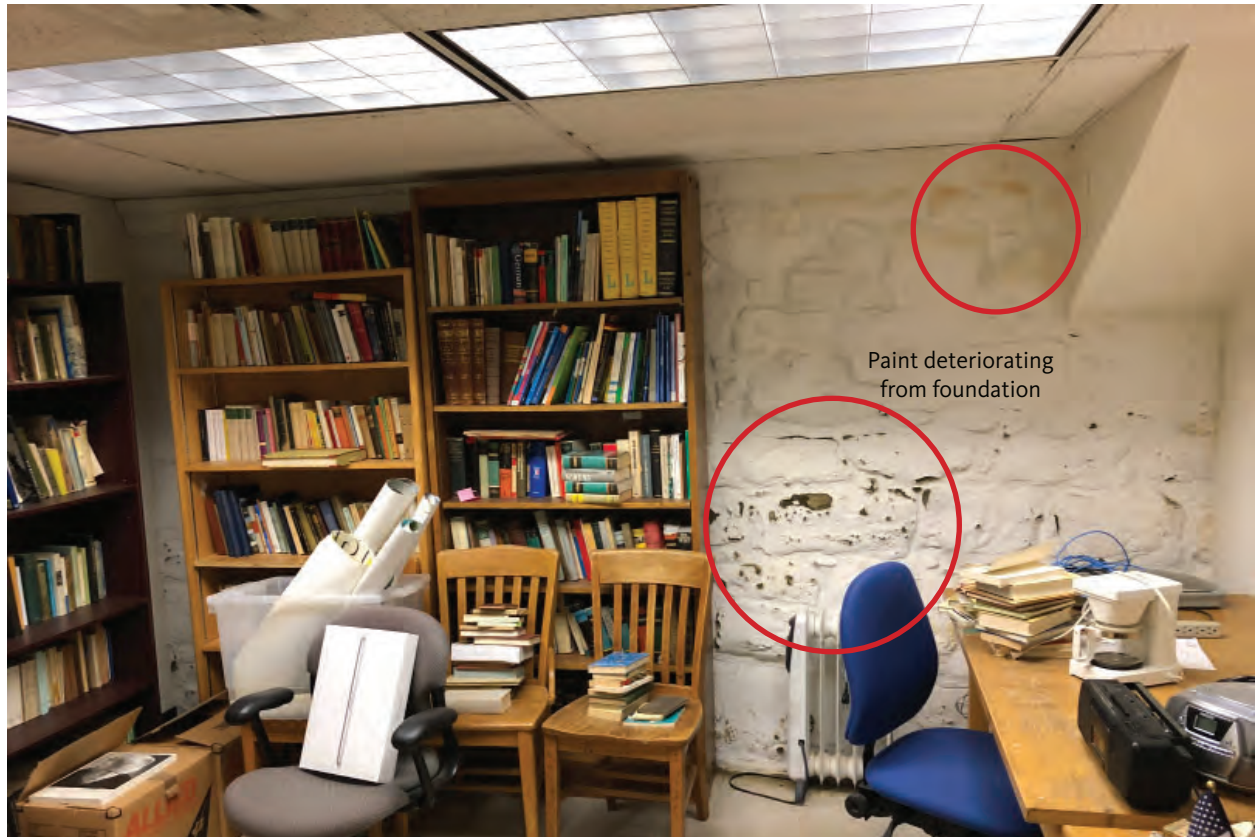
Room 17 (Painted Stone Foundation)

Paint deteriorating
from foundation

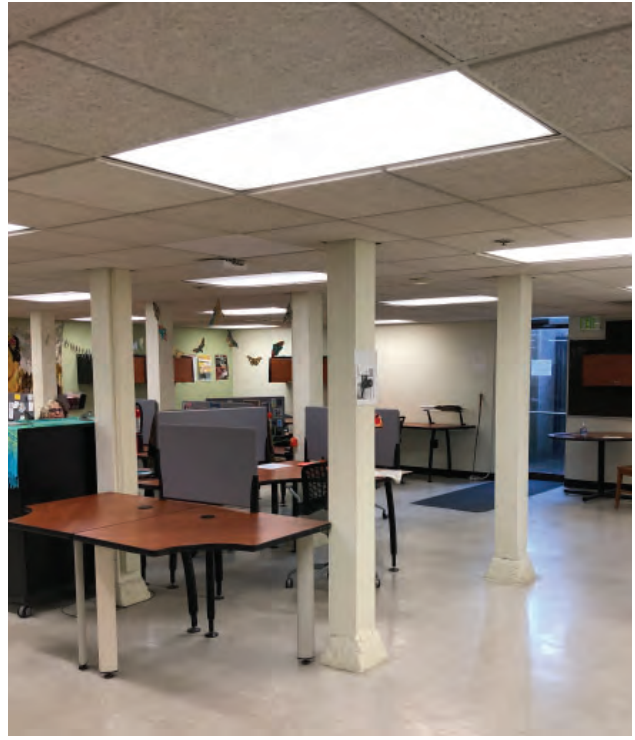
Support pillars not original; further research needed for year pillars were placed/replaced

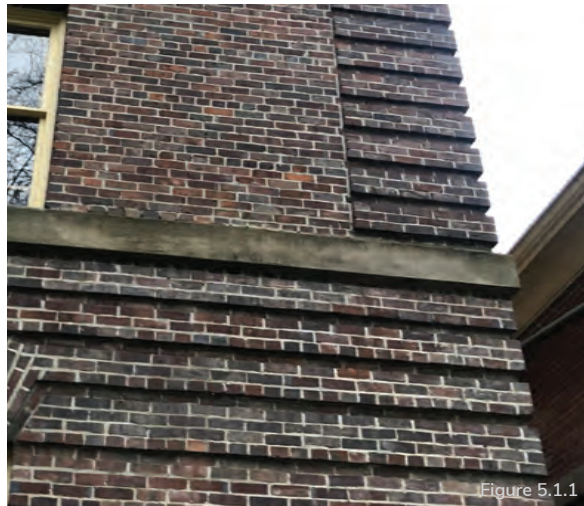
Figure 5.1.1

The exterior walls of Friendly Hall indicate the original structure and its two major additions. All three major constructs use an American or Common bond. A dark brick is used on the original portion (figure 5.1.1), while the additions are clad with a red brick (figure 5.1.2). The 1914 addition on the east also has a different coursing pattern than the other two constructs (figure 5.1.3). The face brick is embellished with quoins, jack arches, and rusticated reveals on the first floor.

The face brick appears intact and in good condition, with limited examples of damage or spalling. A visual inspection showed no indication of rising damp.

- The exterior masonry should be maintained.
- During the proposed seismic upgrade, interior faces of the brick walls will be exposed and additional inspection and testing should be performed.
- All brick, mortar or concrete elements should be cleaned with hot water and brushed where required following best practices for maintenance of historic brick facades.
- Areas of mortar deterioration and cracking should be identified and repointed.
 - All deteriorated mortar joints should be ground using the appropriate grinder profile back to sound material prior to repointing.
 - New mortar shall match the existing in color, texture, composition, and tooling profile. It is recommended that several small test areas be reviewed for visual match prior to commencing with larger areas of repointing.

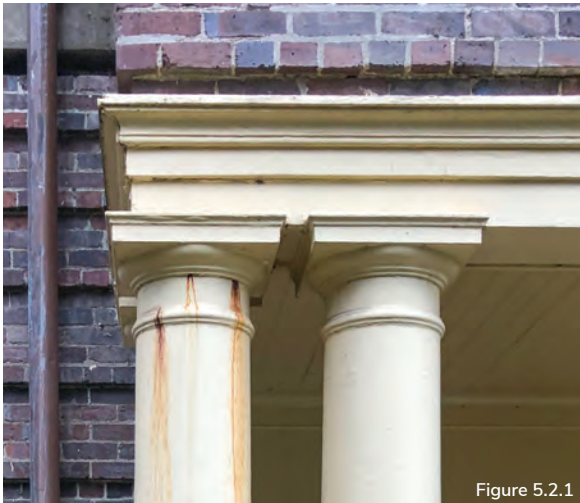
Figure 5.2.1

The wood trim is an important character defining feature around the exterior of the building. It is used as accents and detailed ornament. In some locations, it has experienced water damage, but no significant structural damage or rot was observed. Wood elements include

- At areas with visible wear or water damage, wood elements should be refinished and restored, if possible.
 - If restoration is not possible, matching historic elements should be used as replacements.
- Paint analysis should be performed to determine the original color.

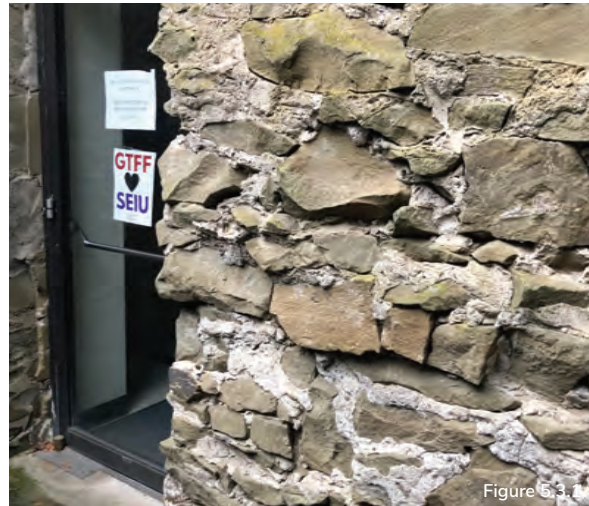
Figure 5.3.1

The West Wing of the building was constructed with a stone foundation that has been exposed in some locations (figure 5.3.1). It is generally in good condition, though the original design did not intend for any stone to be exposed.

- Existing areas of visible stone on the basement level should be refinished as necessary to improve the interior spaces.
- Exterior stone should be cleaned as necessary where exposed.

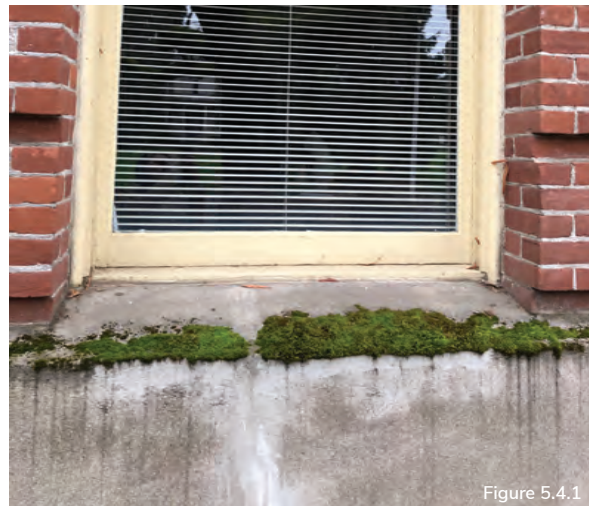
Figure 5.4.1

Building occupants noted that there have been instances of water leakage in the basement floor of the West Wing. Such water intrusion is not unexpected given the age of the building and the limited options for below grade waterproofing available during its construction.

During a walkthrough, areas of organic growth and superficial cracking were observed (figure 5.4.1-2).

Water leakage through the basement or foundation walls can be remediated via two approaches, positive side and negative side remediation.

- Positive Side: A membrane system placed on the exterior face of the structural foundation system.
 - o The highest level of protection would be afforded by excavating the entire perimeter of the building to expose the foundation walls. The exterior wall surfaces would be cleaned, and a new waterproofing membrane would be installed along with new subgrade drainage.
 - o The lowering of the basement floor will necessitate perimeter excavation providing an opportunity for positive side waterproofing treatments.
- Negative Side: A treatment on the interior surfaces of the foundation system.
- Exposed concrete on other exterior areas should be cleaned as necessary.

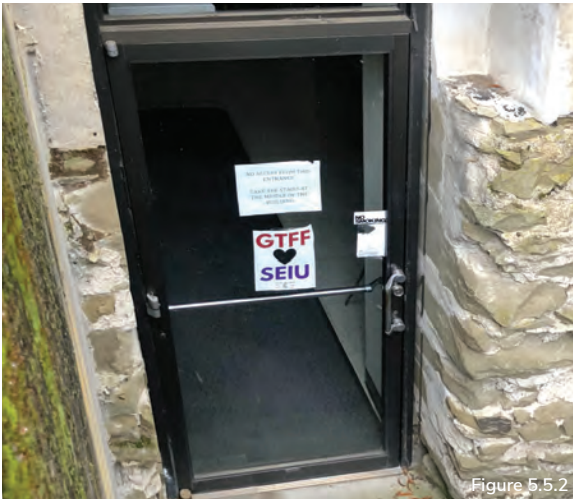
Figure 5.5.2

Generally, the historic exterior doors on the building have been maintained and are functionally adequate (figure 5.5.1). Some have experienced slight aesthetic deterioration which is expected on elements of this age. At exterior basement entries, character compromising doors were installed at some point during previous renovations (figure 5.5.2).

- The exterior wood doors should be restored and refinished.
 - Modern, accessible and historically complementary hardware should replace the existing brushed steel hardware.

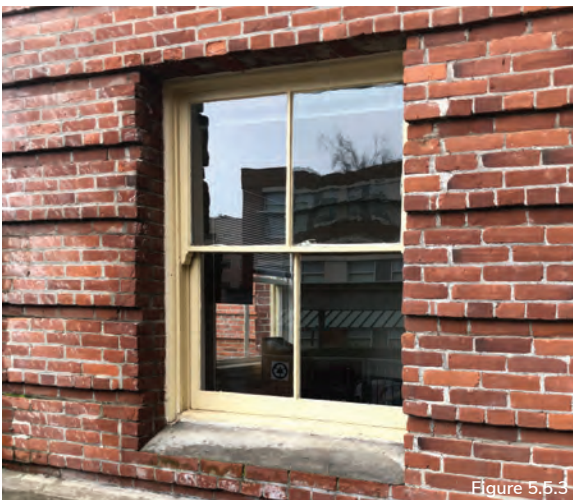
Figure 5.5.3

Various windows have been replaced with louvers for mechanical upgrades over the building's lifespan.

Two oculus windows on the West Wing, one on the north and one on the south, were replaced with emergency exit doors which access the fire escape.

- Existing window openings that have been previously outfitted with mechanical louvers should have historically appropriate windows reinstalled.
- If removal of the fire escapes is deemed necessary, the oculus windows should be recreated to restore the historic appearance.
