Romania Building Preliminary Historic Assessment

University of Oregon
Campus Planning
Campus Planning and Facilities Management

ROMANIA BUILDING

PRELIMINARY HISTORIC ASSESSMENT

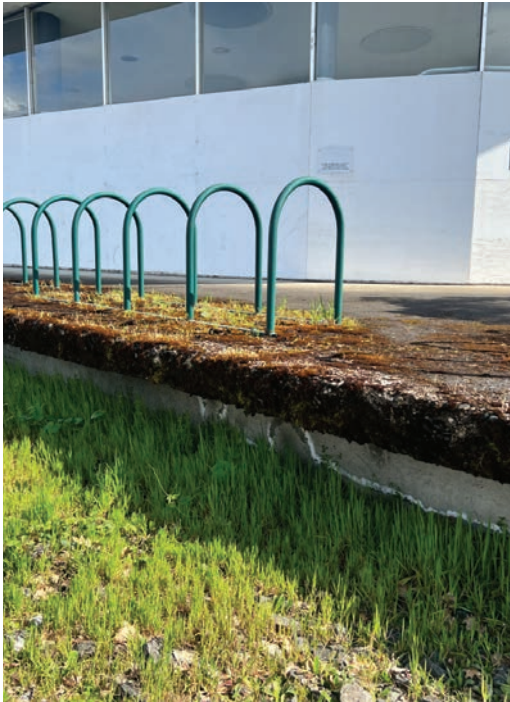
Wood rot and paint tarnish on concrete platform, bike rack addition

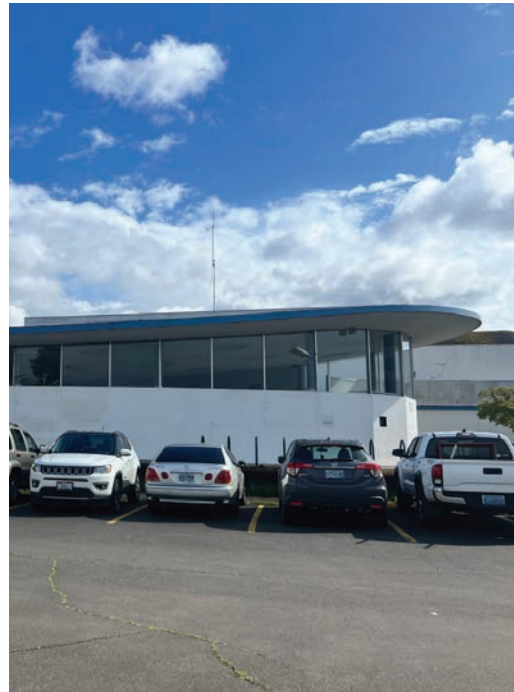
Post 2005 addition of plywood to showroom curtain wall

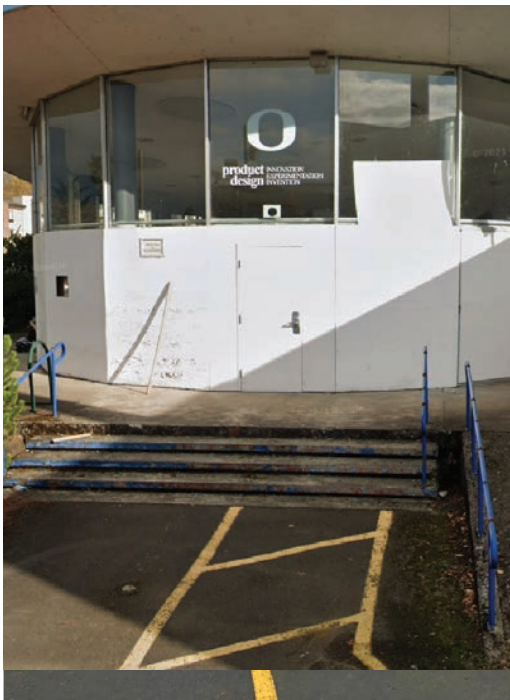
Addition of metal handrails on west stairs and ADA ramp to Showroom

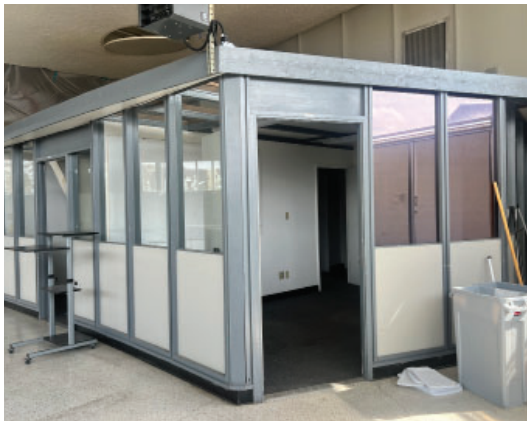
Original office organization relocated next to the north entrance

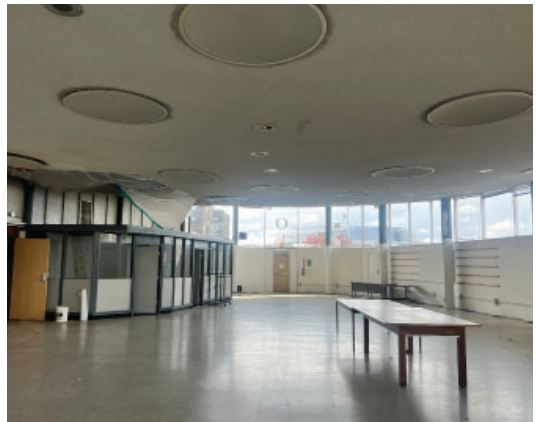
Original glass curtain wall covered with plywood

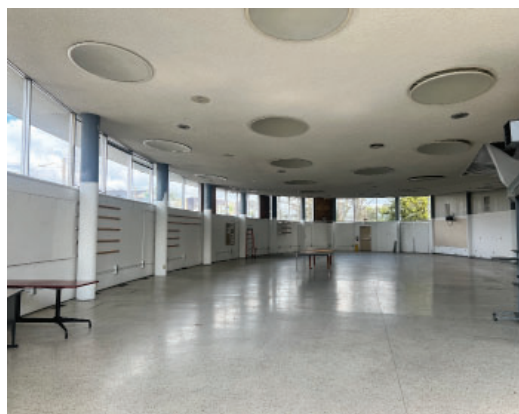
Original terrazzo floor in pavilion space; removal of office spaces from south wall

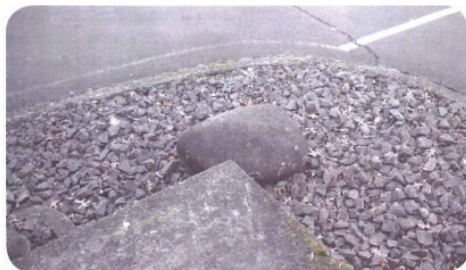
Figure 3.8: Surrounding the Plinth on its north edge are planters filled with large gravel, a few larger rocks and shrubs. Source: Photograph by Author.

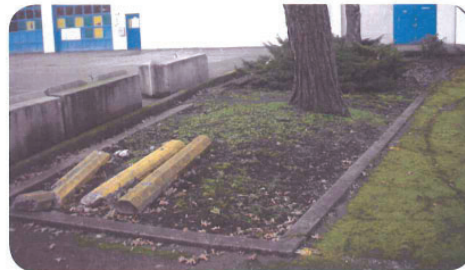
The landscaping on the site is in fair condition as some planter concrete curbs are cracked and damaged and some weeds are growing within the planting area.

Figure 3.9: Original landscape planters remain on the site, including this one on the Showroom's east edge. Source: Photograph by Author.

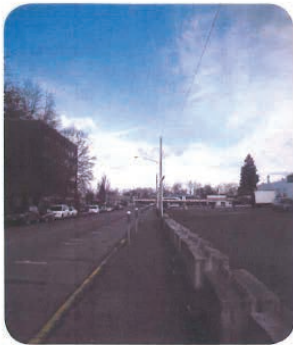
Figure 3.11: The sidewalk along Orchard Street lacks any street trees or landscaped parking strip. Source: Photograph by Author.

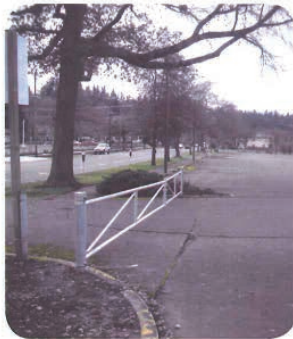
Figure 3.14: Metal gate off of Walnut Street. The same type of gate is found off Orchard Street. Source: Photograph by Author.

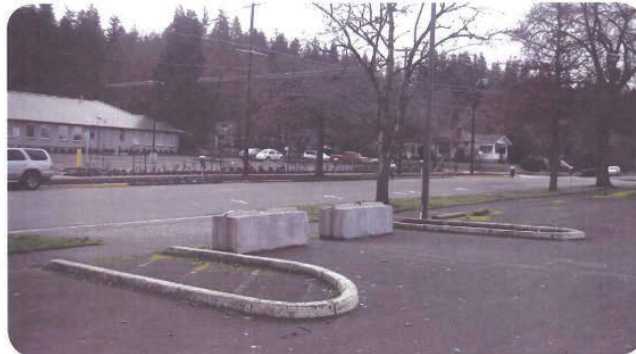
Figure 3.15: The southernmost curb cut along Walnut Street and entrance from east 15th Avenue are blocked with concrete barriers. Source: Photograph by Author.
