CHAPMAN HALL

HISTORIC ASSESSMENT

University of Oregon
Campus Planning
Campus Planning, Design and Construction

May 2015 (updated January 2016)

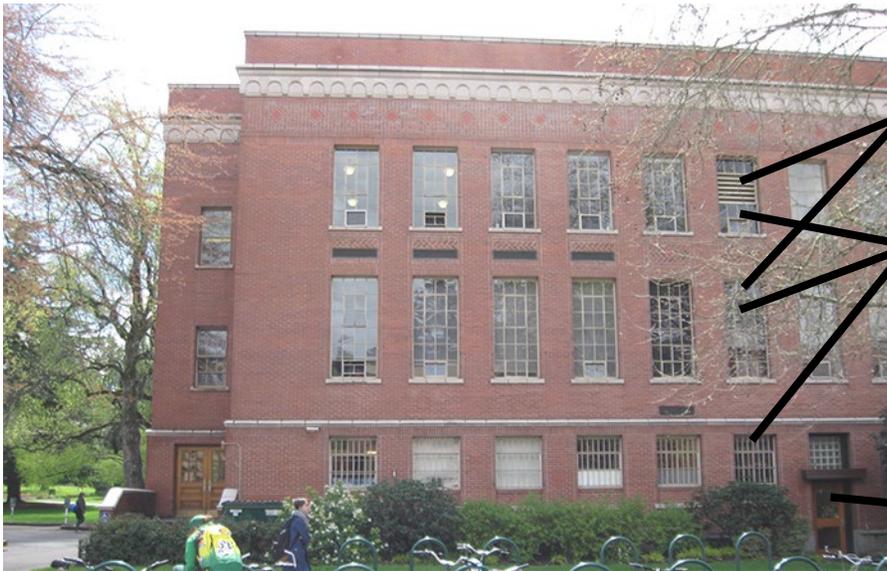
WINDOW ALTERED TO INSTALL VENTILATION GRILL FOR NEW ELEVATOR IN 1990 REMODEL

GLAZING PAINTED A GLOSS BLACK AFTER INSTALLATION OF NEW ELEVATOR SHAFT IN 1990 REMODEL

North facade with the 1966 Secondary North Entry and 1990 ADA remodel alterations. March 2015.

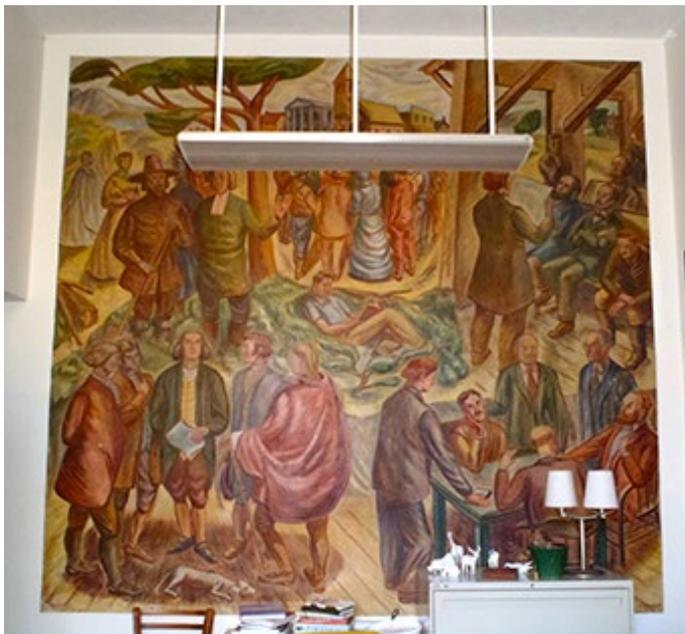
1942 E. R. Scott mural. Notice slight damage to mural on the red jacket near bottom left corner. 2011.

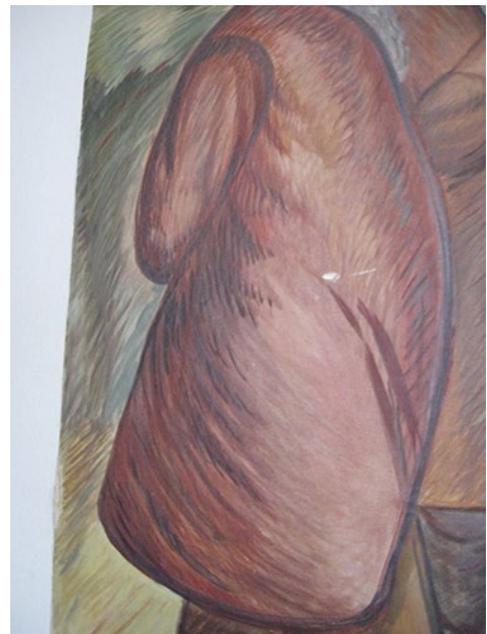
Detail of slight damage to 1942 E. R. Scott mural. March 2015.

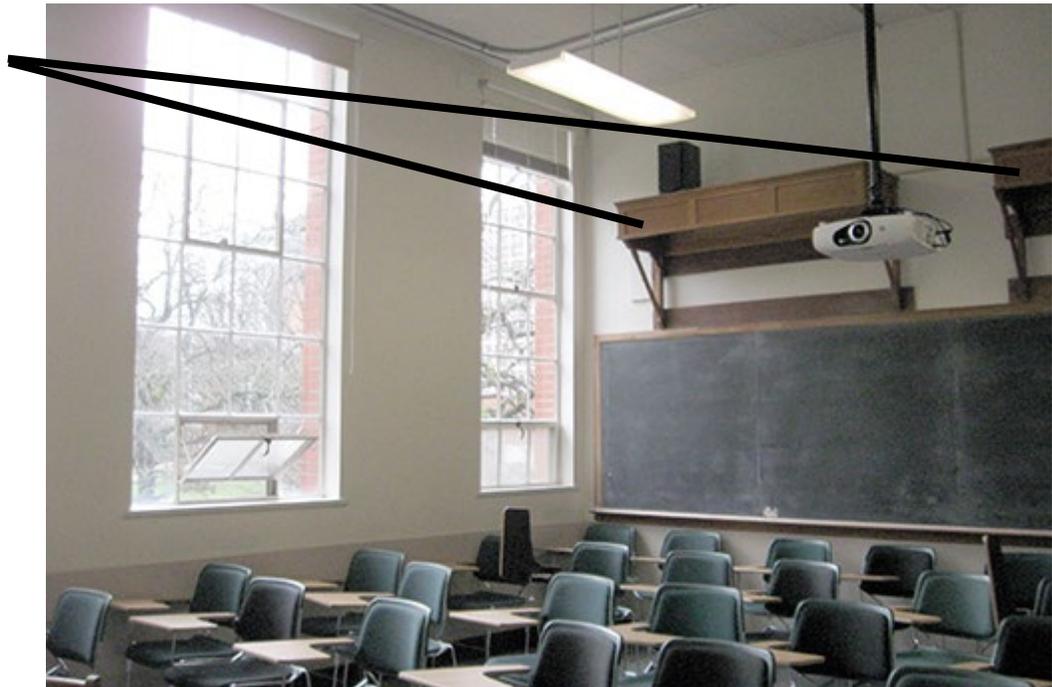
Southwest corner of Room 203. Notice empty map valences along the classroom's western wall. March 2015.

The maps in the map case in Room 203 have since been removed. It is now being used as a shelf for the classroom sound system (see third image on previous page).

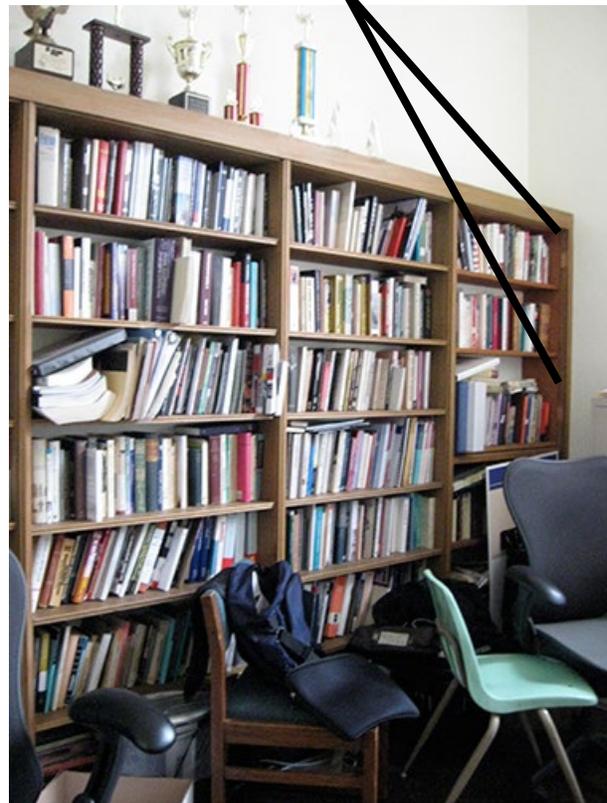
Original built-in bookcases in Room 222. Notice the missing cabinet doors in the far right. March 2015.

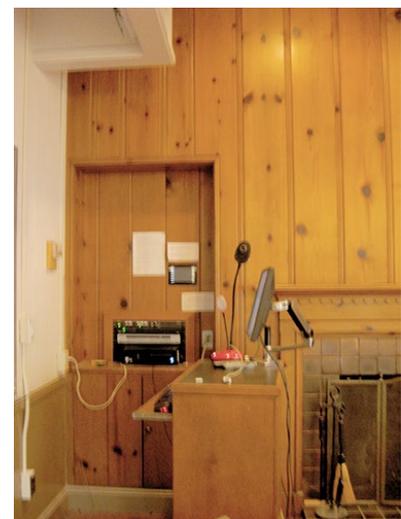
Original built-in bookcase and fuel bin. Shelves of bookcase are no longer existing. March 2015.

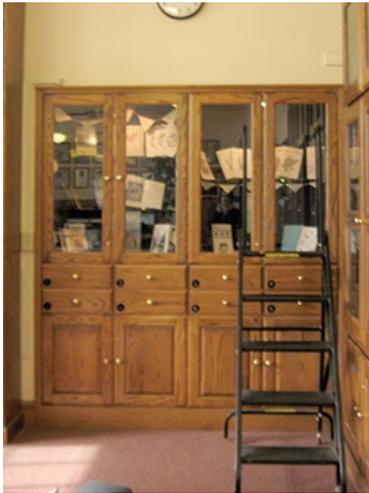
Built-in cabinet on west wall. Configuration matches original drawings but it is presumed that the cabinet faces have been replaced. March 2015.

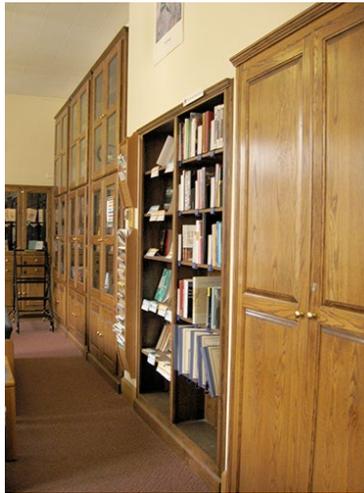
View of north wall. New cabinets on far left. Original but altered built-in bookcase in center. Newer built-in cabinet on right. March 2015.

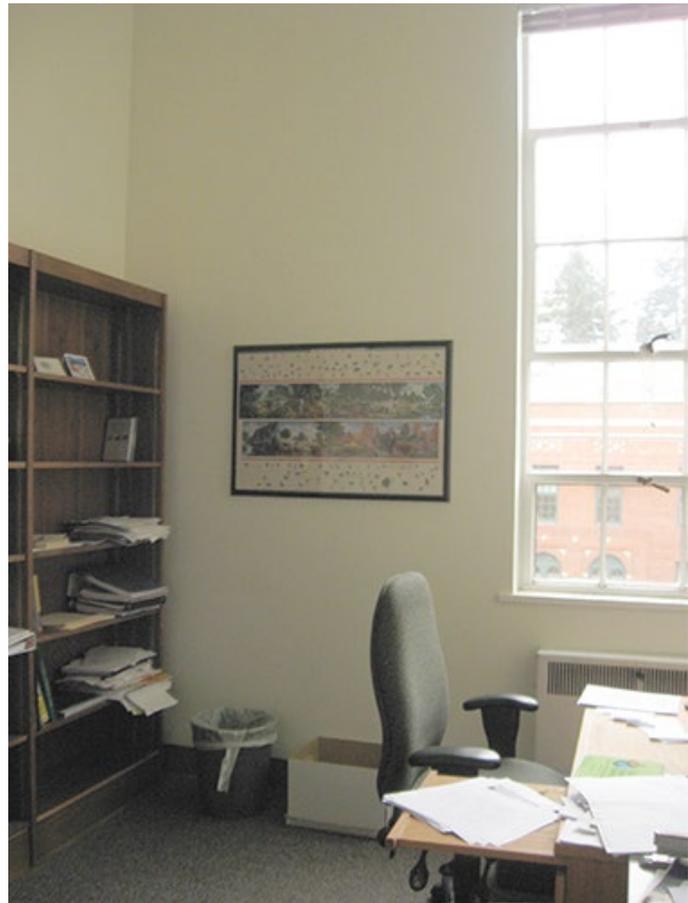
View of northwest corner of Room 320B. Notice placement of built-in bookcase compared to the original drawings above. Also note the difference in construction compared to the original bookcase in Room 320A seen in the photo above. March 2015.

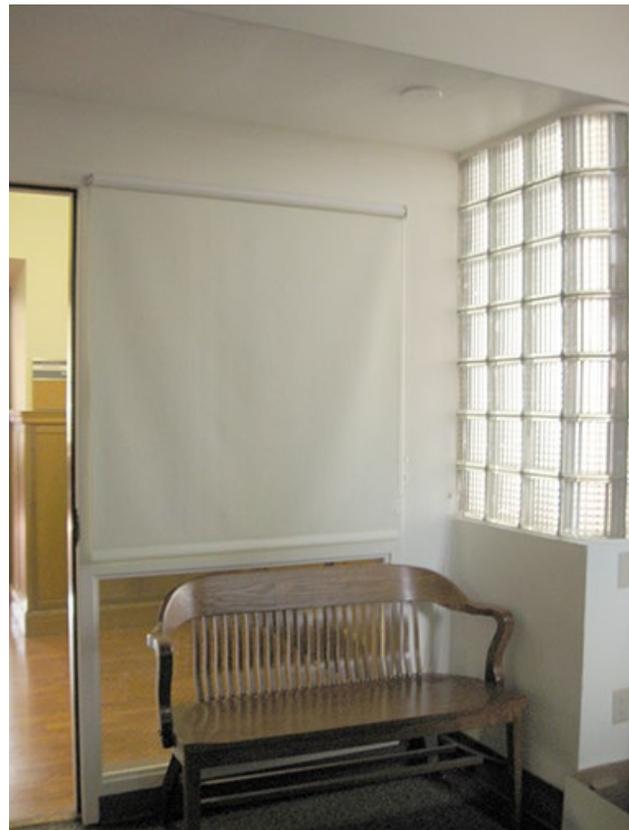
Room 320 looking south. Note original glass block. Originally a built-in counter stood where the storefront window system and bench is located in the photo. March 2015.
