# CHAPMAN HALL

## PRELIMINARY WINDOW ASSESSMENT

University of Oregon  
Campus Planning  
Campus Planning, Design and Construction

June 2015 (updated January 2016)

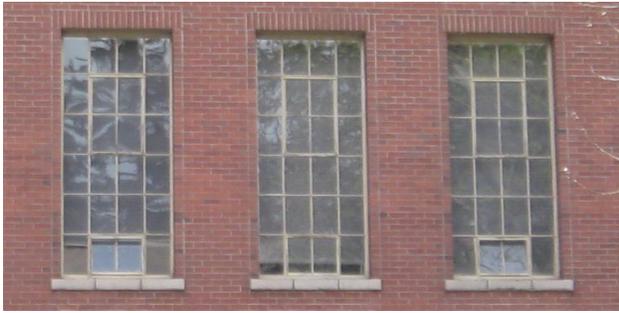
*Typical exterior condition of northern windows.*

In general, the windows on the north facade are in GOOD-EXCELLENT condition. The north facade sees much less sun during the day and, as a result, less moisture evaporates. This has caused some minor vegetative growth on some of the exterior sills.

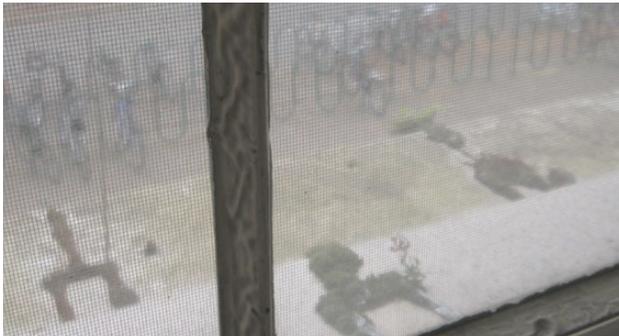
*Vegetative growth on northern window sill and typical paint bubbling on interior of northern windows.*

The steel window frames and sashes appear to be in good condition, although there appears to be some paint bubbling on the interior of some windows located in the offices. Also, there appears to be thick layers of paint on some of the windows. Further investigation should be performed to ensure that there is no corrosion hidden under the paint. Another condition found in some of the typical north windows is missing or replaced hardware.

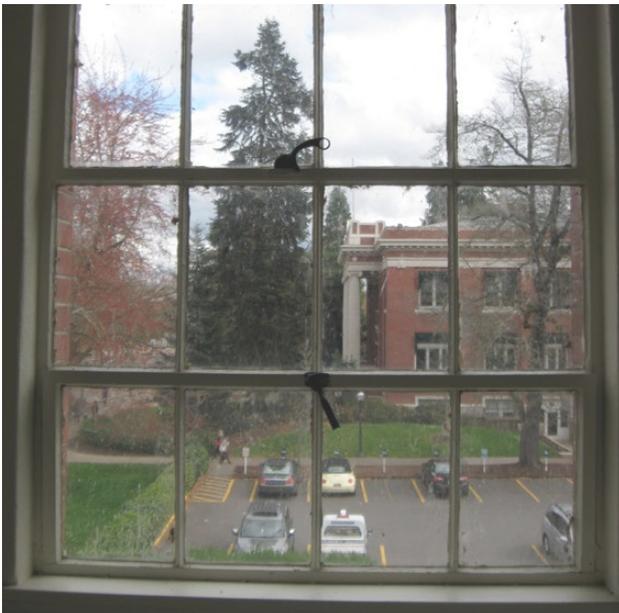
*Typical interior condition of eastern windows.*

There are only a few windows on the east facade. Overall, they appear to be in GOOD condition. The steel window frames and sashes appear to be in good condition, although there appears to be thick layers of paint and bubbling on the interior. Further investigation should be performed to ensure that there is no corrosion hidden under the paint. Also, there is dirt and grime on the exterior windows, especially those on the stairwell windows.

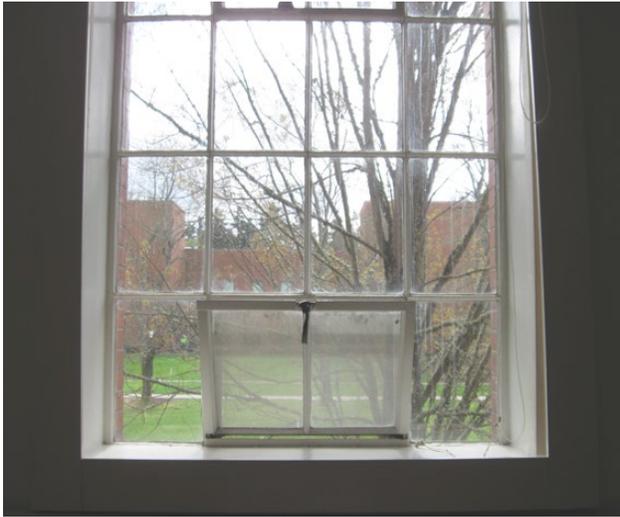
*Typical interior condition of southern windows.*

The condition of the windows on the south facade are primarily in GOOD-EXCELLENT condition with the exception of those in Room 303, which are in FAIR-GOOD condition.

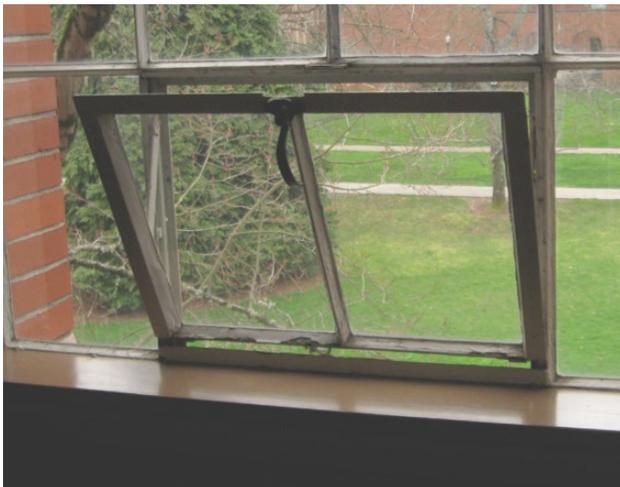
*Cracked paint, chipping glazing putty, and rust on southern window in Room 303.*

The windows in Room 303 that are in FAIR condition have been exposed to large amounts of sun, excessive moisture, improper maintenance/repairs, or various combinations of the three. Ultra Violet (UV) radiation from the southern sun can cause paint and glazing putty degradation. Cracked and chipping paint and glazing putty have allowed moisture to penetrate into the raw steel of the frames and develop into light-medium corrosion on the window interiors. Also, there is a visible amount of corrosion coming through the painted steel lintels. The extent of the rust cannot be determined at this time due to limited access. Considering that other south-facing windows are in better condition than those in Room 303, it appears that there is a greater moisture problem in Room 303. However, a more in-depth assessment should be performed to determine the cause and level of degradation. Finally, the exteriors of some windows have been affected by animal nests.

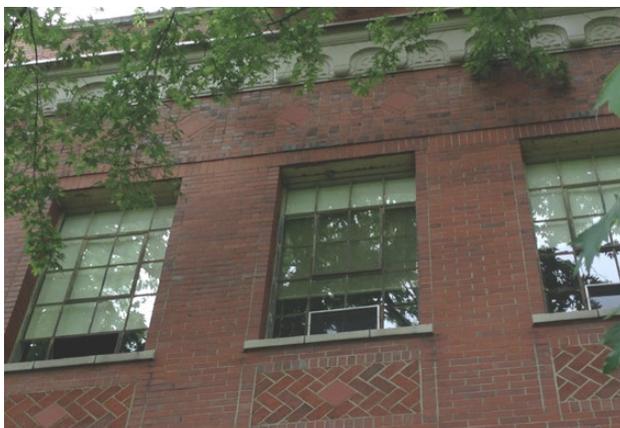
*Rust and animal nest on exterior steel lintels of Room 303 windows.*

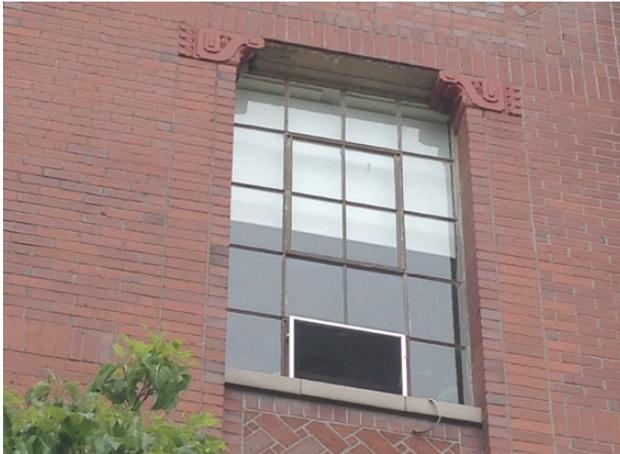
*Typical exterior condition of west windows.*

Overall, the west-facing windows are in GOOD condition. Like the south facade, it receives a lot of exposure as evidenced by the interior cracked and chipped paint and glazing putty, although it is not as prominent as the south facade. Cracked and chipped paint have allowed moisture to find its way into the raw steel beneath and some light corrosion is present on the interior. Some of the steel lintels on the third floor show signs of rust as well. Further investigations should be conducted to verify the extent of the rust. Like the other three facades, the hardware of some of the west facing windows are missing or have been replaced.

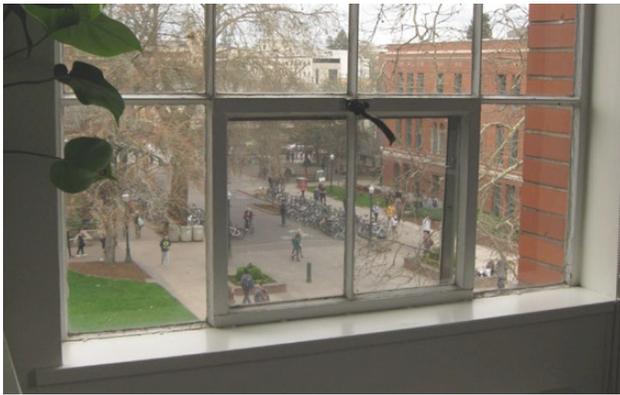
*Typical interior condition of west windows.*

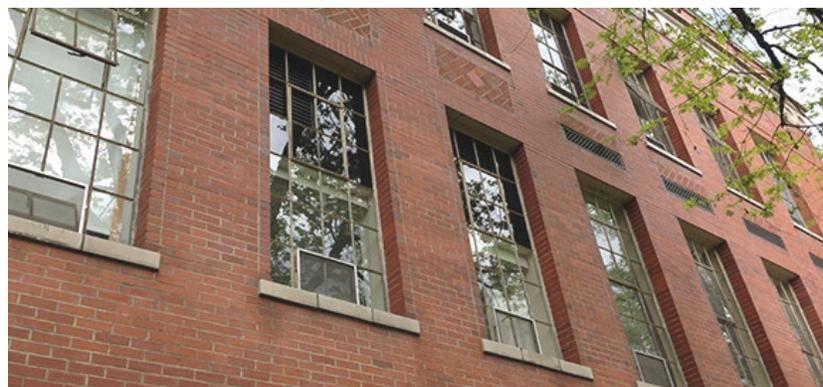
Darkened glazing and vents on south facade of Room 206 as a part of the 2001 Room 207 remodel.

facade were painted a gloss black and vents were inserted. In 2001, Room 207 underwent a renovation. During this renovation, the ceiling of Room 206 was dropped. The glazing above the dropped ceiling was darkened (method used is unknown at this time) and vents were inserted. Also, glazing was darkened and vents were inserted into the window of room 207A on the north facade. In 2013, an air conditioning unit was installed in the third floor computer lab and window coverings were placed on select windows on the first and basement floors to provide visual privacy and reduce glare. Bug screens were also installed on select windows (unknown date).

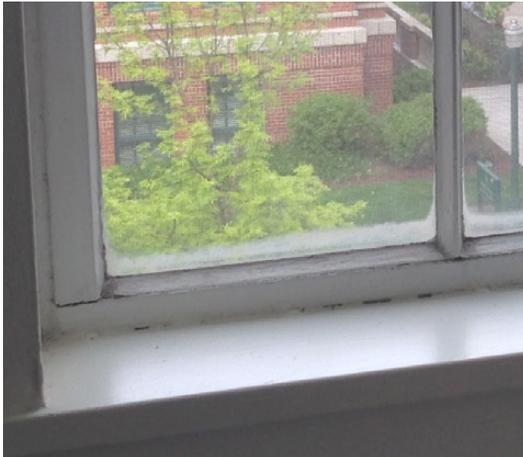
*Slight condensation found on interior of window in Chapman Hall. Notice corrosion appearing at joints of steel frame.*

Both single-pane glazing and steel window frames without thermal breaks are poor insulators and can cause thermal bridging from the exterior to the interior. This means that when the air outside is cold, the interior surface of the window and window frame will also be cold. Not only does this result in greater heat loss, but it can also create condensation problems. When warmer, moist air of the interior touches the cold surfaces of the window, the water vapor in the air will cool, condense, and collect on the horizontal surfaces of the window.

If condensation is allowed to continuously come into contact with the raw metal of the frame, corrosion (rust) can occur, and if left to progress, can cause structural damage to the window. If the weather outside is at a freezing level, the poor insulation of the window and frame can cause the condensation in and around the window to freeze as well. The expansion of the freezing water also contributes to the degradation of the window.

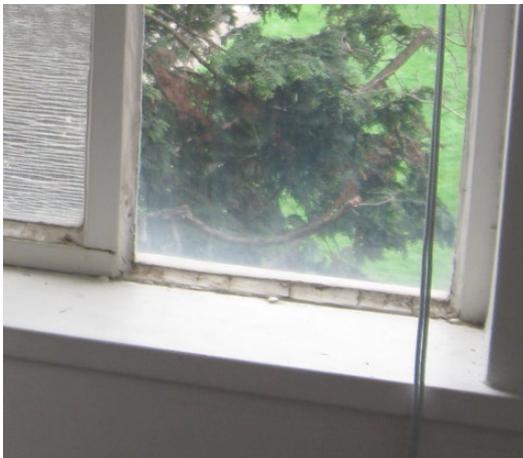
*Corrosion found permeating through cracks in the paint and glazing compound on a window in Chapman Hall.*

The most common source of degradation in steel-frame windows is corrosion. Corrosion (oxidation) is caused by the exposure of raw steel (primarily composed of iron) to air and moisture. Exposure can be caused by excessive and long-term condensation, paint failure, glazing compound failure, building enclosure failures, and other causes that expose the steel to air and moisture.

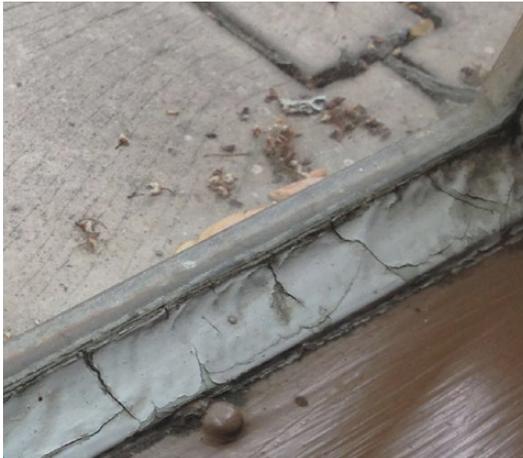
*Paint failure found on a window in Chapman Hall.*

Paint is used to protect the steel from exposure to air and moisture. When the paint is not regularly maintained, cracks and chipping can occur which may result in moisture penetration and subsequently corrosion.

Many layers of paint may also be present. It is important to remember that heavy layers of paint could hide any corrosion problems of the raw steel beneath. It could also negatively affect the operability of the window.

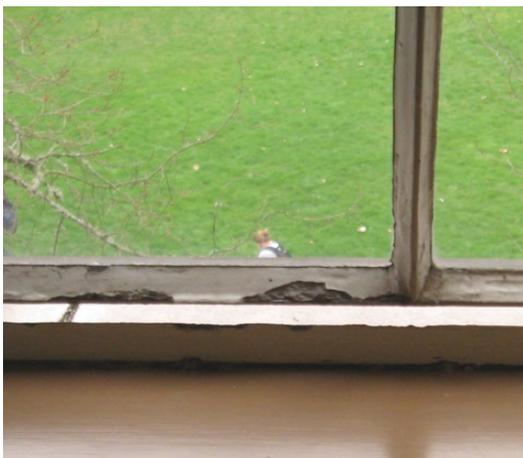
*Glazing compound failure found in Chapman Hall.*

Glazing compound failure can cause glass failure and can allow moisture to penetrate to through the raw steel and induce the process of corrosion.

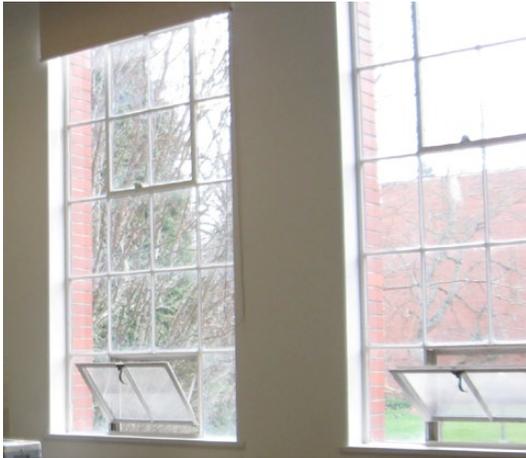
*Locking mechanisms on upper operable sections do not match the rest of the windows in Chapman Hall. It appears that they are missing handles.*

It is common for hardware failure to result in removal or incompatible replacement.

When rehabilitating steel windows, it is important to assess the presence and condition of all window hardware. If hardware is absent or incompatible replacements are present, one should try to find or salvage original hardware from similar windows that may be too damaged to repair. If salvage is not possible, custom fabrication is an option for replication of original hardware.

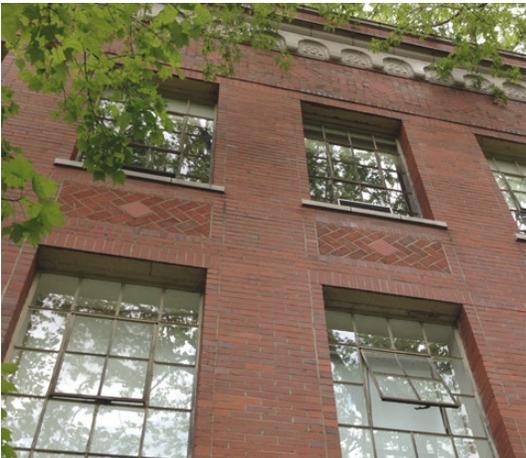
*Corrosion of steel lintel in masonry surrounds on Chapman Hall.*

The condition of these surrounds is a major factor in determining if windows can be repaired in place.
