UNIVERSITY OF OREGON

FRIENDLY HALL ASSESSMENT

FACILITIES ASSESSMENT & FEASIBILITY STUDY

MARCH 2022

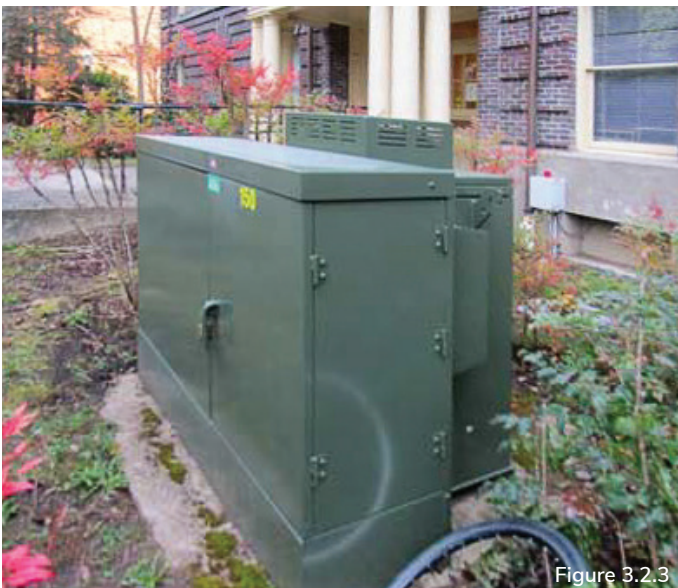
Figure 3.2.3

Friendly Hall is served by a transformer on the west side of the building. The transformer is located on a concrete pad above ground (figure 3.2.3).

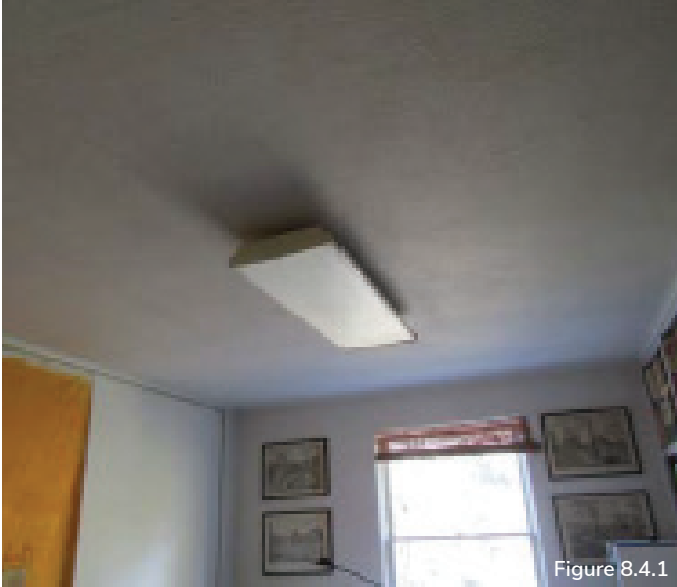
Figure 8.4.1

The interior lighting is showing significant signs of wear and age. It consists of mostly lay-in and surface-mounted fixtures with acrylic, parabolic, or no lenses and T8 fluorescent or compact fluorescent bulbs. The interior lighting varies in age; older fixtures can be found throughout (figure 8.4.1) while some contemporary fixtures exist in previously renovated spaces (figure 8.4.2). Additionally, decorative surface mounted fixtures have been installed in corridors (figure 8.4.3) though they are not original.

Occupancy sensors were observed in select rooms for energy conservation. Integral battery packs or stand-alone bug-eye fixtures were not observed for emergency egress illumination.
