Gerlinger Hall

Preliminary Historic Assessment

University of Oregon
Campus Planning, Design and Construction - January 2014 (updated January 2016)

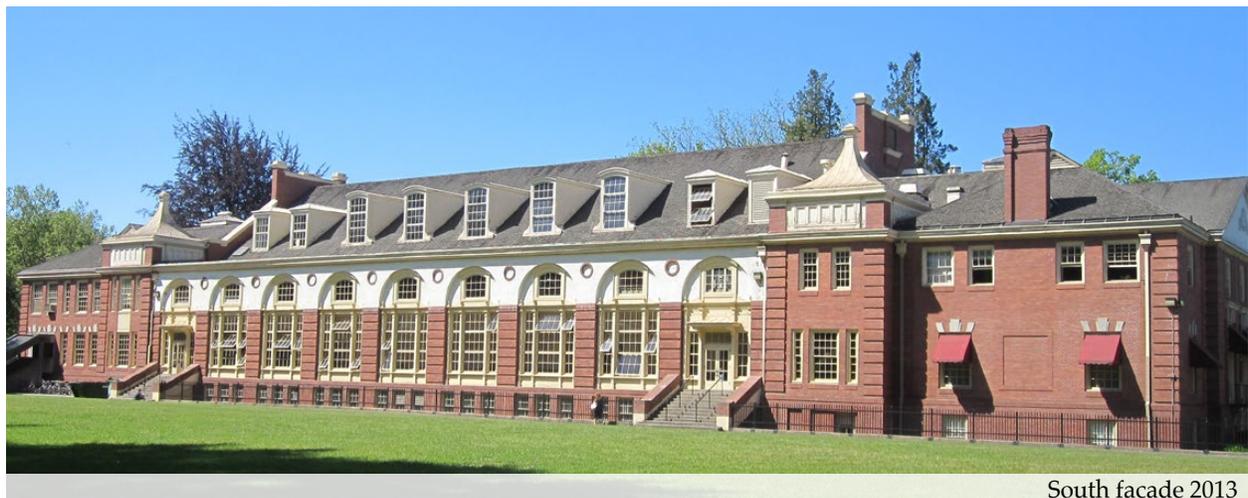
South facade 2013

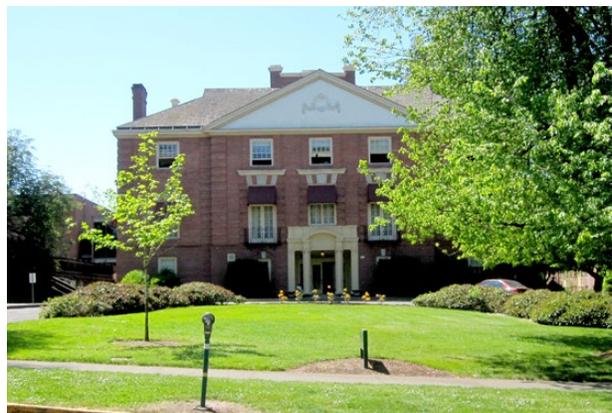
2013 East facade

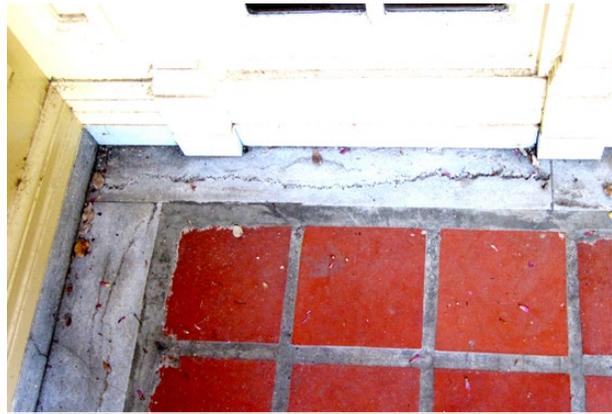
It is important to note that the original materials of the entrance's exterior vestibule have remained intact. These materials include a marble perimeter with a terracotta tile infill.

2013: Original exterior vestibule materials intact

1. Remove all unnecessary exterior conduit and building-mounted flood lights. If required, replace with compatible fixtures.
2. Retain original materials and compatible light fixture at main east entrance.

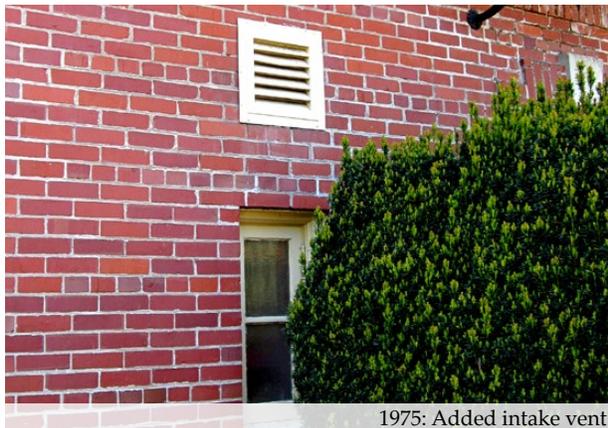
1975: Added intake vent

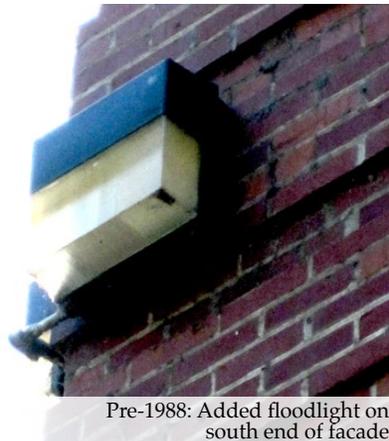
Pre-1988: Added floodlight on south end of facade

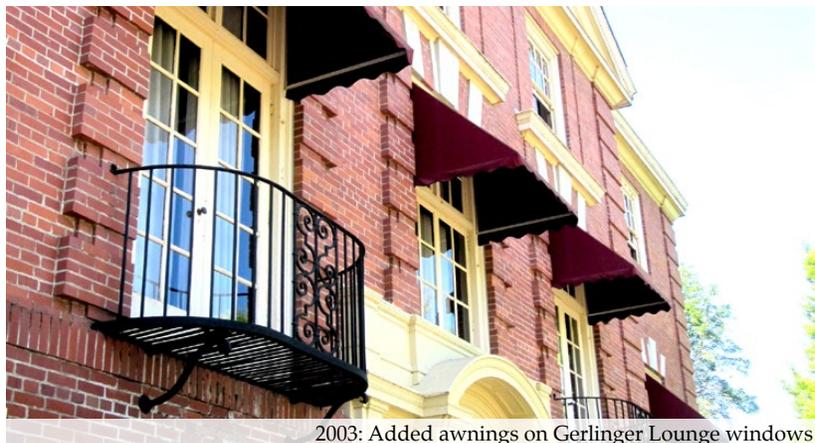
2003: Added awnings on Gerlinger Lounge windows

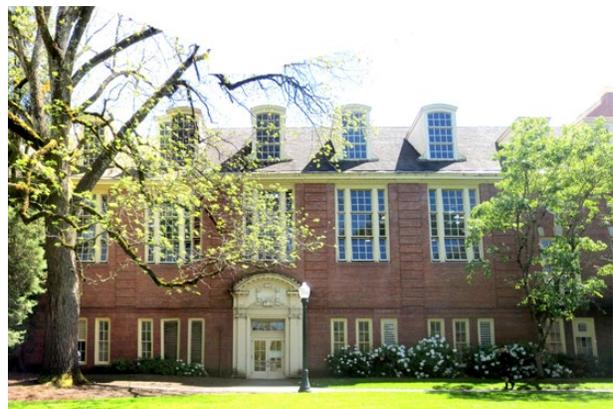
2013 North facade

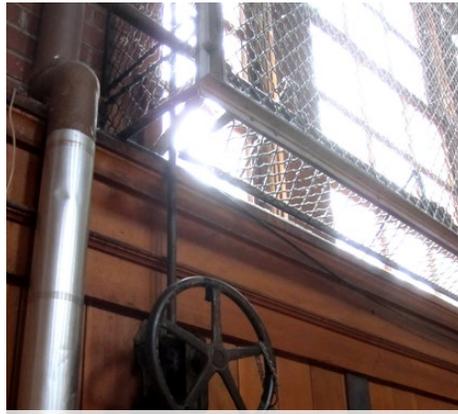
2013: Original wire screens intact

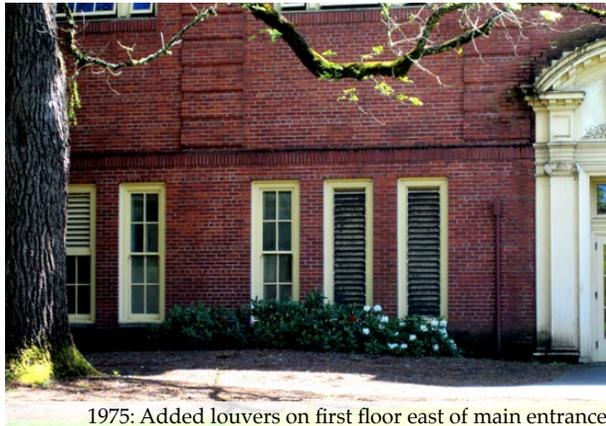
1975: Louvers added into first floor windows and intake vent into masonry east of the main entrance as part of the Locker Room Remodel Project.

1975: Added louvers on first floor east of main entrance

3. Assess current roofing material - consider cedar shingles.
4. Remove all unnecessary louvered vents on the north facade and replace with original sashes, if existing, or compatible new sashes (coordinate removal of vents with Student Recreation Center project).

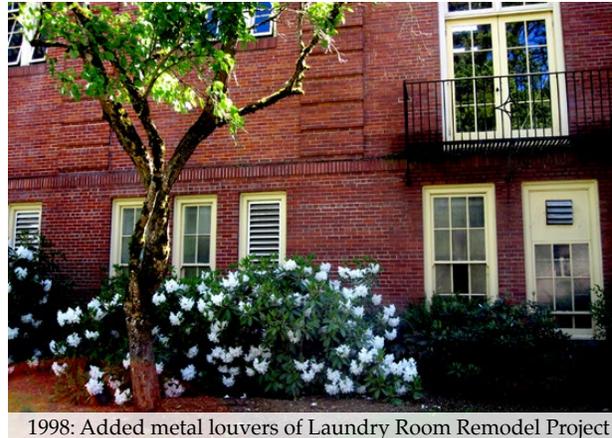
1998: Metal louvers installed to three first-floor windows east of main entrance. Remaining operable window frames were permanently screwed shut as part of the Gerlinger Laundry Room Project.

1998: Added metal louvers of Laundry Room Remodel Project

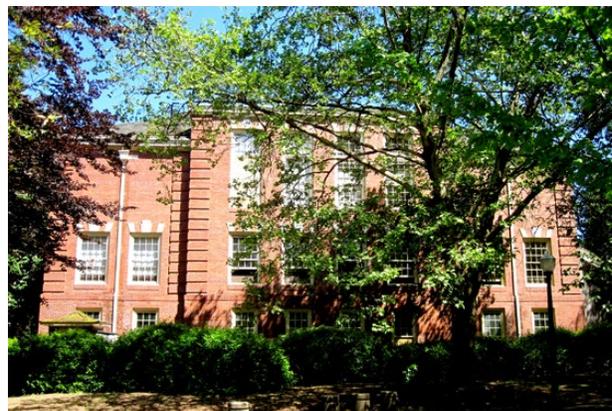
Post 1935: Removal of awnings shown on some of the second floor windows. It is likely the awnings were never replaced as foliage and new campus buildings provided necessary shade for the facade.

2013 West facade (without awnings)

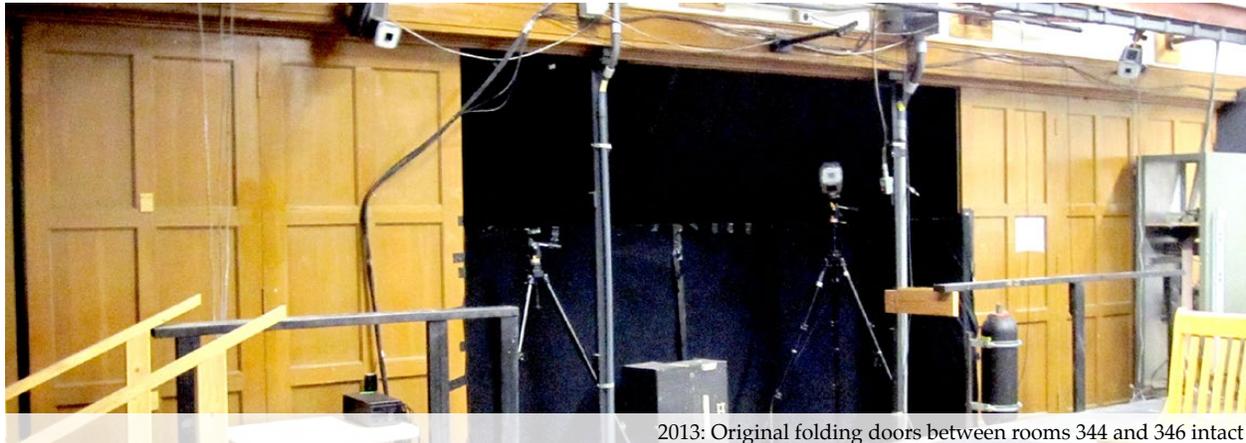
It is important to note that the original interior wood folding walls between rooms 344 and 346 have remained intact.

2013: Original folding doors between rooms 344 and 346 intact

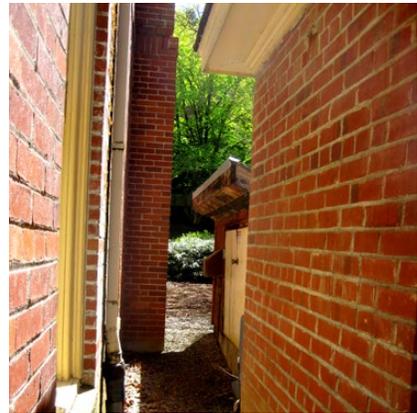
1963: Detached pool chlorinator building constructed at the southwest corner of the building.

1983: Detached surge chamber constructed directly south of the chlorinator building as part of the Pool Restoration Project.

Chlorinator building & surge chamber

9. Remove pump shed.
10. Assess reuse of chlorinator building and/or remove.
11. Repair hardware scars on masonry from iron balcony and ladder on the west facade.

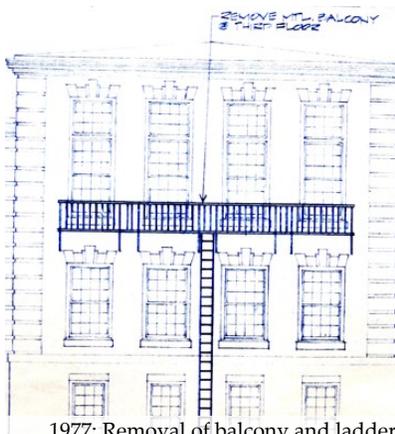
1977: Original wrought iron third-floor balcony and ladder removed.

1977: Removal of balcony and ladder

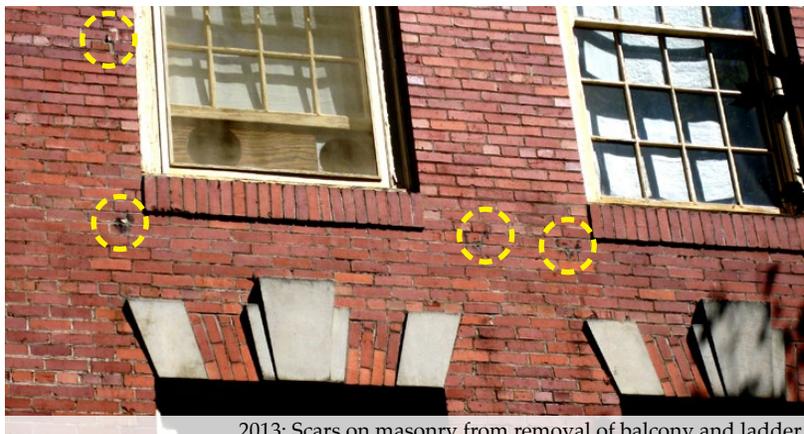
2013: Scars on masonry from removal of balcony and ladder

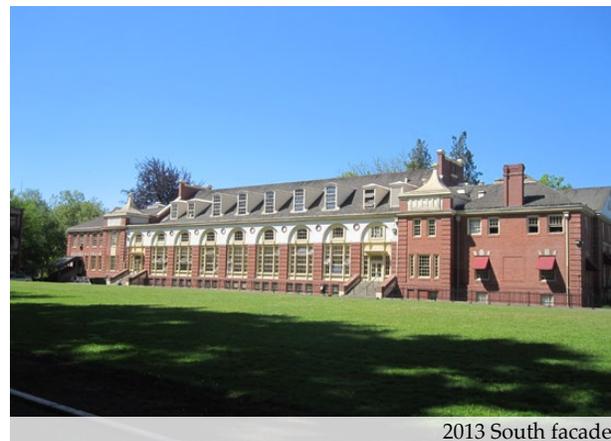
2013 South facade

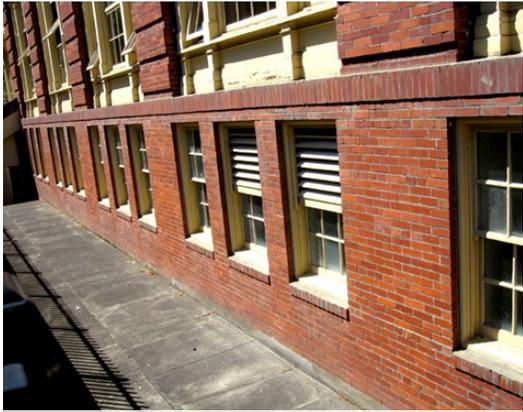
1975: Original glazing, muntins, and stops removed, and louvers installed in original first-floor window frames between main entrances as part of the Locker Room Remodel Project.

1975: Louvers installed in first-floor window frames

12. Assess need for louvered vents on the south facade and possibly replace with original sashes, if existing, or compatible new sashes.
13. Retain and maintain black metal fence along sidewalk adjacent to the south facade.

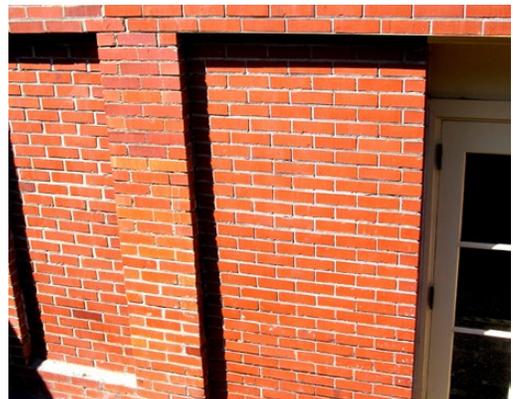
1977: Brick infill of original first-floor openings

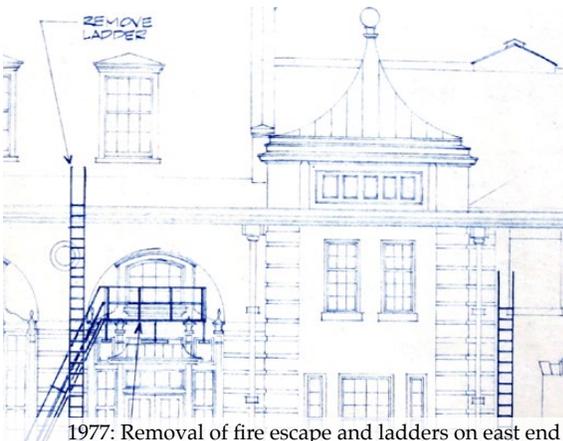
1977: Removal of fire escape and ladders on east end

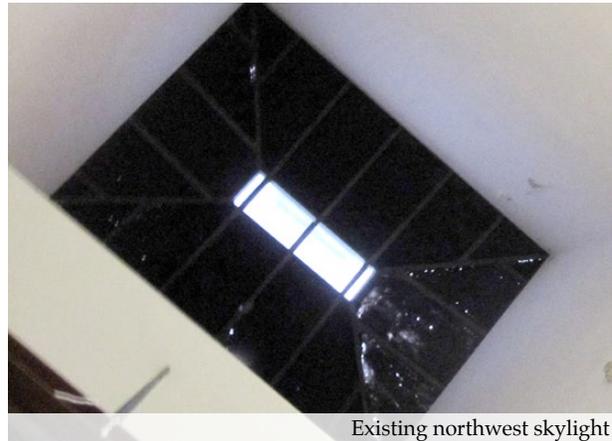
Alterations:
1977: Original ribbed glass ceiling panel removed from each of the three skylights as part of the Life Safety Remodel. The removal of the panels left the skylight wells exposed to users of the space.
1992: Comprehensive repairs made to exterior of building.
Date Unknown: The original glazing of the northwest skylight was painted black to eliminate the allowance of natural light into the space below.

Existing northwest skylight

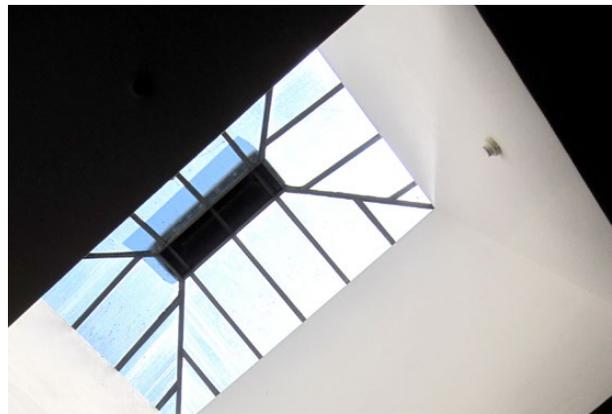
Existing southwest skylight

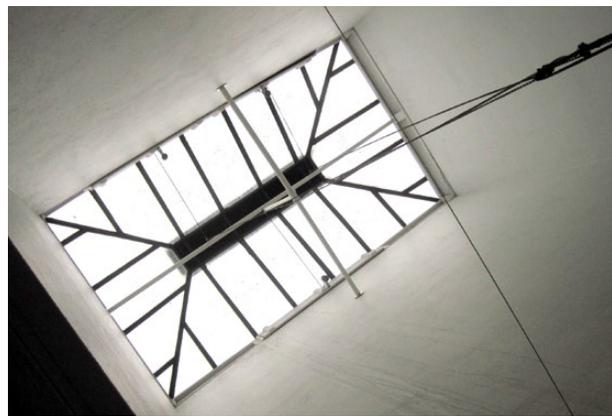
Existing east skylight

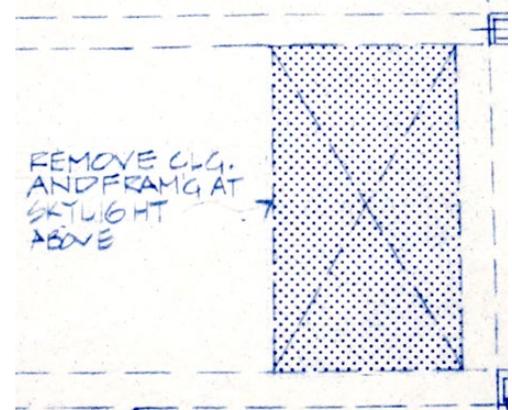
1977: Removal of original ribbed glass skylight panel

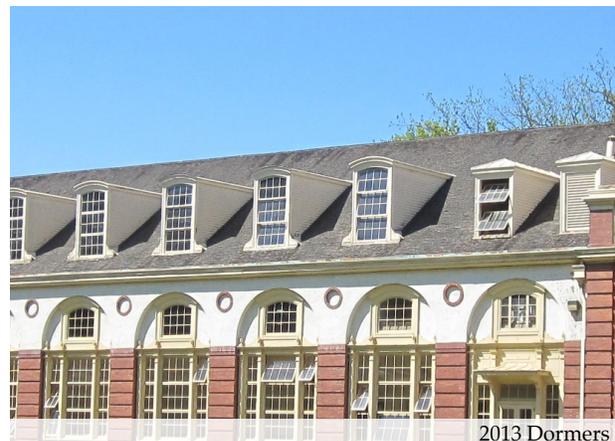
Post 1977: Original exterior, unpainted cedar siding, painted cream.

2013 Dormers

5. Re-side dormers with cedar shingles with clear finish.
6. Assess need for louvered vents in dormers on north and south facades and possibly replace with original sashes, if existing, or compatible new sashes.

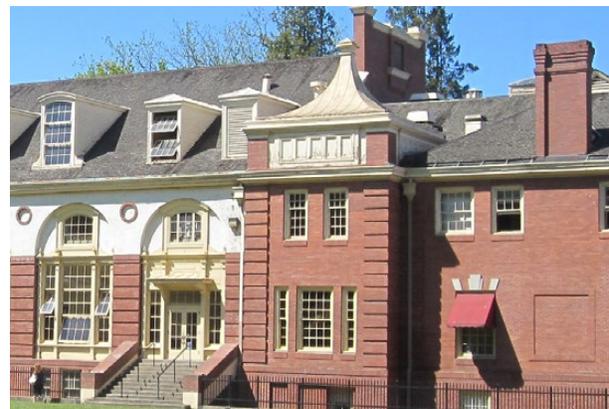
2013 Southeast Tower

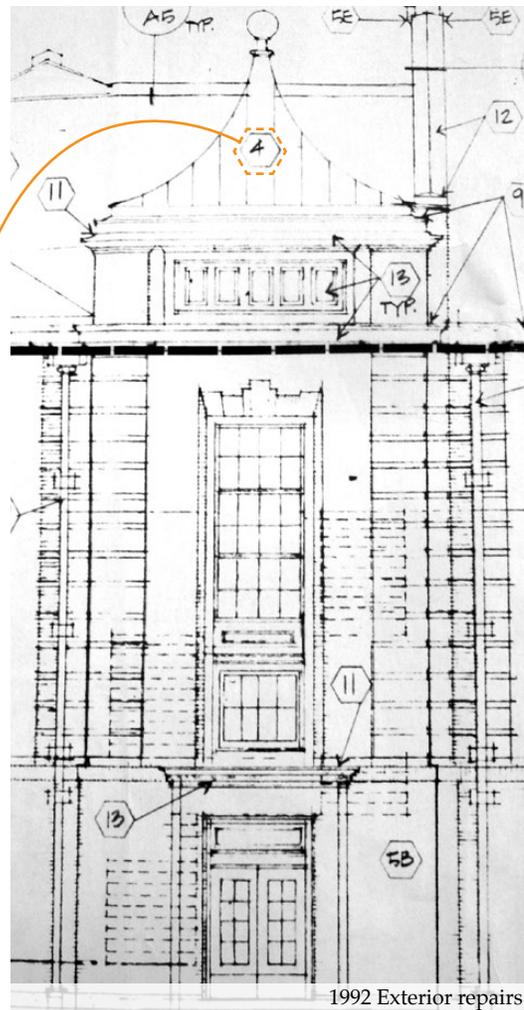
1992 Exterior repairs

4. ROOF AREAS 'D': SCRAPE AND WIRE BRUSH ENTIRE SURFACE OF EXISTING METAL ROOFING TO REMOVE LOOSE PAINT. FIELD PAINT WITH (2) COATS OF PAINT TO MATCH EXISTING COLOR
