## Preliminary Gerlinger Hall Window Assessment

April 2013 (updated January 2016) | University of Oregon | Campus Planning, Design and Construction

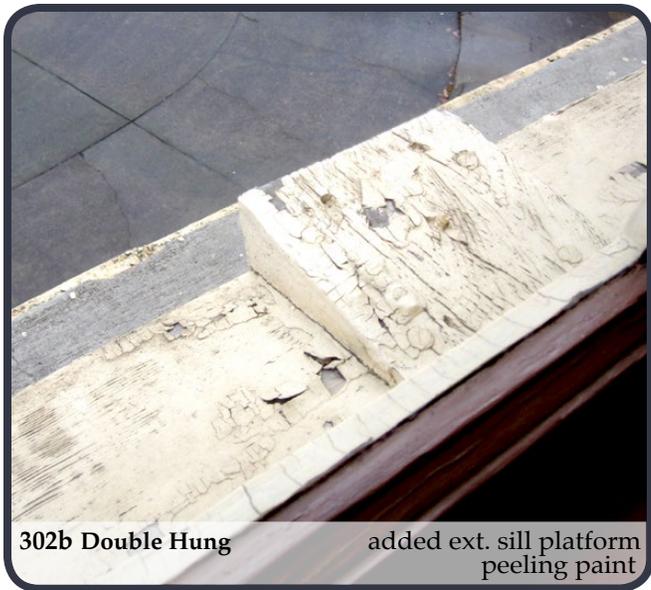
302b Double Hung

added ext. sill platform  
peeling paint

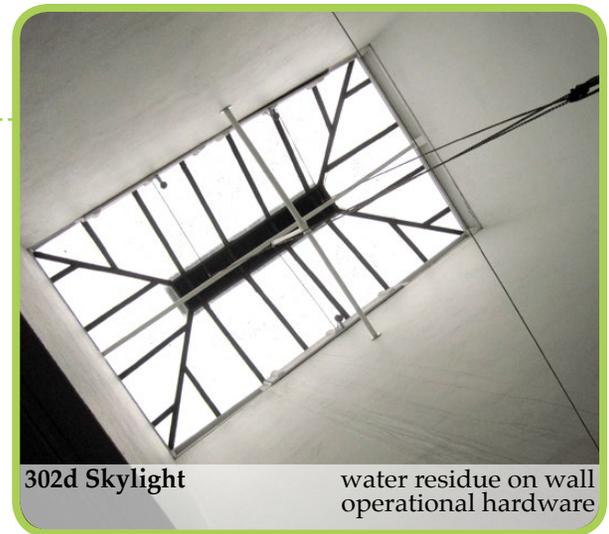
302d	Skylight	Good	Good:	White paint - evidence of water leaking into light well	Fair:	Cracking, chipping & peeling away	Unknown		Fair:	Numerous cracked panes	N/A	N/A	Good:	Original in place - no additions	N/A	Unknown	N	N	Sky	Y			
303Aa	Double Hung	Good	Excellent:	Red paint	Fair:	Cracking, chipping & peeling away	Fair:	Cracking, chipping, pulling away from window	Good:	Gouged upper muntins from center lock	Excellent:	Wood	Good:	Wood - badly chipping paint	Good:	Original in place - added shading device	Excellent	Poor:	Inoperable	Y	N	S	Y

water residue on wall  
operational hardware

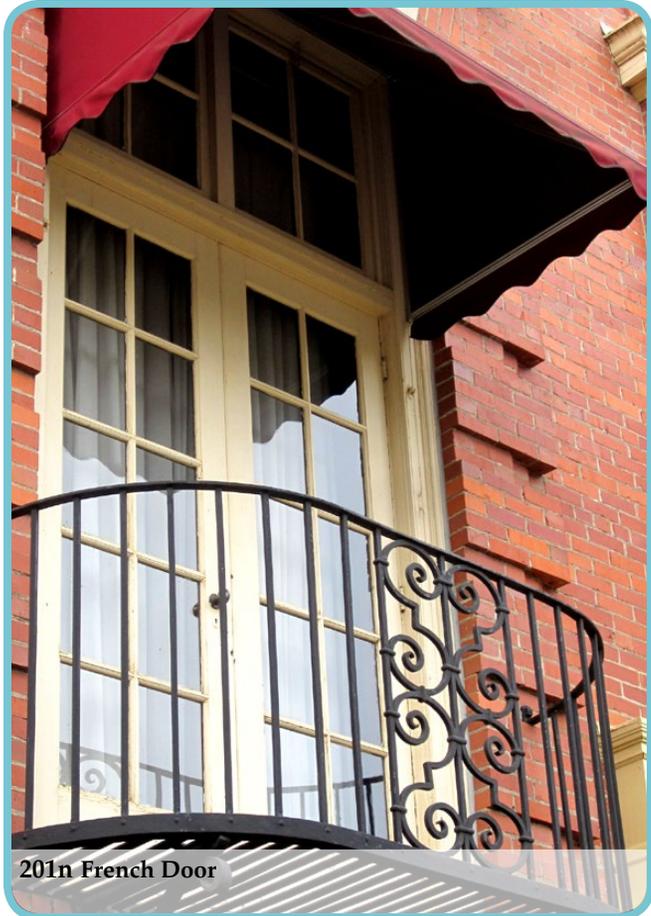
201n French Door

Window #	Window Type	Conditions														Sig-Air Gap?	Dry Rot?	Fac. Elev.	Photo ?				
		Overall	Interior Paint		Exterior Paint		Glazing Compound		Window Parts*	Interior Stool Condition		Exterior Sill Cond.	Hardware		Weight Cord Cond.					Operability			
201n	Door	Good	Good:	Dark wood stain - minor gouging & chipping	Good:	Significant chipping at threshold	Fair:	Cracking, chipping, pulling away from window in areas	Excellent	N/A	N/A	Excellent:	Original in place - no additions	N/A	Good:	Needs force to open	N	N	E	Y			
201o	Transom (hopper)	Good	Good:	Dark wood stain - minor gouging & chipping	Good:	Cracking & chipping	Fair:	Cracking, chipping, pulling away from window in areas	Excellent	Unknown	Unknown	Excellent:	Original in place - no additions	N/A	Unknown		N	N	E	Y			
307a	Horiz. Pivot	Good	Fair:	Cream paint - peeling away, water damage at sill	Good:	Minor cracking & chipping	Good:	Minor cracking	Good:	Water damage of lower rail at sill	Good:	Wood - chipping paint	Good:	Original in place - added safety panel	N/A	Excellent	Y	N	S	Y

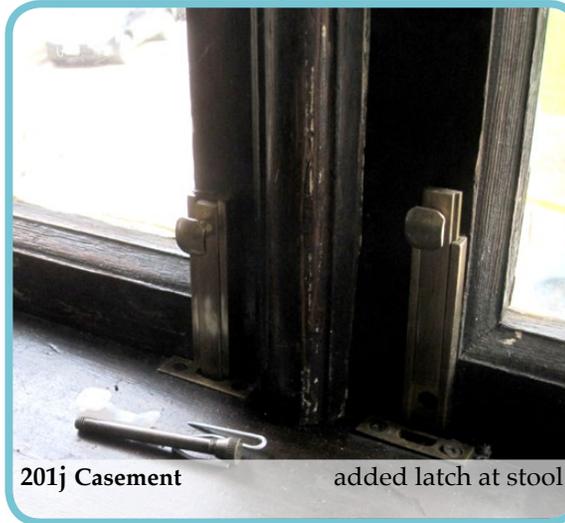
201j Casement

added latch at stool

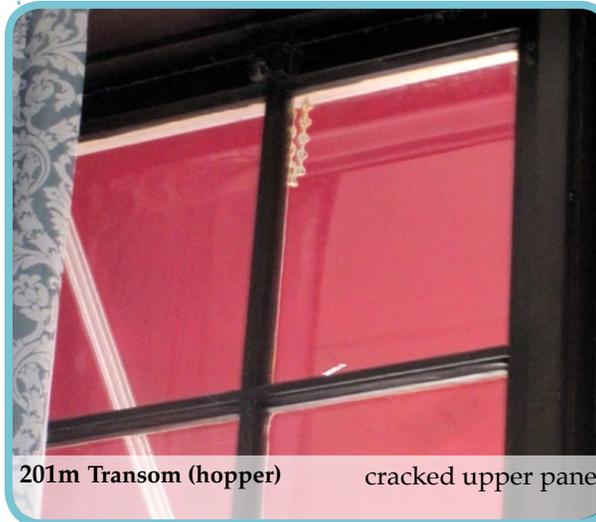
201m Transom (hopper)

cracked upper pane

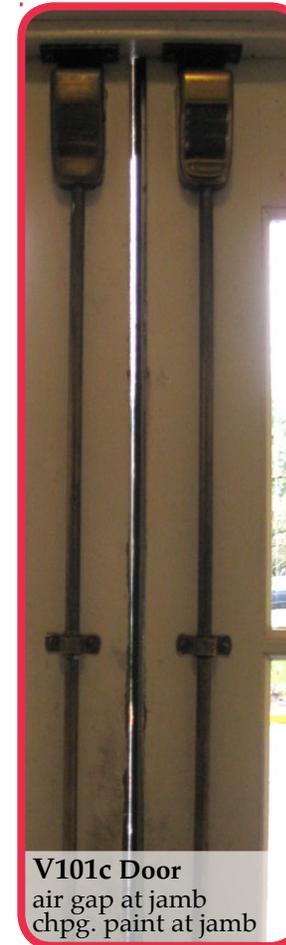
V101c	Door	Good	Good: Cream paint - minor gouging & chipping	Excellent	Excellent	Good: Minor gouging of lower muntins	N/A	N/A	Good: Does not latch shut	N/A	Good: Does not latch shut	N	N	E	Y
V101d	Fixed Side Lite	Excellent	Excellent: Cream Paint	Excellent	Excellent	Excellent	N/A	N/A	N/A	N/A	N/A	N	N	E	Y
V101dd	Fixed Side Lite	Excellent	Excellent: Cream Paint	Excellent	Excellent	Excellent	N/A	N/A	N/A	N/A	N/A	N	N	E	Y
101a	Double Hung	Excellent	Excellent: Cream Paint	Excellent	Good: Minor cracking	Excellent: Etched glazing for privacy	Excellent: Wood	Good: Wood - cracking paint	Good: Original in place - added safety bracket on upper sash	Excellent	Poor: Both sashes painted shut	N	N	E	Y
101b	Hinged Sash	Excellent	Excellent: Cream Paint	Good: Minor cracking	Good: Minor cracking	Excellent: Etched glazing for privacy	Excellent: Wood	Good: Wood - cracking paint	Good: Original in place - no additions	N/A	Poor: Painted shut	N	N	E	Y

air gap at jamb  
chpg. paint at jamb

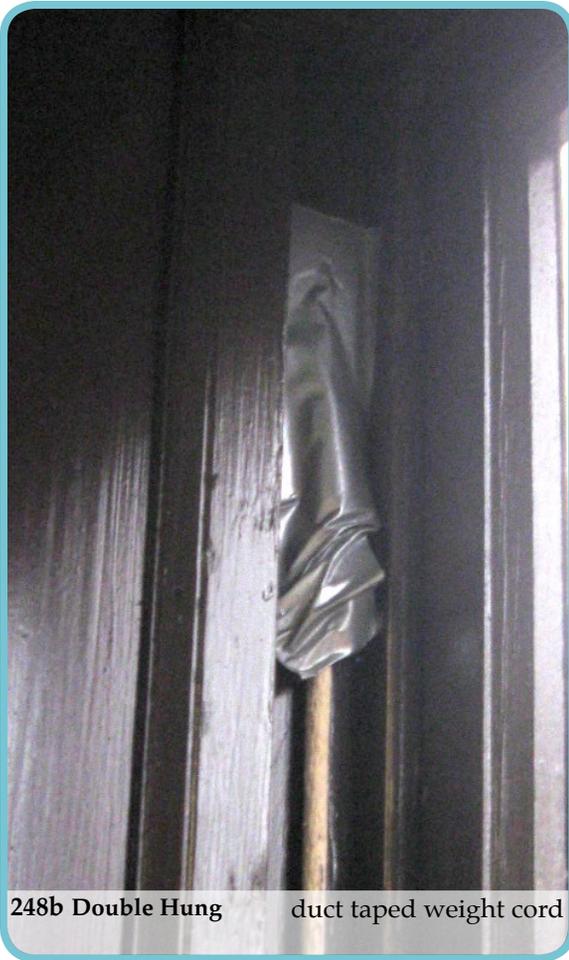
248b Double Hung duct taped weight cord

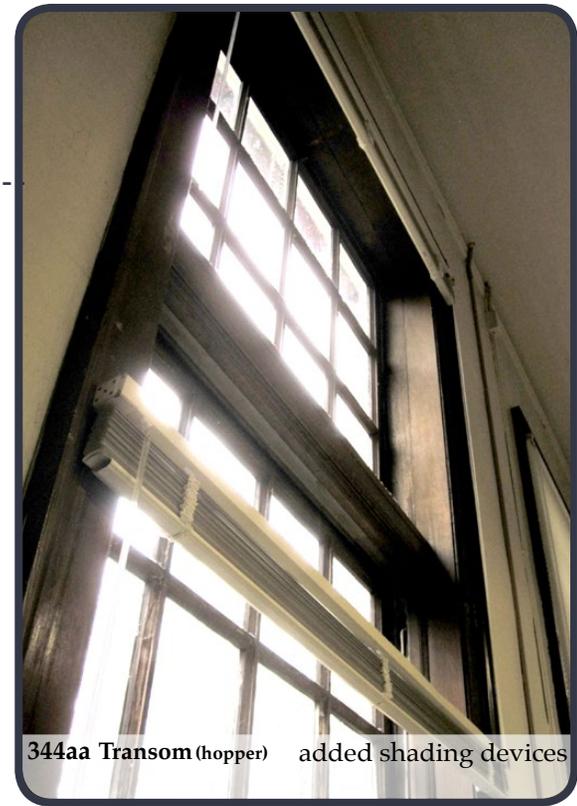
344aa Transom (hopper) added shading devices

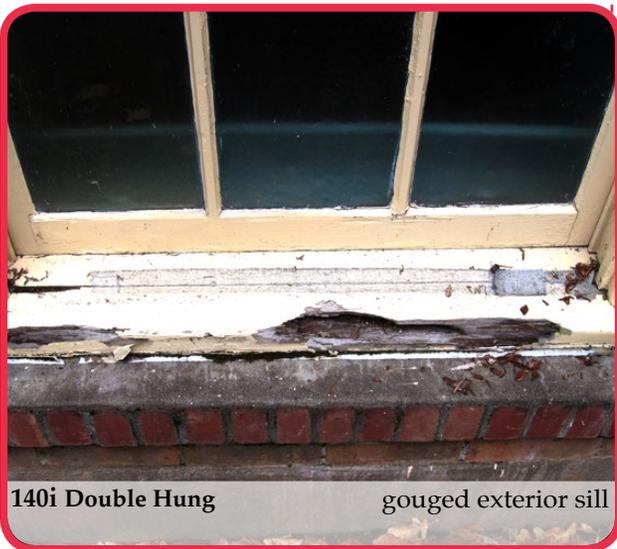
140i Double Hung gouged exterior sill

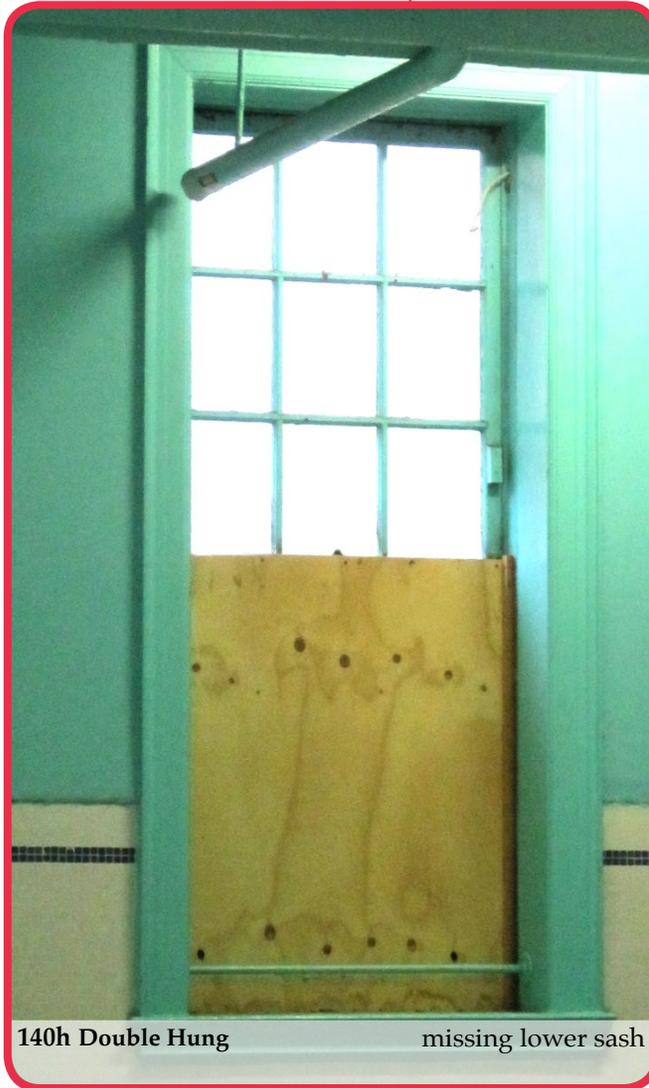
140h	Double Hung	Fair	Good: Teal paint - minor cracking & chipping	Good: Cracking & chipping	Excellent	Poor: Missing entire lower sash	Excellent: Wood	Excellent: Wood	Fair: All hardware on lower sash missing	Poor: Both broken	Poor: Inoperable	Y	N	W	Y
140i	Double Hung	Fair	Good: Teal paint - minor cracking & chipping	Fair: Cracking, chipping & peeling away	Excellent	Excellent	Good: Wood - minor gouging	Poor: Wood - significant gouging	Good: Original in place - added safety bar, blocking on upper sash	Excellent	Poor: Inoperable	Y	N	W	Y
140j	Double Hung	Good	Good: Teal paint - minor cracking & chipping	Excellent	Excellent	Good: Left interior stop bulging	Excellent: Wood	Excellent: Wood	Good: Original in place - added safety bar, blocking on upper sash	Excellent	Poor: Inoperable	N	N	W	Y
140k	Double Hung	Good	Good: Teal paint - minor cracking & chipping	Excellent	Good: Minor cracking	Good: Left interior trim pulling away	Excellent: Wood	Excellent: Wood	Good: Original in place - added safety bar & blocking on upper sash	Excellent	Poor: Inoperable	N	N	W	Y

140h Double Hung missing lower sash

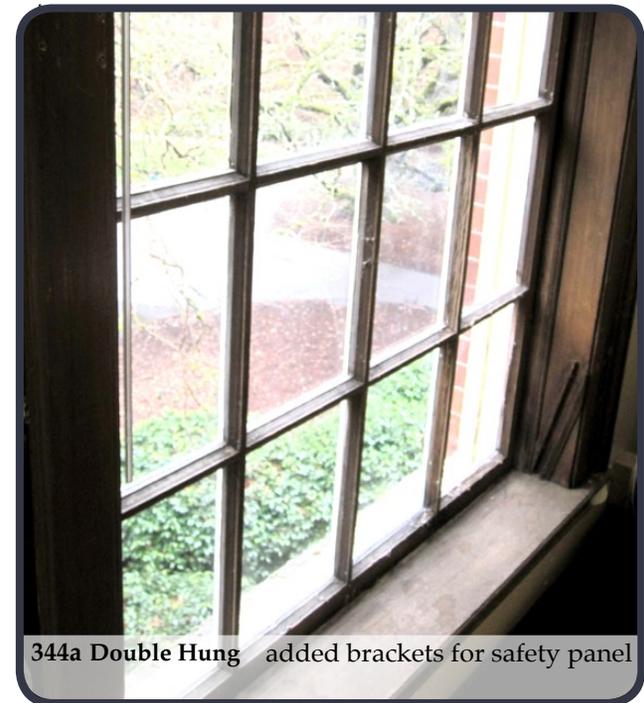
344a Double Hung added brackets for safety panel
