STRAUB HALL INTERIORS PRELIMINARY HISTORIC ASSESSMENT

CAMPUS PLANNING, DESIGN AND CONSTRUCTION
JANUARY 2011 (UPDATED JANUARY 2016)

This assessment identifies Straub Hall's historically significant interior finishes, features, and spaces.

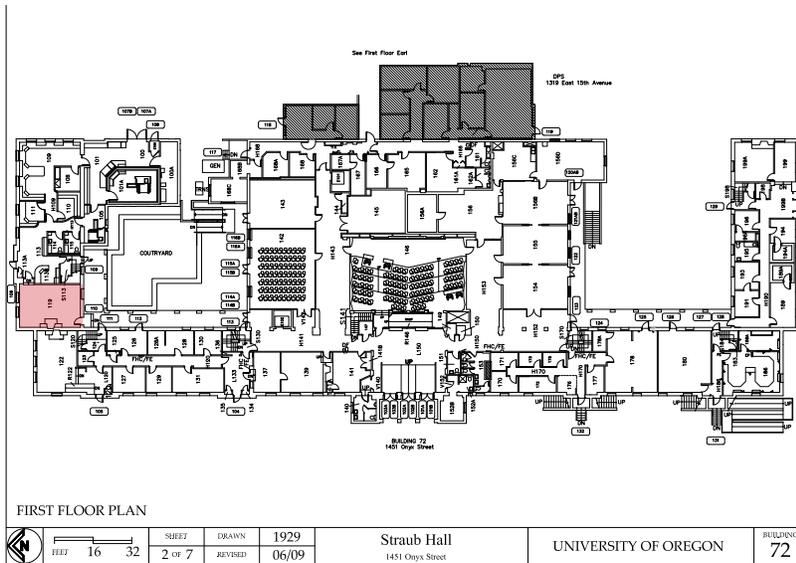
^ FIREPLACE CONTEXT.

Historic Materials: One-half of the entry archway, all window casings, the fireplace and its mantel, built-in shelving and wood paneling.

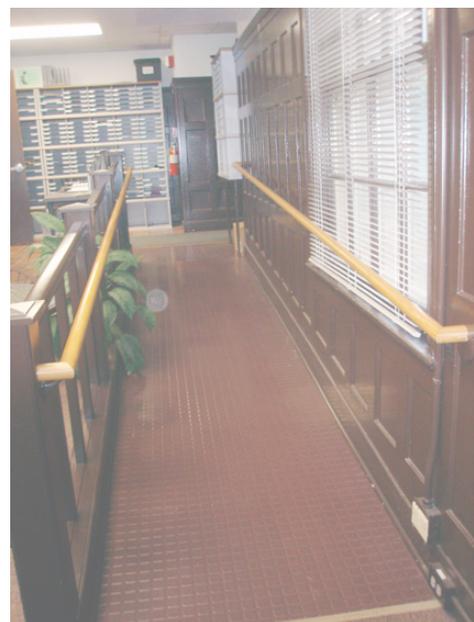
Alterations: The ramp along the west wall, as well as the paneling along the same wall, were 1974 ADA additions. The archway was effectively widened 3' when the closet and adjacent wall were removed to allow for the ramp. The mirror above the mantle was removed and the carpeting was installed. It is unclear if the original taupe linoleum flooring remains underneath the carpet.

^ NEW RAMP AND WALL PANELS.

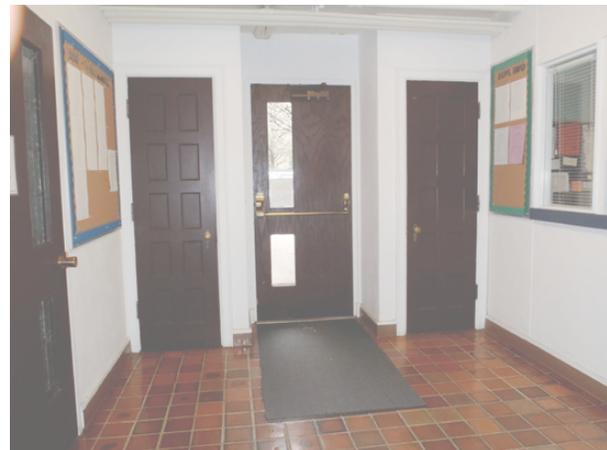
^ ENTRY PASSAGE.

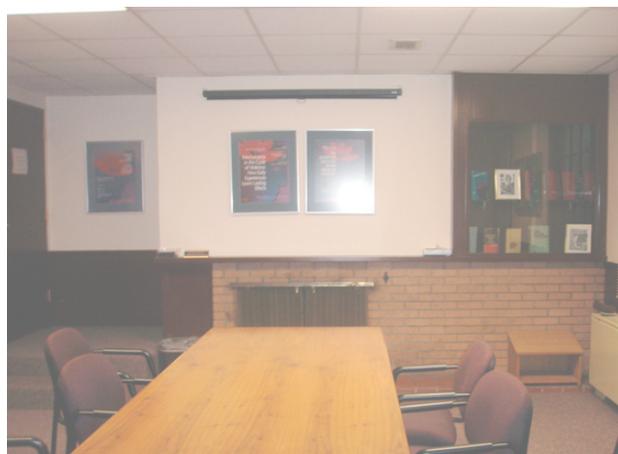
Alterations: Half of the archway was filled in, and the room was divided into two spaces.

^ ROOM 139.

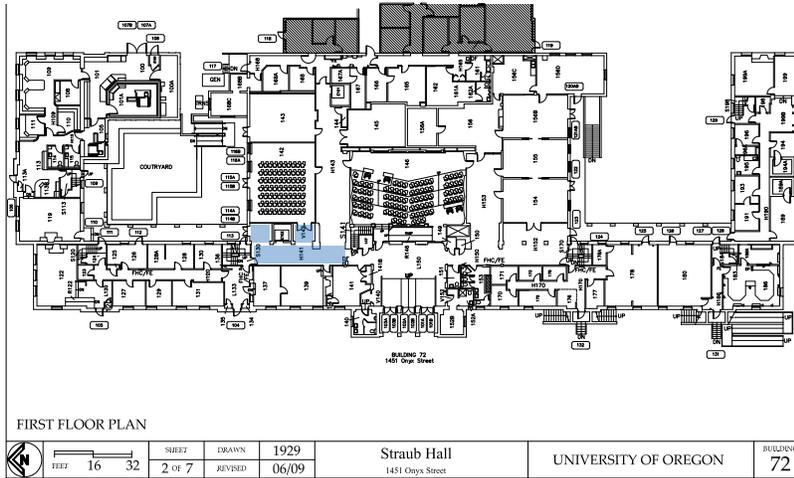
^ CEILING DETAIL.

The original ceiling was covered by an acoustical suspended tile system. In 1974 an elevator was added between two existing structural columns, which were maintained.

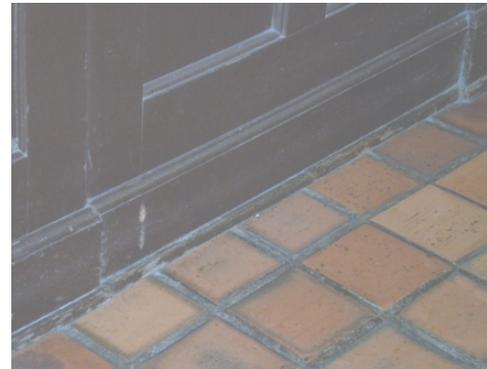
^ FLOOR TO BASE DETAIL.

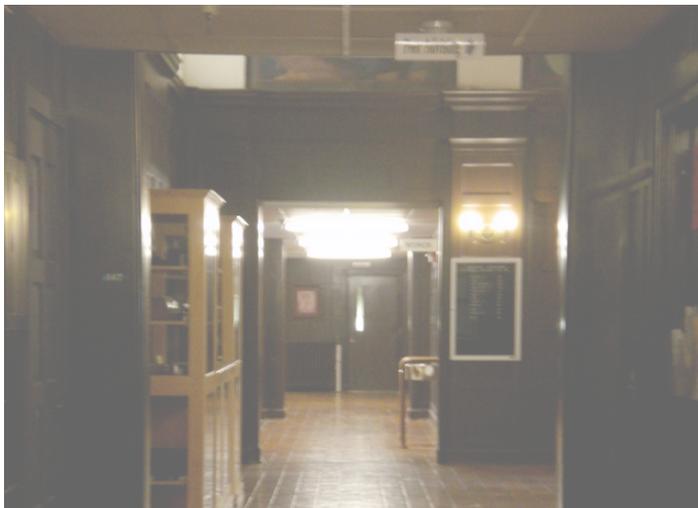
Significant portions of the wood paneling have been replaced due to general upkeep.

^ NORTH HALLWAY LOOKING SOUTH.

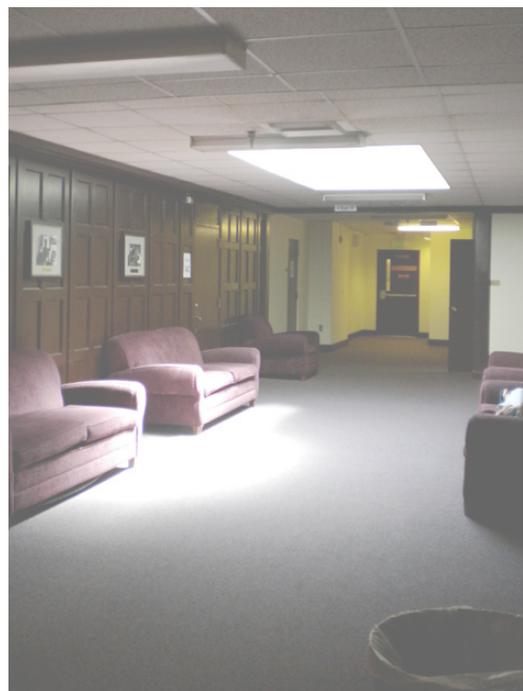
The original ceiling has been covered by a suspended acoustical tile system.

^ NORTH SKYLIGHT HALLWAY.

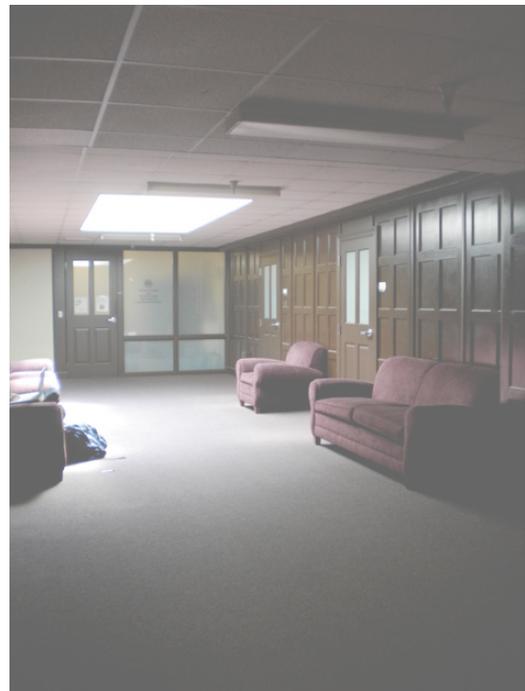
The original ceiling has been covered by a suspended acoustical tile system.

^ SOUTH SKYLIGHT HALLWAY.

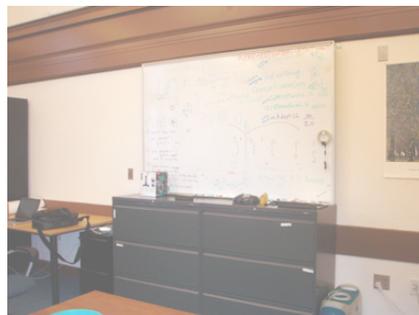
New doors leading to the hallway at the west end of the room replaced a portion of the original accordion wall, now fixed in place. They are covered by a whiteboard and storage cabinet. The doors were kept to allow large equipment to be moved in and out, though these doors are never used.

^ FURNITURE BLOCKED WEST DOORWAY.

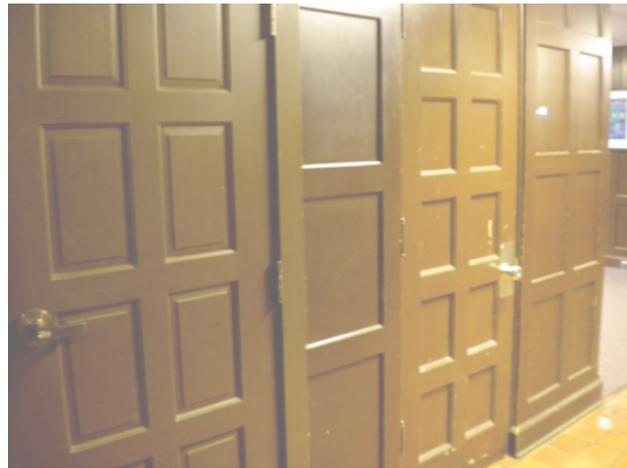
^ HALLWAY DOOR STYLES.

The east wall’s material and double doors are not original but were added in the 1974 remodel and have been preserved since then. A door to what was a trunk room (now a collection of small offices and subject run rooms) has been sealed, but the molding remains. The doors throughout the space are all different, only one being the original style (north of the skylight, first door to the east).

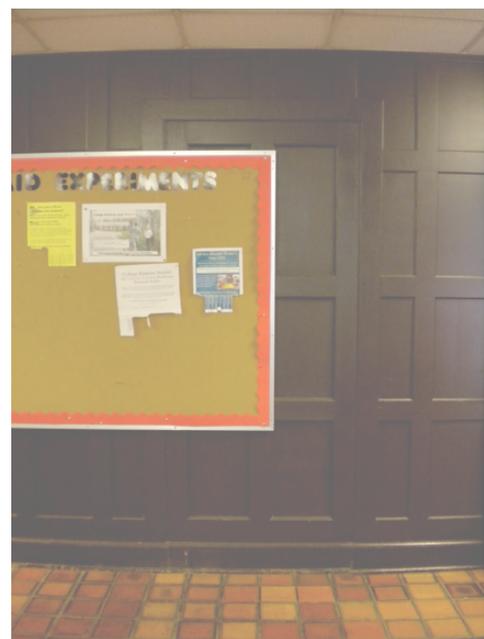
^ SEALED DOORWAY.

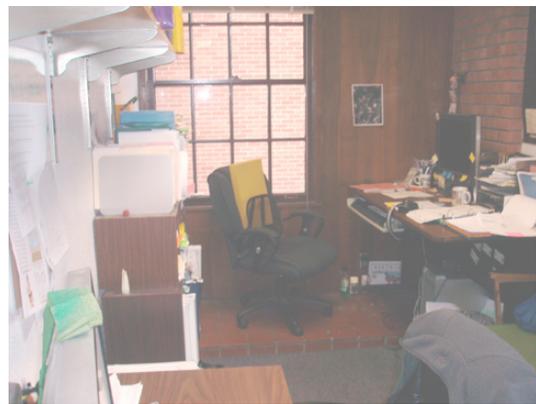
^ FIREPLACE TILING EXTENDING.

Alterations: This room has been divided into two rooms, bisecting the fireplace's tiles. The bricks surrounding the fireplace and the wainscoting have been replaced, along with the addition of the office door. The ceiling tiles have been glued onto the original ceiling; no moulding remains.

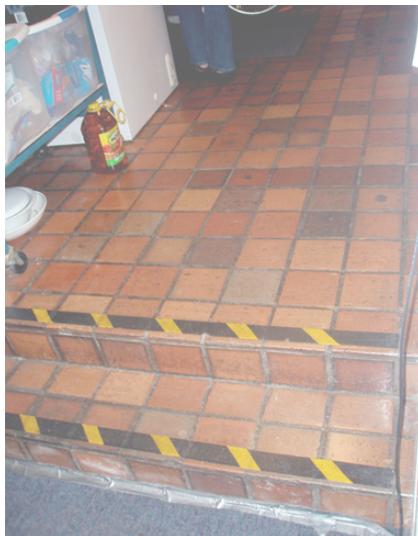
^ ENTRY CERAMIC TILES.

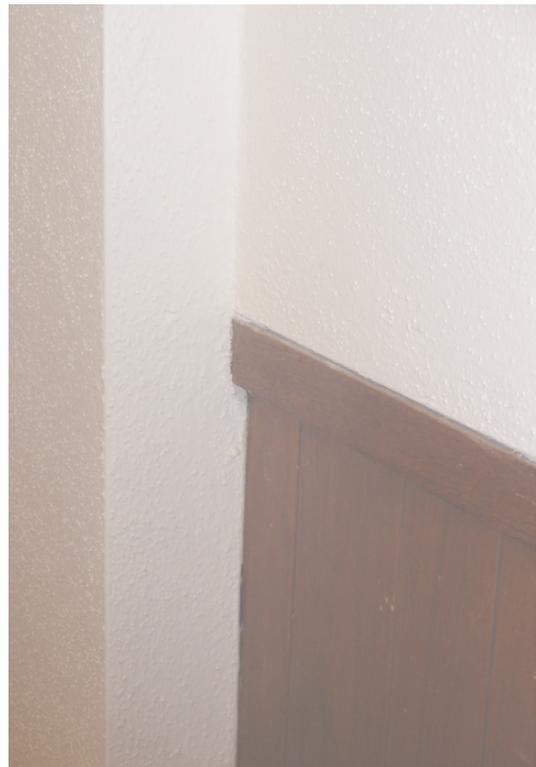
^ WAINSCOTING DETAIL.

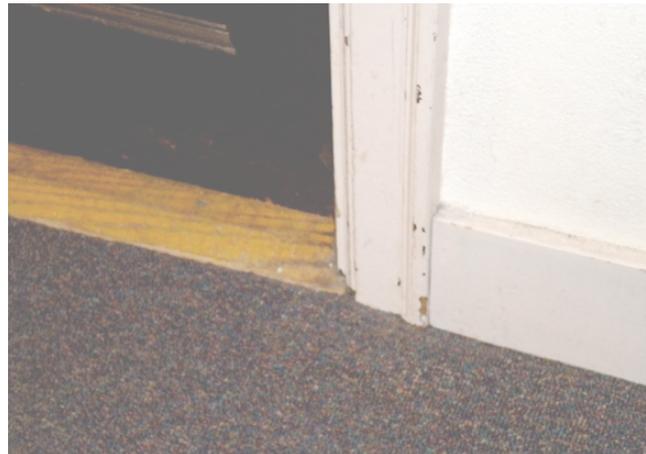
^ SECOND FLOOR BASEBOARD DETAIL.

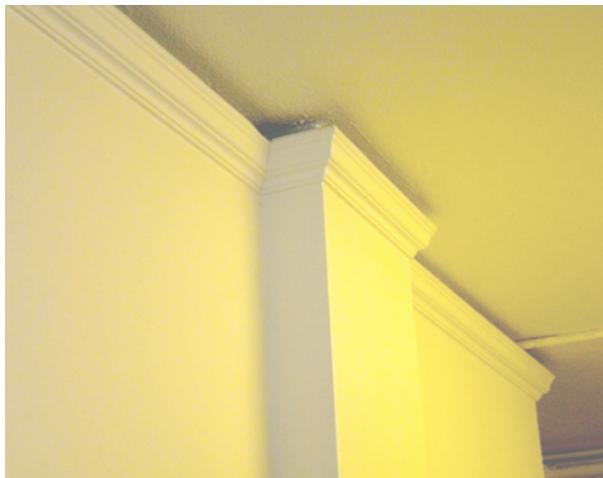
^ MOULDING DROP DETAIL.

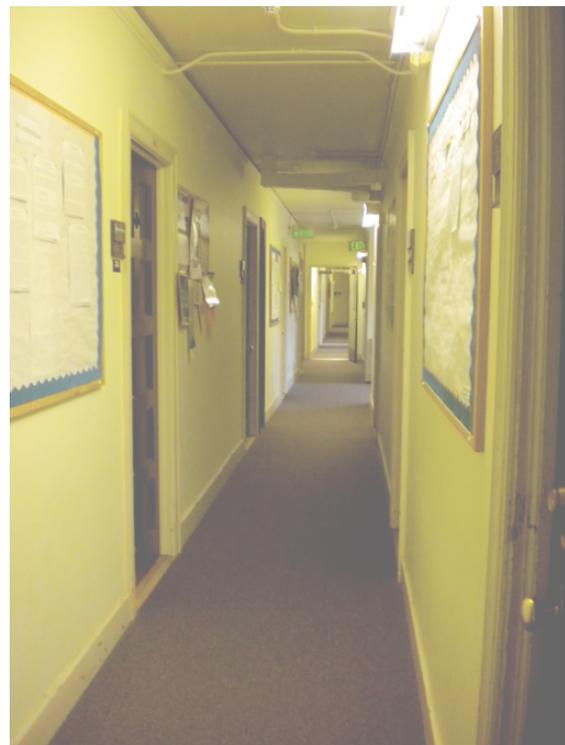
Alterations: In 1974 surface-mounted piping and electrical conduits were added. An elevator shaft and fire doors were also added. In 1984 new carpeting was installed. It is unclear if the original taupe linoleum remains under the carpet.

^ SECOND FLOOR HALLWAY.

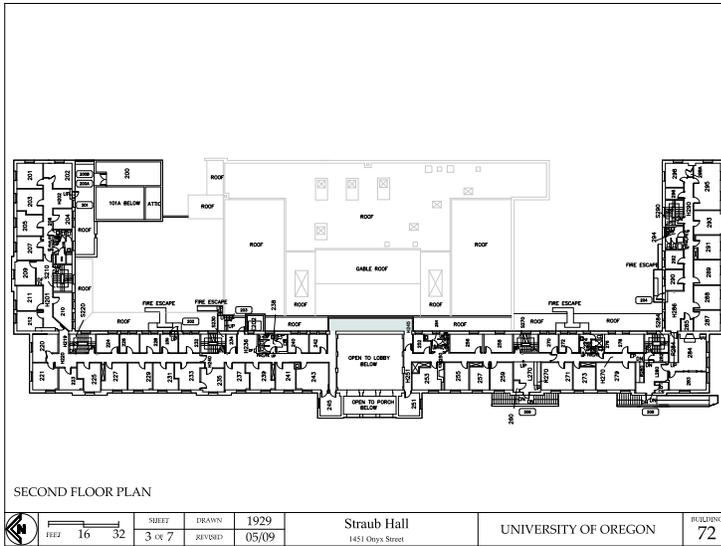
FROM UPPER RIGHT: CORRIDOR SKYLIGHTS; LIGHTING DETAIL; WINDOW DETAIL; CORRIDOR VIEW; MATERIAL OVERLAP DETAIL.

The only alterations to the west wall seem to be the additions of the steel piping across the windows, baseboard heaters, and the electrical light fixtures.

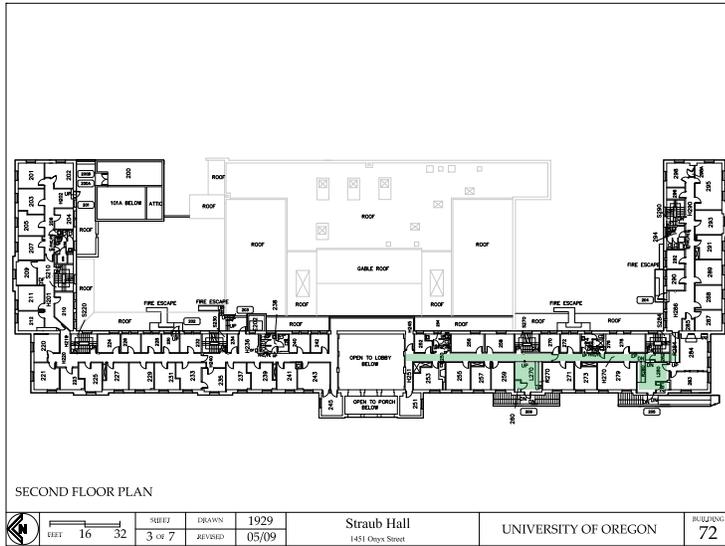
^ SOUTH HALLWAY MOLDING DETAIL.

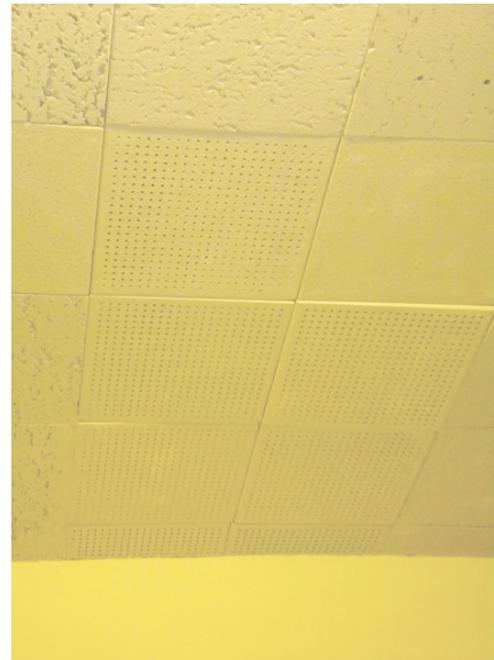
Alterations: Acoustical ceiling tiles, an ADA ramp, and fire doors were added. Most doors appear to be new. In 1984 new carpeting was installed. It is unclear if the original taupe linoleum remains under the carpet.

^ SOUTH HALLWAY CEILING DETAIL.

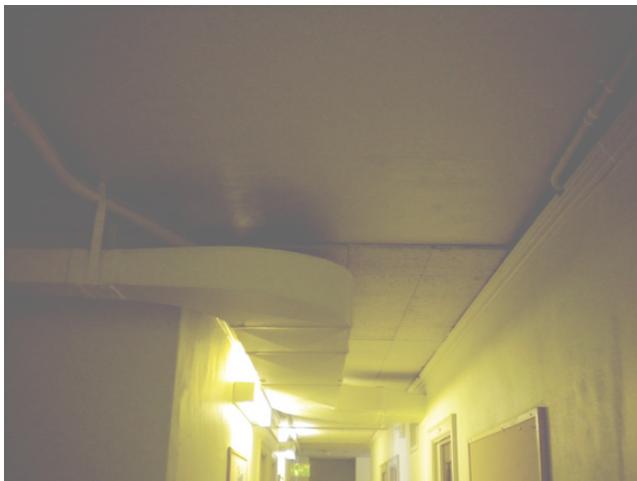
^ END OF ACOUSTIC PANELS DETAIL.

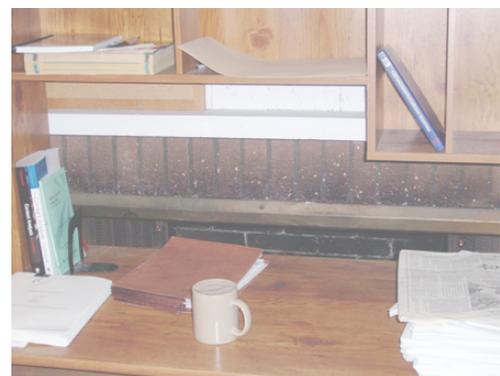
Alterations: The space was divided into three offices. All wall, floor, and ceiling finishes were altered. The fireplace's brick and tile work may have been removed and replaced.

^ FIREPLACE.

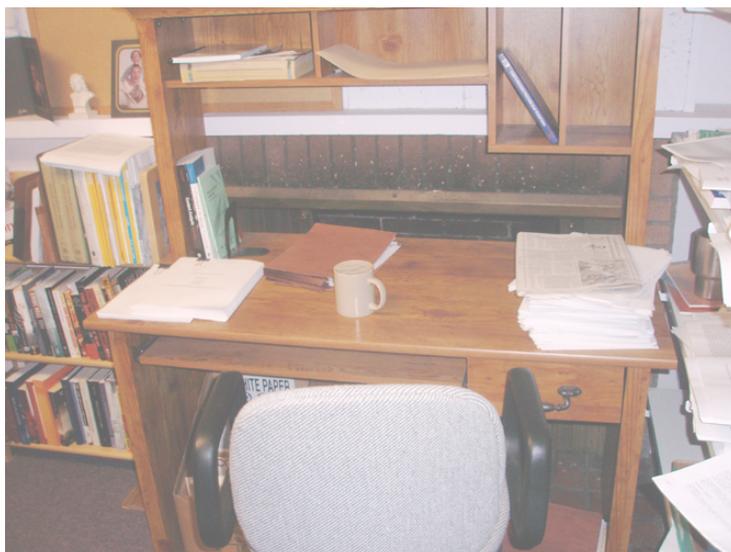
^ FIREPLACE CONTEXT.

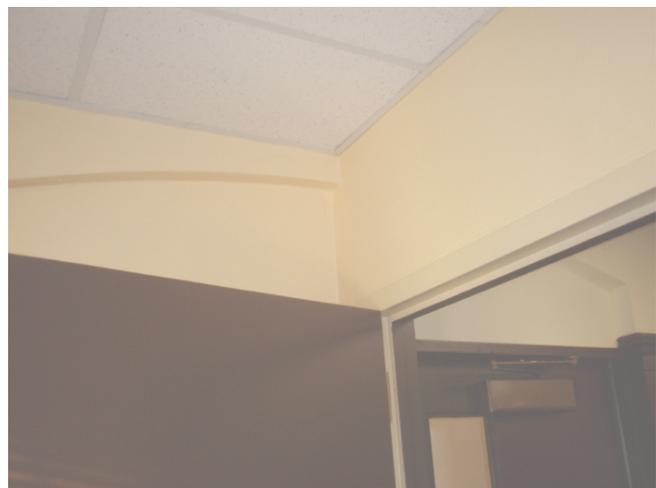
^ ENTRY ARCHWAY DETAIL.

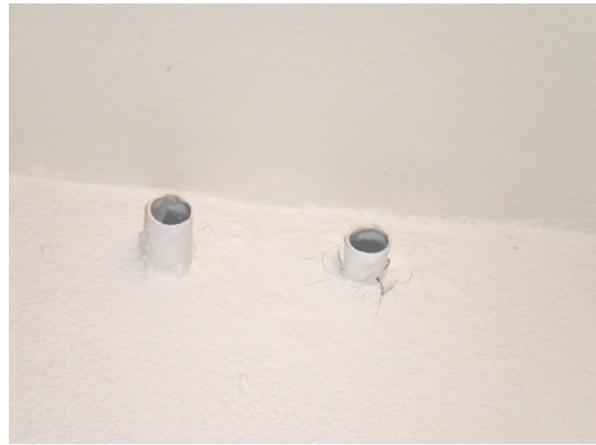
^ NORTH HALLWAY PIPE CUT OFF.

Alterations: New doors; all exposed piping, fire doors, electrical, and mechanical units were added. In 1984 new carpeting was installed. It is unclear if the original taupe linoleum remains under the carpet.

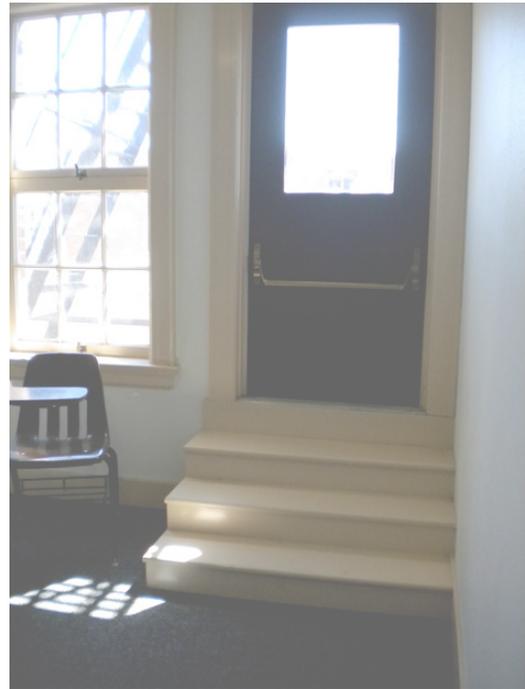
^ NORTH HALLWAY 3RD FLOOR FIRE ESCAPE.

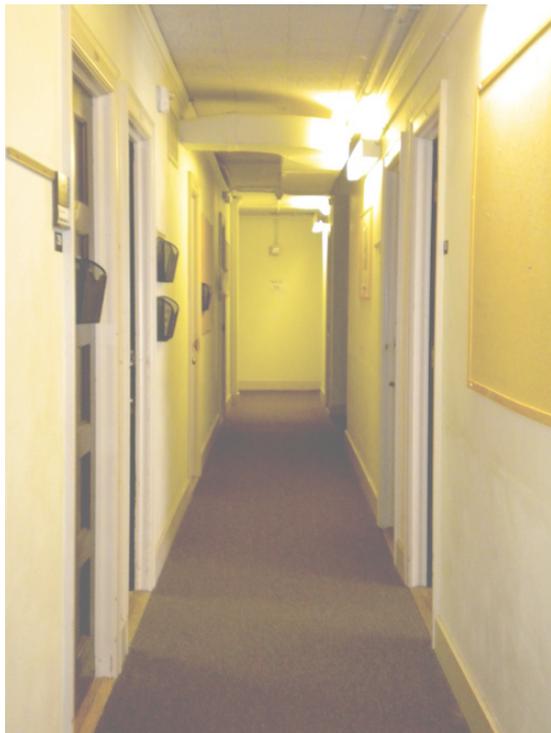
^ NORTH HALLWAY 3RD FLOOR.

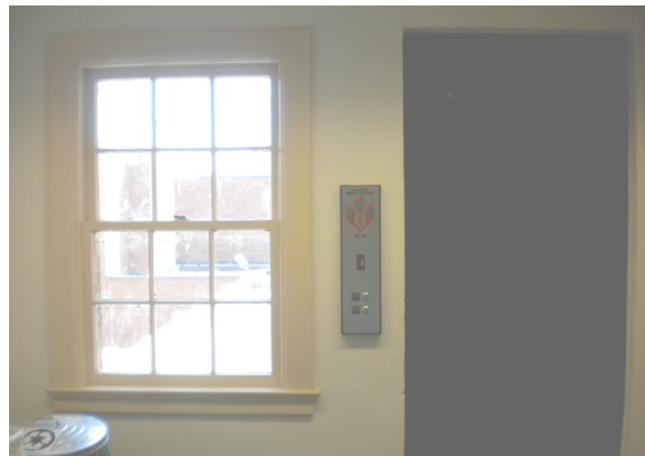
^ WINDOW CASING WITH ELEVATOR.

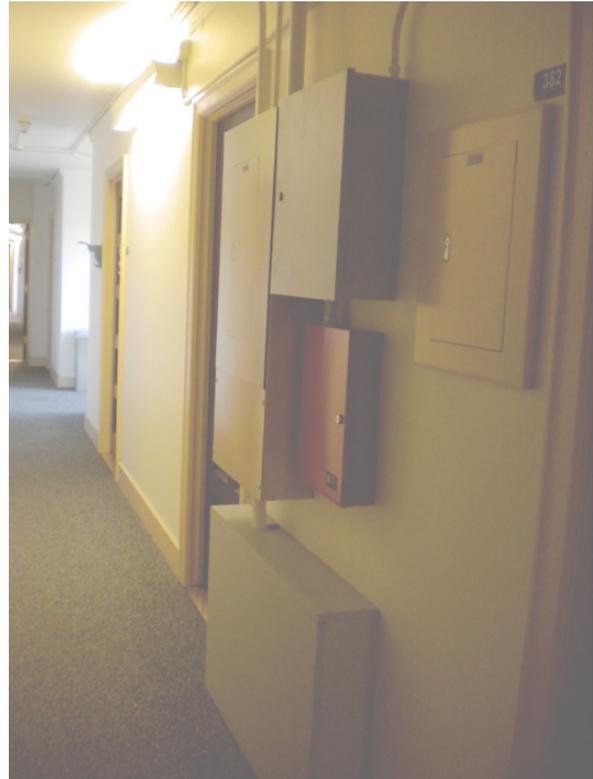
^ SOUTH HALLWAY THIRD FLOOR.

Alterations: New doors; all exposed piping, fire doors, electrical, and mechanical units were added. In 1984 new carpeting was installed. It is unclear if the original taupe linoleum remains under the carpet.

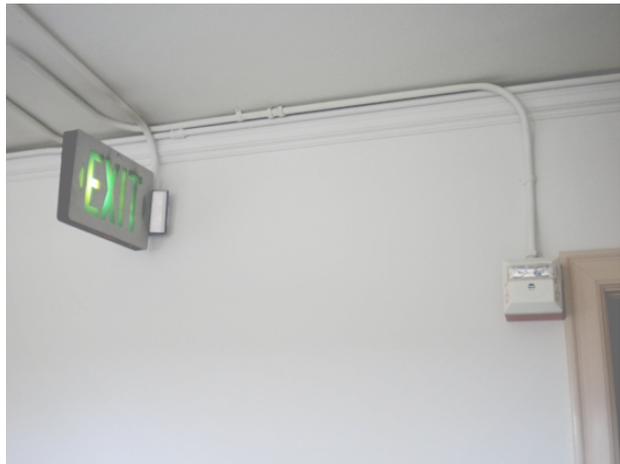
^ELECTRICAL DETAIL.

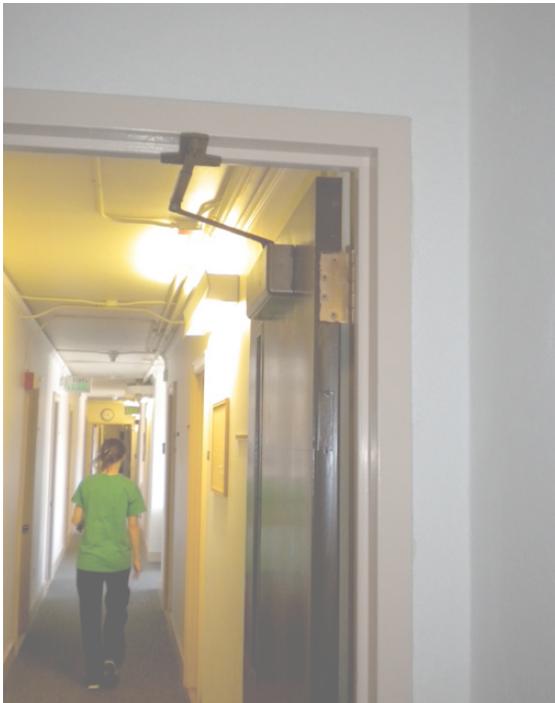
^NEW FIRE DOOR DETAIL.

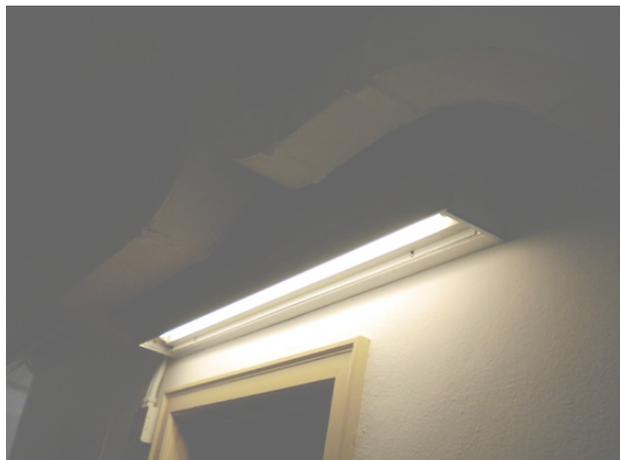
^MECHANICAL DETAIL.

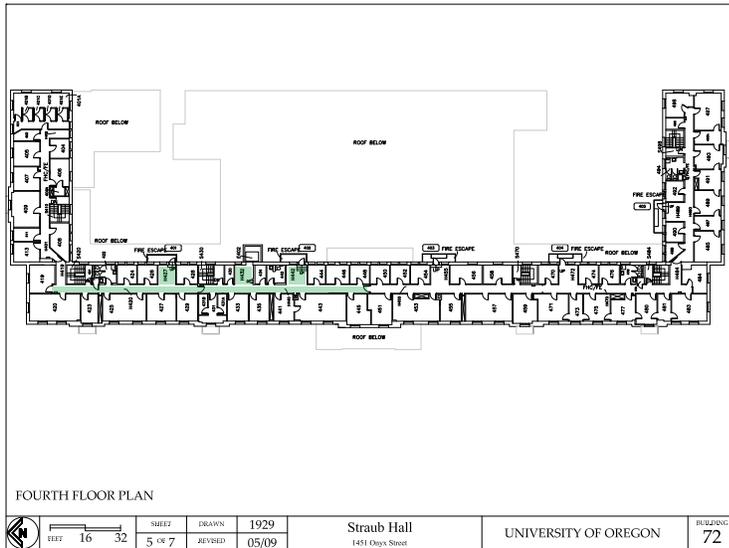
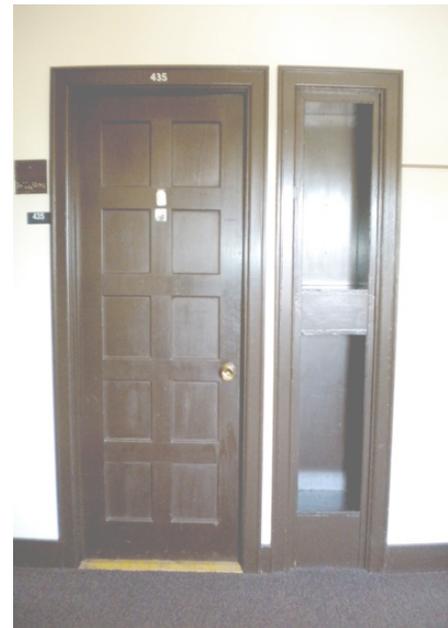
^ NORTH HALLWAY 4TH FLOOR ORIGINAL DOOR AND TELEPHONE CASE.

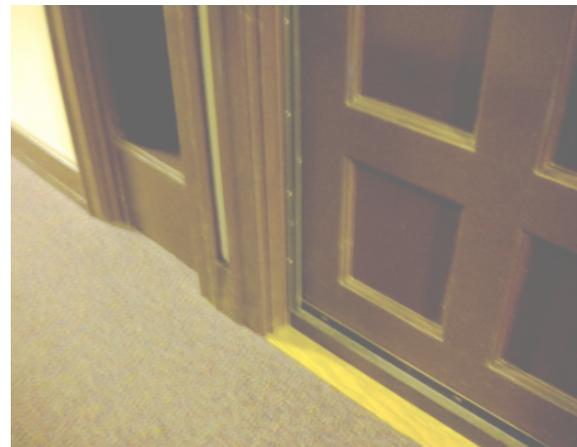
^ NORTH HALLWAY 4TH FLOOR BASE DETAIL.

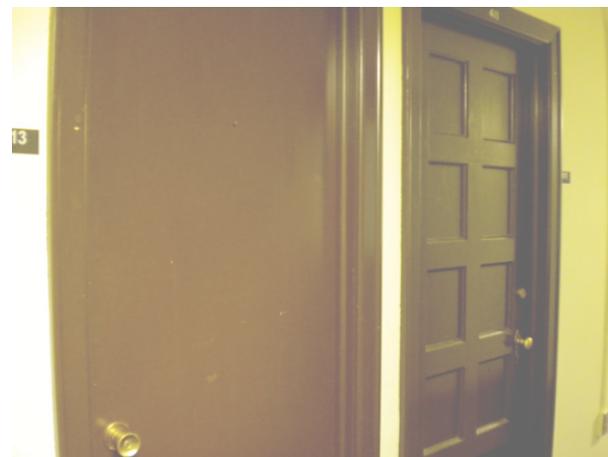
Alterations: All exposed piping, electrical, and mechanical units were added, as were fire doors and a fire escape door. In 1984 new carpeting was installed. It is unclear if the original taupe linoleum remains under the carpet. A few doors have been replaced as well (*see North Hallway 4th Floor New vs. Old Door*).

^ NORTH HALLWAY 4TH FLOOR NEW VS. OLD DOOR.

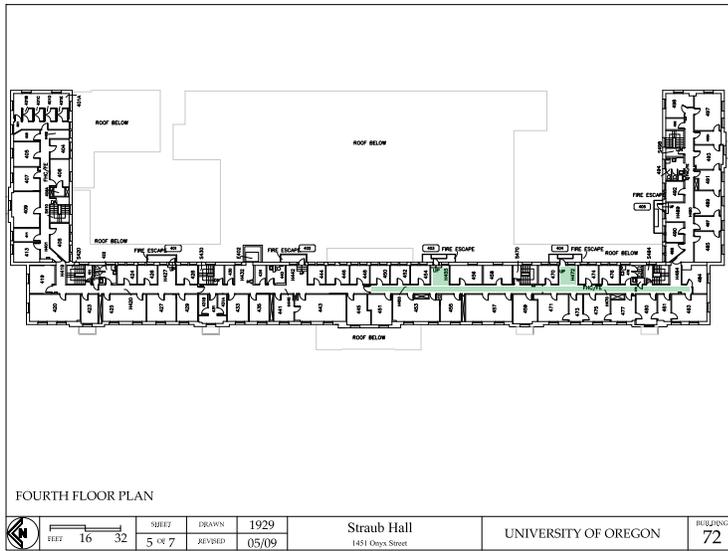
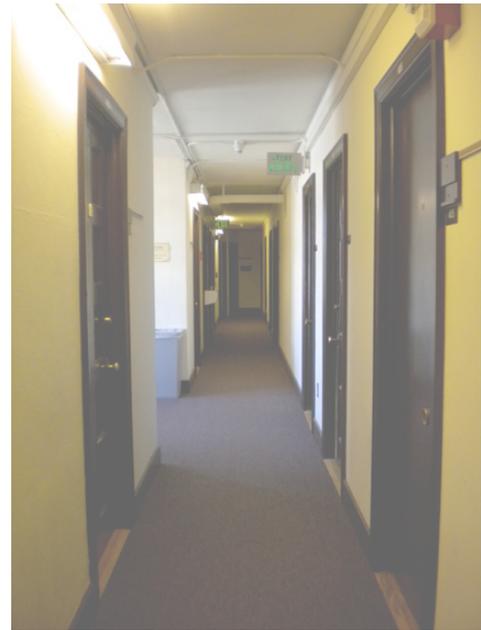
^ SOUTH HALLWAY 4TH FLOOR.

Alterations: All exposed piping, electrical, and mechanical units were added, as were fire doors and a fire escape door. The fire escape ladders are original but have been moved from their original locations. In 1984 new carpeting was installed. It is unclear if the original taupe linoleum remains under the carpet.

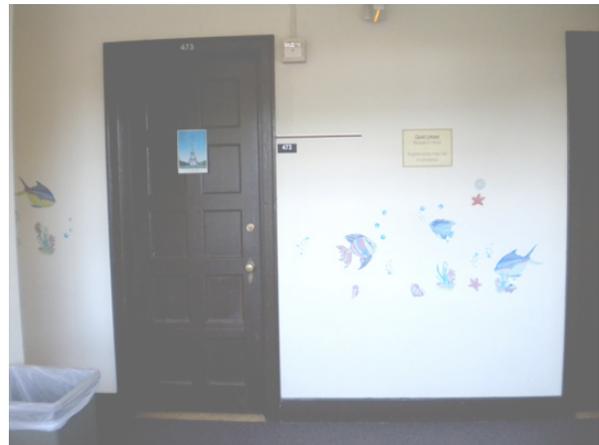
^ SOUTH HALLWAY 4TH FLOOR DETAIL.

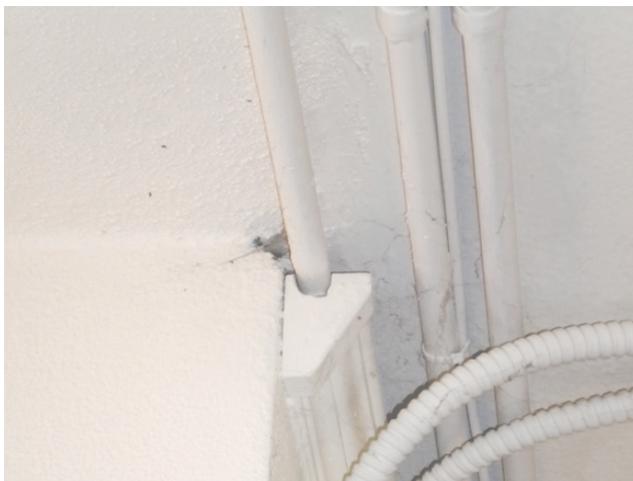
^MOLDING AND PIPING DETAIL.
