Straub Hall Window Condition Assessment

May 2011 (updated January 2016)

University of Oregon

Campus Planning, Design and Construction

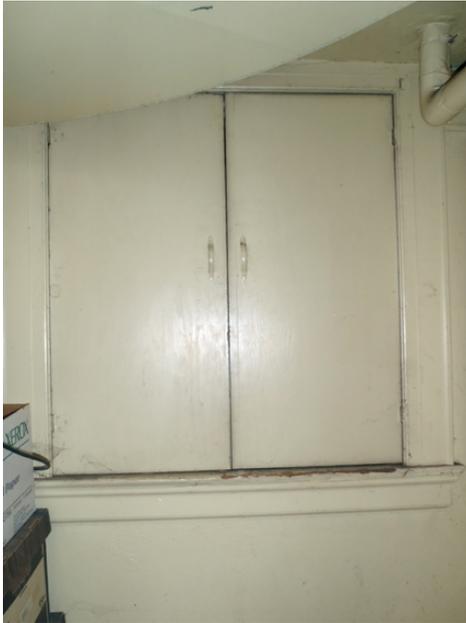
30Ab ^

030Ab	casement	good, some chipping	good	NA	excellent	yes, opens to foundations	no	good, but no longer connects to outdoors	north	window is now a closable connection to foundation	yes

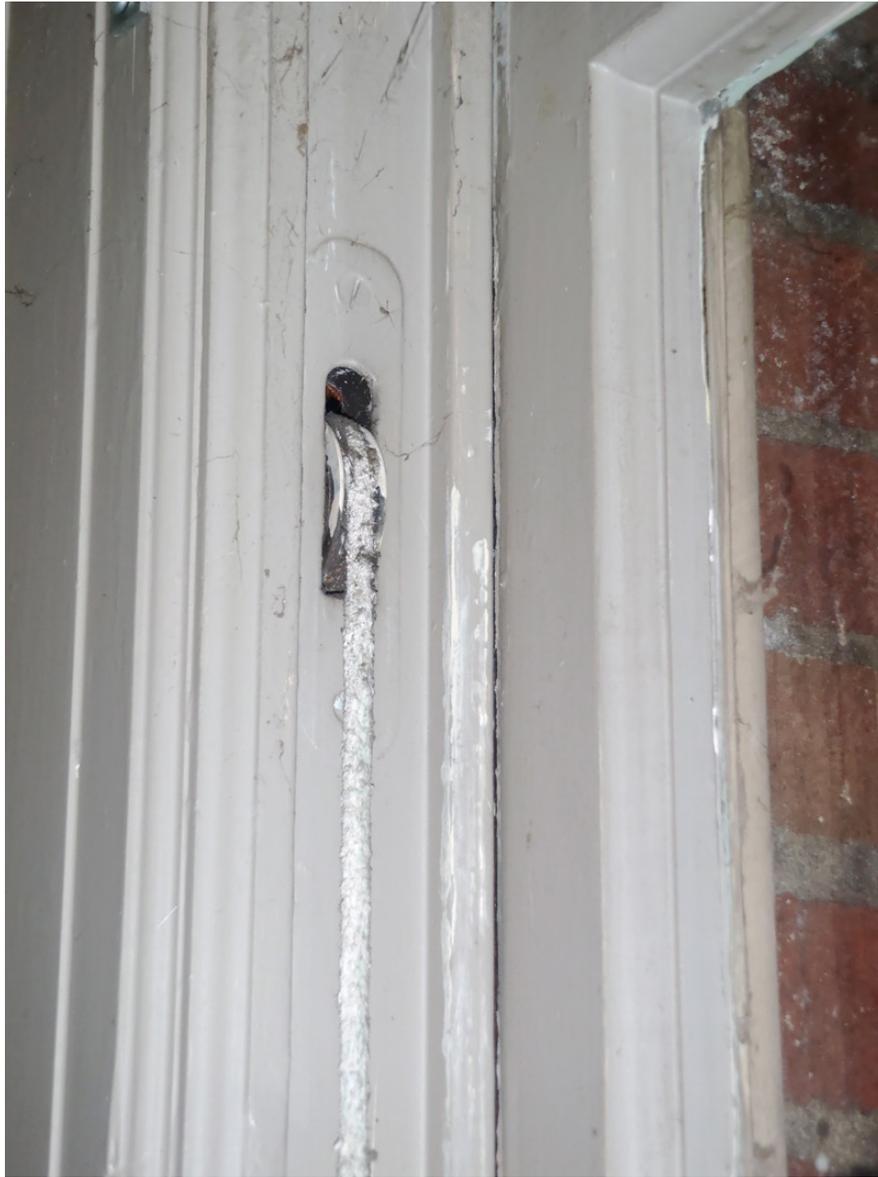
^ 152Ba

Window #	Window Type	Conditions							Facing Elev.	Comments	Photo
		Paint	Window Parts*	Brick Sill Condition	Hardware	Operability	Dry Rot	Overall			
152Ba	double hung w/ wood muntins, opening from top & bottom	deeply flaked sill and lower exterior casing	excellent	major moss accumulation	excellent	yes	no	fair	south	major moss accumulation, sill sits ~1" above ground level	yes
153a	double hung w/ wood muntins	excellent	excellent	major moss accumulation	excellent	no	no	excellent	west	this window has been sheetrocked over from the interior, it is located in the women's bathroom. Assessment made from exterior.	
154a	double hung w/ wood muntins and a fixed upper	excellent, some chipping on exterior	excellent with exterior wood framed screen	good, minor moss accumulation	excellent	not accessible	no	excellent	south		yes
155a	double hung w/ wood muntins and a fixed upper	good, some chipping	excellent with exterior wood framed screen	good	excellent	yes	no	excellent	south		yes

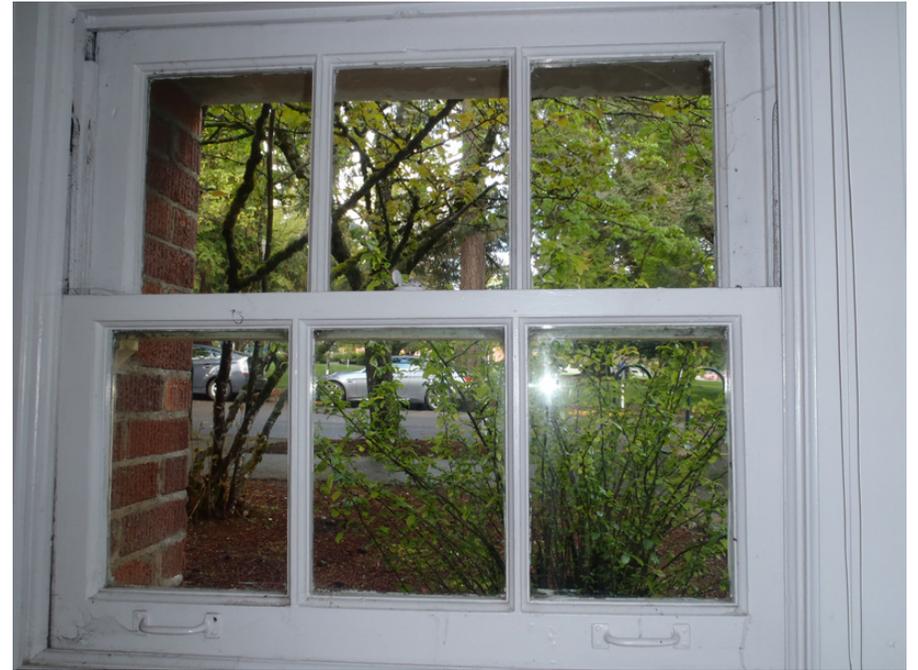
170a >

168Ca	vinyl, horizontal slider	excellent	excellent	flushed with metal	excellent	yes	no	excellent	north	bars and screens on new vinyl windows	yes
170a	casement window with wood muntins	excellent	good	good, minor moss accumulation	new locking hardware - two sliders on top and two on bottom	yes	no	excellent	west	altered from original configuration	yes
S170a	6 pane fixed window with wood muntins	good, some chipping	good	excellent	none	no	no	good	east	has this window been replaced? There seems to be grooving for movement but it is unoperable.	yes
172a	6 pane double hung w/ wood muntins	good, some chipping	good	good, moss accumulation	good, lock and pulls are intact	yes	no	excellent	west		yes

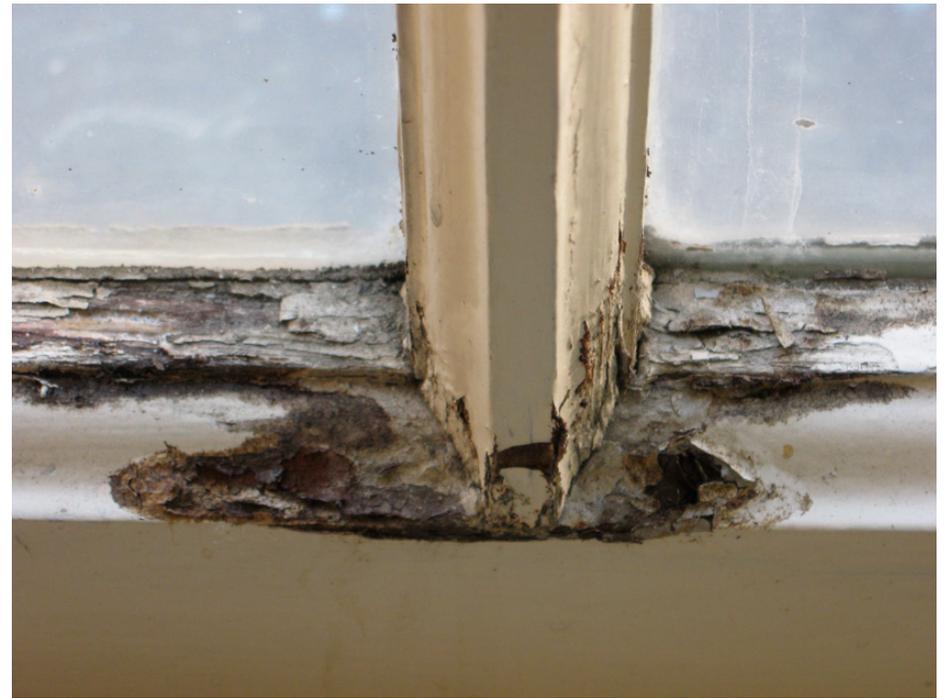
^ 274a

274a	12 pane double hung, with wood muntins	excellent	all glass replaced with white painted wood	excellent	excellent	yes	no	good	east	wood replacing glass for privacy - another restroom	yes
278a	double hung w/ wood muntins	good, some chipping	good, horizontal blinds attached at top, chips and dents	excellent	excellent	not accessible	no	good	east

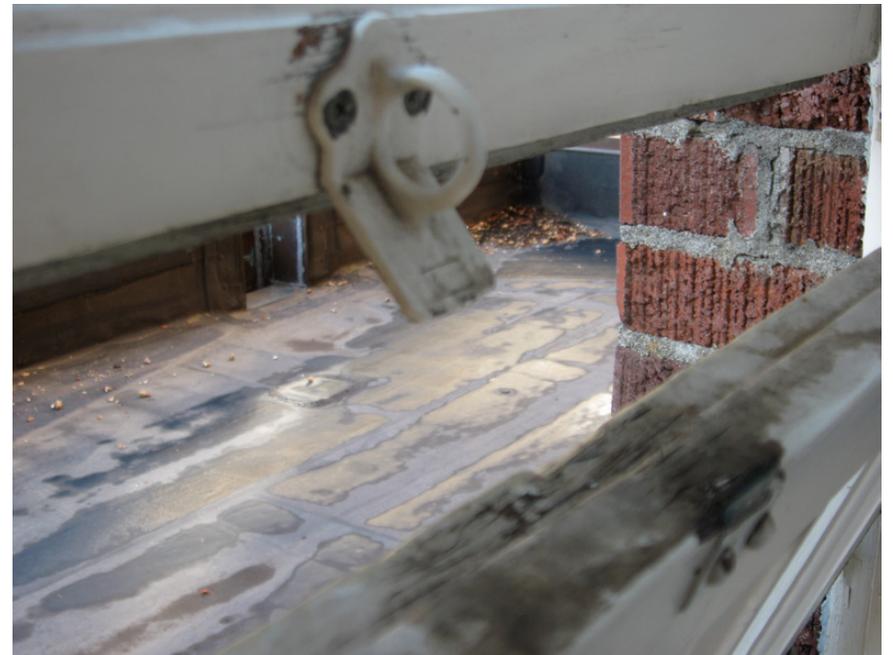
^ 208a

Window #	Window Type	Conditions							Facing Elev.	Comments	Photo
		Paint	Window Parts*	Brick Sill Condition	Hardware	Operability	Dry Rot	Overall			
208a	double hung w/ wood muntins	good, some chipping on interior, extensive chipping on exterior	stool damaged, lower 8 glass panes painted white	good, metal sheathing covering sill	good, lock and pulls are intact	top window sits on exterior supports for ventilation, bottom is fixed	no	fair	south	sill damage is from stall sizes changing through the years and the slot for stall supports moving	yes
209a	double hung w/ wood muntins	excellent, some chipping on interior	good, few chips and dents	good moss accumulation	excellent	yes	no	good	north		yes
210a	stacked wood awning window with muntins	good, some chipping	dropped ceiling attached to upper casing, vertical blinds attached	excellent	excellent	yes	no	excellent	south	opens to rooftop	yes
210b	stacked wood awning window with muntins	good, some chipping	dropped ceiling attached to upper casing, vertical blinds attached	good, mortar crack evident	excellent	yes	no	excellent	south	opens to rooftop	yes
