DEADY HALL ASSESSMENT
UNIVERSITY OF OREGON

03 November 2017

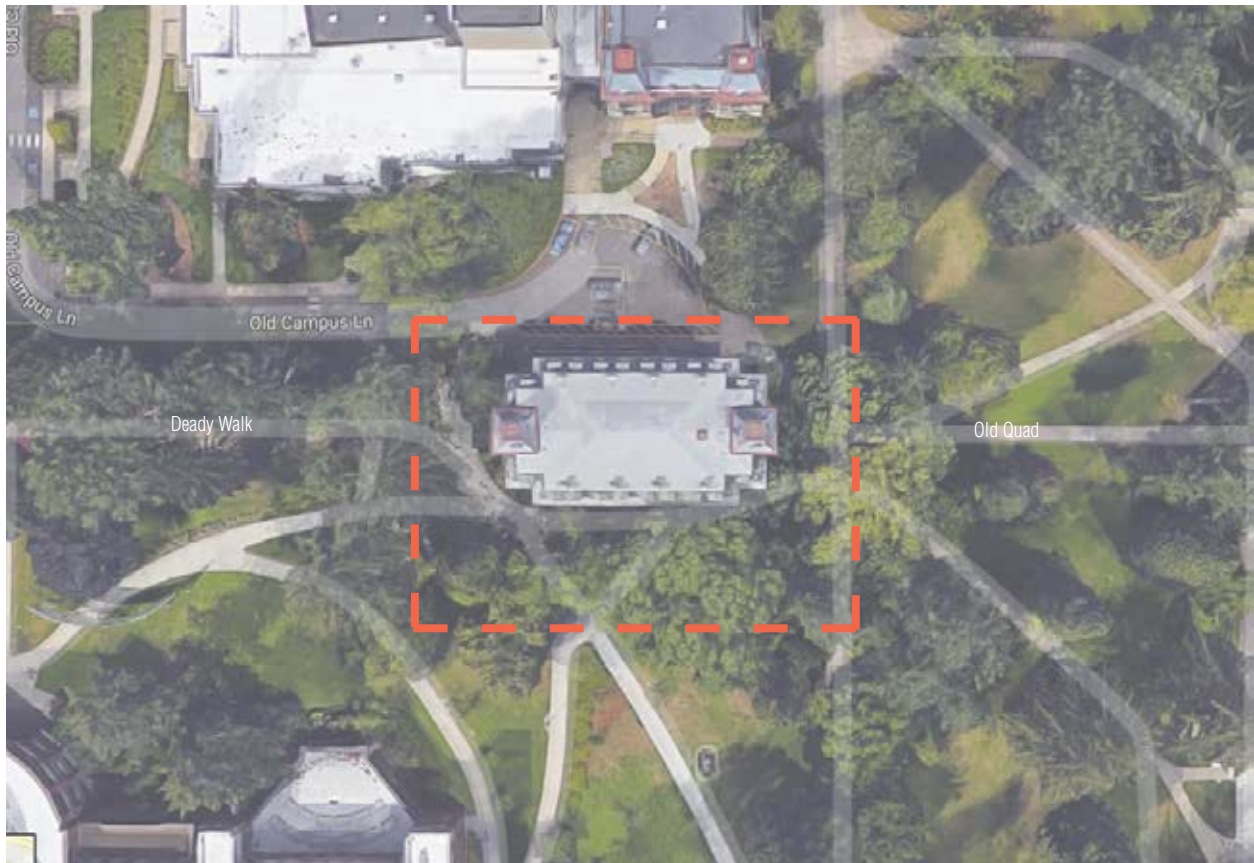
Project Boundary (shown dashed) - for the purposes of this assessment the project boundary was limited to the area shown by the UO and HEA team during the initial project meeting.

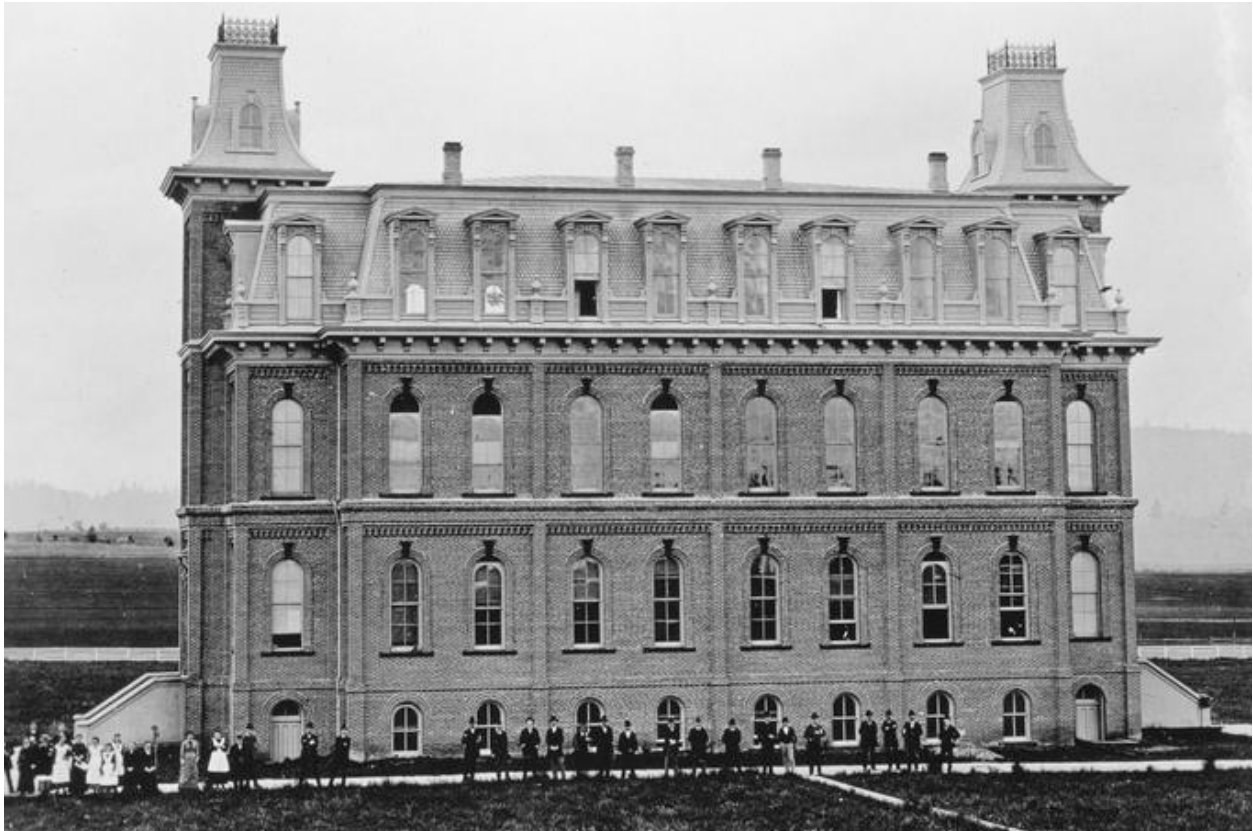
Deady Hall is most recognized for its exterior Italianate design comprised of brick masonry construction capped with a mansard roof with distinctive dormer windows and towers. Most of the original exterior historic fabric remains, including brick walls, double-hung wood windows with decorative cast zinc trim, wood doors at the east and west entrances, a bracketed wood cornice, and tall crested towers. Other items have been replaced in kind on the exterior, such as the wood shingled roof and wood parapet with urns. A protective grey sand-painted finish coat covering the brick, originally applied in the 1890s to match neighboring Villard Hall in appearance, is extant, although deteriorating.

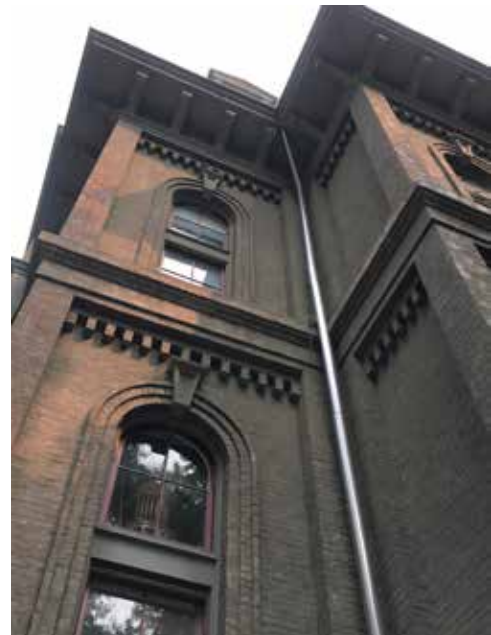
Image 8: Detail of exterior masonry features that include brick pilasters, belt courses with dentils, and rowlock arches.

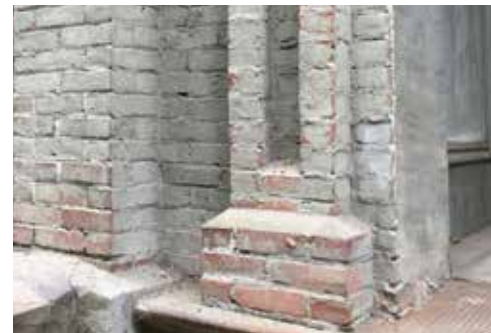
Image 9: Deteriorating exterior finish coat reveals the original red-orange brick units.

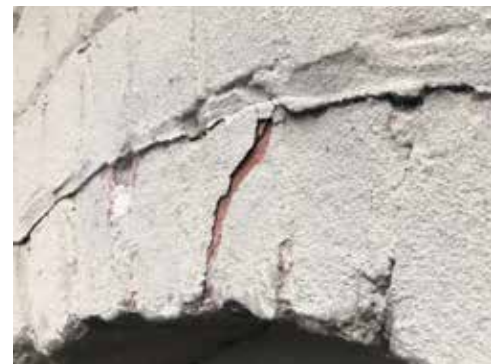
Image 10: Detail of the exterior sand painted finish coat. At areas where the coating is spalling, it is taking the brick fireskin with it.

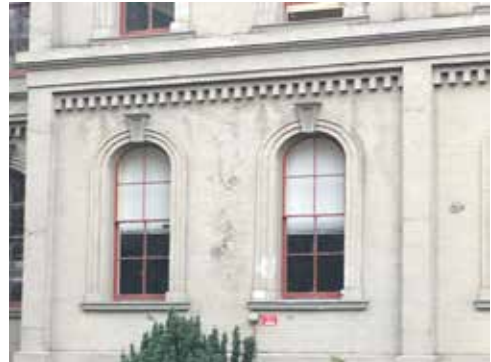
Image 11: Typical exterior soiling and staining along the north elevation.

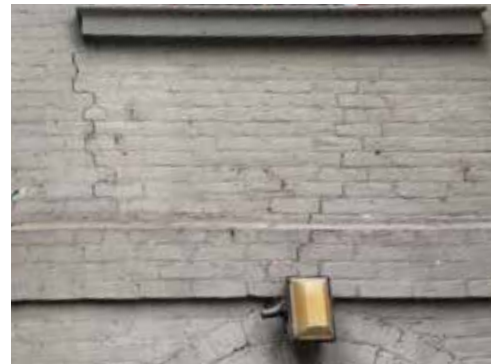
Image 12: Detail of common crack locations extending from window sills and above arched openings.

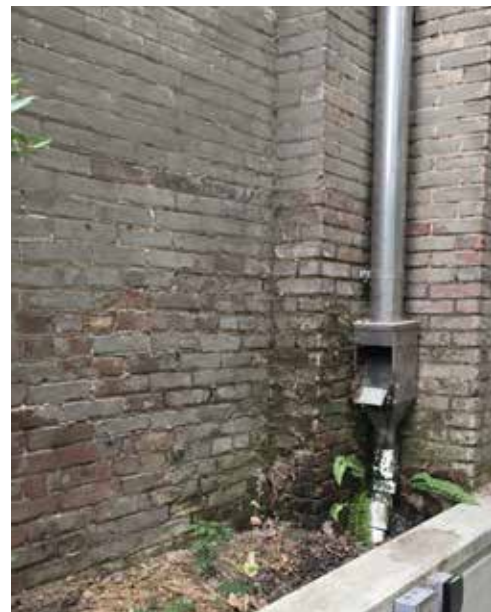
Image 13: Overspray at downspout locations causing high moisture levels along the brick exterior, deteriorating the finish coat and mortar joints and causing high levels of biogrowth.

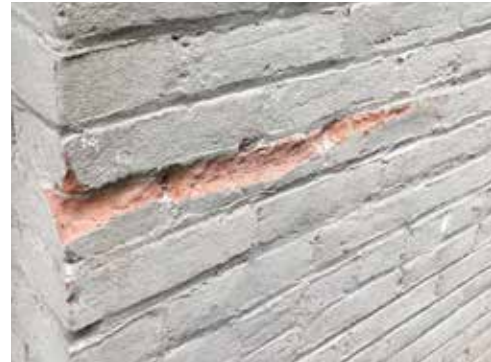
Image 14: Damaged exterior brick from an unknown external force.

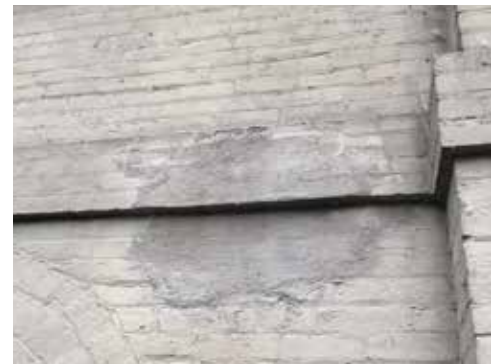
Image 15: A common cementitious infill patch, typical at the north and south elevations.

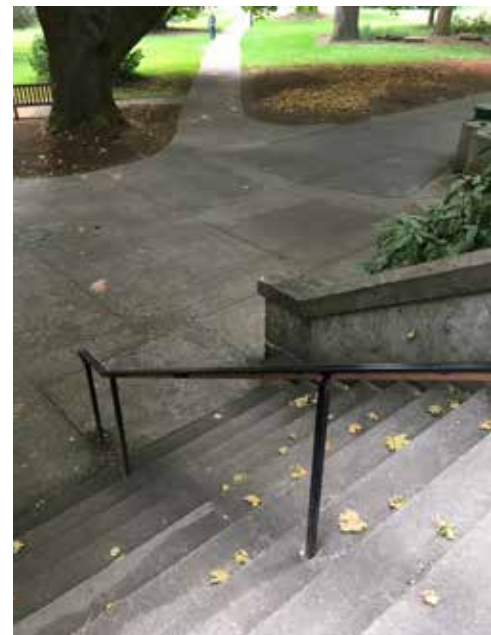
Image 16: Detail of concrete exterior stairs along the east and west elevations. Tread noses have been patched (lighter in color) and a modern metal rail runs down the center of the stair.

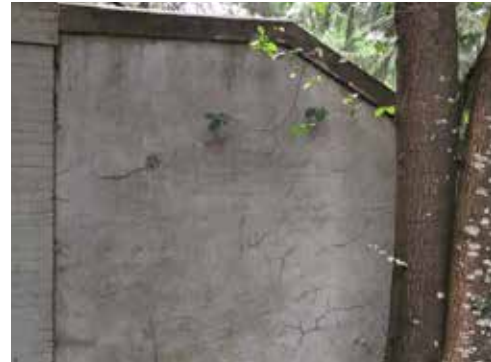
Image 17: Detail of typical hairline cracking at concrete stair wing walls.

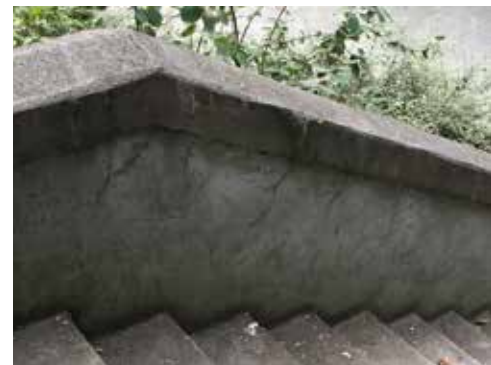
Image 18: Cracking and spalling along the concrete cap of the exterior stair wing walls, and continuous hairline cracking.

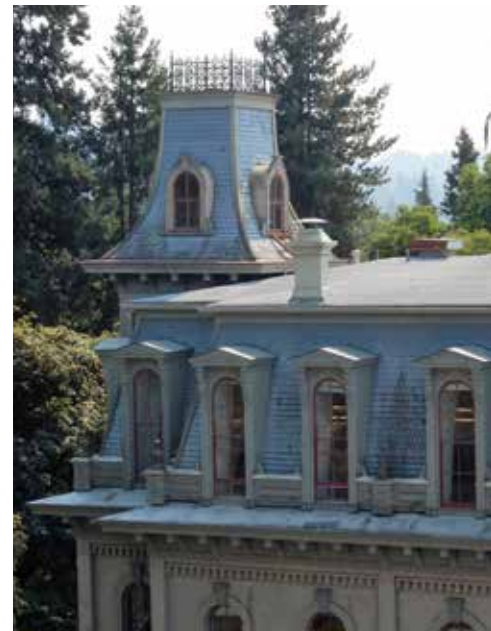
Image 19: The iconic mansard roof and tower at the east end, also mirrored at the west end. Wood shingles are weathered and the wood parapet shows signs of deterioration.

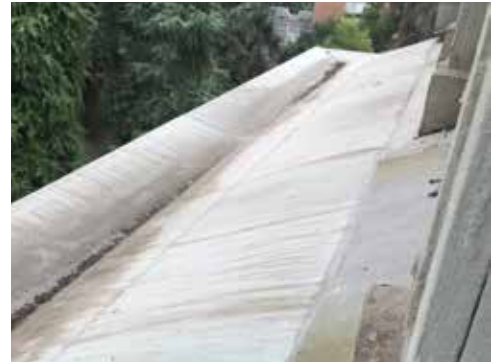
Image 20: Detail of the roof membrane at the third floor dormers. Although stained, the membrane appears intact.

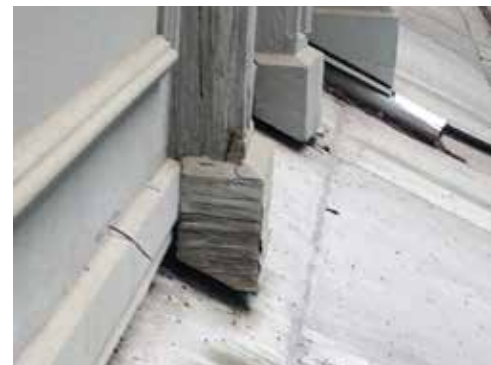
Image 21: Detail of rotting wood members hovering above the roof membrane at the wood parapet..

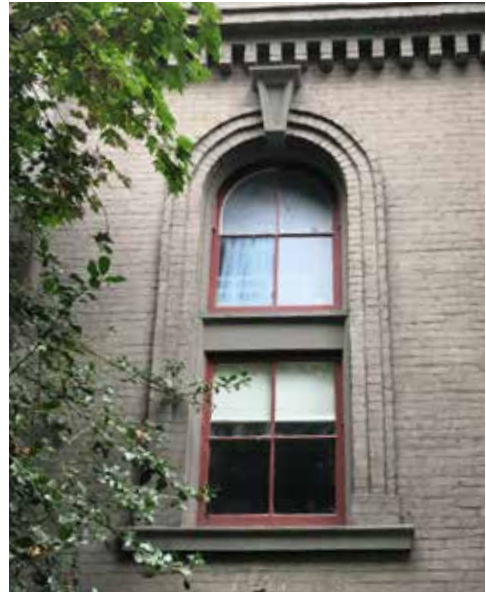
Image 23: One of six windows converted to pivoting sash with a broad horizontal mullion. These date to 1914 when the floor levels were subdivided with the introduction of mezzanines.

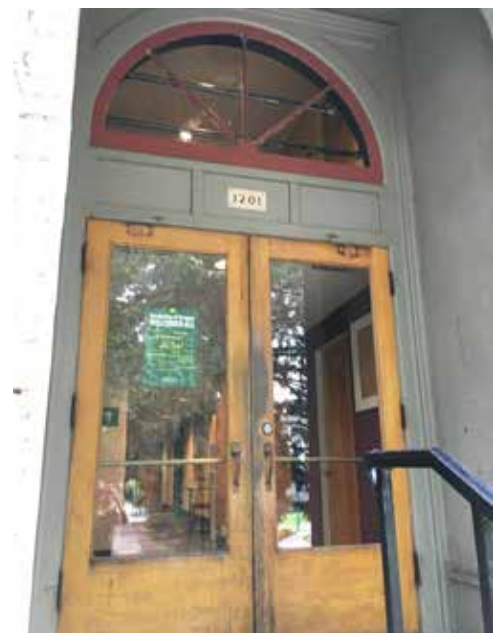
Image 28: One of two exterior double doors that serve as the main entrances centered at the east and west elevations. Door slabs are weathered at the exterior. Transom units and trim are in good painted condition.

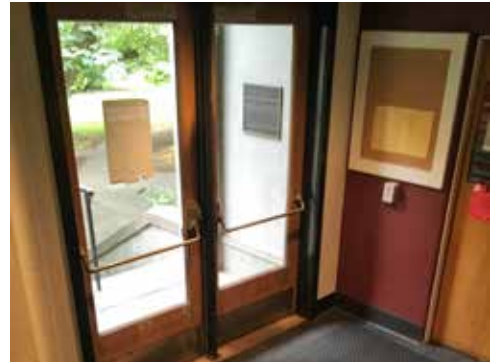
Image 29: Interior view of the first floor main entrance doors. Hardware includes brass panic bars and kick plates reminiscent of the historic period of significance.

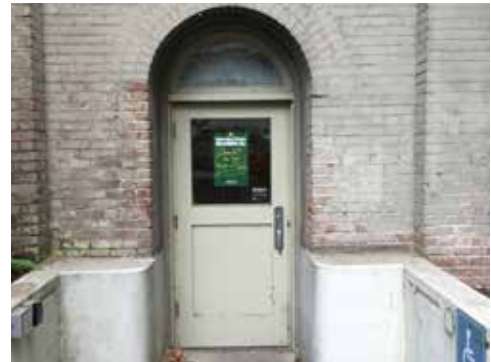
Image 30: Door slabs at the north elevation basement entrances are half-lite modern replacements. Original units were 5-panel wood doors.

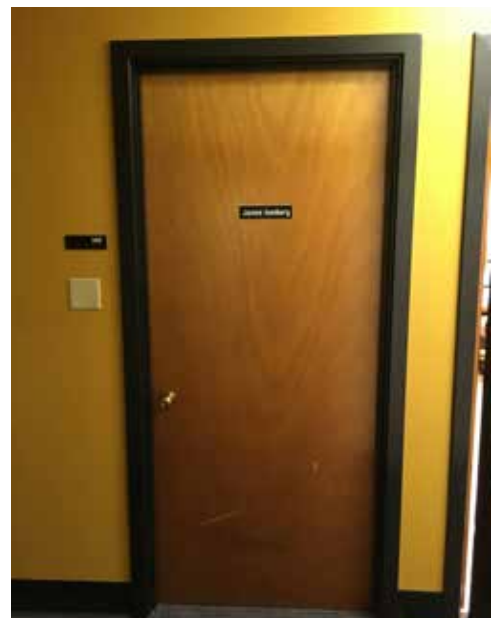
Image 31: A typical wood slab interior door, either hollow or solid core. Original interior doors had 4- or 5-panel wood slabs.

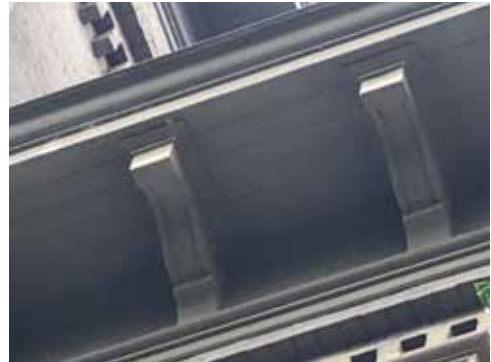
Image 32: Detail of exterior wood brackets in good condition that add to the Italianate style of Deady Hall.

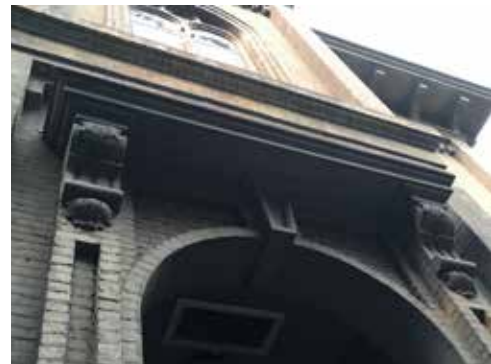
Image 33: Cast metal brackets and keystones, painted with a sanded finish to match the brick finish, decorate door and window openings.

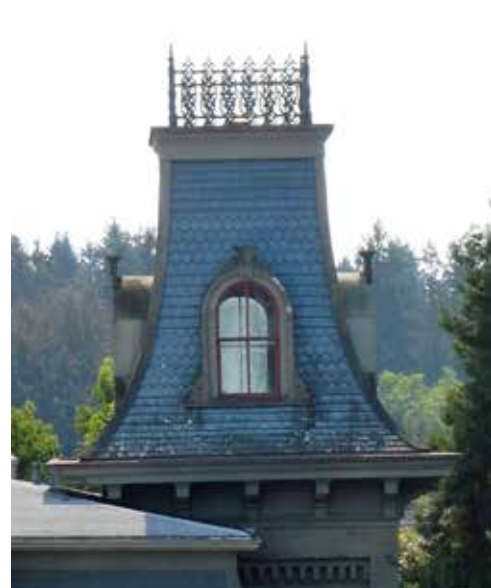
Image 34: One of two iron crested towers.

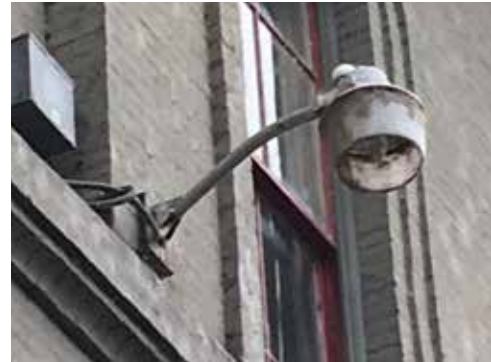
Image 35: An incompatible exterior sconce along the north elevation.

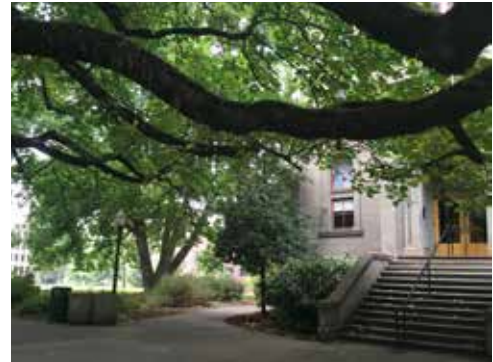
Image 38: Branches from the historic Big Leaf Maple at the east elevation hover above the main entrance steps.

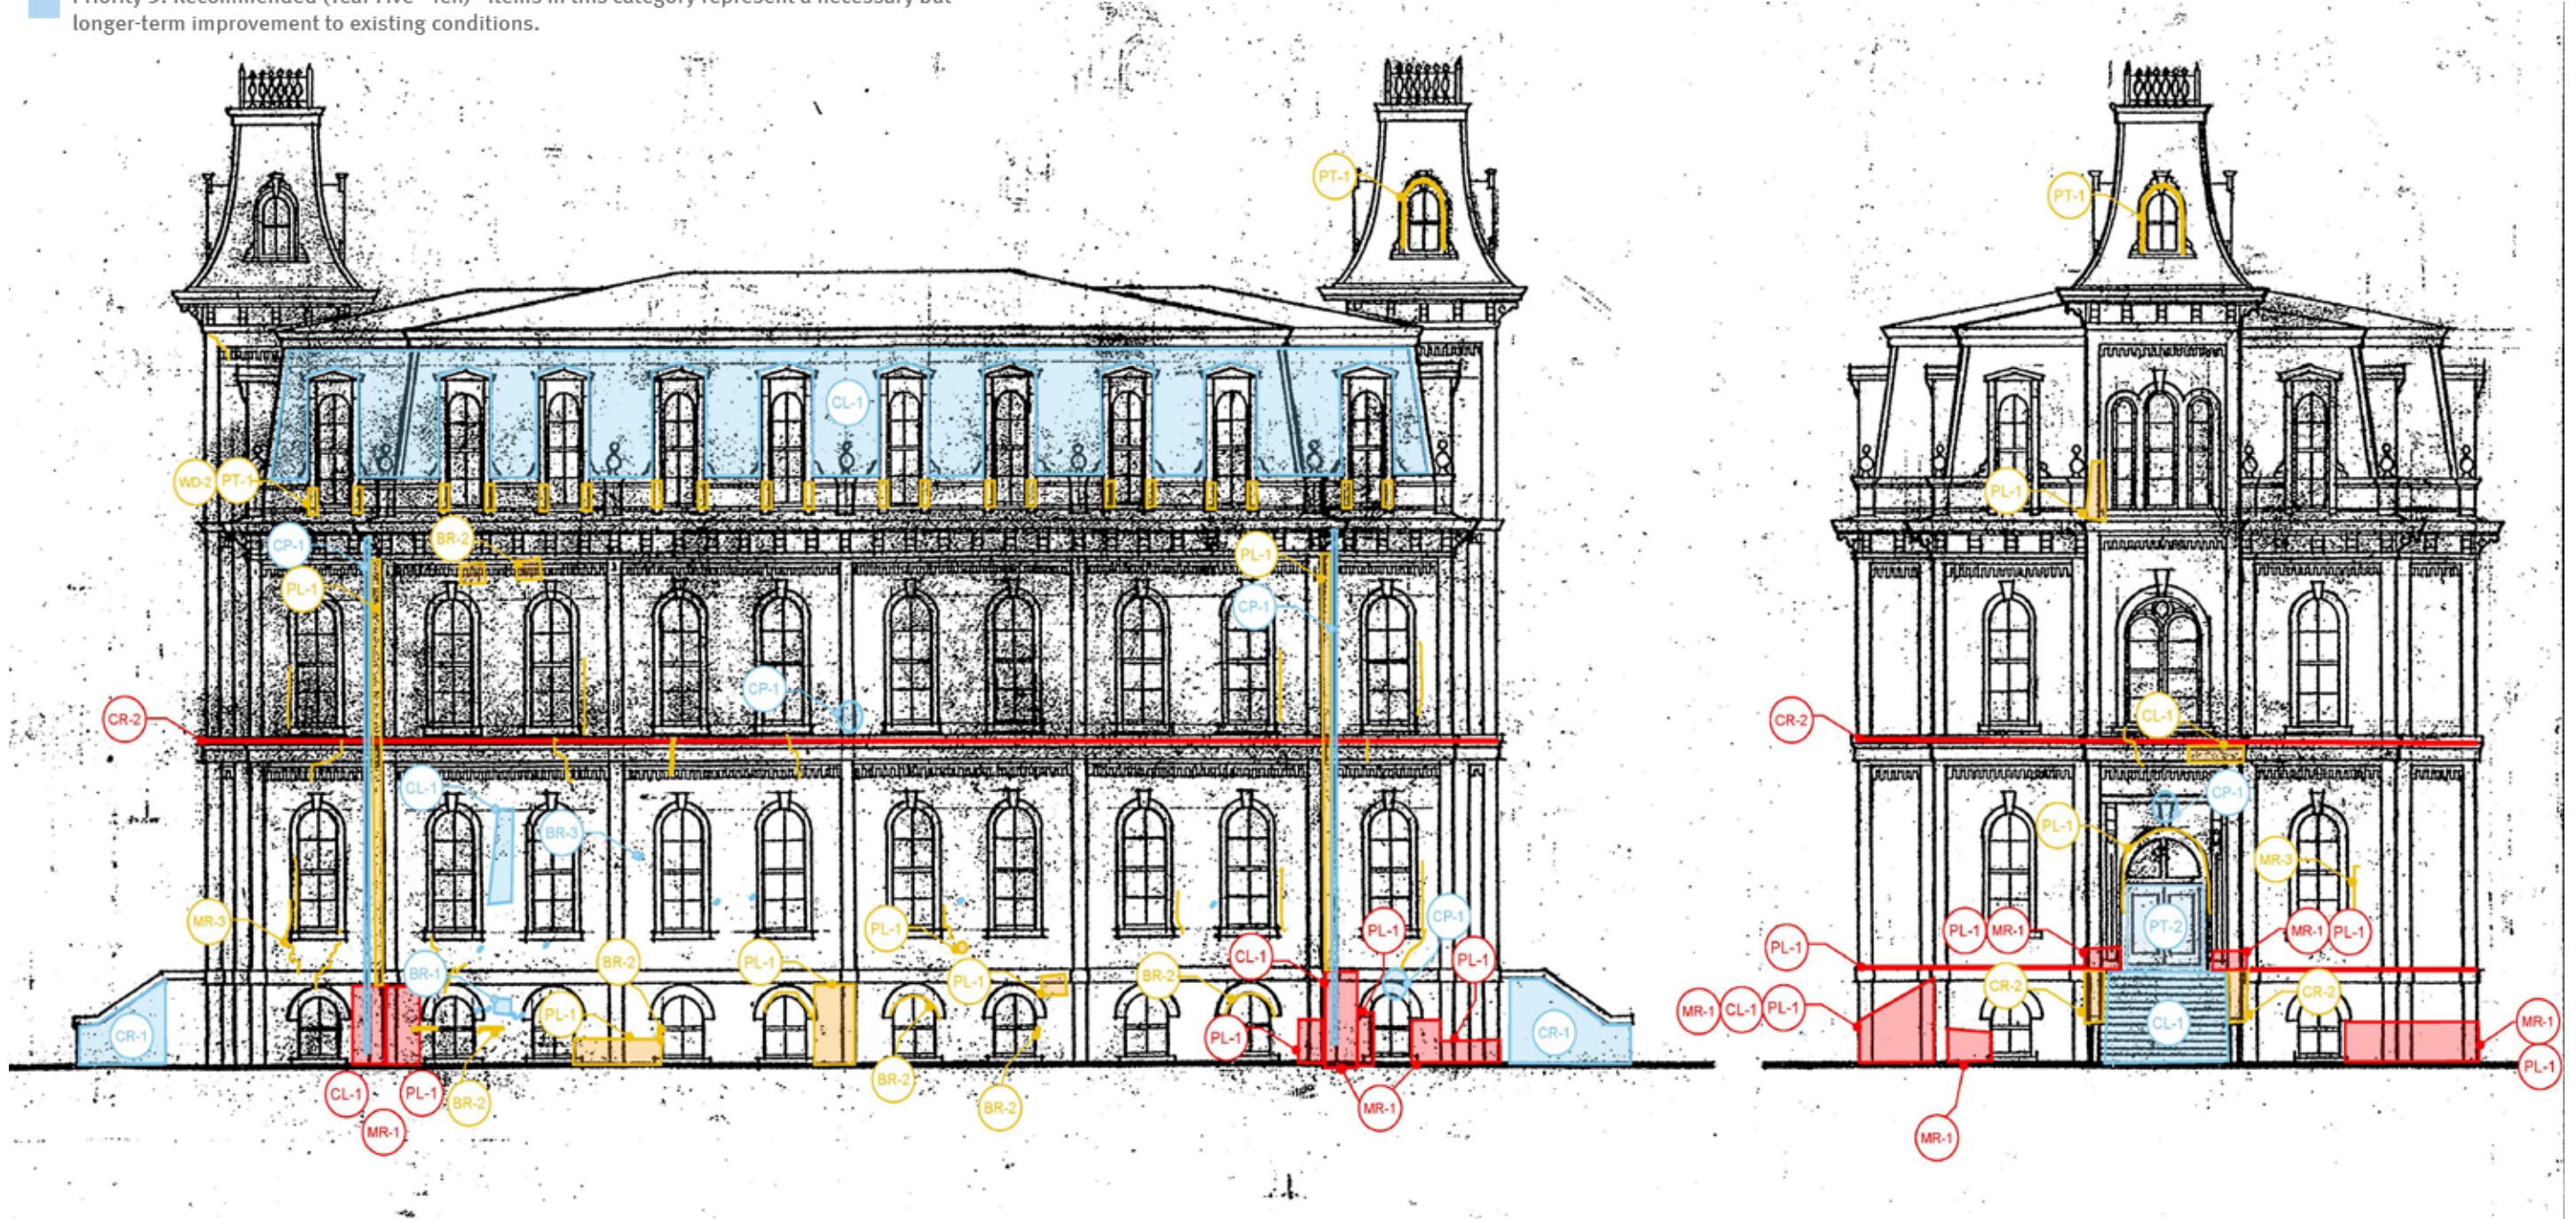
- Priority 1: Critical (Immediate - Year Two) - Items in this category require action within two years.
- Priority 2: Necessary- Not Yet Critical (Year Two - Five) - Items in this category include conditions requiring prompt attention.
- Priority 3: Recommended (Year Five - Ten) - Items in this category represent a necessary but longer-term improvement to existing conditions.

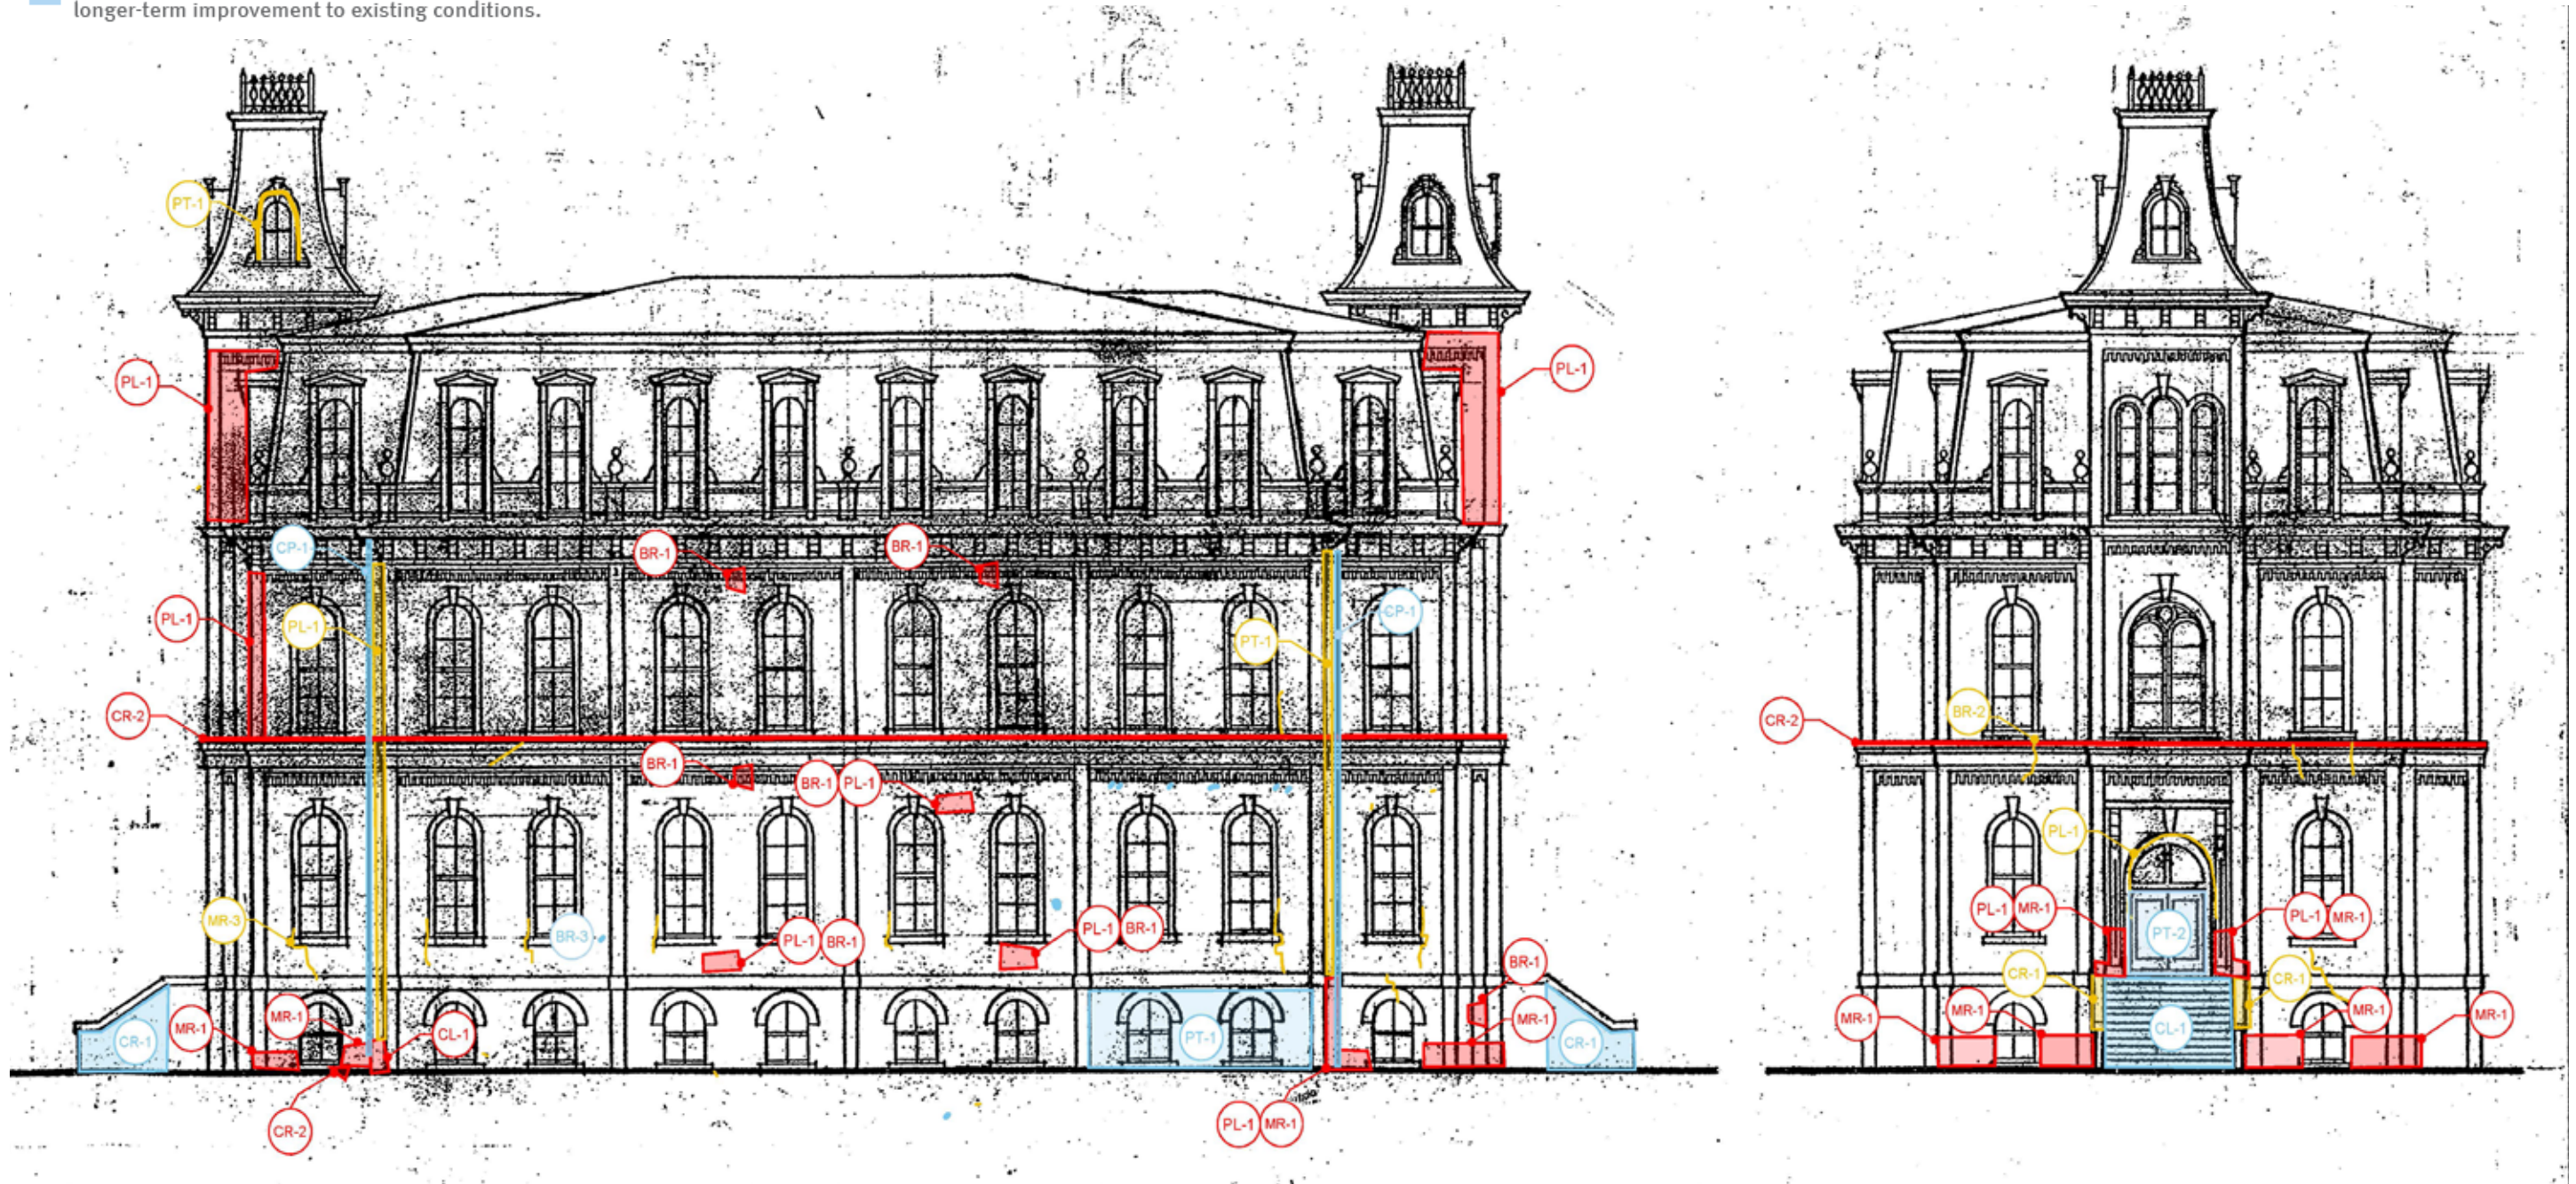
- Priority 1: Critical (Immediate - Year Two) - Items in this category require action within two years.
- Priority 2: Necessary- Not Yet Critical (Year Two - Five) - Items in this category include conditions requiring prompt attention.
- Priority 3: Recommended (Year Five - Ten) - Items in this category represent a necessary but longer-term improvement to existing conditions.

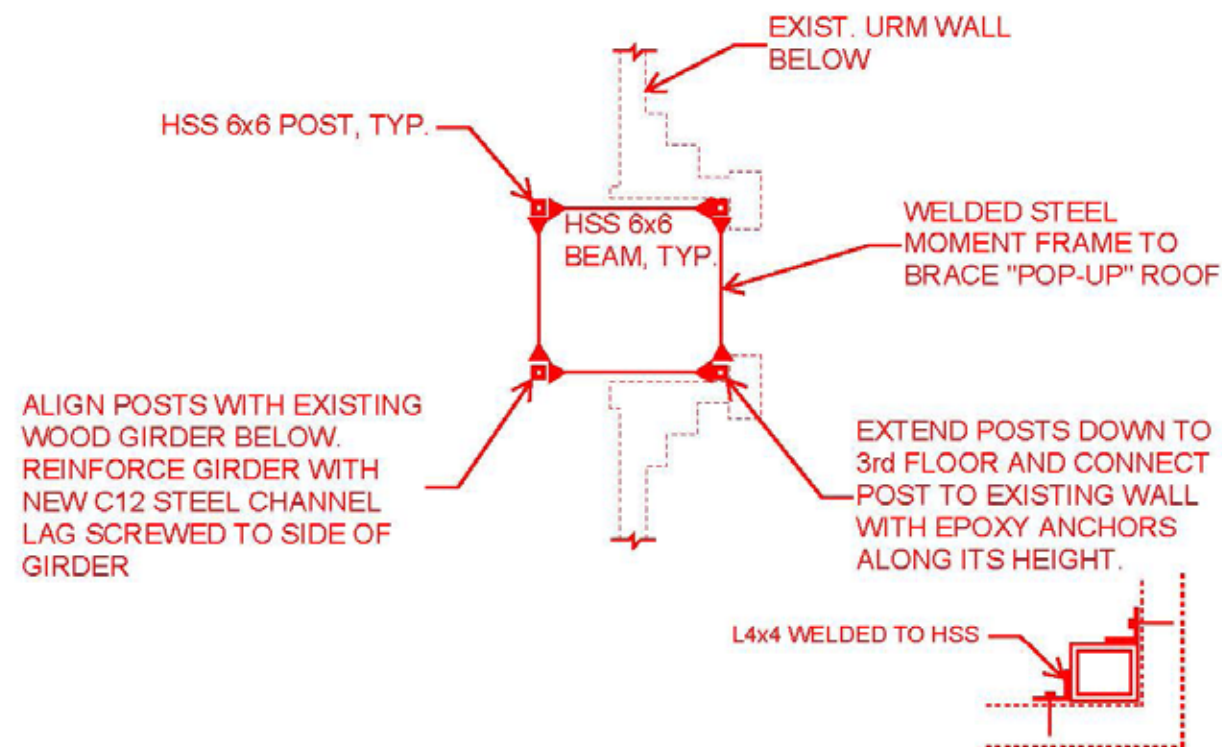
11 POP-UP ROOF BRACING

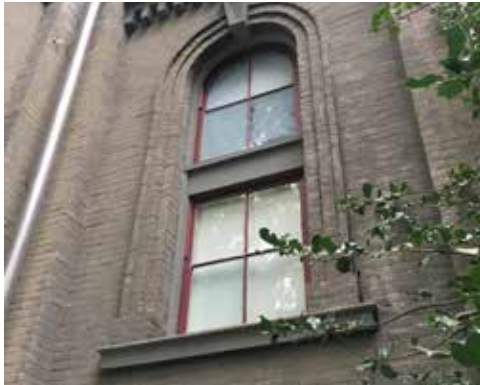
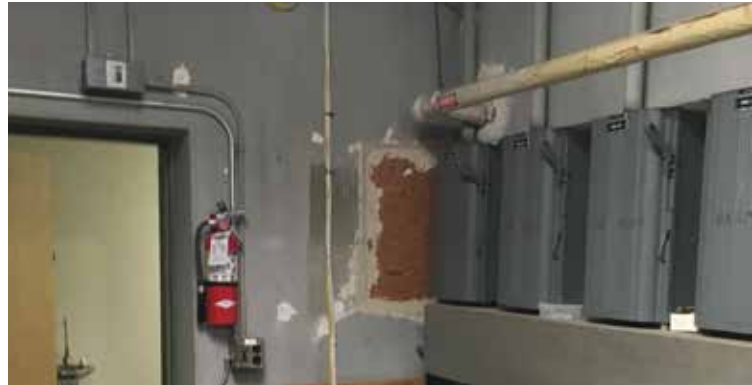
MECHANICAL - HEATING, VENTILATING, AND AIR CONDITIONING

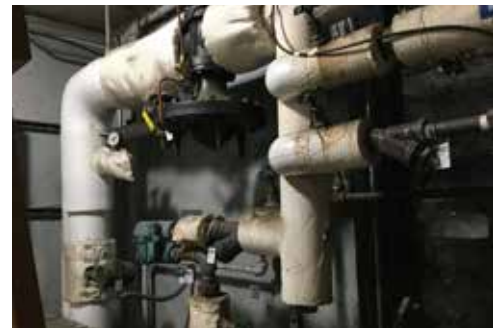
IMAGE M1: 2" condensate return piping mains at the northeast tunnel

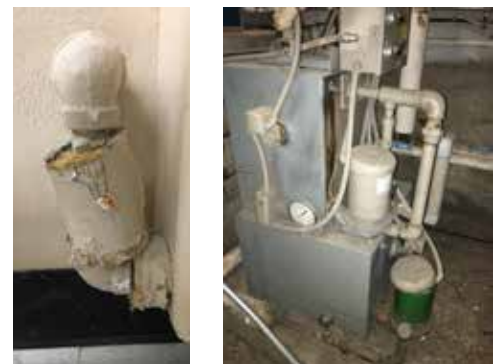
IMAGE M3: Heating system piping and equipment in disrepair.

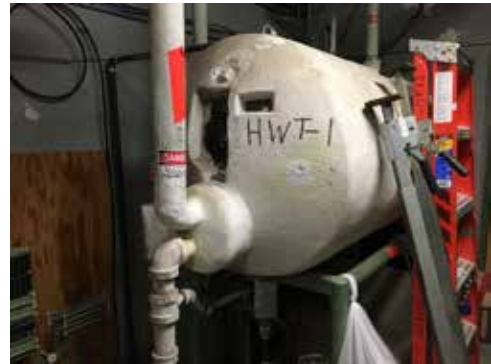
IMAGE P1: The 150-gallon storage hot water storage tank.

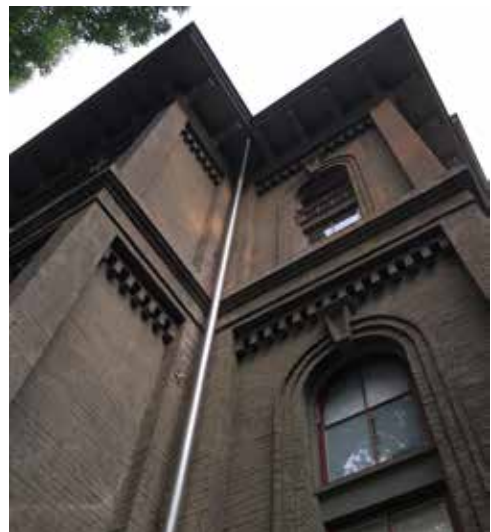
IMAGE P4: Galvanized downspouts pipe runoff from the roof to storm drain line connections.

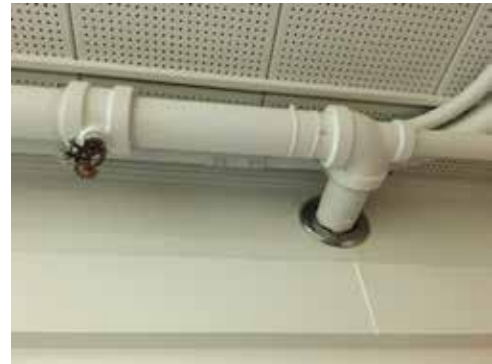
IMAGE FP1: Typical 4” fire sprinkler water line.

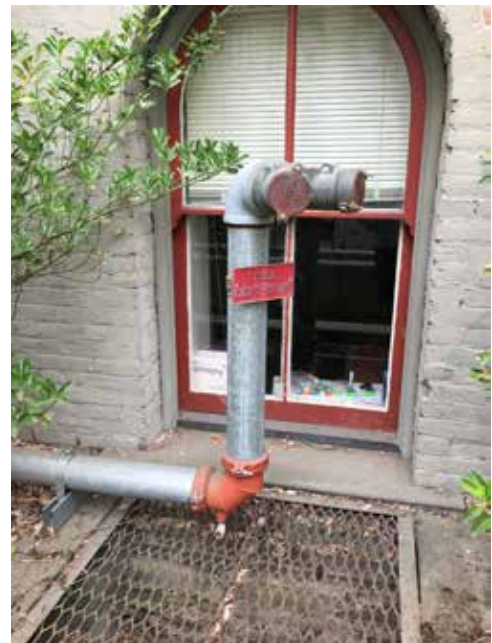
IMAGE FP2: Exterior fire department connection along the north elevation.

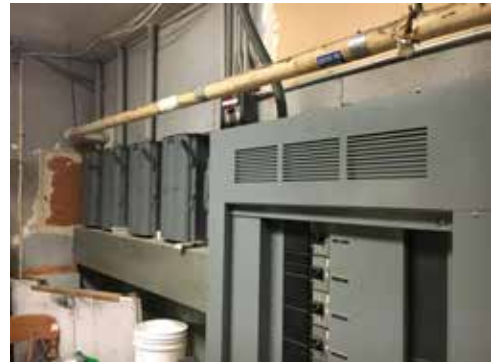
IMAGE E1: The electrical system switchboard in the basement mechanical room.

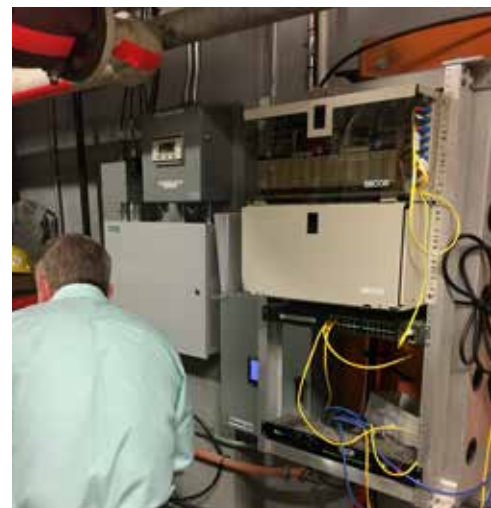
IMAGE E3: Campus fiber optics rack in boiler room.

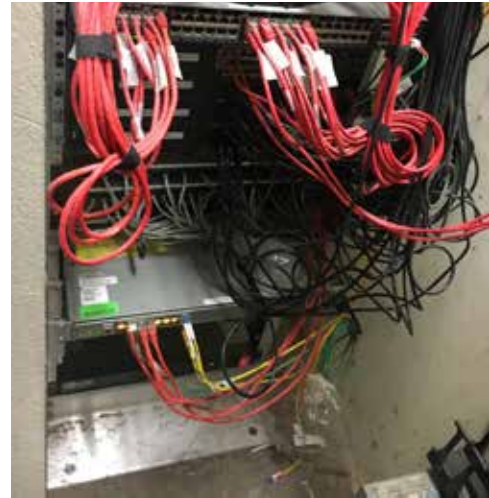
IMAGE E4: Servers and Cat 5e cabling chase space next to elevator in basement.

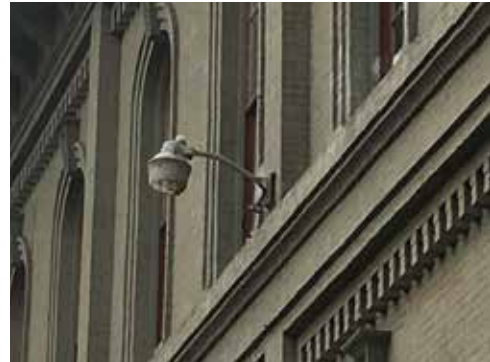
IMAGE E11: Wall-mounted shop light at the north exterior elevation, second floor.

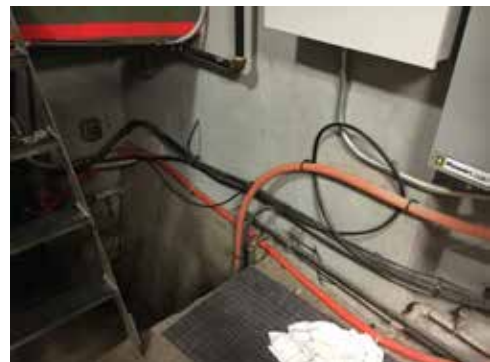
IMAGE E12: Campus fiber optics route into the building from the steam tunnel at the northeast corner at basement level.

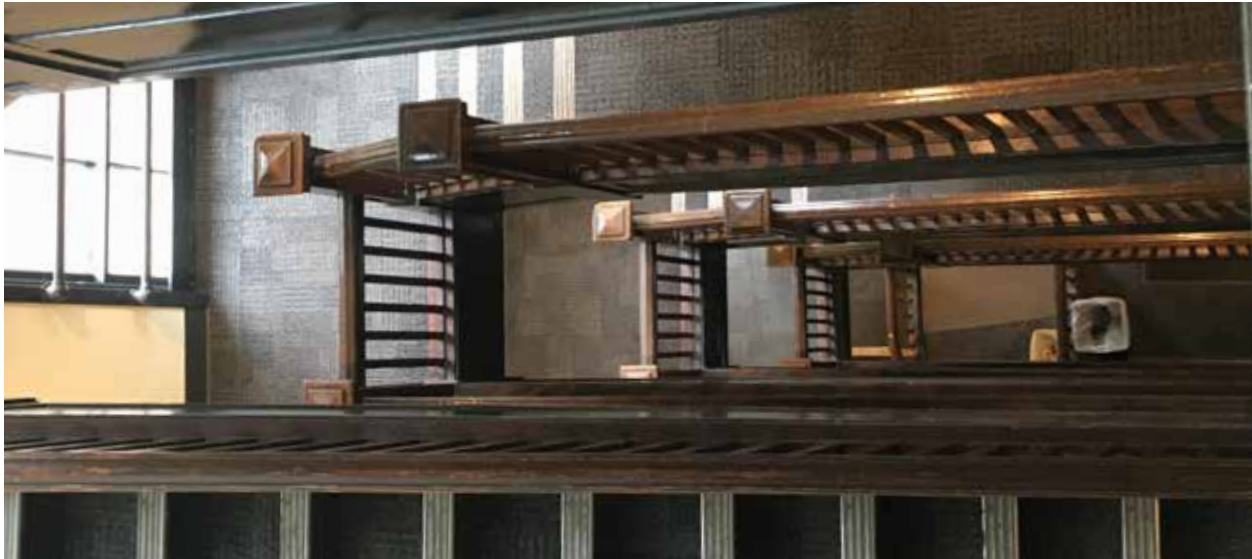
Following the major interior alterations in the 20th century, remaining historic materials and small scale features are minimal. However many spatial qualities and some classroom and office locations dating back to both 1876 and 1914 remain intact. This section provides an assessment of the interior program and finishes with recommendations for an interior rehabilitation that combines features from both historic periods.

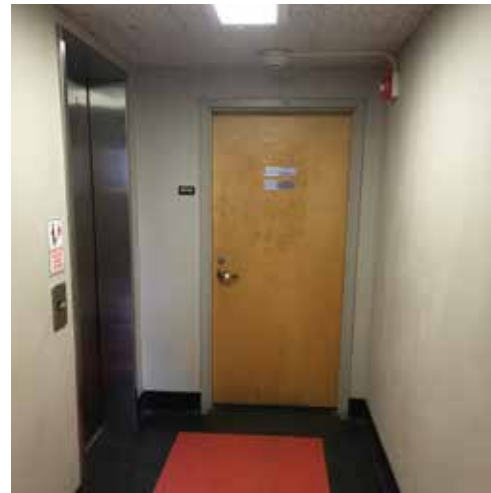
Image 42: Uninviting secondary corridors lead to the elevator entrances at all floors.

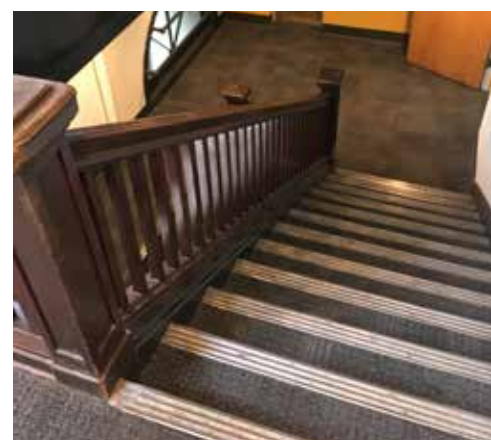
Image 44: Typical conditions of the interior stairs dating to 1914. Treads are carpeted with metal nosing and handrails are painted wood and worn.

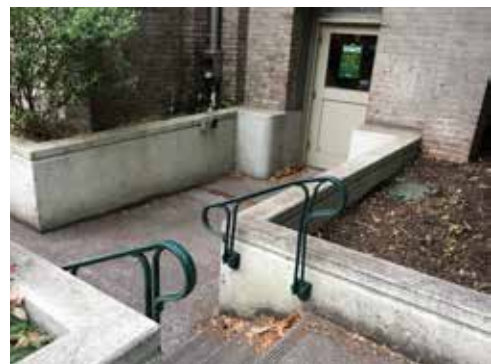
Image 45: Detail of the ADA entrance at the northwest corner of the building. This basement entrance is accessed by both stairs and a compliant ramp.

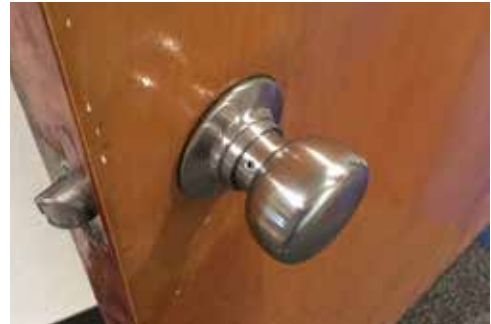
Image 47: Example of a typical knob-style interior door handle. Metal finishes vary.

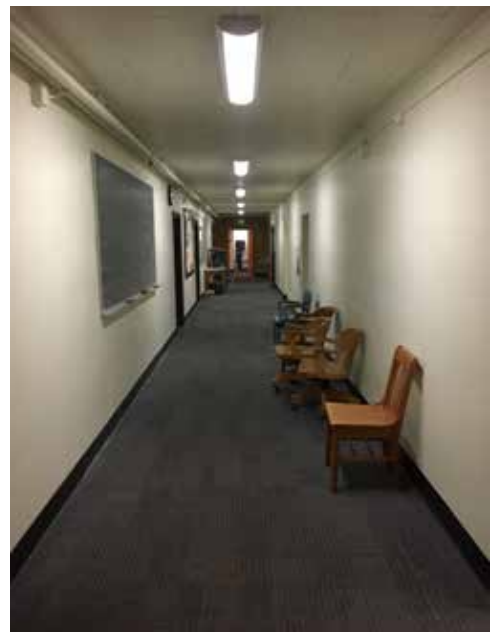
Image 49: The unwelcoming basement corridor, which serves as a primary corridor for those entering the building from the ADA entrance at the northwest corner.

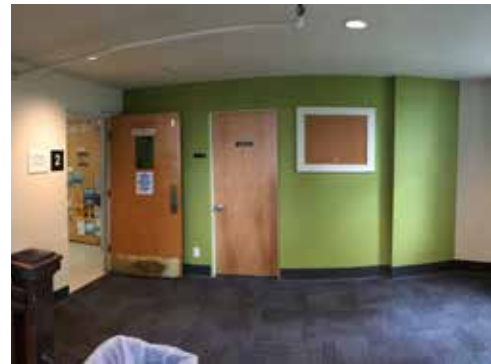
Image 56: Existing stair landings are enclosed by the use of offices, identified by the green wall in this image.

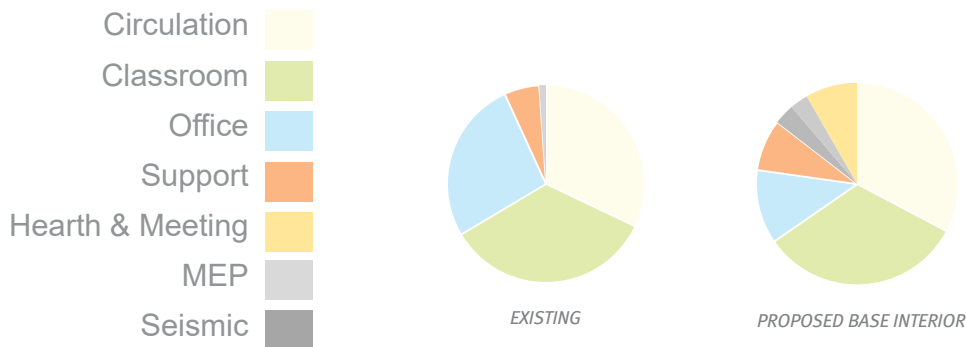
Proposed Second Floor Alternate

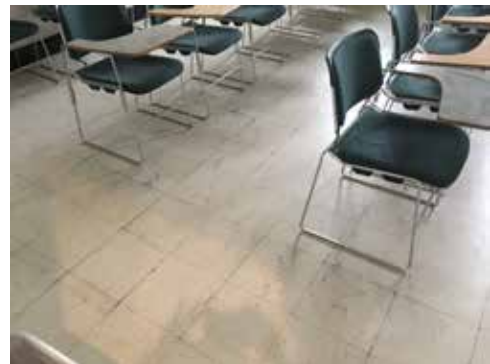
Image 63: Detail of typical VCT that is heavily worn in classrooms.

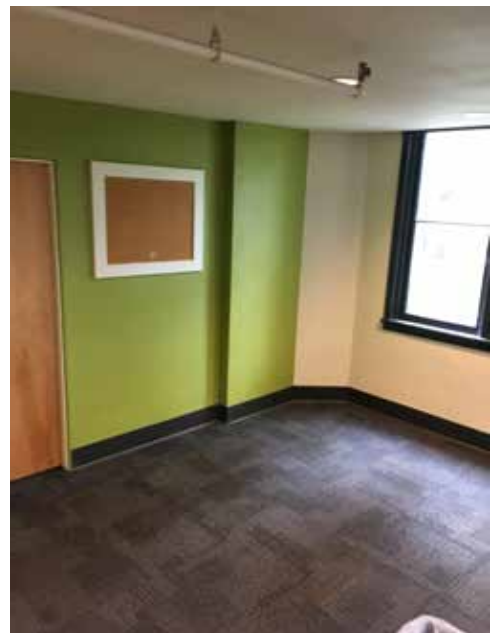
Image 64: Bold colors and carpeting at a stair landing. Colors vary throughout the building.

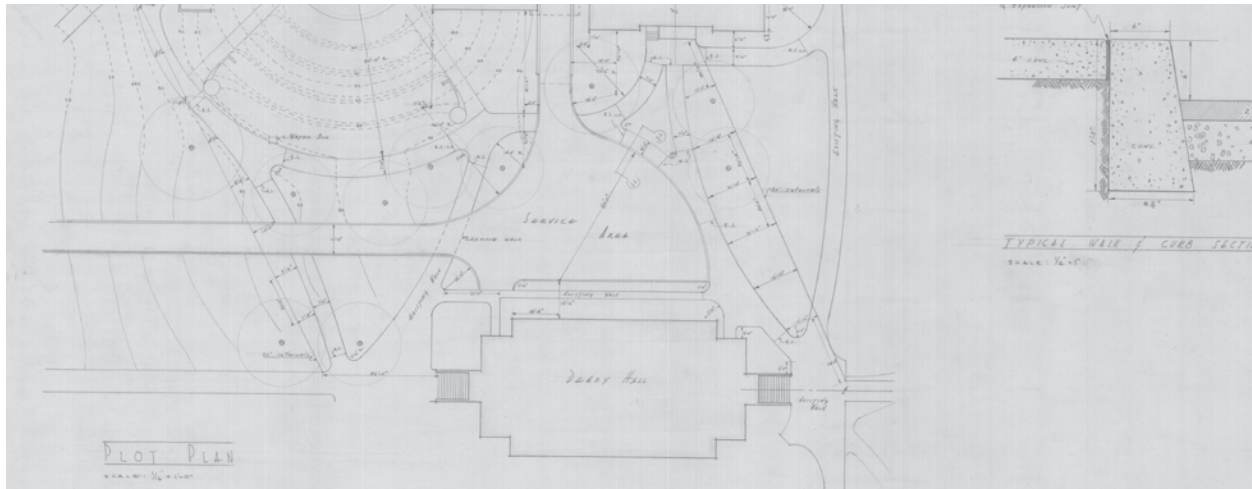
The following analyses and recommendations focus on the site features within the project boundary, including pathways, ramps and entry stairs, as well as site utilities.

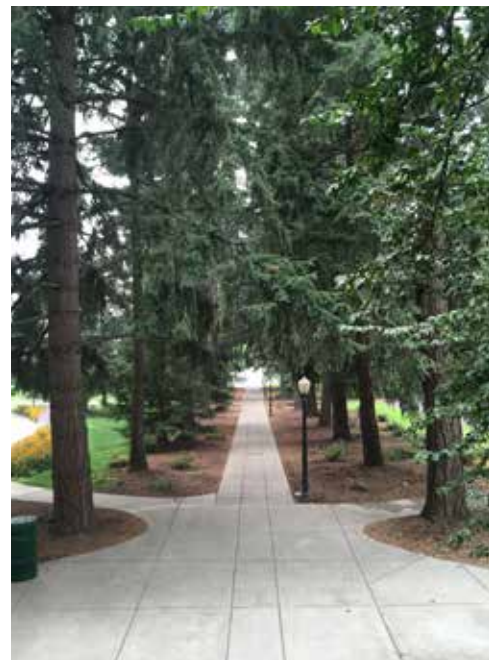
Image 71: The sidewalk extending from the west end of Deady Hall, also known as the “Deady Walk”, is in good condition.

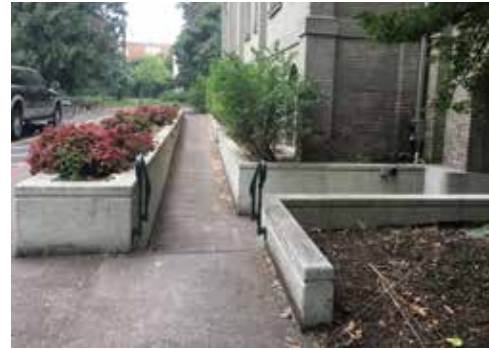
Image 72: Exterior ADA ramp at the north elevation, in fair condition.
