DEADY HALL ASSESSMENT
UNIVERSITY OF OREGON

03 November 2017

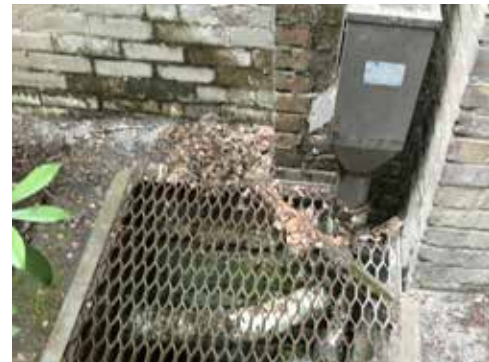
Image 74: Storm drainage and pipe access at the down spouts at each corner of the building's exterior.

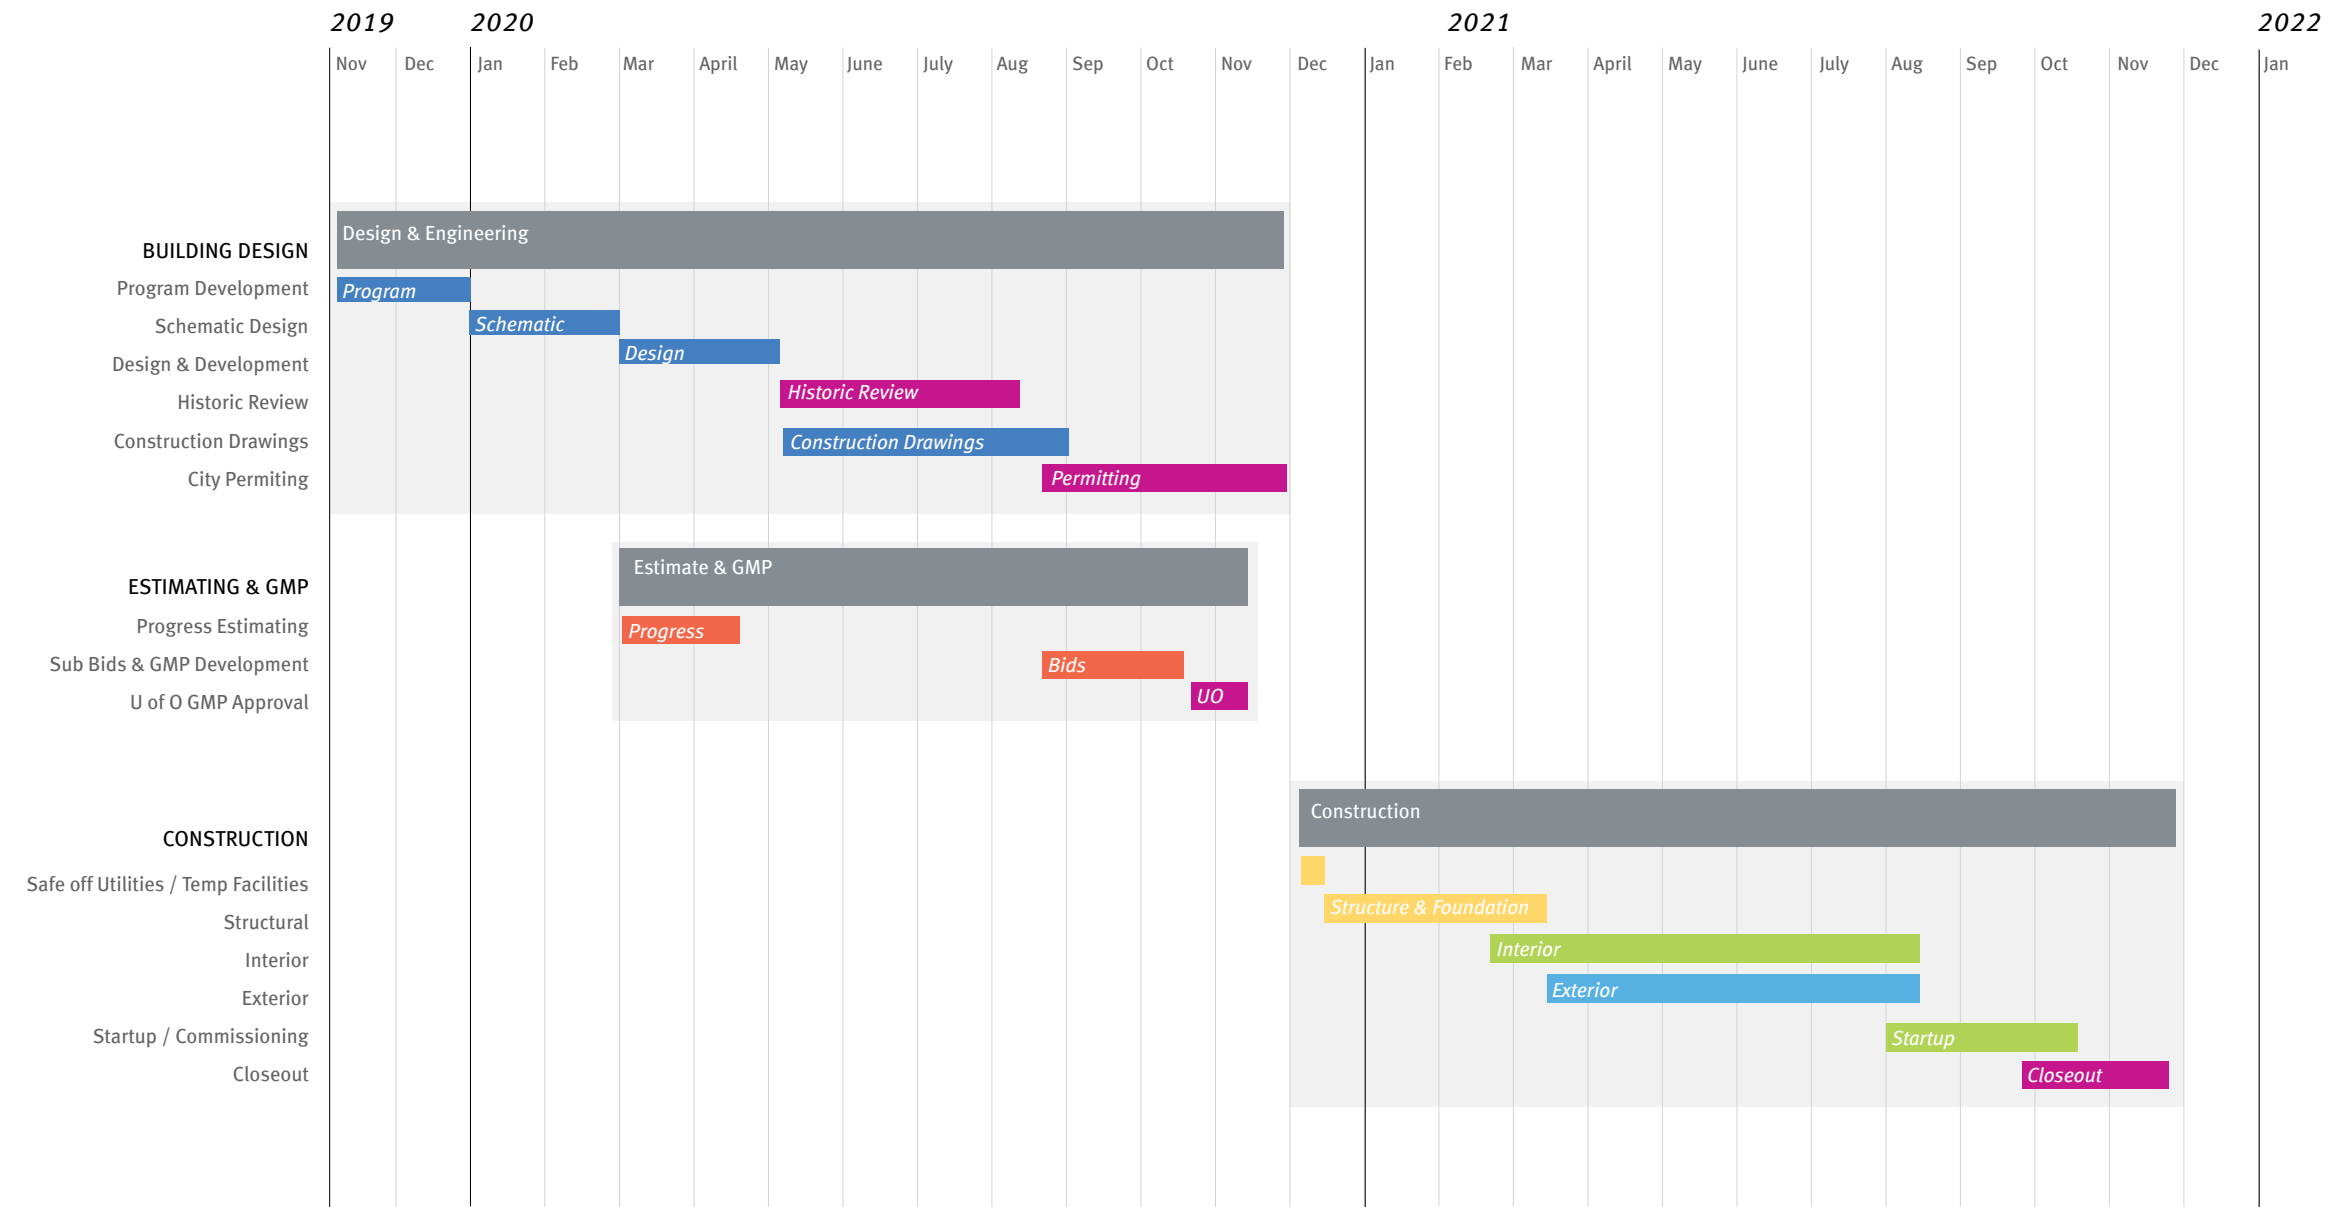
- PHASES**
- Proposals / Estimates
 - Design
 - Core & Shell
 - Structure & Foundation
 - Tenant Improvement
 - Review
