University of Oregon

2017 Deferred Maintenance Building Assessment
Villard Hall/ Miller Theatre Complex

November 3, 2017

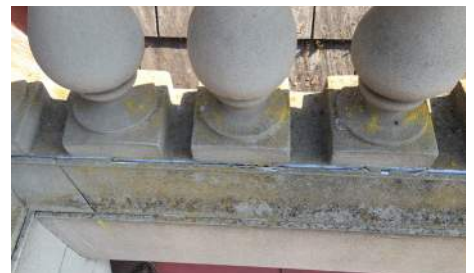
TFG08

The balustrades at the base of the mansard roof (TFG08), the railing at the east entry (TFG09), and columns (TFG10-TFG11) at the east entry are wood framed and coated with a cementitious waterproofing coating to provide a stone/stucco finish similar to the rest of the wall. The coating is deteriorating in the form of cracking and spalling due to loss of adhesion with the underlying wood. As a result, with the coating not providing protection at numerous areas around the building, the underlying wood has started to deteriorate. In several cases, large gaps in the wood seams and joints were observed (TFG12).

- Remove existing wedge anchor and fill resulting hole with stucco repair mortar as referenced above.

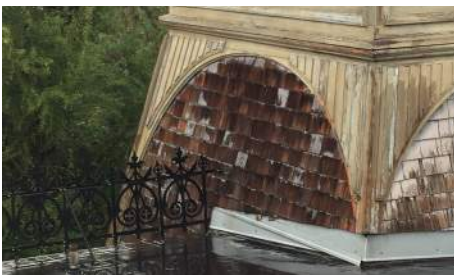
TFG13

The steep-sloped portions of the building are covered with painted wood shingles on all sides. A coating procedure was completed reportedly back in the late 1990's. At the north mansard and the northeast/northwest corner elements, the paint is failing badly (TFG13-TFG16). This may be due to the notion that the shingles were not back primed. Spot coating failure was noted at other limited locations throughout the roof. Coating flaking and deterioration of the underlying wood shingles were noted. Other areas of the mansard roof, notably the east elevation, saw the highest concentration of moss growth on the building (TFG17).

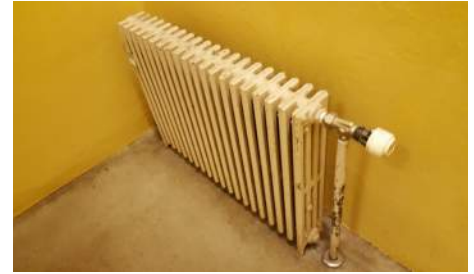
The existing controls system is a pneumatic controls system that is outdated and does not provide adequate controllability of systems resulting in operational inefficiencies. The controls system should be replaced with a new Siemens automated controls system to match and tie into the existing campus system.

Existing cast iron steam radiator

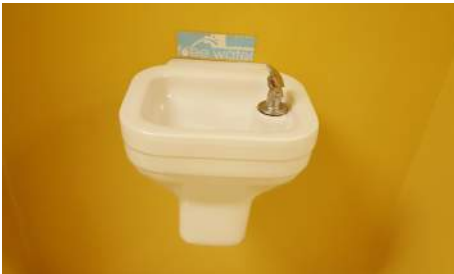
Fixtures in the building are outdated and not water efficient. As a component of sustainability measures incorporated into the renovation, all plumbing fixtures are recommended to be replaced with water conserving models meeting 2014 Oregon Energy Efficiency Code requirements.

Existing Drinking Water Fountain

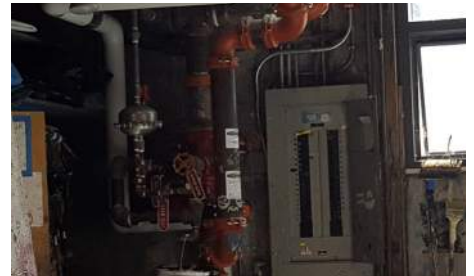
Villard Hall and the Robinson Theater are both fully sprinklered including the attic spaces. A visual inspection of the sprinkler pipe exterior shows little or no signs of exterior corrosion. An internal inspection of the pipe system should be performed as part of the renovation project. Fire water enters the building on the south end of the theater into the Scene Shop (Room 5) via a 4-inch main and includes all necessary valves and gages including check valves for the FDC. The system as installed is not configured for forward flow testing as required by NFPA 13 and NFPA 25. Forward flow testing will require the addition of a valve or means of proving full design flow is available to the building without flowing water through the heads.

Fire water service entering the building

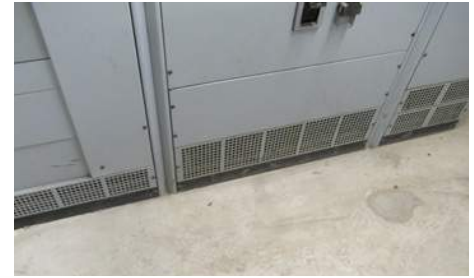
Inside the main electrical room there is no panic hardware on the main egress door and due to the size of the gear the room is required to have two exits per National Electrical Code/NFPA 70. Also, there is an open 'hole' in the room to bring in outside air without proper protection to keep water from entering the space. Any flooding on the exterior ground level will allow water to enter the main electrical room, only a few feet from the main gear, and present an electrocution hazard to room occupants. The wall opening is next to the fire department connection (FDC) and roof drain piping increasing the potential for water infiltration and flooding in the Electrical Room.

Main gear not located on a raised equipment pad and no seismic support.

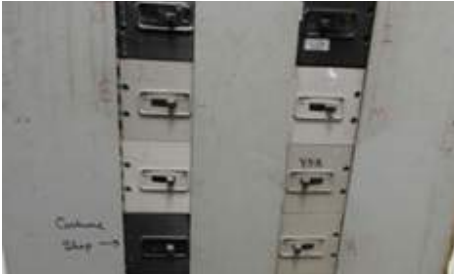
Custom made/modified distribution panelboard

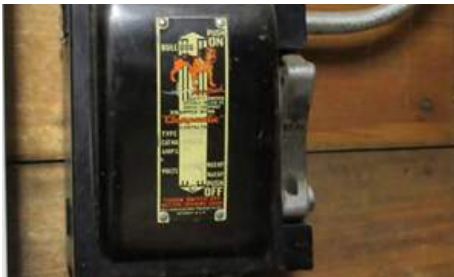
There is a significant quantity of old electrical equipment located throughout the site. Equipment in the range of 60-80 years old is still in use without availability of spare and replacement parts.

Example of a 67-year-old disconnect; typical throughout the building

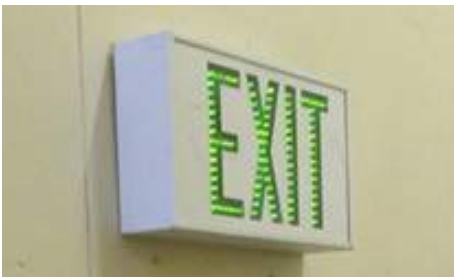
Exit signs appear to be powered through local batteries; every exit sign tested while on site had failed batteries and failed to turn-on. The exit signs are also a variety of styles and finishes. Other battery-based egress lighting was observed in Theater (Room 102) and random, unplanned locations.

Exit sign variety

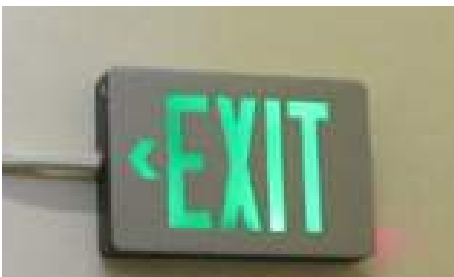
Exit sign variety

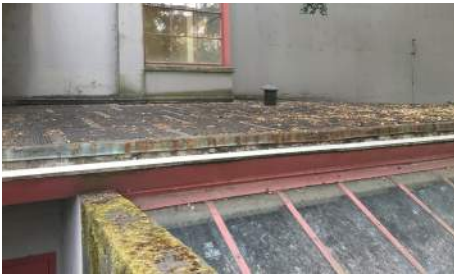
TFG39

The roof of the Green Room is composed of a single ply EPDM membrane with walkpads (TFG38-TFG39). The roof is sloped to drain to the north and west. The roof is in good condition and only requires regular maintenance at this point in time. An internal “hidden” gutter is present on two sides and leads to a downspout at the southwest corner of this roof (TFG40-TFG42). The gutter is provided with very little slope to drain and is filled with tree debris. Additionally, the wood fascias concealing the gutter are warped and their finishes are peeling away.
