Fenton Hall Window Condition Assessment

May 5, 2010 (updated January 2016)
University of Oregon
Campus Planning, Design and Construction

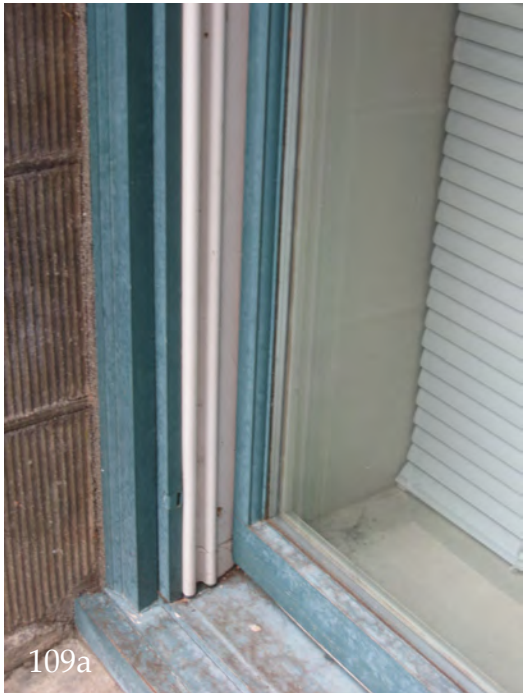
Window #	Window Type	Conditions							Facing Elev.	Comments	Photo
		Paint	Window Parts	Concrete Sill Cond.	Hardware	Operability	Dry Rot	Overall			
109a	Double hung, Double paned	Sill bare, exterior casing bare at base. Discolored at most exposed lower portion	J-Excellent IC-Excellent RS-Excellent St-Excellent Si-Excellent	Cracked	Plastic stop on top rail	Appears to be functional, Not tested	None observed	Excellent	South	This window appears to be new, jamb material is plastic or vinyl, warning label on sill was painted over and is now warped from exposure. Conditions assessed from the exterior.	yes
109b	Double hung, Double paned	Sill bare, exterior casing bare at base. Discolored at most exposed lower portion	J-Excellent IC-Excellent RS-Excellent St-Excellent Si-Excellent	Doorway fill, does not match surround	Plastic stop on top rail	Appears to be functional, Not tested	None observed	Excellent	South	This window appears to be new, jamb material is plastic or vinyl, warning label on sill was painted over and is now warped from exposure. Conditions assessed from the exterior.

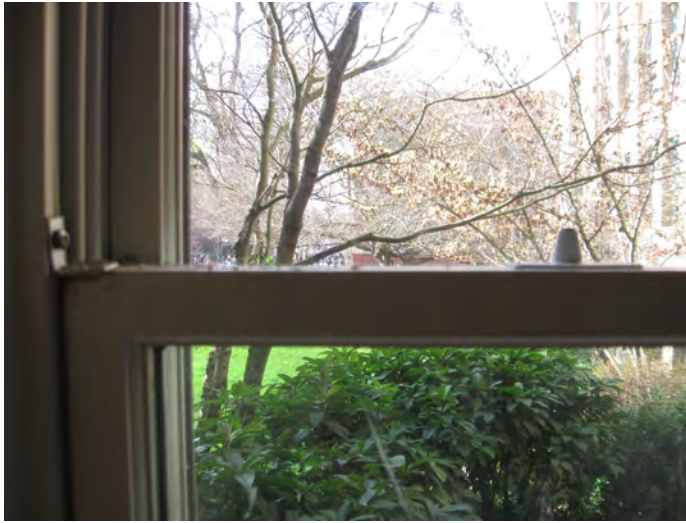
Window #	Window Type	Conditions							Facing Elev.	Comments	Photo
		Paint	Window Parts	Concrete Sill Cond.	Hardware	Operability	Dry Rot	Overall			
110a	Double hung, Double paned	Excellent	J-Excellent IC-Excellent RS-Excellent St-Excellent Si-Excellent	Excellent	Plastic stops on top of rail as well as an L bracket on left side of interior stop	Yes, functional	None observed	Excellent	West	This window appears to be new, jamb material is plastic or vinyl	yes
117a	Double hung, wood	Excellent	J-Excellent IC-Excellent RS-Excellent St-Excellent Si-Excellent	Small chip in sill	In addition to original hardware, an L bracket was added to stop window being raised	Yes, functional	None observed	Excellent	North		
117b	Double hung, wood	Excellent	J-Excellent IC-Excellent RS-Excellent St-Excellent Si-Excellent	Minor crack	In addition to original hardware, an L bracket was added to stop window being raised	Yes, functional	None observed	Excellent	North

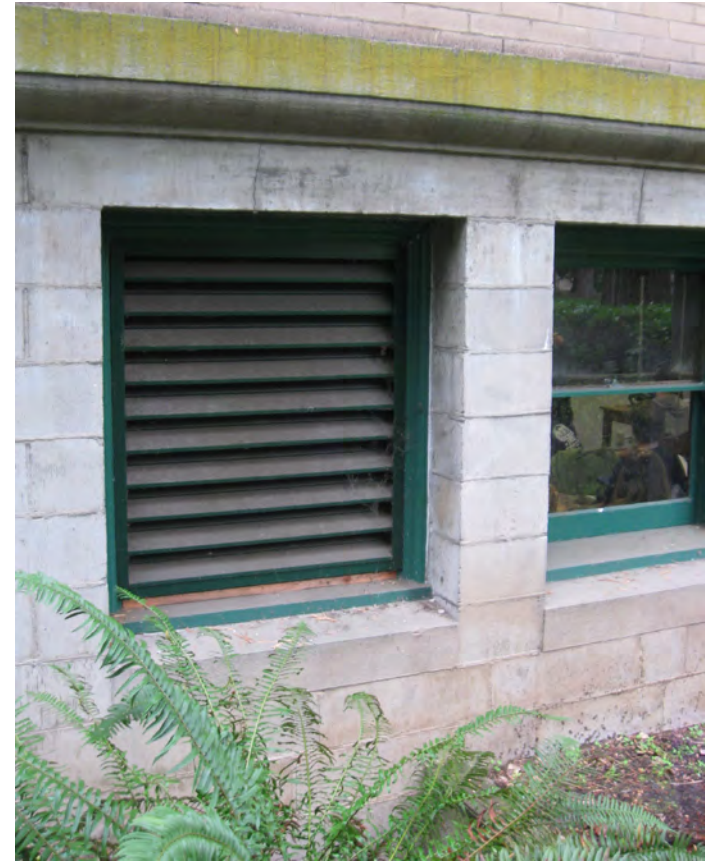
Window #	Window Type	Conditions							Facing Elev.	Comments	Photo
		Paint	Window Parts	Concrete Sill Cond.	Hardware	Operability	Dry Rot	Overall			
118a	Wood vent in window opening	Excellent	J-Excellent IC-Excellent RS-Excellent St-NA Si-NA	Excellent	None Present	Not operable	None observed	Excellent	North	This is a vent that takes up the entire opening, it is in excellent condition. Conditions assessed from the exterior.	
119a	Double hung, wood	Excellent	J-Excellent IC-Fair RS Excellent St- Excellent Si- Excellent	Excellent	In addition to original hardware, an L bracket was added to stop window being raised	Yes, minimally functional currently	None observed	Excellent	East	Interior stops loose on both sides, appears repair to weights was attempted	yes
119b	Double hung, wood	Excellent	J-Excellent IC-Excellent RS-Excellent St-Excellent Si-Excellent	Excellent	In addition to original hardware, an L bracket was added to stop window being raised	Yes, functional	None observed	Excellent	East

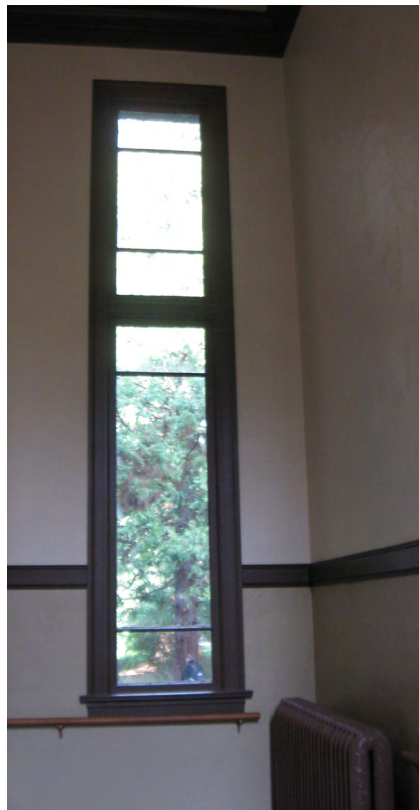
Window #	Window Type	Conditions							Facing Elev.	Comments	Photo
		Paint	Window Parts	Concrete Sill Cond.	Hardware	Operability	Dry Rot	Overall			
201a	Full height, Fixed glass, 1 horizontal mullion, 4 horizontal muntins	Excellent	J-Excellent IC-Excellent RS-Excellent St-Excellent Si-Excellent	Right side sill chipped	Appears to be original	Yes, functional	None observed	Excellent	North		yes
201b	Full height, Fixed glass, 1 horizontal mullion, 4 horizontal muntins	Some flaking on sill and exterior rail	J-Excellent IC-Excellent RS-Excellent St-Excellent Si-Excellent	Small chip	None observed	Not operable	None observed	Excellent	South		
201c	Transom window over primary entry, One mullion division at center	Excellent	J-Excellent IC-Excellent RS-Excellent St-Excellent Si-Excellent	Excellent	None observed	Not operable	None observed	Excellent	East		yes

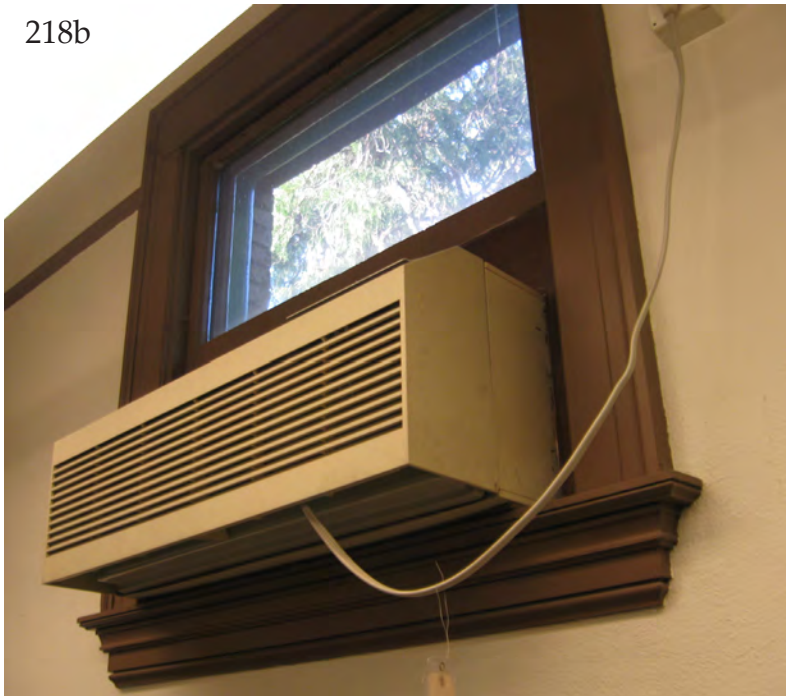
Window #	Window Type	Conditions							Facing Elev.	Comments	Photo
		Paint	Window Parts	Concrete Sill Cond.	Hardware	Operability	Dry Rot	Overall			
218b	Double hung clearstory, lower half modified	Excellent	J-Excellent IC-Excellent RS-Excellent St-Excellent Si-Excellent	Thin crack	Appears to be original hardware	Not operable	None observed	Excellent	North	Lower portion modified to accommodate air conditioning unit	yes
218Ba	Double hung wood	Sill fully exposed, flaking on inside around lower rail	J-Excellent IC-Excellent RS-Excellent St-Excellent Si-Fair	Excellent	in addition to original hardware a sliding lock has been added on the left	Yes, functional	None observed	Excellent	West	Some checking on sill	
218Ca	Double hung clearstory	Excellent	J-Excellent IC-Excellent RS-Excellent St-Excellent Si-Excellent	Excellent	Appears to be original hardware	Operability not tested due to height	None observed	Excellent	North

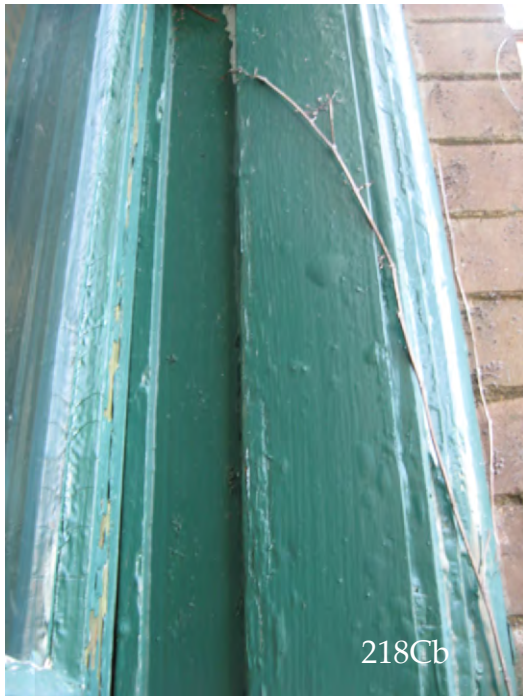
218Cb	Double hung wood	fair	J-Excellent IC-Excellent RS-Excellent St-Excellent Si-Excellent	Crack in top of sill, right side grout cracked, brick pulled out of grout	Appears to be original hardware	Yes, functional	None observed	Excellent	West	Sill fully exposed, some bubbling on external casing	yes

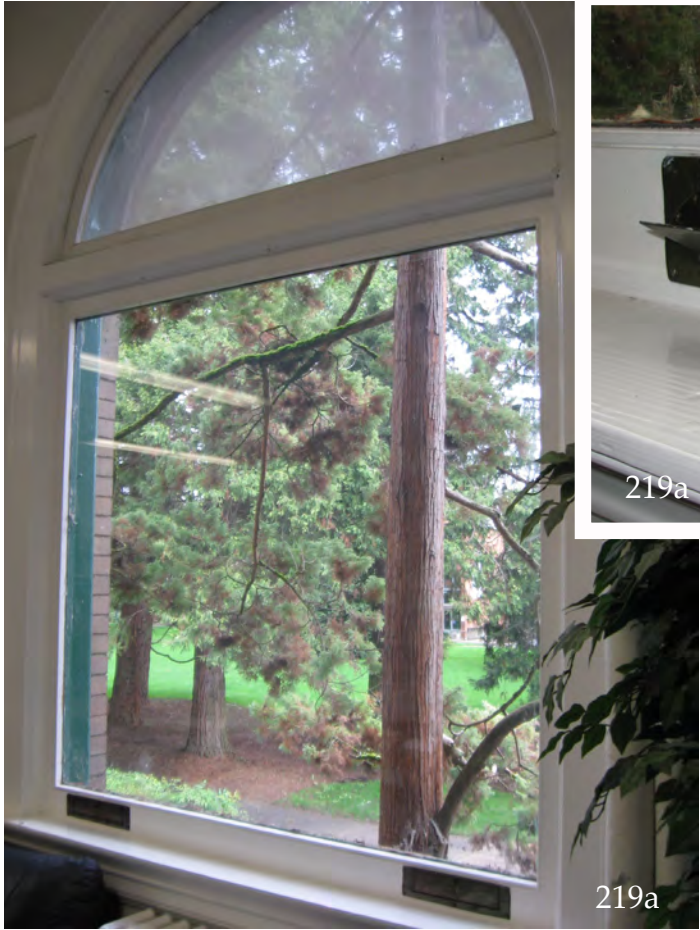
Window #	Window Type	Conditions							Facing Elev.	Comments	Photo
		Paint	Window Parts	Concrete Sill Cond.	Hardware	Operability	Dry Rot	Overall			
219a	Large Fixed lower window, operable arched transom window	minimal flaking on sill, large bubbles on exterior casing above transom	J-Excellent IC-Excellent RS-Excellent St-Excellent Si-Excellent	Excellent	transom lock and stop chains do not appear to be original	Yes, functional	None observed	Excellent	East	Original operable lower vents almost completely clogged as they are dirty and have been painted over from the exterior. Transom with exterior screen. Extensive bubbling in exterior paint above transom possibly linked to water infiltration.	yes
219b	Large Fixed lower window, operable arched transom window	minimal flaking on sill, large bubbles on exterior casing above transom	J-Excellent IC-Excellent RS-Excellent St-Excellent Si-Excellent	Excellent	transom lock and stop chains do not appear to be original	Yes, functional	None observed	Excellent	East	Original operable lower vents almost completely clogged as they are dirty and have been painted over from the exterior. Transom with exterior screen. Extensive bubbling in exterior paint above transom possibly linked to water infiltration.

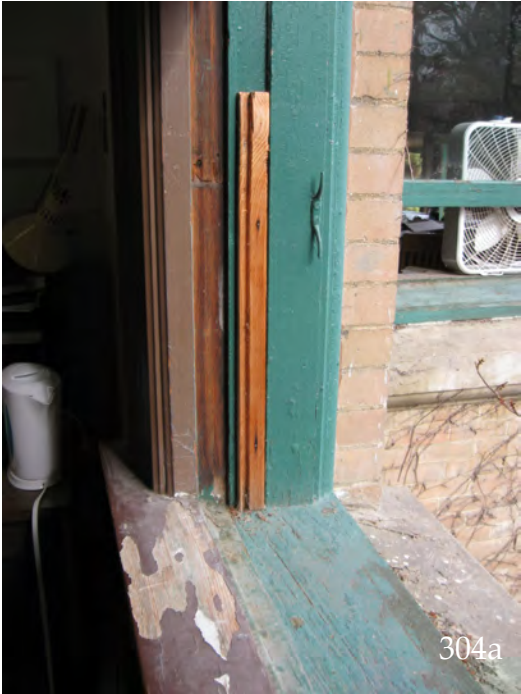
304a	Double hung wood, upper window decorative diagonal pattern	Flaking on sill and stool	J-Excellent IC-Excellent RS-Excellent St-Excellent Si-Excellent	Excellent	Appears to be original hardware, additional wood glides added in jamb, perhaps to stabilize window.	Yes, functional	None observed	Excellent	East	Diagonal muntins squat in shape. Old vies growing around exterior of window.	yes

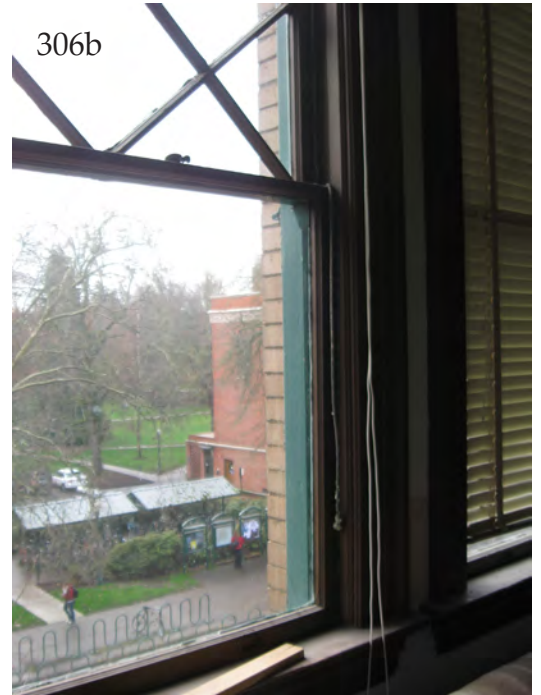
306b	Double hung wood, upper window decorative diagonal pattern	Deep flaking on jamb and sill fully exposed	J-Excellent IC-Excellent RS-Excellent St-Excellent Si-Fair/Poor	Excellent	Appears to be original hardware	minimally functional, right cord broken	None observed	Excellent	South	Diagonal muntins squat in shape. Flaking paint on lower interior rail reveals the possibility of past condensation accumulation. Sill deeply checked.	yes

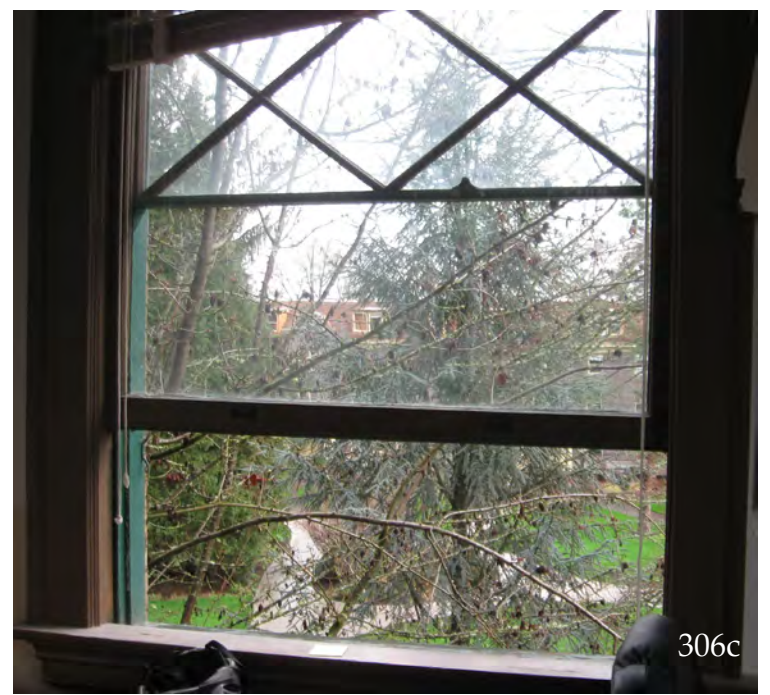
Window #	Window Type	Conditions							Facing Elev.	Comments	Photo
		Paint	Window Parts	Concrete Sill Cond.	Hardware	Operability	Dry Rot	Overall			
306c	Double hung wood, upper window decorative diagonal pattern	Deep flaking on jamb and sill fully exposed	J-Excellent IC-Excellent RS-Excellent St-Excellent Si-Excellent	Excellent	Appears to be original hardware	Yes, functional	None observed	Excellent	East	Diagonal muntins squat in shape. Sill deeply checked.	yes
307a	Double hung wood, upper window decorative diagonal pattern	Deep flaking on jamb and sill fully exposed	J-Excellent IC-Excellent RS-Excellent St-Excellent Si-Fair/Poor	Hairline cracks	Appears to be original hardware	Yes, functional	None observed	Excellent	South	Diagonal muntins tall and narrow in shape. flaking paint on lower rail reveals the possibility of past condensation accumulation. Sill deeply checked. Blue tape closing opening between lower rail and window pane.	yes

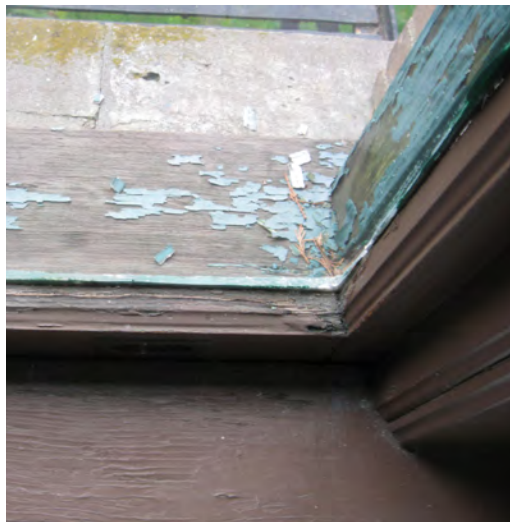
318a	Double hung wood, upper window decorative diagonal pattern	Sill, stool, lower section of exterior jamb, and interior rail exposed.	J-Excellent IC-Excellent RS-Excellent St-Excellent Si-Excellent	Sill cut out to insert fire stair	Appears to be original hardware	Yes, functional	None observed	Excellent	West	Diagonal muntins tall and narrow in shape. flaking paint on lower rail reveals the possibility of past condensation accumulation.	yes
318b	Double hung wood	Sill flaking	J-Excellent IC-Excellent RS-Excellent St-Excellent Si-Excellent	Sill cut out to insert fire stair, some cracking at fire stair connection	Appears to be original hardware	Yes, functional	None observed	Excellent	West	Flaking paint on lower rail reveals the possibility of past condensation accumulation.
