# Friendly Hall

## Preliminary Historic Assessment

University of Oregon  
Campus Planning  
Campus Planning and Facilities Management

October 2022

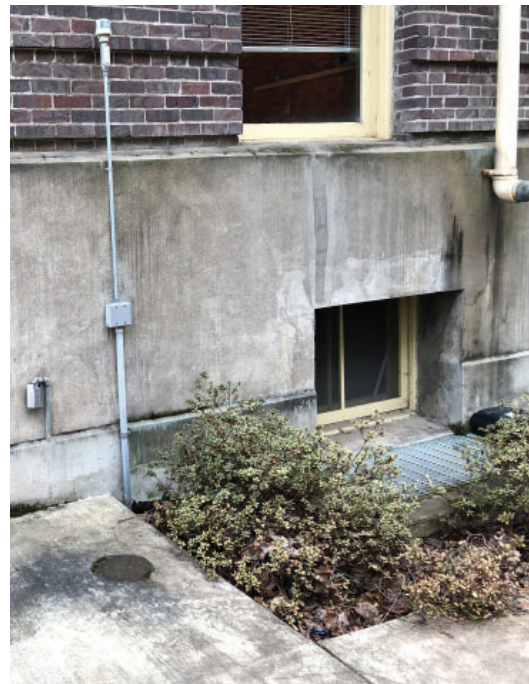
Foundation showing repairs, mechanical equipment added to facade is not original.

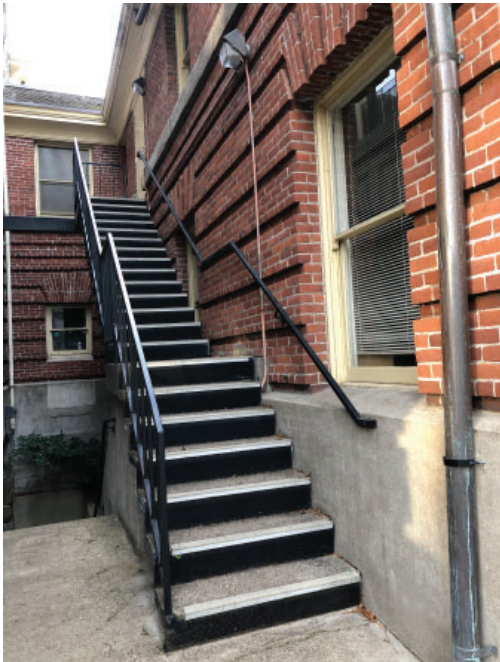
Light fixtures are not original.  
Foundation differences between  
basement and ground level.

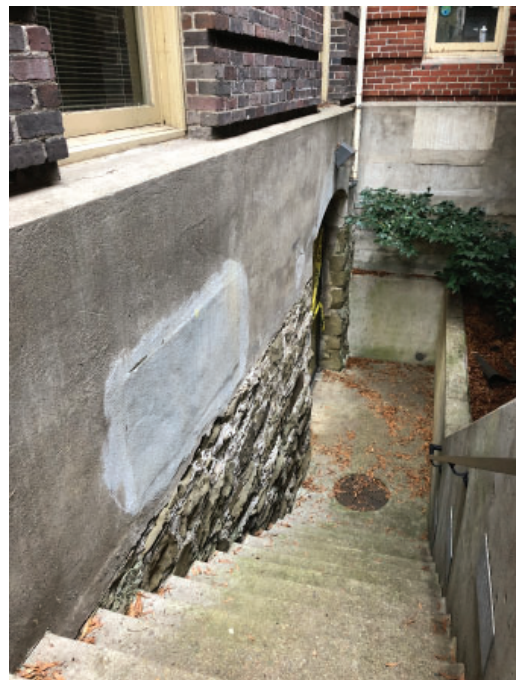
Difference between original stone  
foundation and 1914 addition  
foundation. 1914 addition used  
different colored brick

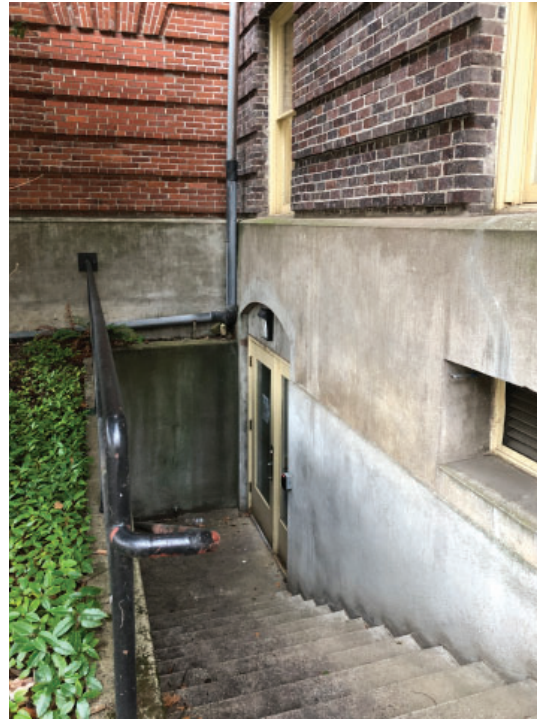
Stairwell leading down to basement shows foundation differences. Brick color differences between additions and original building.

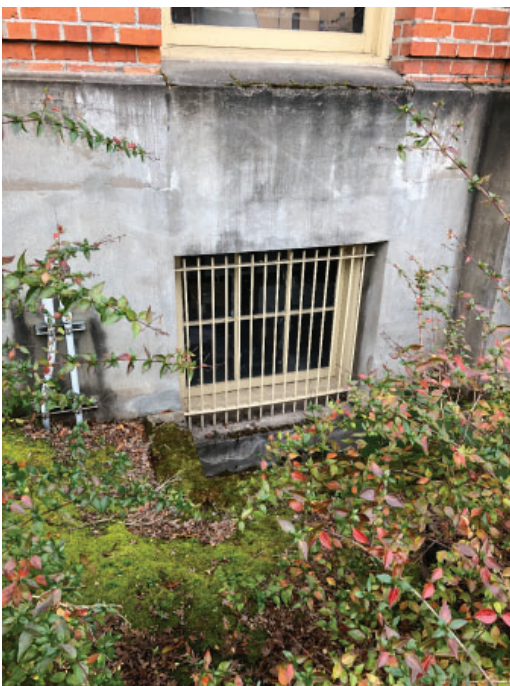
Water damage on window sills; basement windows with bars that are not original.

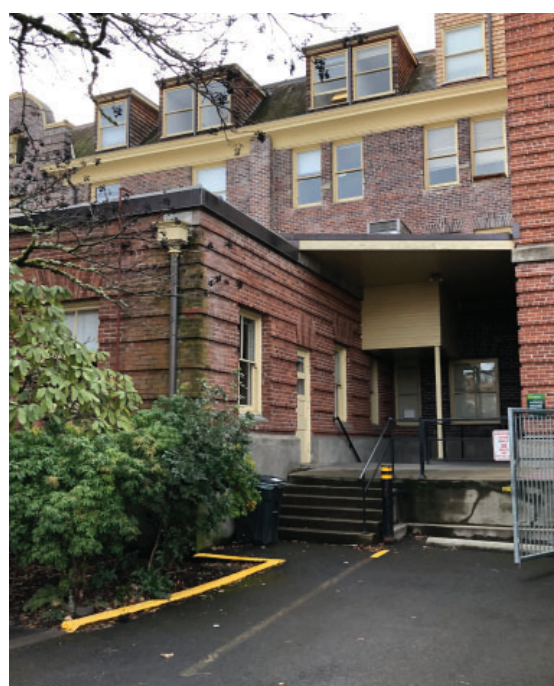
Dormers added to east facade. Overhang above the stairs and entrance is not original.

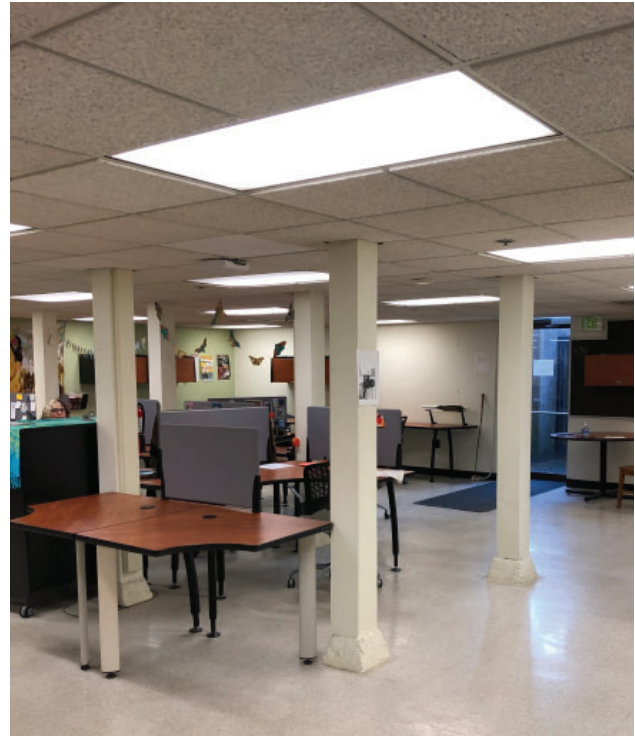
Support pillars not original; further research needed for year pillars were placed/replaced

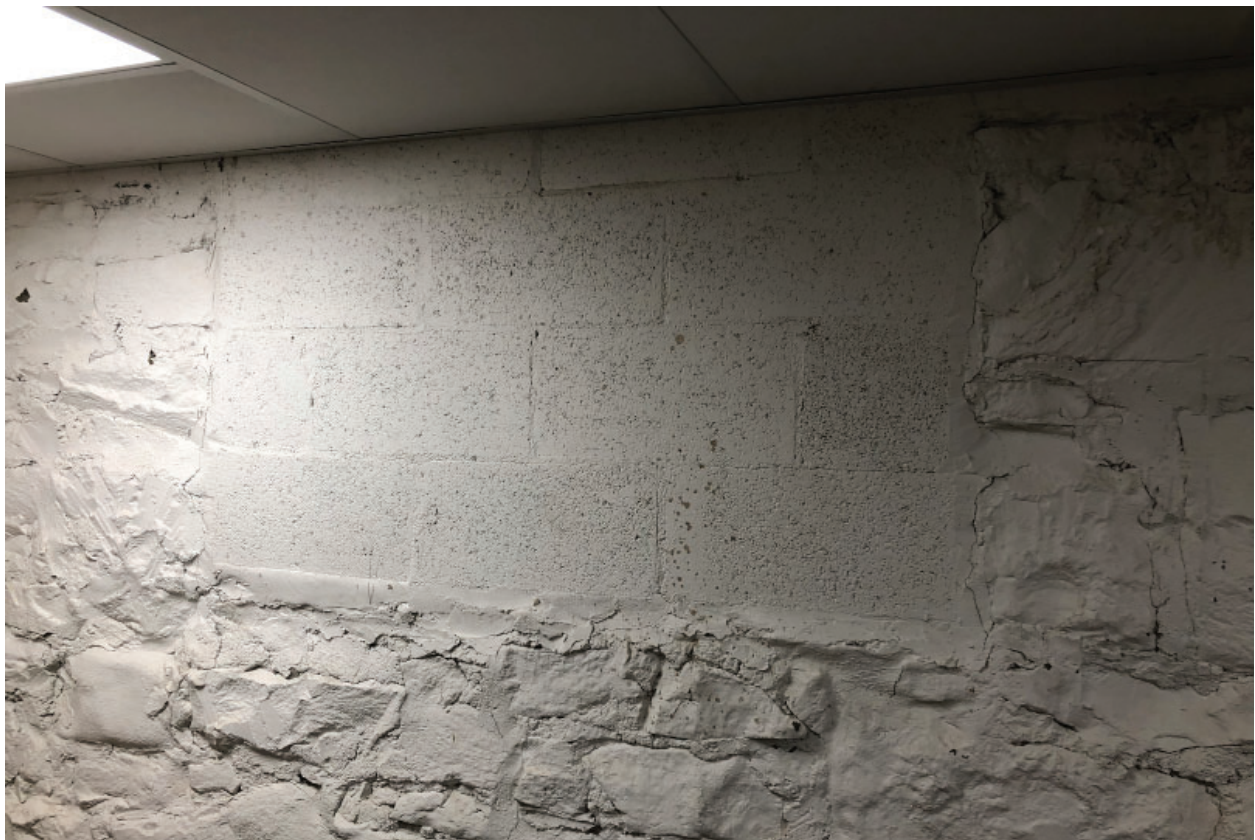
Room 20 (Old vs. New Foundation)

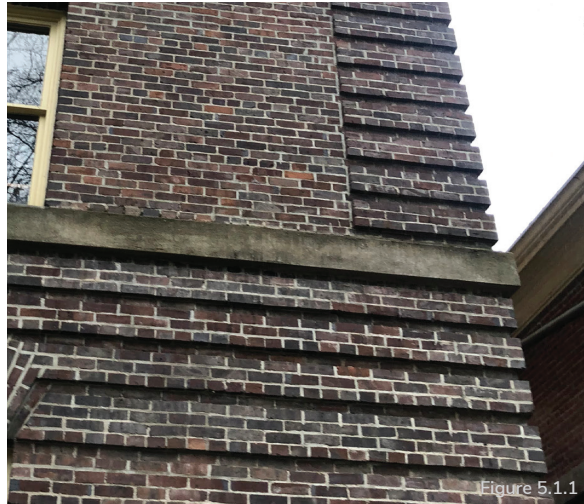
Figure 5.1.1

The exterior walls of Friendly Hall indicate the original structure and its two major additions. All three major constructs use an American or Common bond. A dark brick is used on the original portion (figure 5.1.1), while the additions are clad with a red brick (figure 5.1.2). The 1914 addition on the east also has a different coursing pattern than the other two constructs (figure 5.1.3). The face brick is embellished with quoins, jack arches, and rusticated reveals on the first floor.

The face brick appears intact and in good condition, with limited examples of damage or spalling. A visual inspection showed no indication of rising damp.

- The exterior masonry should be maintained.
- During the proposed seismic upgrade, interior faces of the brick walls will be exposed and additional inspection and testing should be performed.
- All brick, mortar or concrete elements should be cleaned with hot water and brushed where required following best practices for maintenance of historic brick facades.
- Areas of mortar deterioration and cracking should be identified and repointed.
  - All deteriorated mortar joints should be ground using the appropriate grinder profile back to sound material prior to repointing.
  - New mortar shall match the existing in color, texture, composition, and tooling profile. It is recommended that several small test areas be reviewed for visual match prior to commencing with larger areas of repointing.

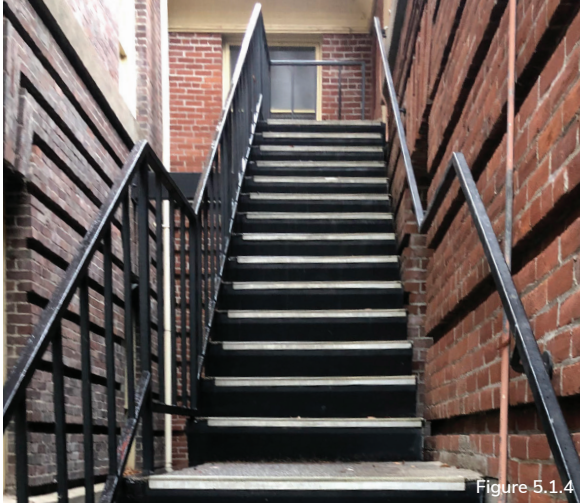
Figure 5.1.3

Mortar joints are generally intact and in good condition. There are some areas of previous repointing that are an inadequate match to the historic mortar color and texture (figure 5.1.3) which should be replaced.

- Brick that is fractured, chipped, or spalling should be removed and replaced with brick that matches the original size, shape, color, and texture.
- The south exit stair should be removed and the underlying brick should be repaired to restore the historic appearance.

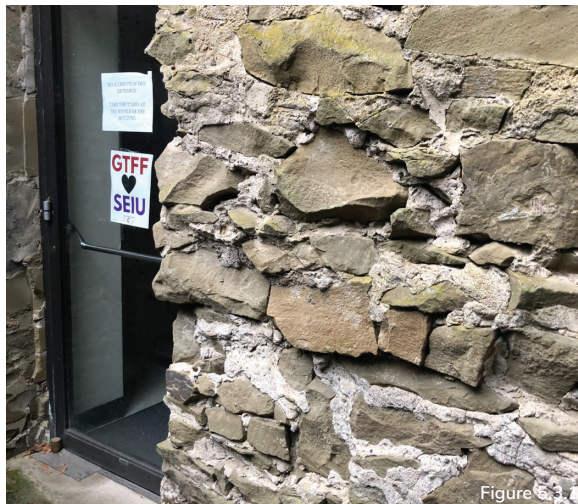
Figure 5.3.1

The West Wing of the building was constructed with a stone foundation that has been exposed in some locations (figure 5.3.1). It is generally in good condition, though the original design did not intend for any stone to be exposed.

- Existing areas of visible stone on the basement level should be refinished as necessary to improve the interior spaces.
- Exterior stone should be cleaned as necessary where exposed.

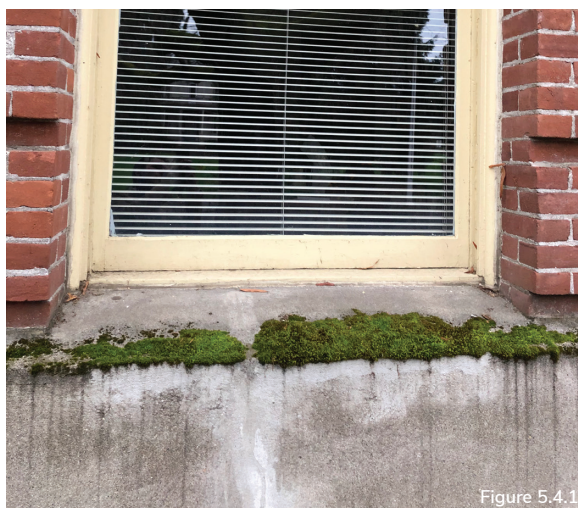
Figure 5.4.1

Building occupants noted that there have been instances of water leakage in the basement floor of the West Wing. Such water intrusion is not unexpected given the age of the building and the limited options for below grade waterproofing available during its construction.

During a walkthrough, areas of organic growth and superficial cracking were observed (figure 5.4.1-2).

Water leakage through the basement or foundation walls can be remediated via two approaches, positive side and negative side remediation.

- Positive Side: A membrane system placed on the exterior face of the structural foundation system.
  - o The highest level of protection would be afforded by excavating the entire perimeter of the building to expose the foundation walls. The exterior wall surfaces would be cleaned, and a new waterproofing membrane would be installed along with new subgrade drainage.
  - o The lowering of the basement floor will necessitate perimeter excavation providing an opportunity for positive side waterproofing treatments.
- Negative Side: A treatment on the interior surfaces of the foundation system.
- Exposed concrete on other exterior areas should be cleaned as necessary.

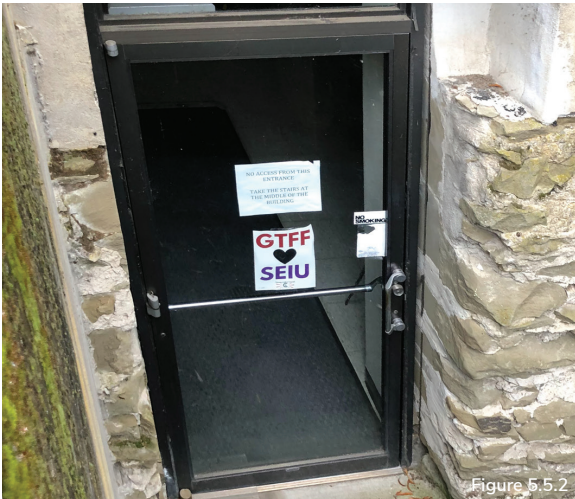
Figure 5.5.2

Generally, the historic exterior doors on the building have been maintained and are functionally adequate (figure 5.5.1). Some have experienced slight aesthetic deterioration which is expected on elements of this age. At exterior basement entries, character compromising doors were installed at some point during previous renovations (figure 5.5.2).

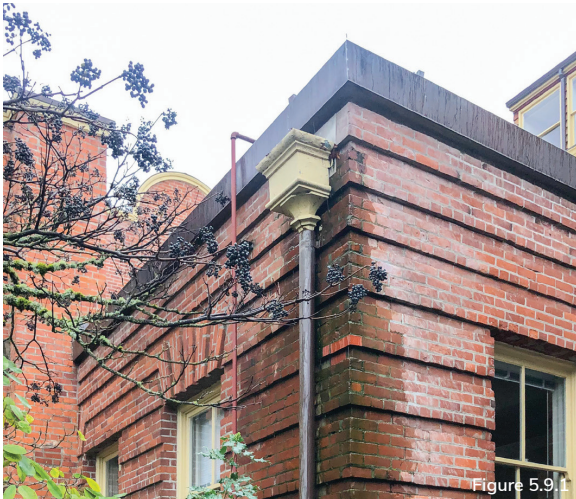
Figure 5.9.1

Two oculus windows on the West Wing, one on the north and one on the south, were replaced with emergency exit doors which access the fire escape.

- If possible, remove the existing fire escapes.
  - If restoration is chosen, fire escapes should receive high performance, weather-resistant finishes to prevent future deterioration. They should also be modified to prevent ground level access from the exterior of the building.
  - If they are removed, the existing downspouts and standpipe should be reconfigured to better complement the historic architecture. The egress doors from the fourth floor should be removed and be replaced with the original oculus windows.
