LANDSCAPE RESOURCE SURVEY
 University of Oregon Campus Heritage Landscape Plan
 Eugene, Lane County, Oregon • Spring 2007

15th Avenue Axis (z)

Landscape Resource Survey
15TH AVENUE AXIS

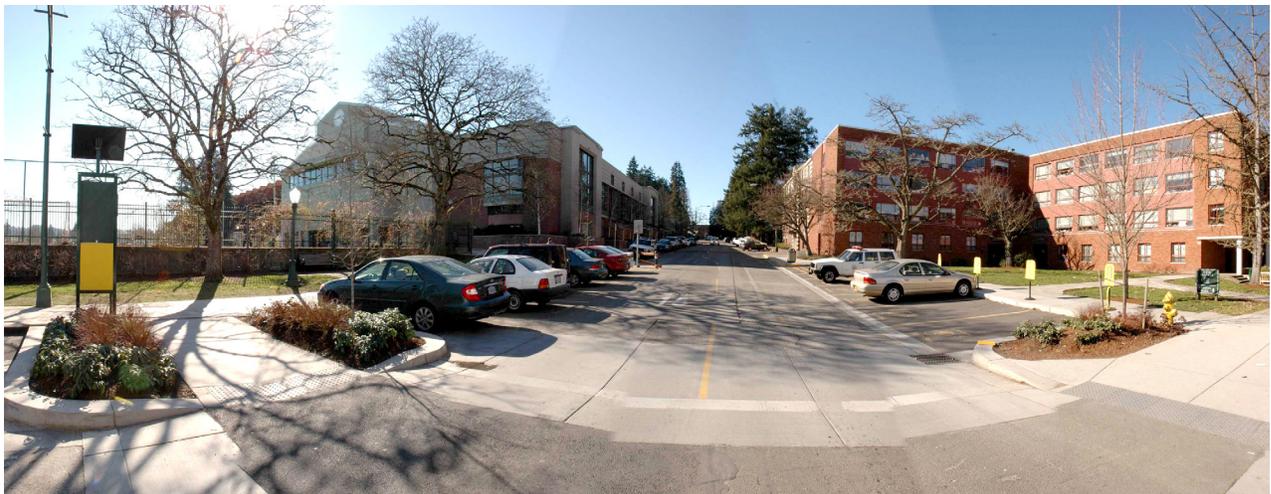
View looking west with Earl Hall at right and the Student Recreation Center at left.

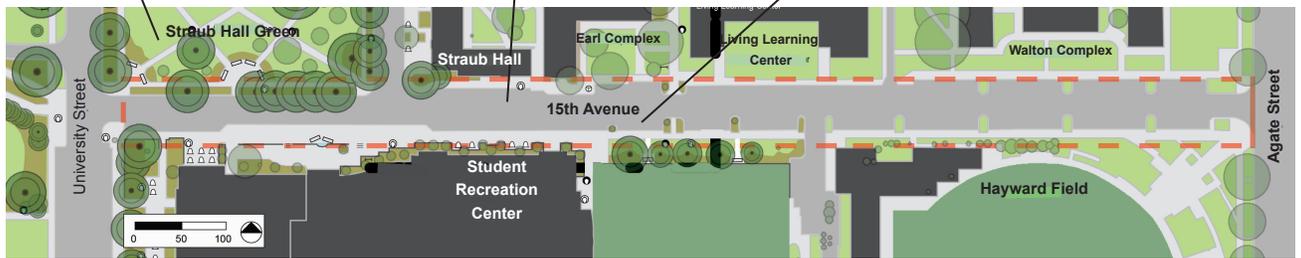
LANDSCAPE AREA SITE MAP — Highlighting existing elements from the period of significance (1876-1974).

Some of the Douglas firs planted near the Onyx Intersection may date back to the Inception Era

Crimson King Norway maples were planted during the Lawrence/Cuthbert Era

Retaining wall appeared during the Lawrence/Cuthbert Era

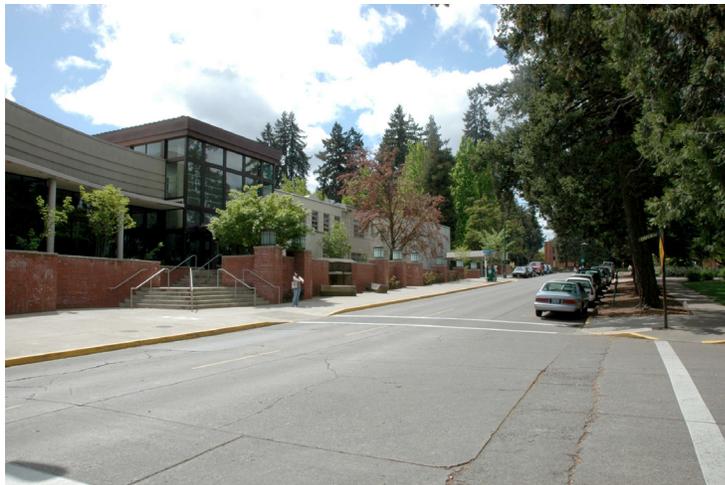
The Douglas firs that date back from the Inception Era shown at right, and the new Student Recreation Center and Esslinger Hall at left.

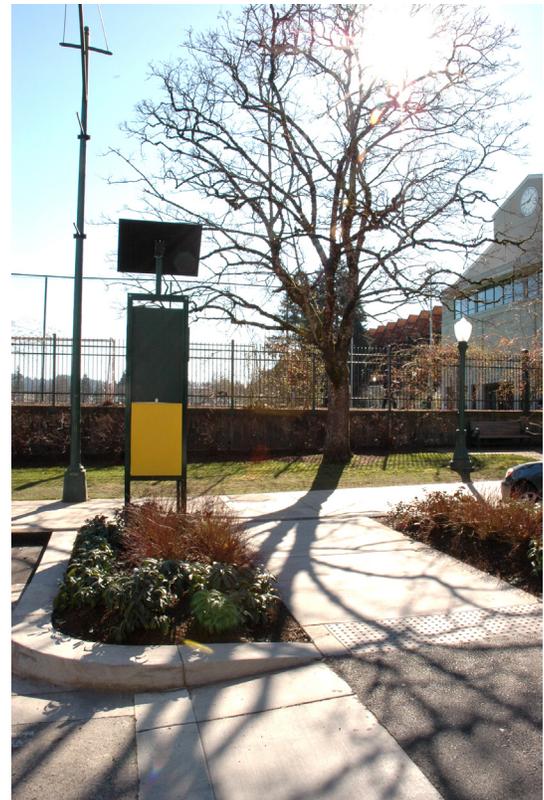
The concrete retaining wall and one of the three Crimson King Norway maples, both dating back to the Lawrence/Cuthbert Era.

There are few small-scale elements of note, one of which is a concrete retaining wall along the field west of Hayward Field, dating from the Lawrence/Cuthbert Era. Other small scale elements are associated with the newer building projects.

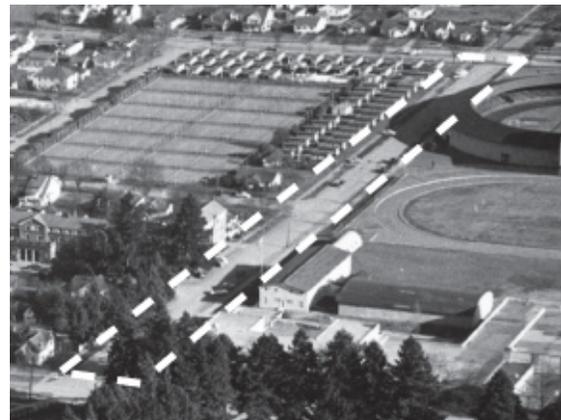
1950 aerial

A long row of temporary student housing trailers extend from east of Straub Hall to Agate Street, eventually replaced by the Walton and Earl Residence Halls. Straub Hall Green now occupies the northeast corner of 15th Avenue and University Street. The large Douglas firs along this stretch of the Axis are the oldest trees on the street. The north grandstand of Hayward Field has been razed and parking along the Avenue is at a premium. Cars park diagonally in front of the Walton Complex, and these spaces have moved the sidewalk slightly to the north. Parallel parking is provided along the remaining length of the Axis on both sides of the Avenue.
