University of Oregon

Campus Tree Plan

October 2001
Updated July 2008

University of Oregon Campus Tree Plan

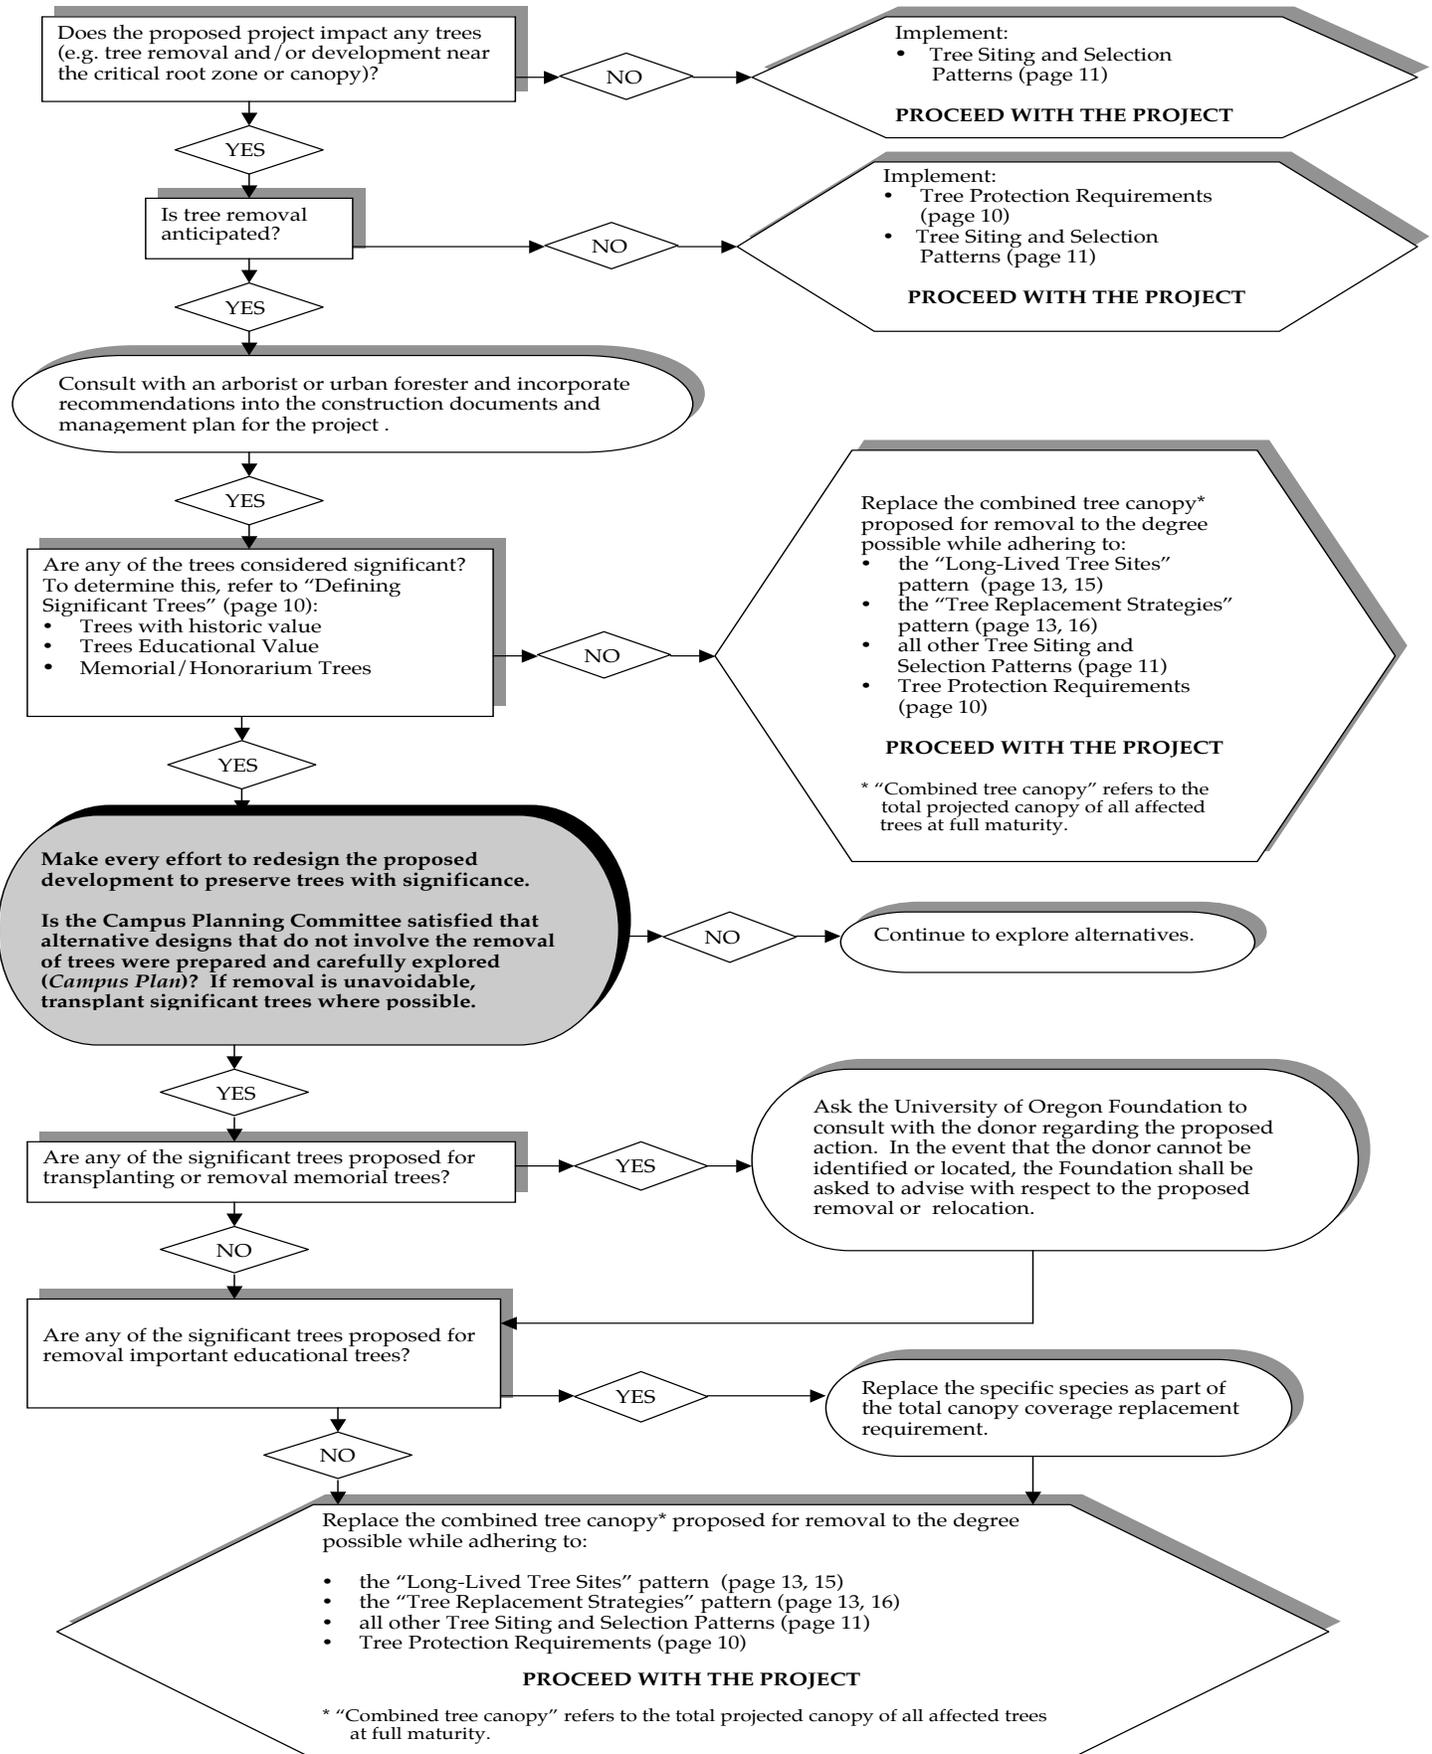
4.1.1 Table: Decision Tree

Every development project on campus must adhere to the steps covered in the following flow chart:

When proposed development may negatively impact trees (e.g., adjacent construction and/or removal), it is important to define the significance of the affected trees. If a tree meets one or more of the characteristics stated below, every effort should be made to preserve it. The steps noted in the tree responsibility flow chart should be followed.

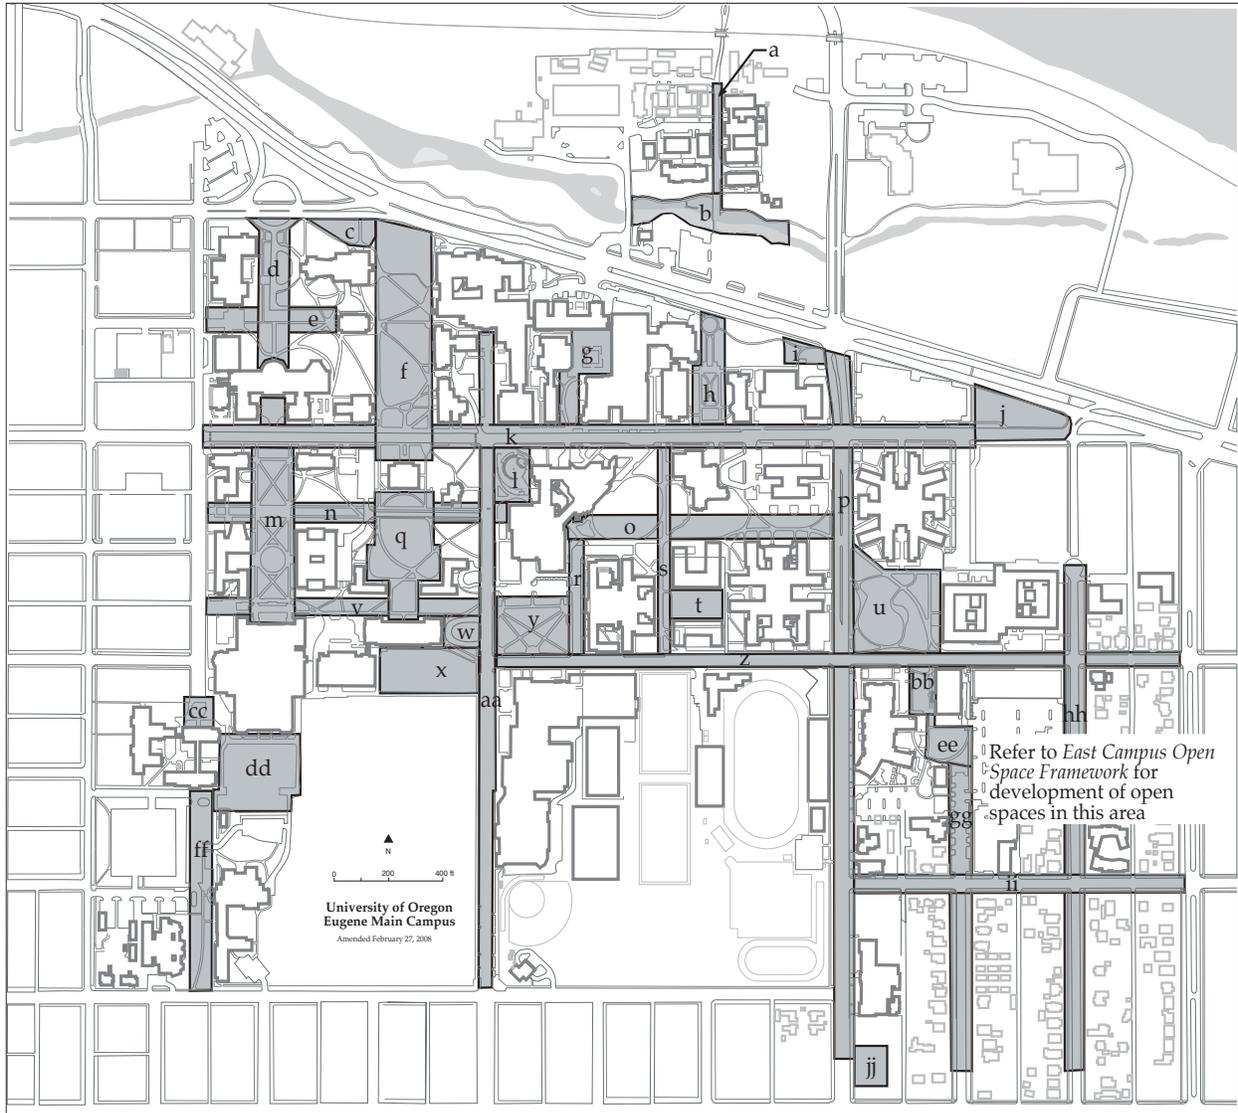
Map: Designated Open Spaces

A description of the existing and desired tree canopy is provided for the designated open spaces (in bold) on the pages indicated.

- Memorial Quadrangle (m), page 21
- Old Campus Quadrangle (f), page 21
- Women’s Memorial Quadrangle (q), page 23

As noted in the "Designated Open Space" pattern, every tree that helps form or reinforce the identity of these designated open spaces should be afforded extra care. In addition, the "Long-lived Tree Sites" pattern gives priority to planting trees in designated open spaces. For this reason, this plan focuses on defining the desired character of the tree canopy for the Designated Open Spaces (refer to map, 6.1.1. Designated Open Spaces on page 20).
