Erb Memorial Union Preliminary Historic Assessment

University of Oregon
Campus Planning, Design and Construction
December 2011 (updated August 2015 and January 2016)

Summary: This preliminary assessment identifies the historic significance of the Erb Memorial Union's landscape features, exterior facades, and interior spaces.

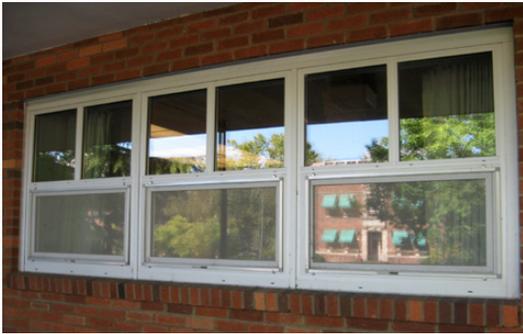
All north-facing windows in the Walnut Room were replaced in 2009. A wider opening was cut for windows, date unknown.

Date Unknown: The original window openings of the Walnut Room were expanded from individual to a set of three (refer to dwg #1). The replaced windows match the original double-over-single type.

2009: All windows of the Walnut Room were again replaced to match the existing window function, rail width, mullion size, and location. The main door was replaced with a single swing.

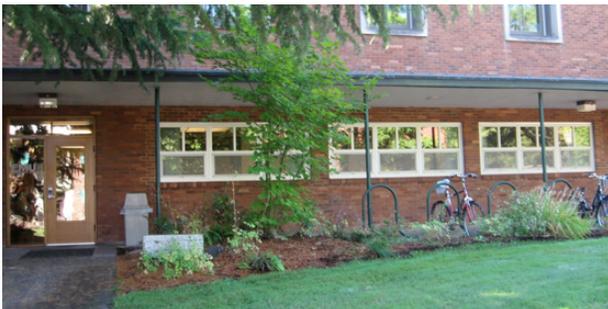
Original opening for Post Office double-swing door, replaced in 2009 with a single swing door.

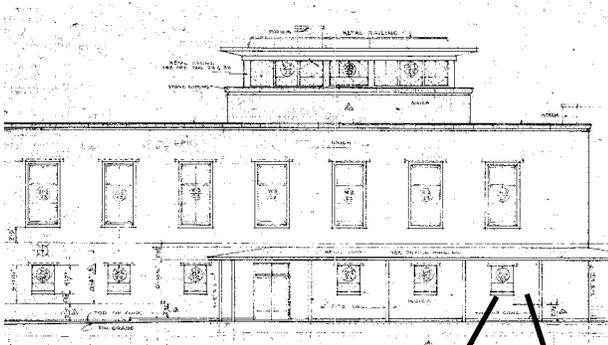
Dwg #1: Original Elevation c. 1948 showing original size of first-floor windows (single wide).

Original openings expanded, date unknown.

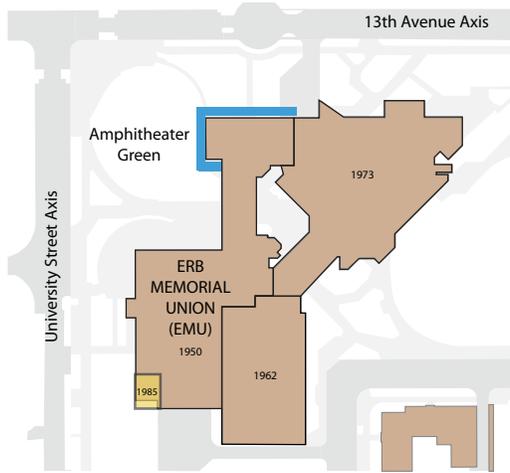
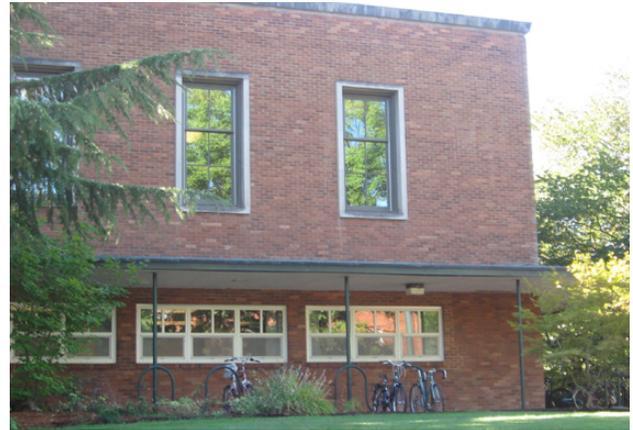
Second-floor windows all replaced in 2007.

Alterations:
2007: During a remodel of the Mills International Center, all seven windows on the north facade and the single window on the west facade were replaced with a wood assembly, profile to match existing wood windows (refer to diagram). On the interior, the existing trim was reinstalled.

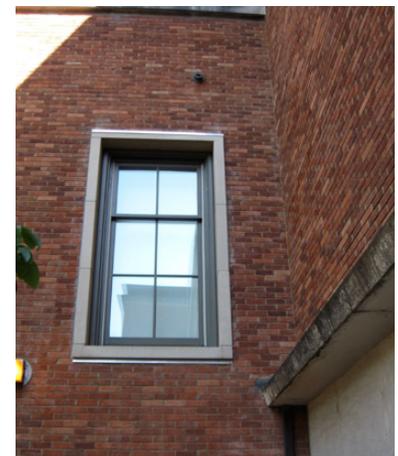
New opening for a window cut in south-facing wall to match existing during 2007 remodel.

On the south-facing facade, a new opening was made for an additional window. New interior trim, specified to match existing trim, was installed.

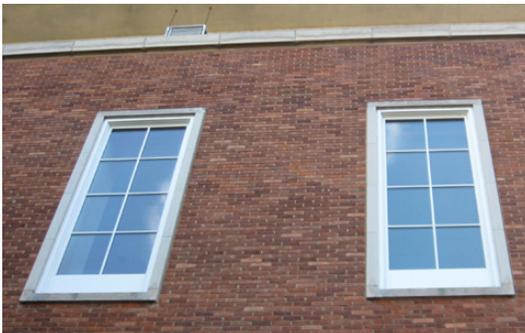
Second-floor windows had glass replaced in 2009; original wood frame & mullions.

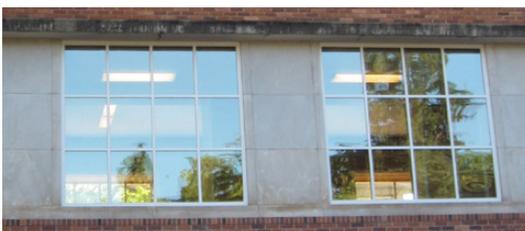
First-floor windows, glass replaced in 2009.

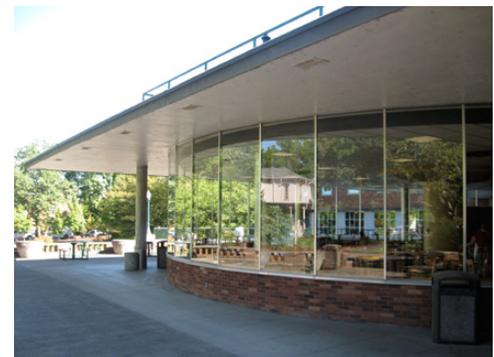
Original storefront system of Fishbowl.

1998: Fishbowl SW entrance storefront system replaced. Door and frame removed from brick facade next to this entrance and infilled with similar brick veneer. One sliding window located on curve of Fishbowl storefront system was removed.

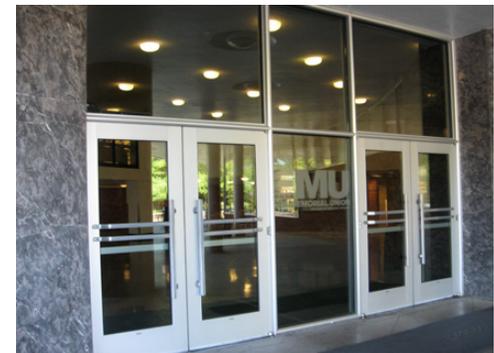
Main Entrance doors & windows replaced in 2009, maintaining hardware.

2009: Main entrance storefront system doors and windows replaced, maintaining original hardware.

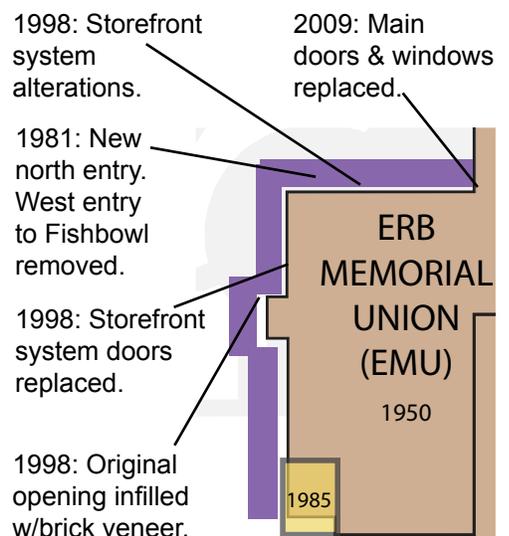
Diagram of First-Floor Alterations

(1) 2009: Doors & windows replaced original concrete panels & second level windows.

(2) 1985: Doors replaced hardware only.

(3) 1985: Double doors replaced w/ windows.

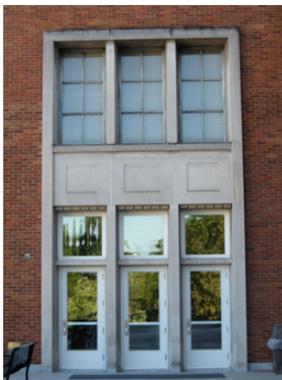
(1) Replacement doors & hardware in 2009. Original cast concrete detailing & upper level windows.

2009: Single-pane glazing was replaced with double pane on ballroom windows on the west facade. The existing doors and hardware were replaced. Main doors from the balcony to ballroom lobby were replaced.

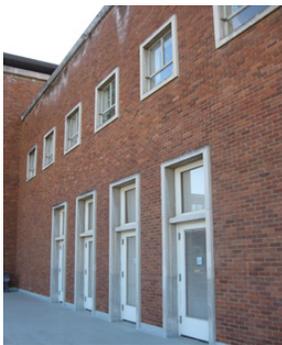
(2) Three original balcony doors, with far right door retaining original hardware.

1985 Addition: An addition was built, altering the original west facade. Seven double doors on the west wall, opening out onto the terrace. These were labelled E1-E7 from south to north on the 1948 drawings. During the 1985 remodel E3 and E7 were replaced with new double doors. All other double doors were replaced with double-over-double windows. One opening for original double doors was infilled. Doors from the Gumwood Room opening onto north balcony had hardware replaced, with the exception of one door on the far west edge which retains the original hardware (refer to image #2).

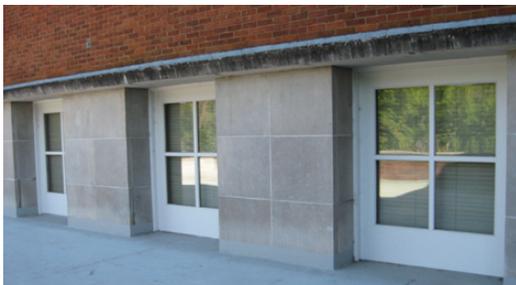
(3) Three sets of double doors replaced by double-over-double windows in 1985.

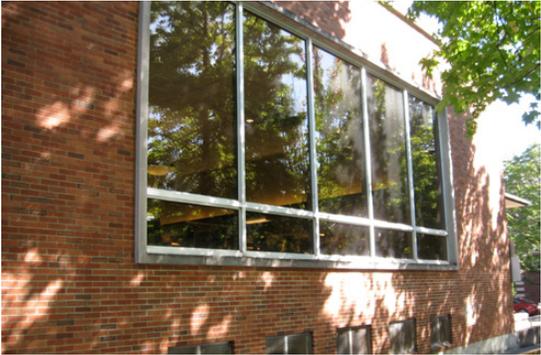
South Dining storefront windows replaced in 2009. Original vent openings below to basement.

2009: The original 1960 drawings of the South Dining windows were specified with $\frac{1}{4}$ inch thick grey glass. This was replaced with 1 inch protective glazing and aluminum stop matching original height, width, and finish. The South Entrance doors were replaced, maintaining original aluminum storefront system and glazing surrounds. East-facing windows of the first-floor offices were replaced to match original double-over-single hung windows, but double glazed (refer to third photo).

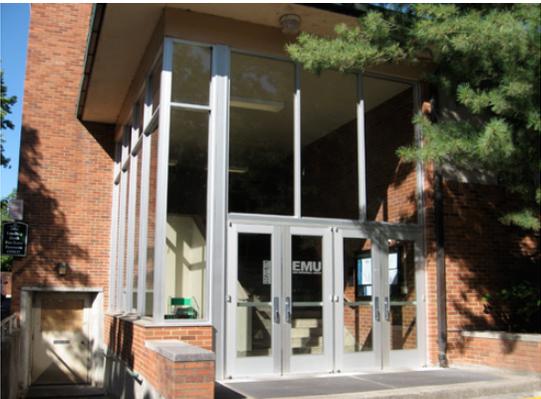
South Entrance aluminum storefront system replaced in kind in 2009. Original 1962 brick & limestone walls

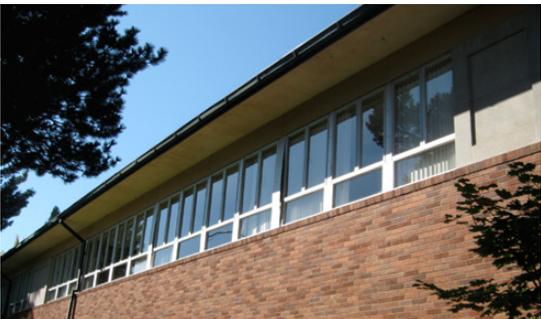
East-facing office windows replaced in 2009, with original stone panels (top right)

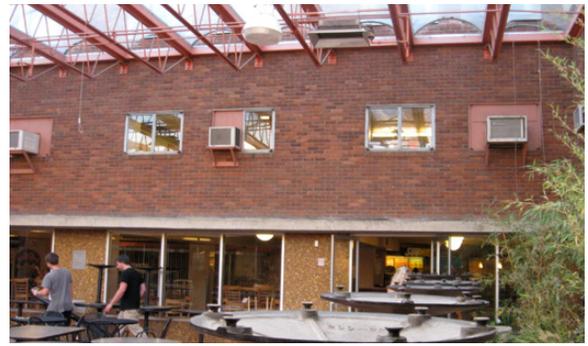
Original west wall made interior courtyard during 1962 addition

1962 Addition: Widened openings for windows and doors on the first floor replaced original windows when the addition turned the space into a courtyard. Mosaic tile was added on top of existing stone on bottom portion of the west wall. Fixed windows on the west facade, with the exception of two, were replaced by sliders. On the south-facing facade, all but one fixed window were replaced by sliders, and vents were installed. The window on the far south end of the west wall was infilled with brick veneer to match original.

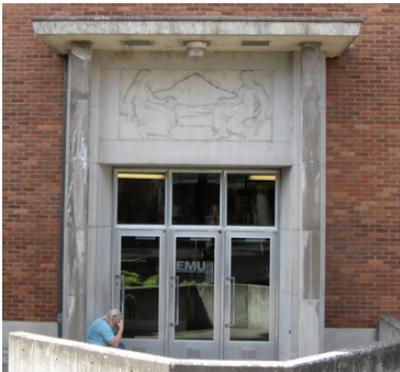
Original opening & engraving of East Entrance w/steel door and window replacements in 2009.

2009: The East Entrance door frames and glass were replaced with a steel storefront system. Original concrete canopy and sculptured panel remain.

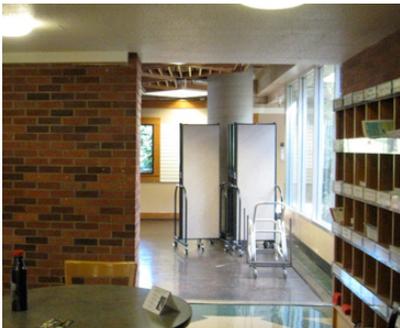
One of three openings in lobby cut in original exterior wall to make way for 1973 skybridge.

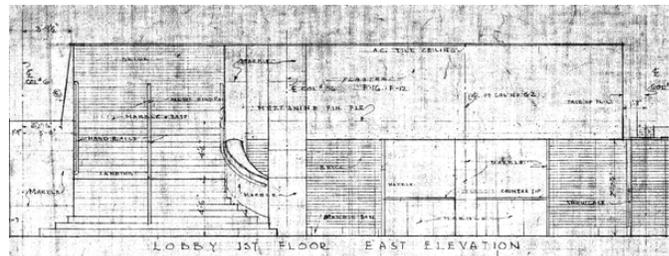
Original 1948 lobby east elevation.
Description of alterations: Marble column, brick, linotile counter tops and showcase removed. Single swing door removed and replaced by larger opening.

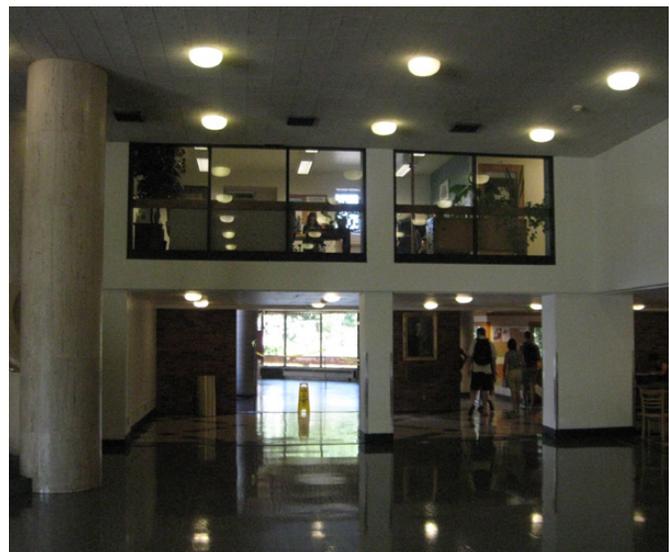
Looking east to 1970s addition - Mezzanine storefront windows added.

1973 Addition: Openings for storefront windows were cut out of the mezzanine wall.

2009: Storefront system was replaced, maintaining original door hardware.

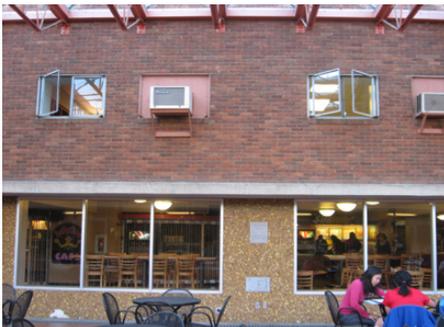
Original 1950 exterior wall converted to courtyard space (facing west).

1962 Addition: The original exterior west wall of the courtyard was significantly altered by the addition of all current windows and doors.

1973 Addition: The roof covering was added to mitigate leaks from the courtyard into the bowling alley area in the basement below. The fountain was abandoned due to leakage, but c. 1990 an attempt to use it as a fountain once more lasted several years. Finally, in 2009 it was converted into a planter due to leakage.

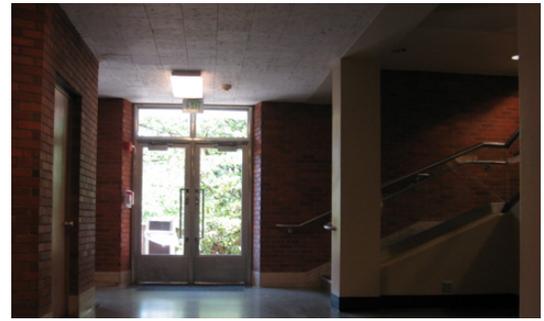
Glass panes in doors replaced in 2009 (looking west).

2009: Glass panes in the west doors to the exterior were replaced with similar style.

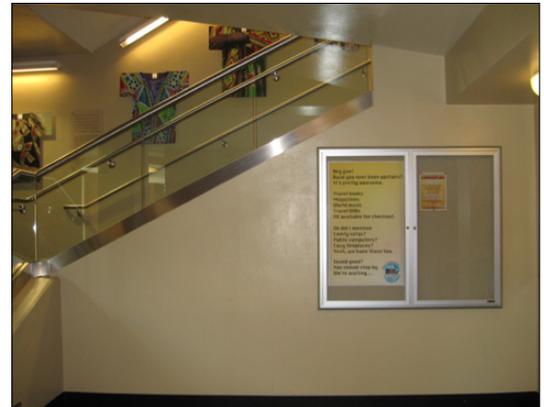
New handrails installed in 2000 Mills International Center remodel (looking north).

2000: The stair handrail was replaced as part of the Mills International Center Remodel. Elevator addition at this time installed a new door on the east wall.

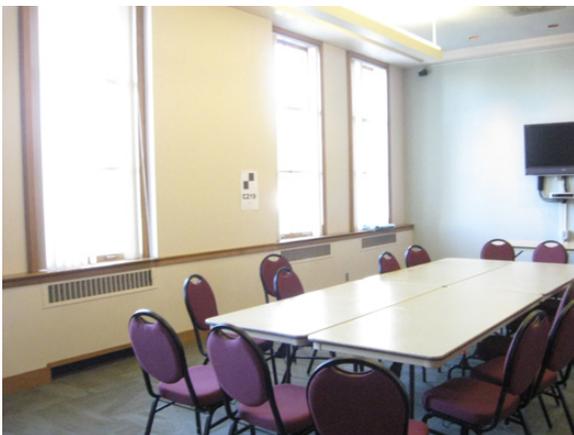
Single pane glass replaced with double pane in 2009.

2009: Single-pane glass in the windows were replaced, hardwood frames preserved.
