Eugene Millrace Restoration and Enhancement

Michael See, Dale Groff,
Dale Shank, John van Staveren
Pacific Habitat Services, Inc.
9450 SW Commerce Circle, Suite 180
Wilsonville, Oregon 97070
(503) 570-0800
(503) 570-0855 FAX
PHS Project Number: 6667

November 15, 2019

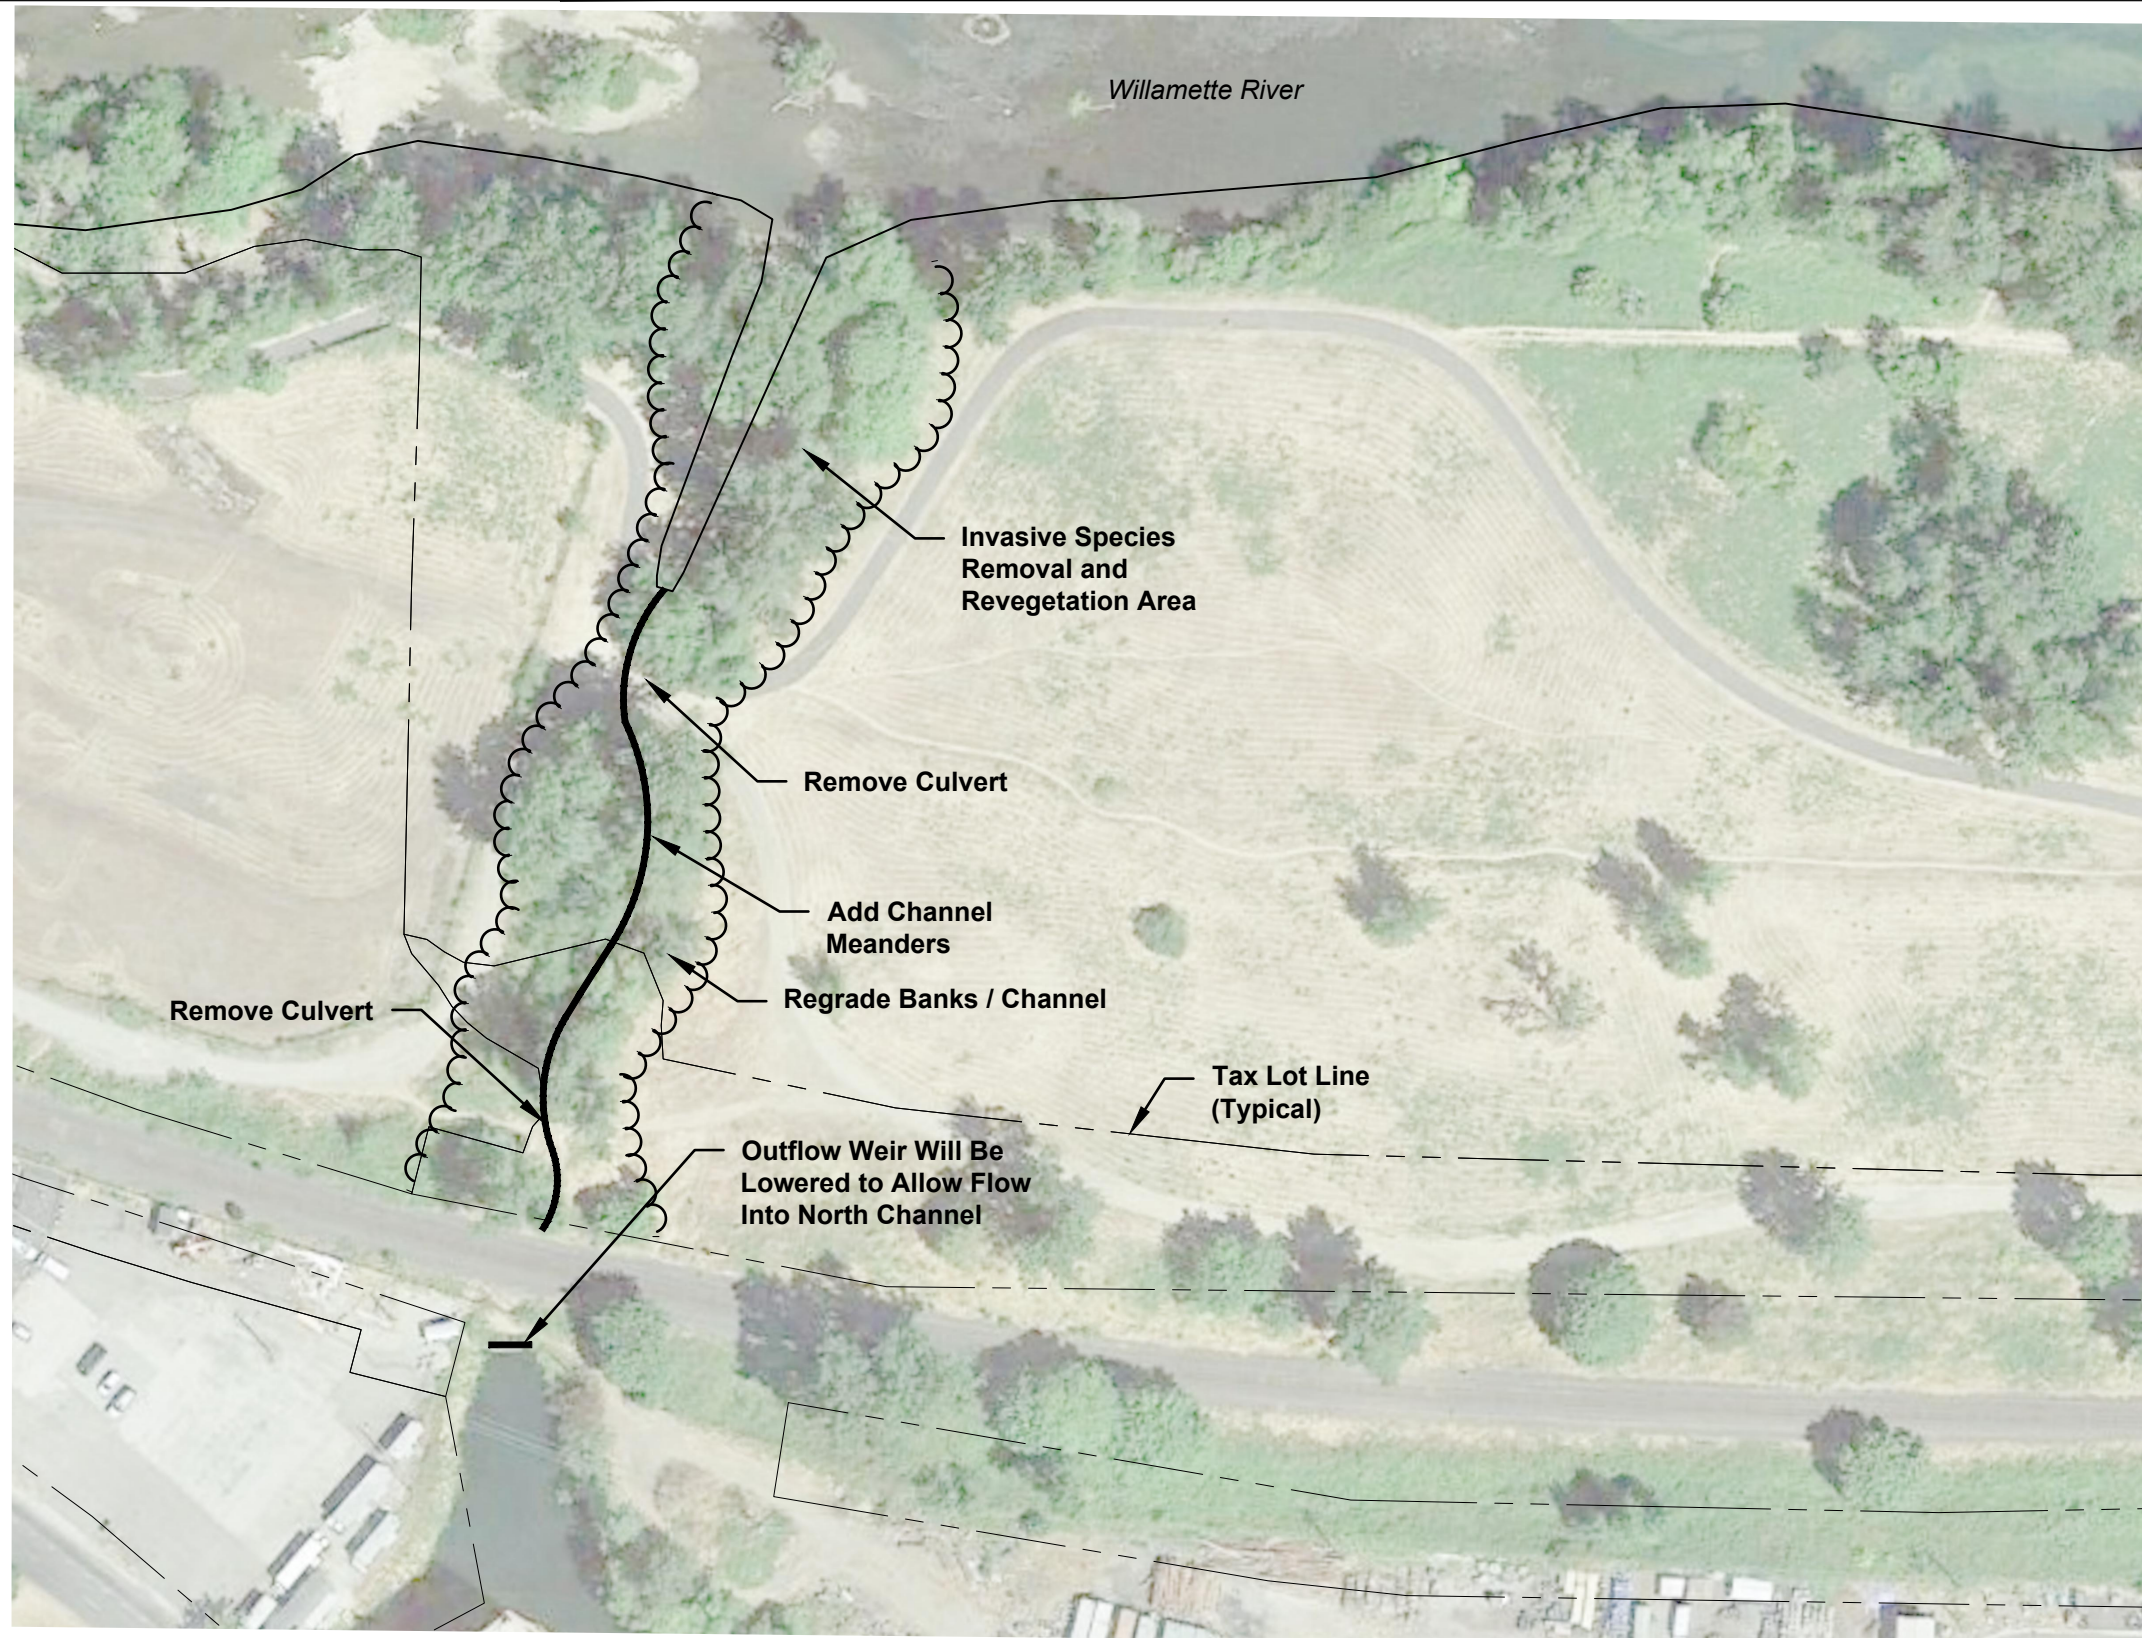
FIGURE
1A

Outflow to Willamette River (Section 1)
 Millrace Enhancement - Eugene, Oregon

The Mill Pond is the widest and the most downstream section of the Millrace. Water currently flows south out of the Mill Pond through a 30-inch culvert under Franklin Boulevard. Another weir is located along the northern bank of the Mill Pond. Water in this direction flows under a railroad and through a channel, called the North Channel, and into the Willamette River (Figure 1A). Water flows over this weir during the rainy season and when the pumps are running. Typically only one of three valves are open during normal operation. The weir structure is also the location for a future vehicular bridge to allow Campus Planning and Facilities Management vehicles access and egress from the University power plant facilities. Construction of the bridge may require that the weir be replaced or upgraded. This upgrade could allow for lowering of the weir or modification to increase flows into the North Channel. The construction costs of weir replacement are unknown, though will likely cost over \$15,000.

Other than providing backwater habitat from the Willamette River, the North Channel provides only minimal habitat for aquatic species. The hydrology of the channel can be improved by

lowering the height of the weir and extending the period and the volume of water that flows in this direction.

Enhancements to the North Channel could include stream restoration techniques to add sinuosity and riffle pool complexes, which will require that existing culverts be removed. Currently the stream banks within this area are steep; re-grading the banks will improve channel stability, and improve access for educational and research purposes. The morphology of the proposed stream improvements will be designed based on hydrologic models, which will factor in the existing slope leading down to the Willamette River. Existing vegetation within the creek's riparian area consists of mature trees, with an understory dominated by English Ivy and Himalayan blackberry. Mature trees will be preserved to the extent practicable, but some trees may need to be removed to conduct earthwork. Invasive species will be removed and will be replaced by native vegetation. Establishing more permanent hydrology and restoring the channel to a more natural form will improve the overall habitat of the stream channel and riparian areas. It will also increase the area's ability to provide off-channel refugia for salmonids migrating through the Upper Willamette River.

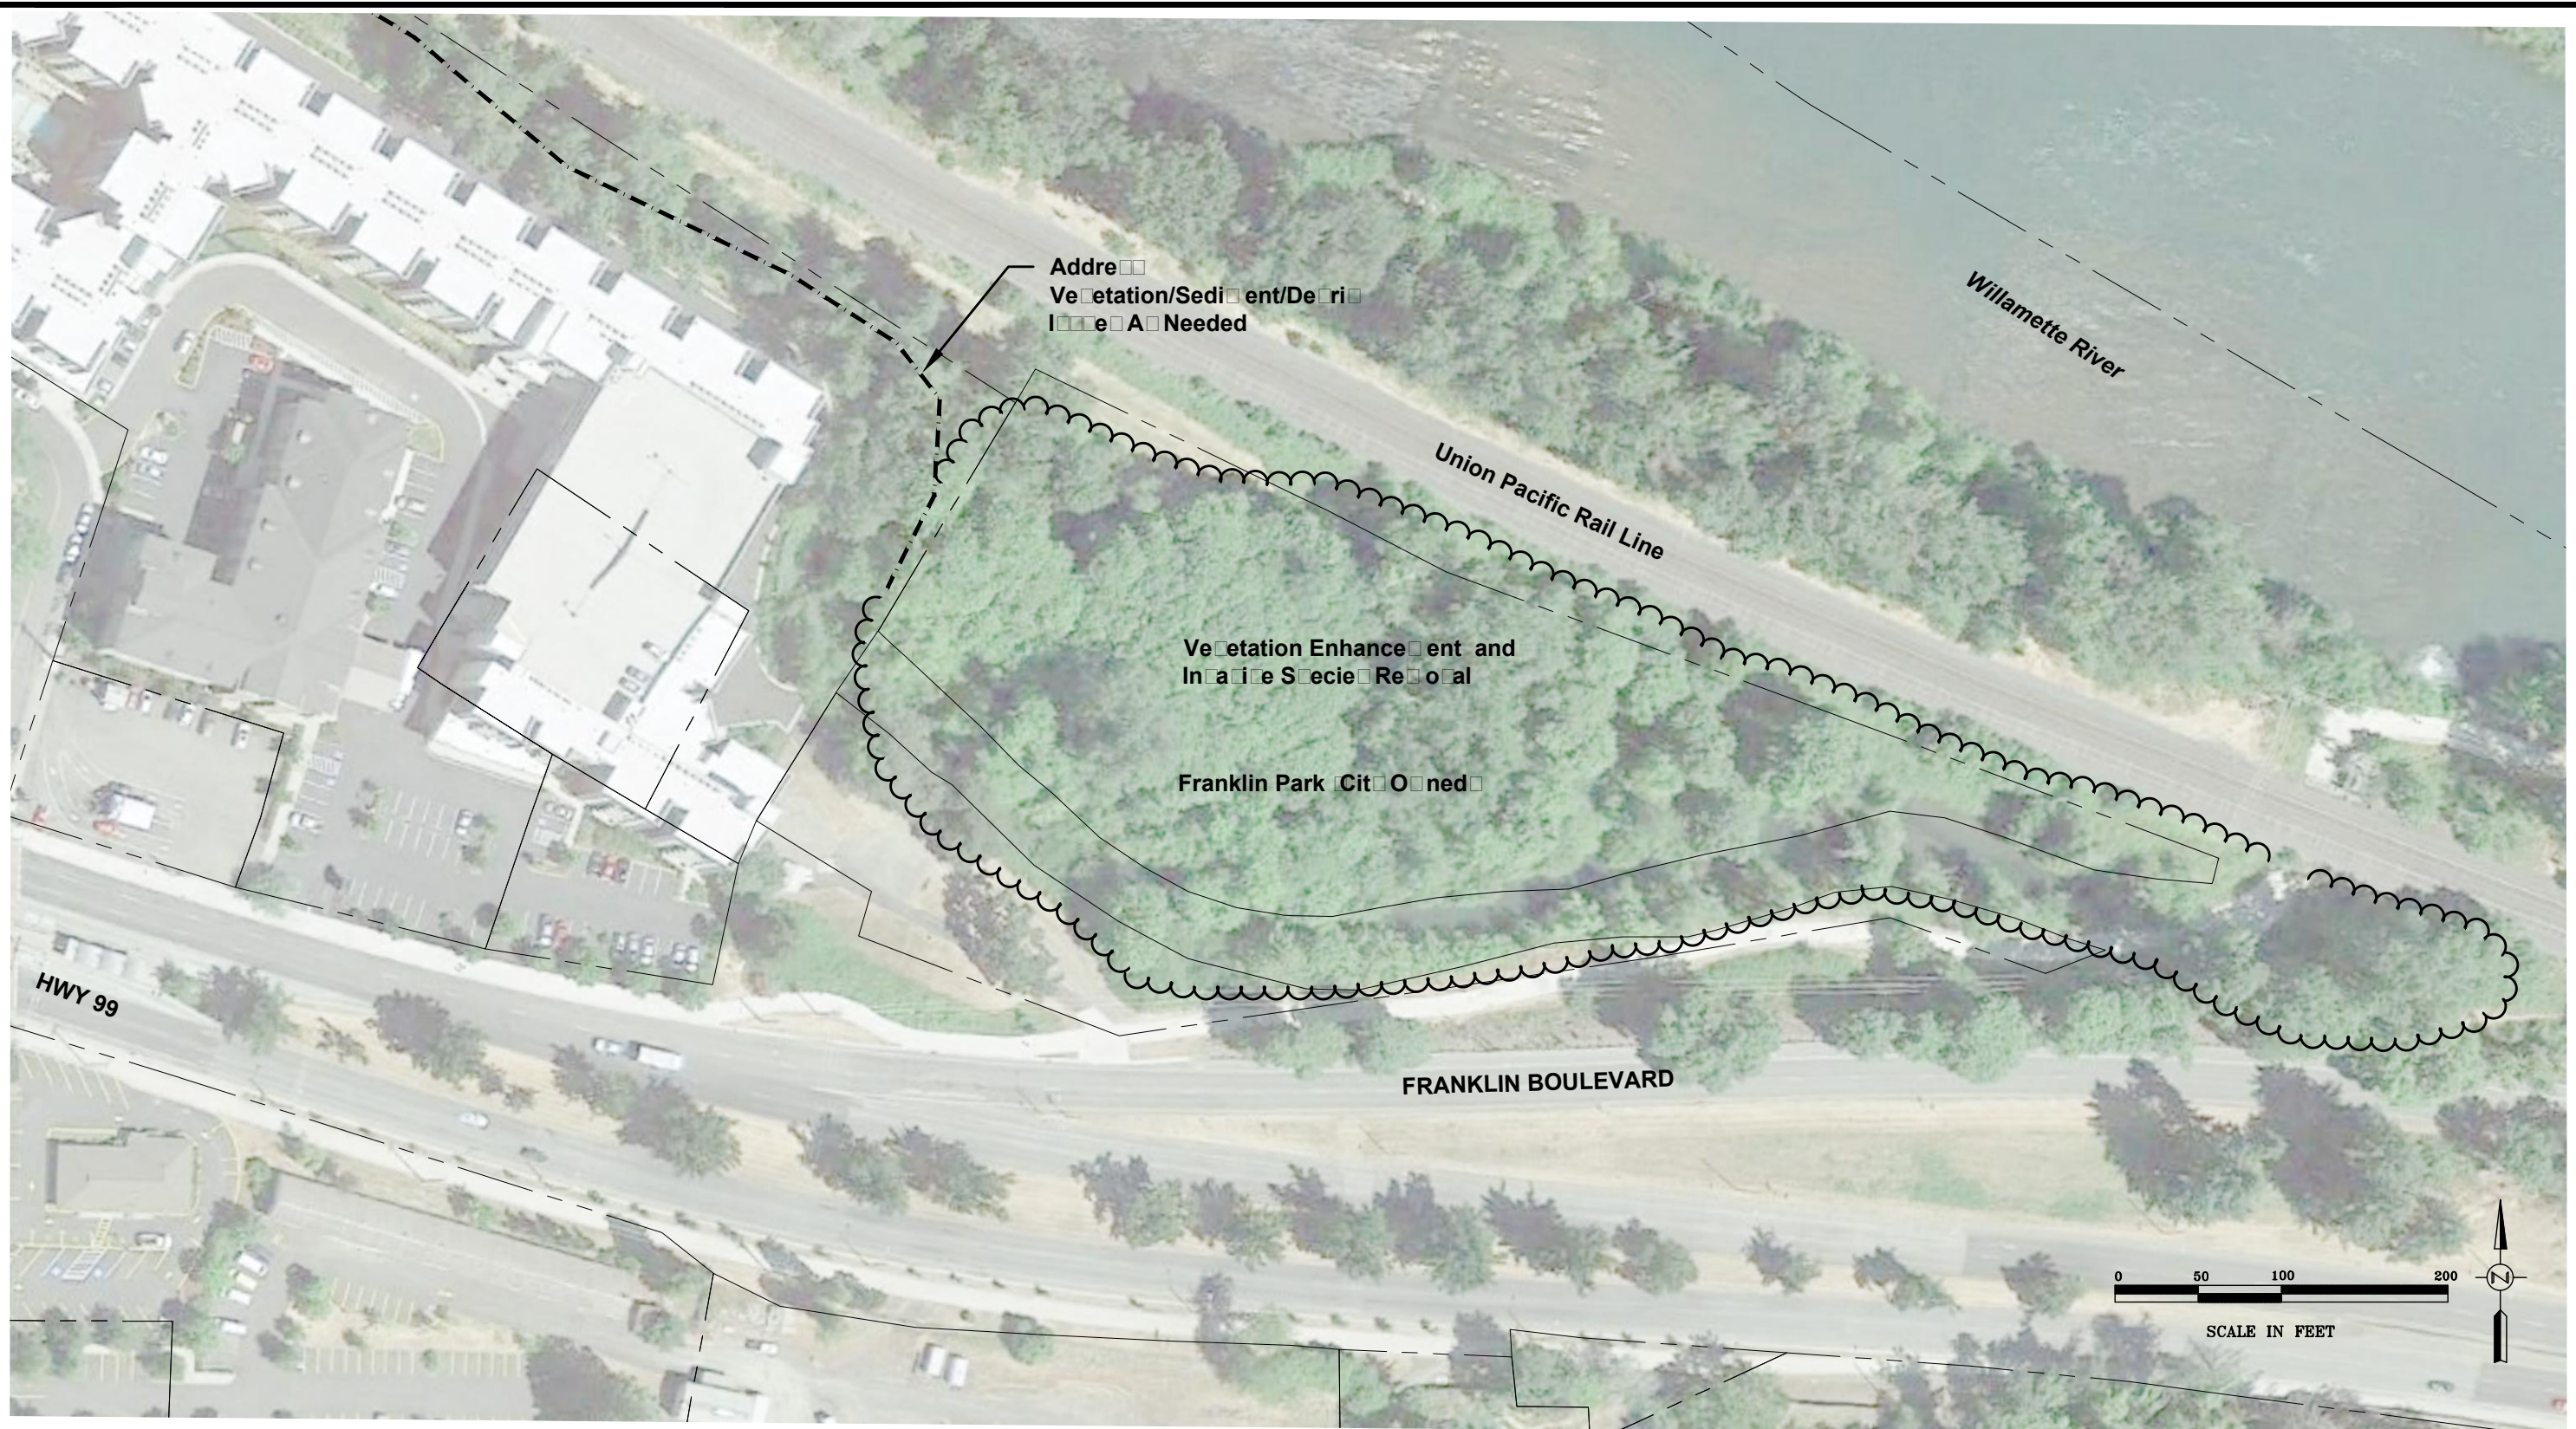
FIGURE
1E

Franklin Park (Section 5)
 Millrace Enhancement - Eugene, Oregon

The Franklin Park section of the Millrace is approximately 4 acres in size. It contains natural wetlands within the Millrace channel surrounded by mature trees and other native vegetation. There are limited opportunities to generate ecological lift or improve water quality; therefore, we propose to conduct only invasive species removal, and revegetation within this section.

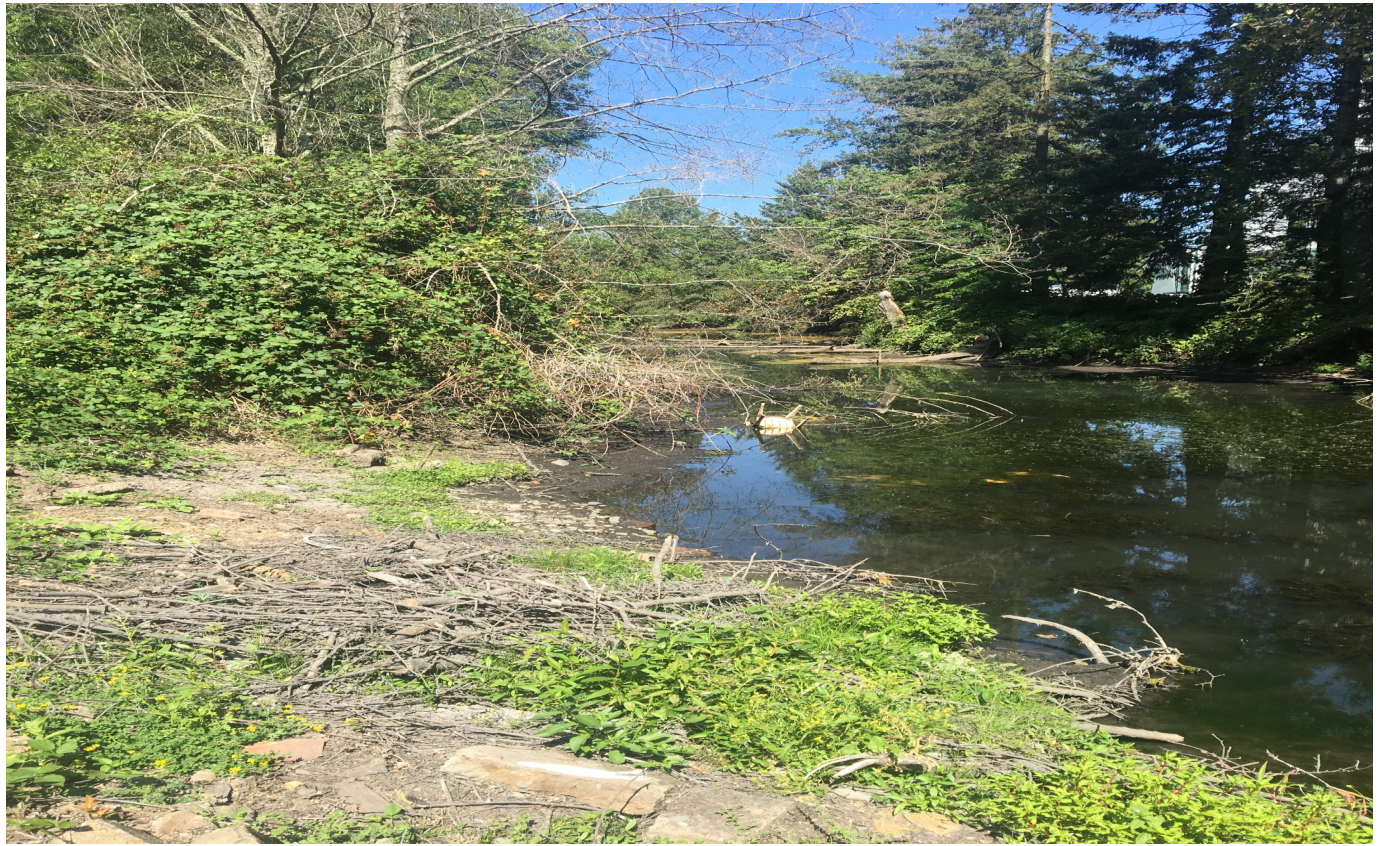
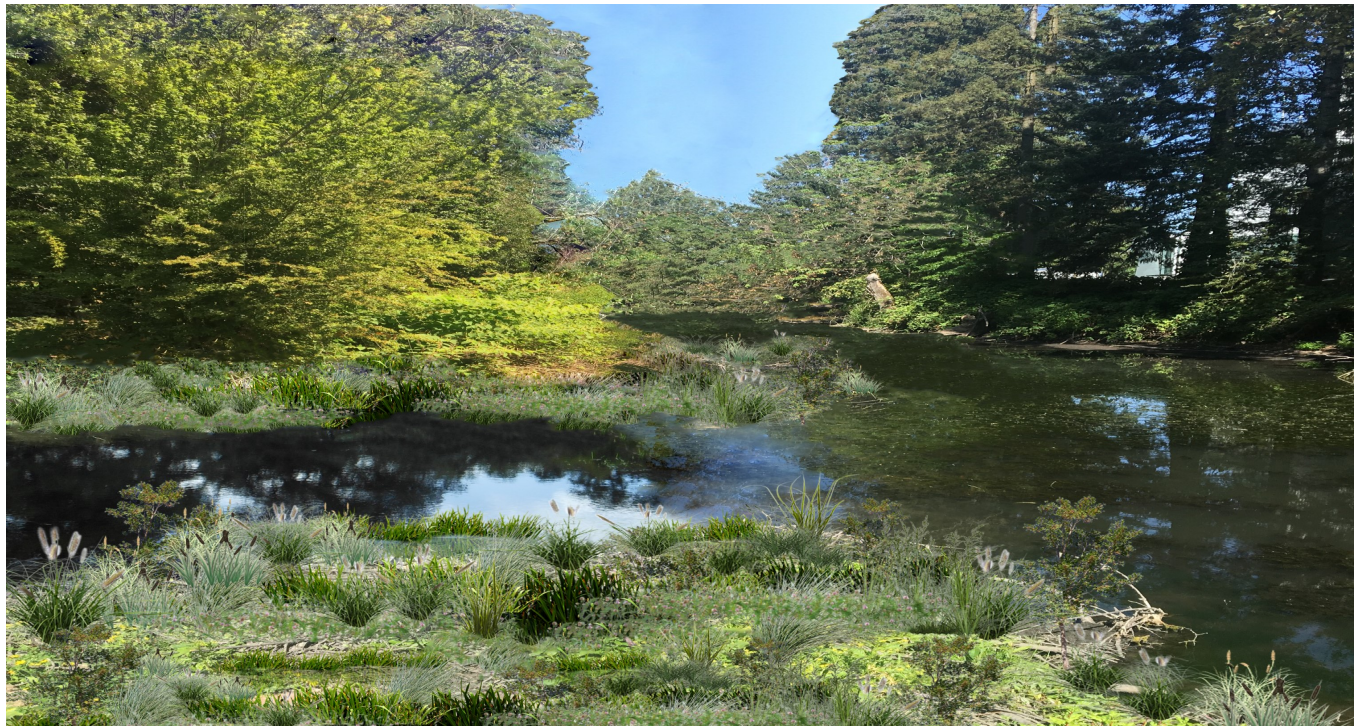
Millrace Enhancement - Riparian Enhancement Opportunity

Several areas along the Millrace have unstable banks and are actively eroding. Bank erosion is particularly noticeable along the northern bank of the Mill Pond. These areas are a source of sediment within the Millrace and contribute to degraded water quality. Eroding banks do not provide a suitable substrate for desirable native plant species, and are often colonized by blackberry or other invasive species. The Millrace is a low energy system with limited ability to sort sediments and develop a naturally stable form through normal stream processes; therefore, bank stabilization should be a high priority for improving water quality and riparian habitat. Figure 2 shows an example of riparian enhancement with native plants.

Where practicable, we propose reshaping the banks to a gradual, stable slope. Soil lifts, toe rock, and root wads may also be installed to protect areas against future erosion. These areas will subsequently be planted with native trees, shrubs, and herbaceous vegetation.

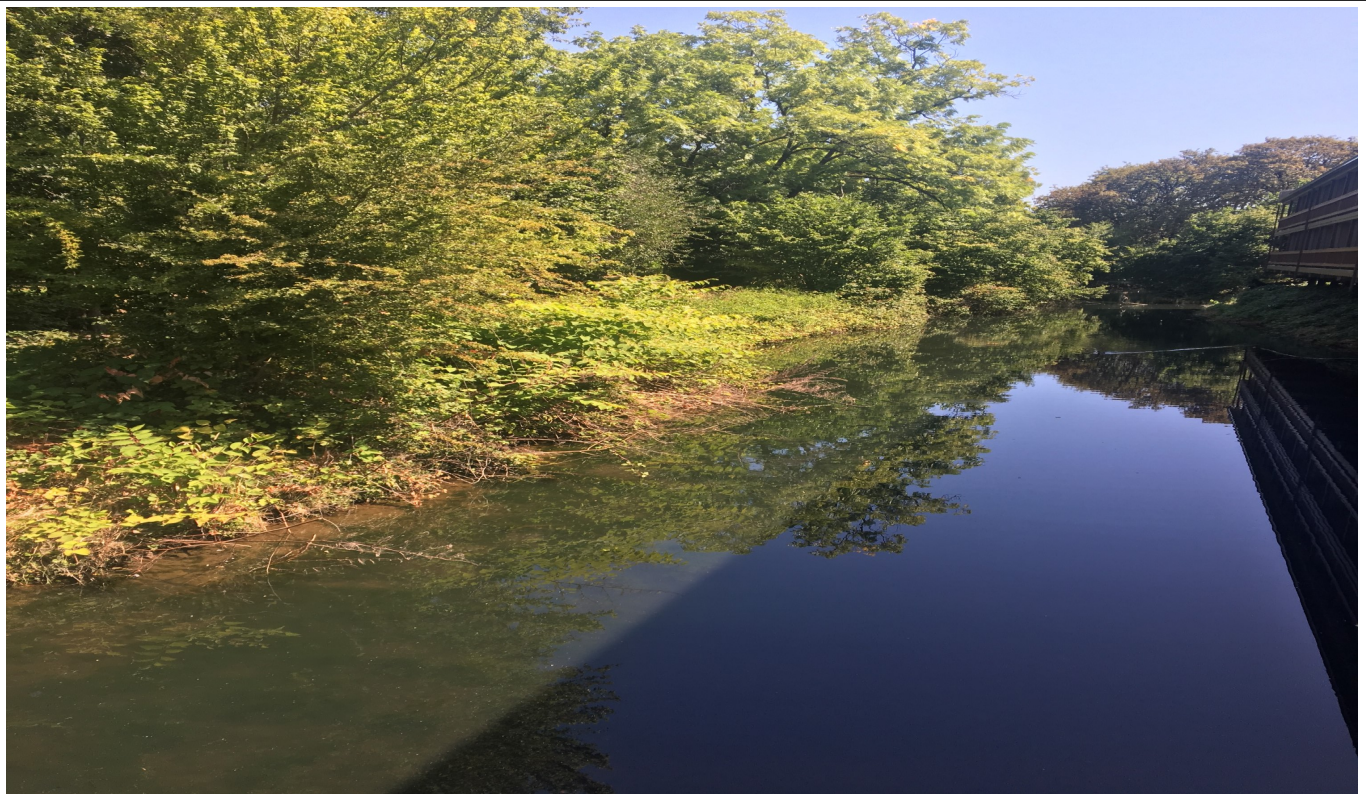
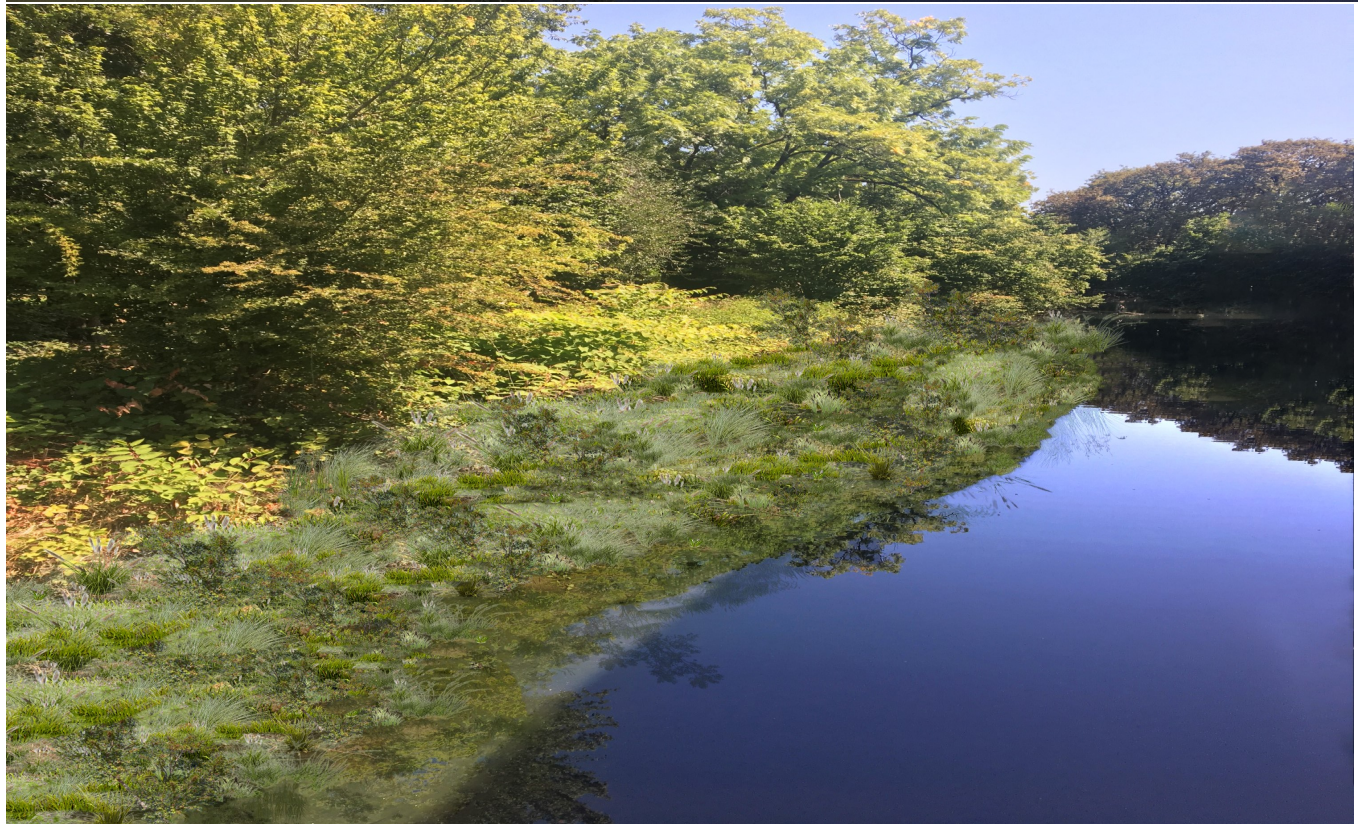
Millrace Enhancement - Created Wetland

The narrower channel will provide areas where wetlands can be constructed within the Millrace channel. The University owns the entirety of the north bank through this section; therefore we propose wetland construction wholly on University-owned property. The constructed wetlands will be created near the water elevation, and will be designed to be seasonally inundated. Constructed wetlands will improve water quality by assimilating water born pollutants, and trapping sediments and particulate matter. They will be planted with native vegetation. Figure 6 shows a conceptual idea of what a created wetland could look like. The south bank of the Millrace in this section is private property consisting of residential buildings and yards; no activity is proposed on private property at this time. Figure 7 is another example of a created wetland. Although the section shown is south of Franklin Boulevard and not within the focus area of this report, it shows how the complexity of the channel can be enhanced by creating wetlands along the banks of the Millrace.

Section 4 will also incorporate wetland construction within the Millrace channel. The approach will be similar to Section 3, except the wetlands will be constructed along both sides of the channel opposite meander bends as depicted in Figure 6.

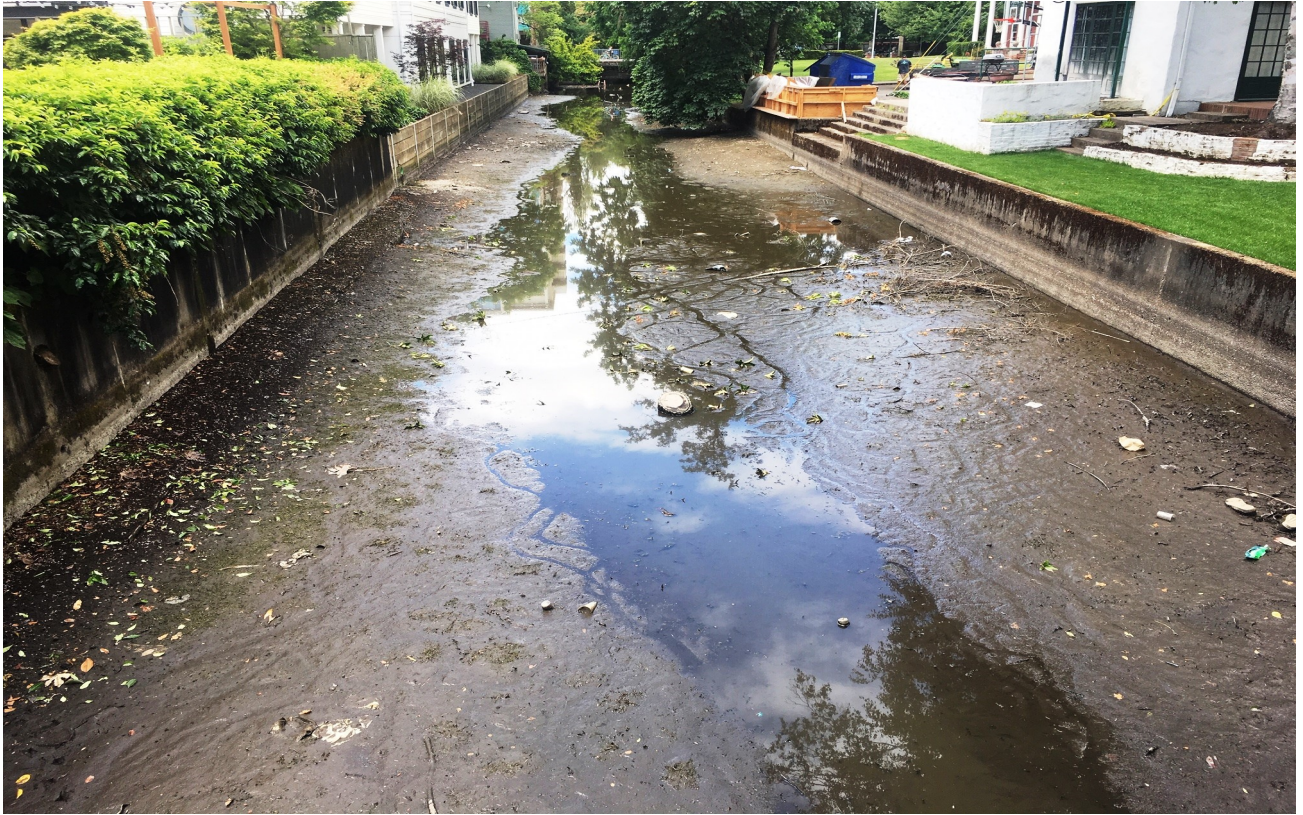
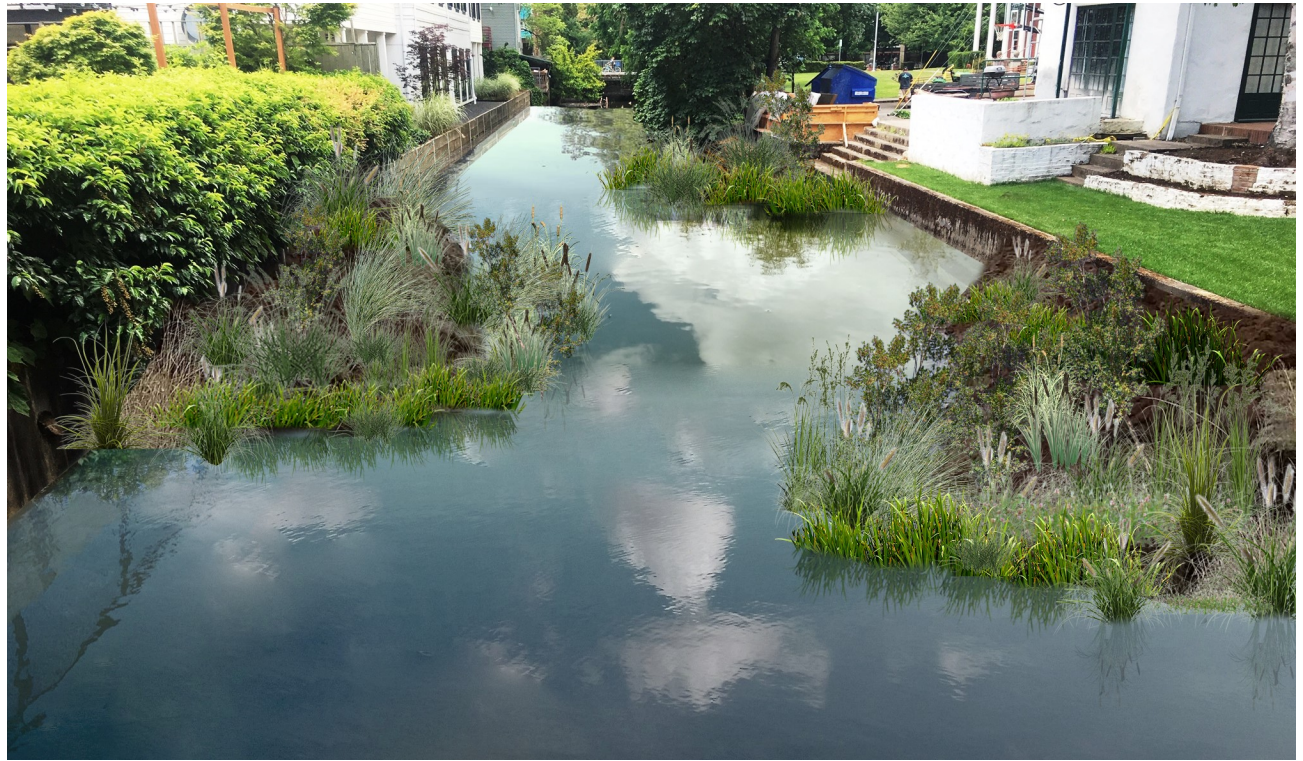
FIGURE
7

Millrace Enhancement - Created Wetland

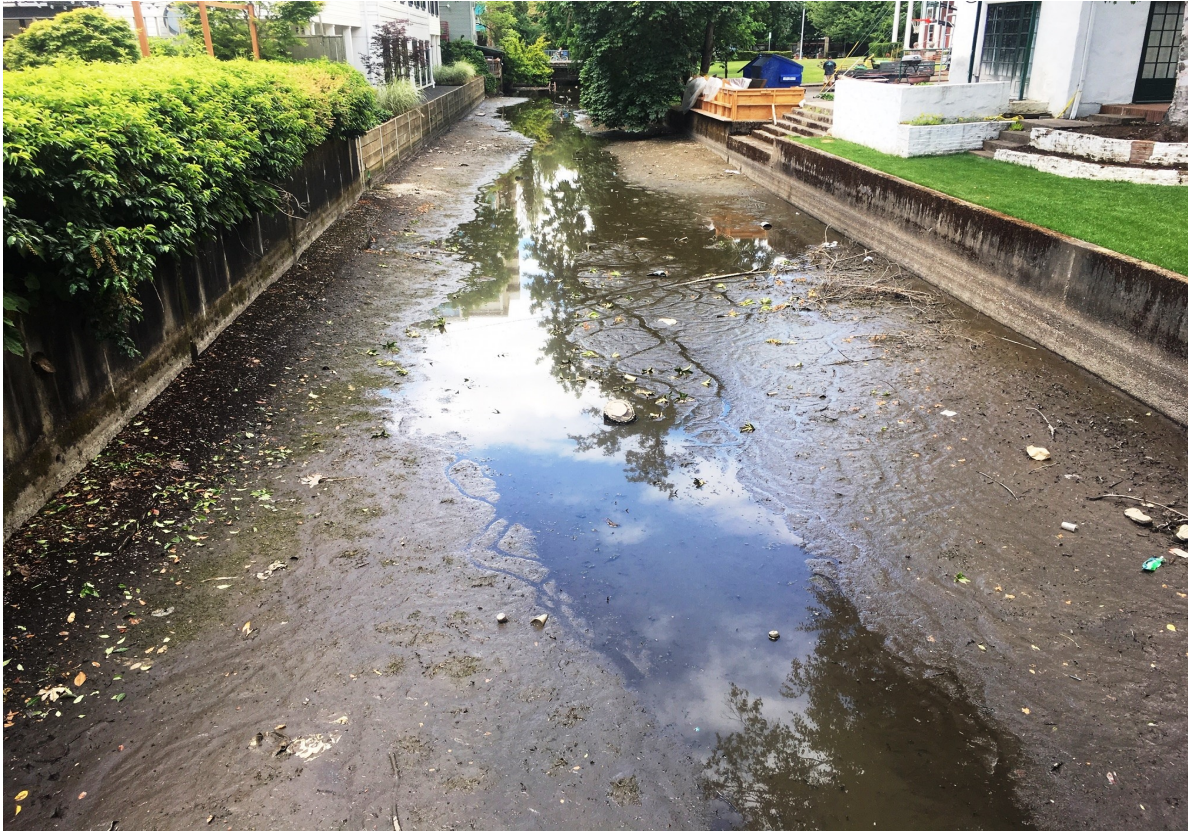
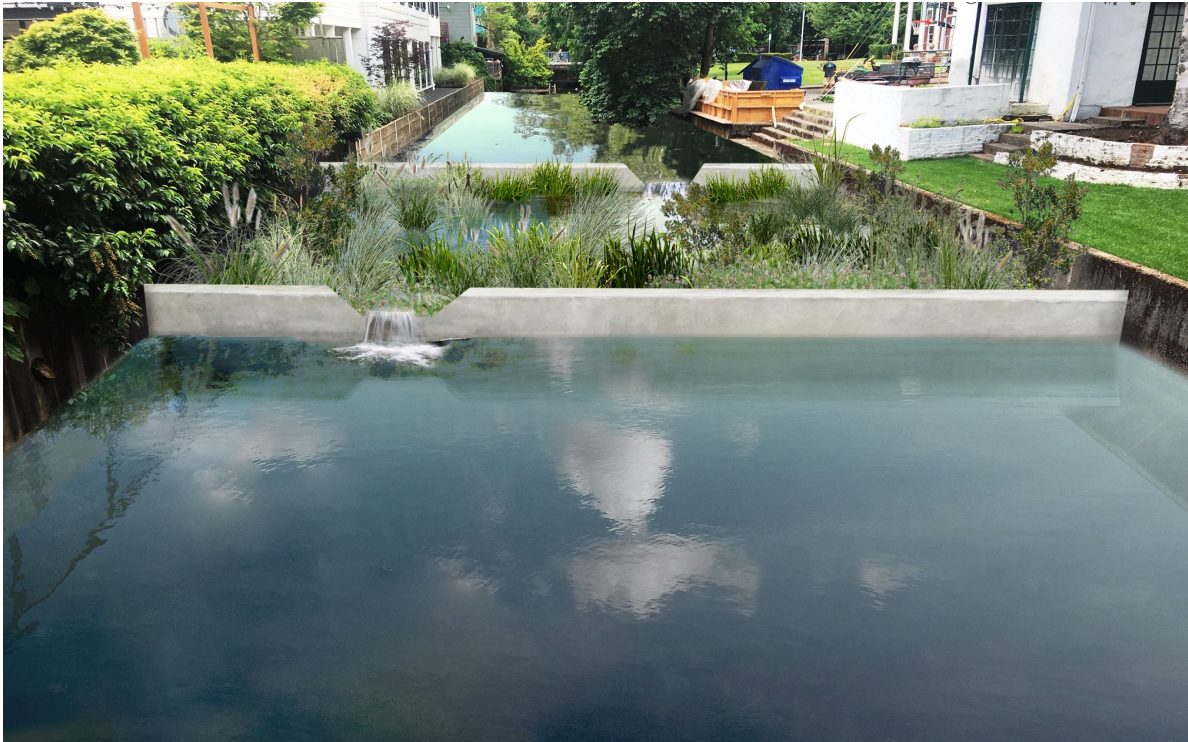
FIGURE
8

Millrace Enhancement - Water Quality Cell

constructed wetlands. The channel will be given a natural meander pattern through this reach as well. These cells will consist of weirs or structures that will impound water within the Millrace channel. The designed cells will incorporate vegetated zones to allow for better water quality improvement. The cells will act similarly to wetlands in that they will absorb sediment and pollutants. They will have a longer residence time than flow-through wetlands, and should provide more effective water quality improvements. Figure 8 is a conceptual idea of what a water quality cell could look like, though we realize this photograph is taken in the section of the Millrace south of Franklin Boulevard.
