**MILLRACE ENHANCEMENT FEASIBILITY STUDY
EUGENE, OREGON**

Prepared for:
CITY OF EUGENE
Eugene, Oregon

Prepared by:
Scientific Resources, Inc.
Lake Oswego, Oregon

September 14, 1990

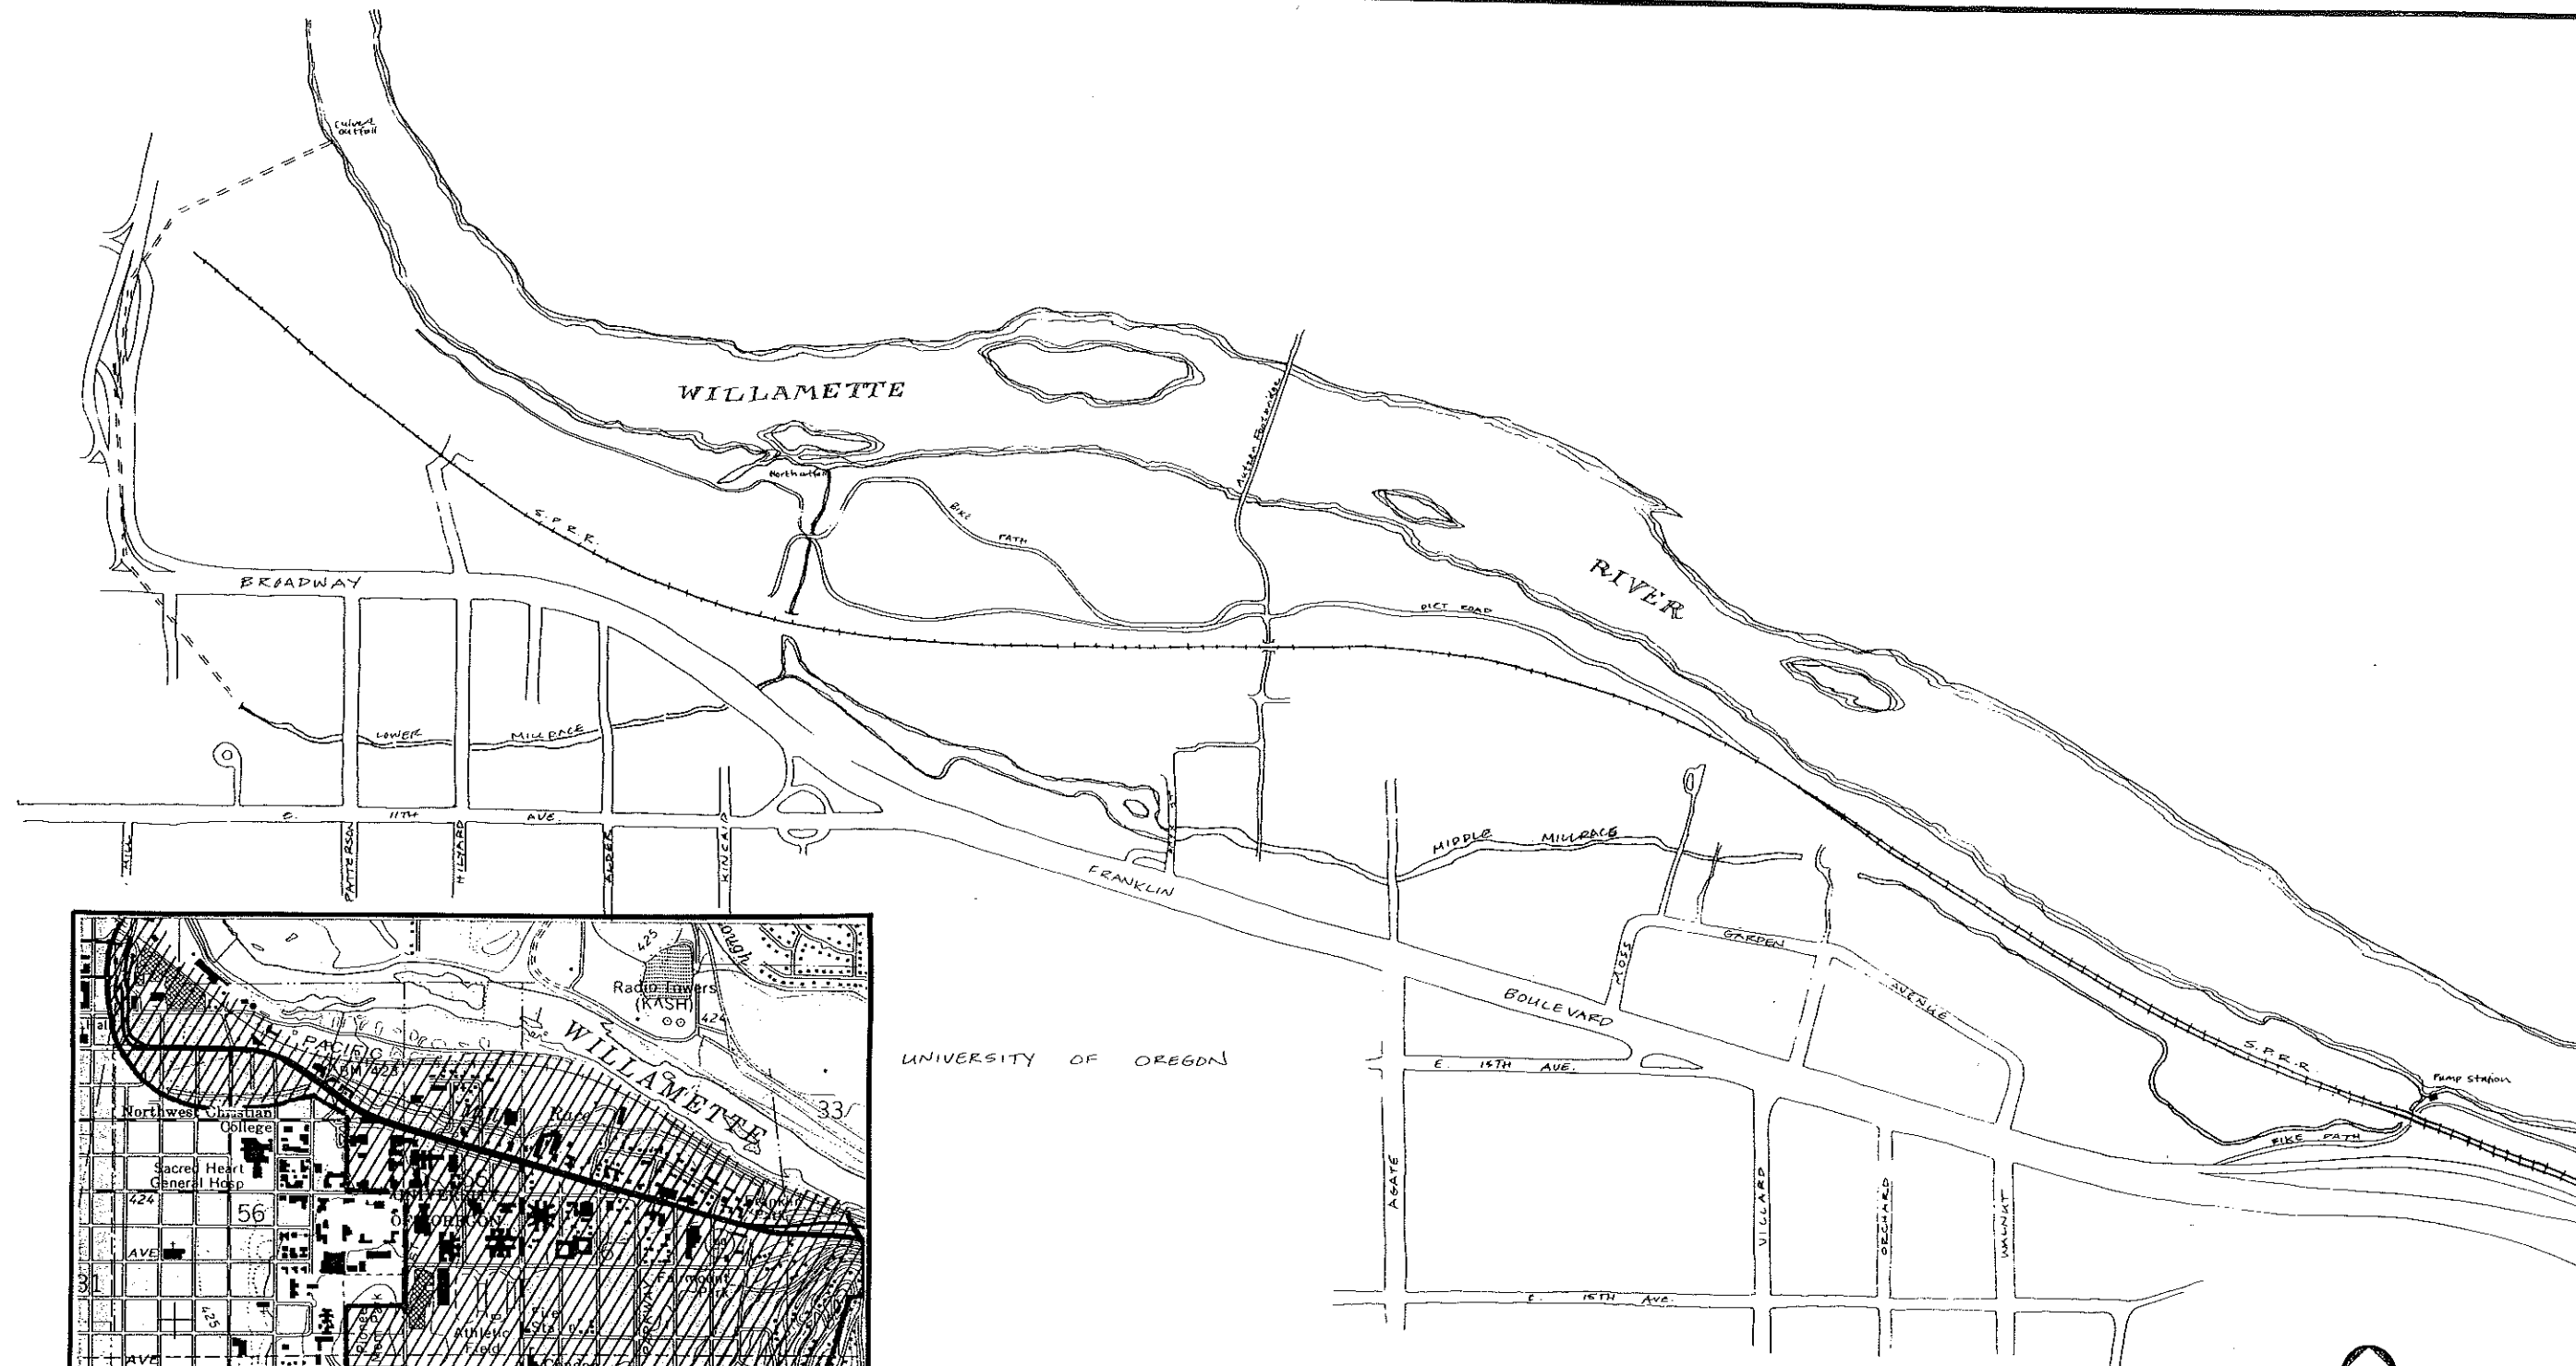
Millrace study area
(Drainage basin)

Study Area
1
EUGENE MILLRACE

The Millrace is located east of downtown Eugene and north of the University of Oregon (Fig. 1). The Millrace extends through a varied landscape of woods, orchard and parks, housing and commercial development. Paralleling the course just to the north is the Willamette River and the Southern Pacific Railroad. Its drainage basin encompasses some 660 acres of residential and commercial properties, campus, parks and woodland.

Running parallel to the south bank of the Willamette River between the river and Franklin Boulevard (Fig. 1), its course is approximately 7600 feet of open waterway with some 2500 to 3000 feet of the final course culverted. The upper, unculverted portion begins at a pumping station on the Willamette River just west of the Interstate 5 bridge. Between Onyx Street and the junction with Franklin Boulevard, the Millrace widens to a pond edged by a University park. At the western end of the pond, the Millrace branches to two channels. A short channel drains north into the Willamette River. The other channel, called the lower Millrace, begins at Franklin Boulevard and drains to the west between small residential and commercial lots. Between Patterson and Ferry Streets, the Millrace enters a culvert and is piped under the city to its final outfall into the Willamette River.

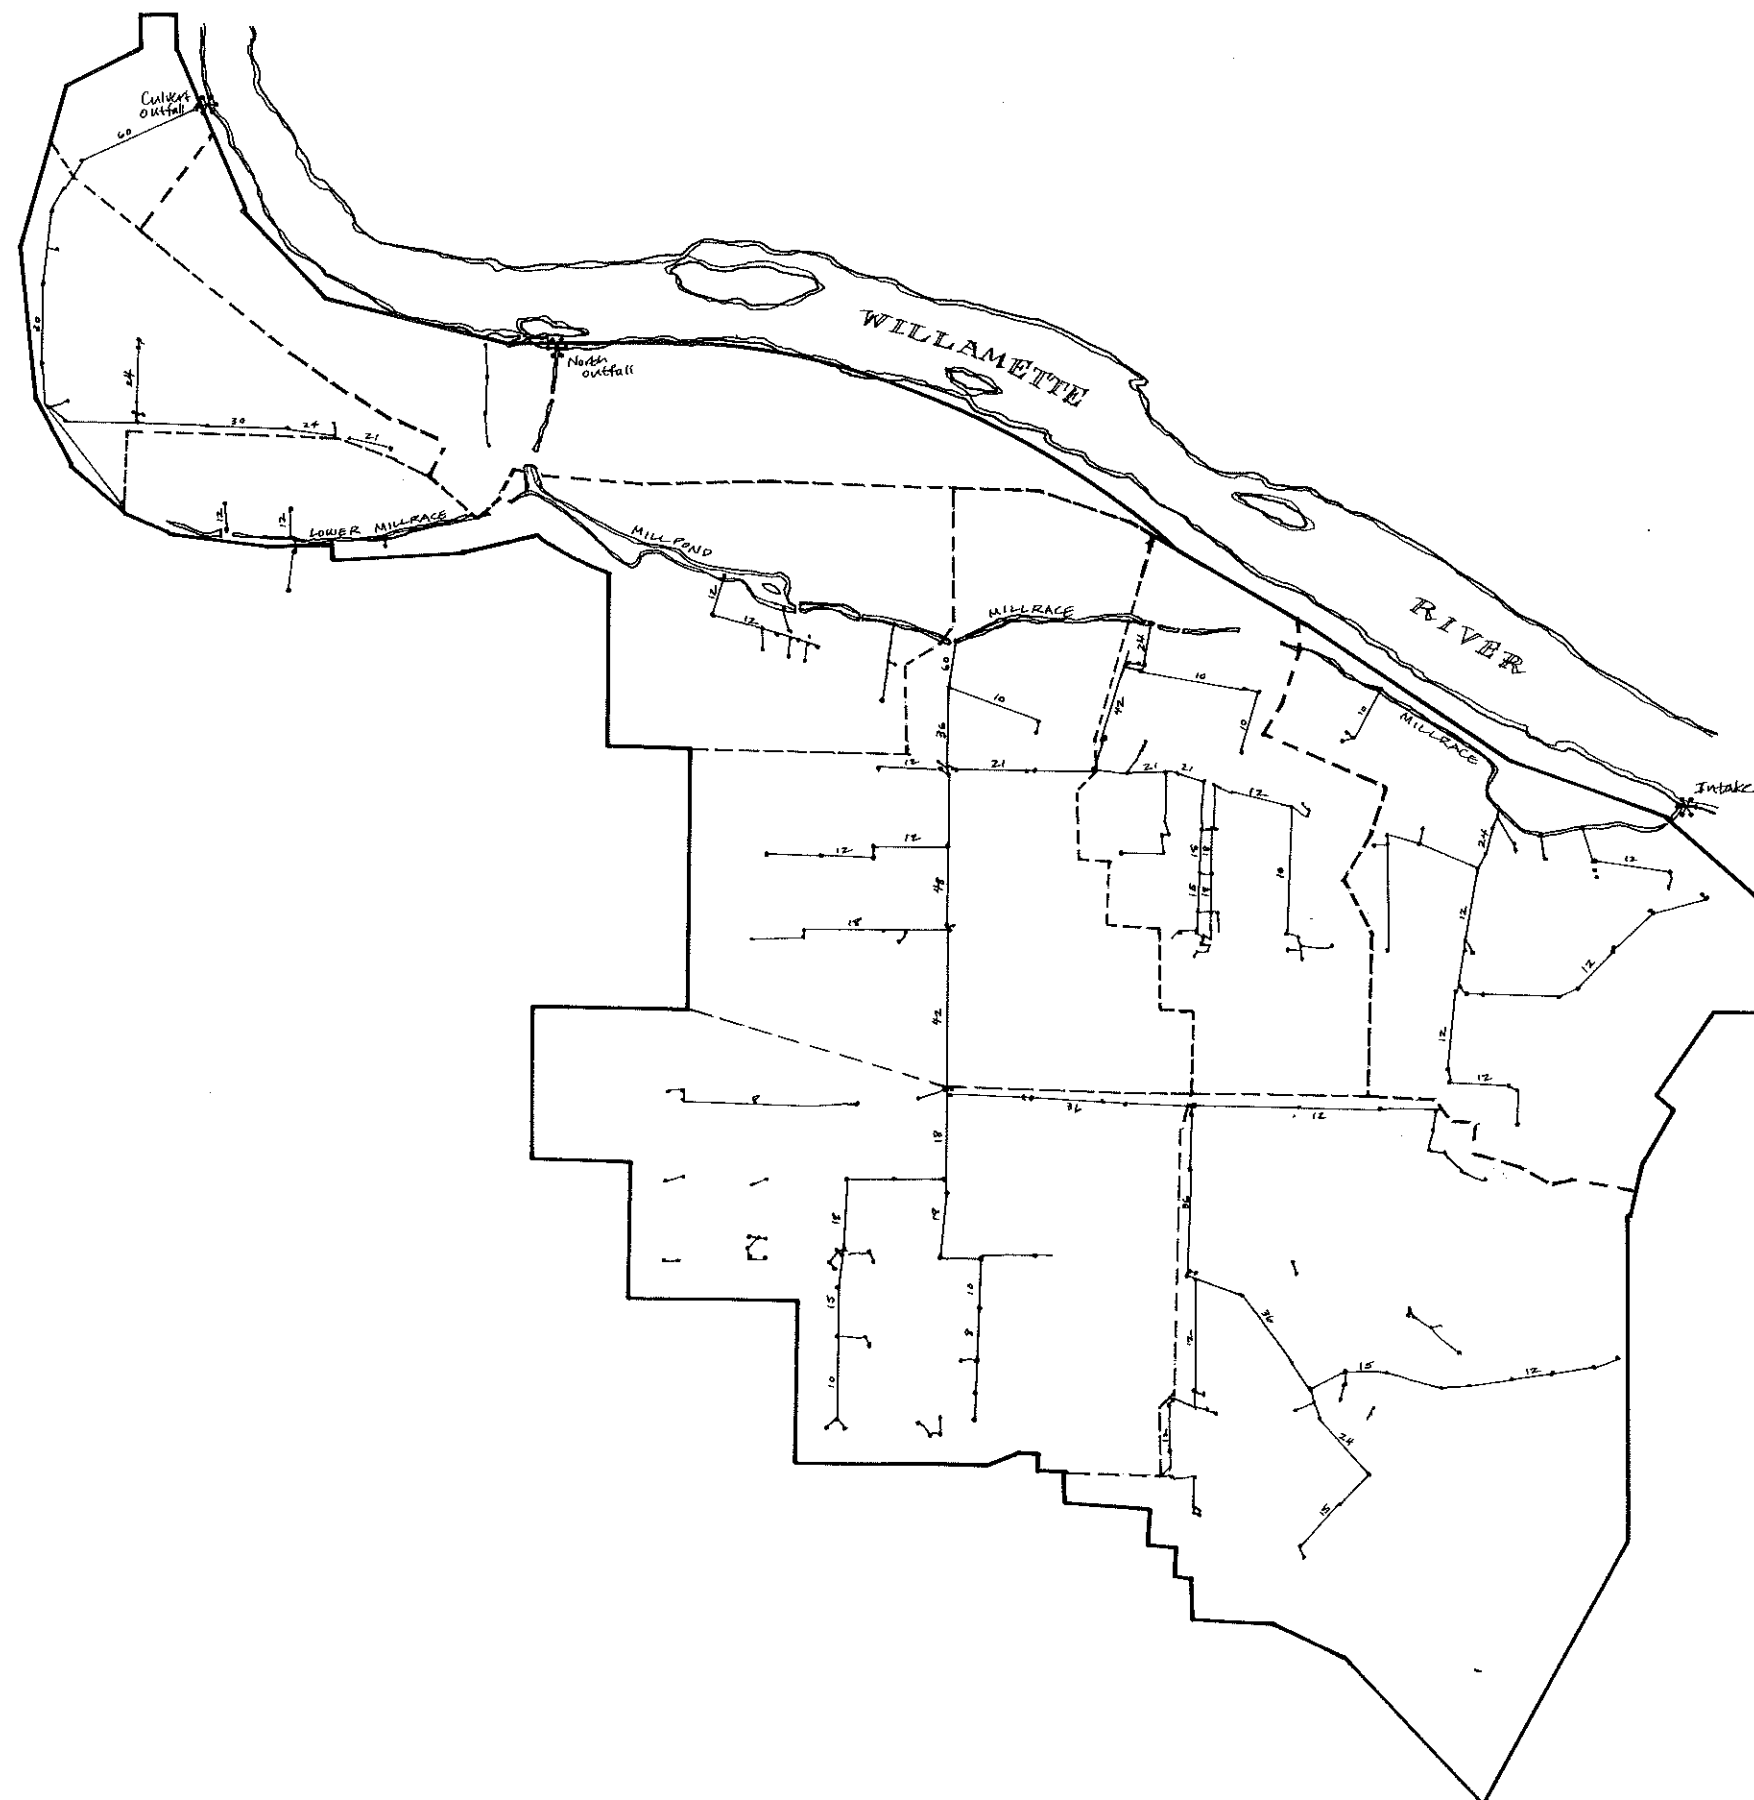
FIGURE 4

- Drainage subbasin
- * Intake/outflow
- Storm drain pipe & size

Millrace Drainage System
 EUGENE MILLRACE

The drainage basin of the Millrace is approximately 660 acres, ranging from the 934-foot summit of Hendricks Park to the Willamette River at approximately 420 feet (Fig. 4). The majority of the basin is between 430 and 440 feet in elevation. The City of Eugene has divided the area into nine subbasins which drain storm runoff into the Millrace at three major (24-inch pipes or larger) and several minor locations. The location of the major stormwater drainageways is shown on Figure 4.
