# An Archaeological Assessment of the Eugene Millrace Diversion Dam and Intake for the I-5 Willamette River Bridge (#08329) Project, Lane County, Oregon

October 2007

Heritage Research Associates Report No. 314

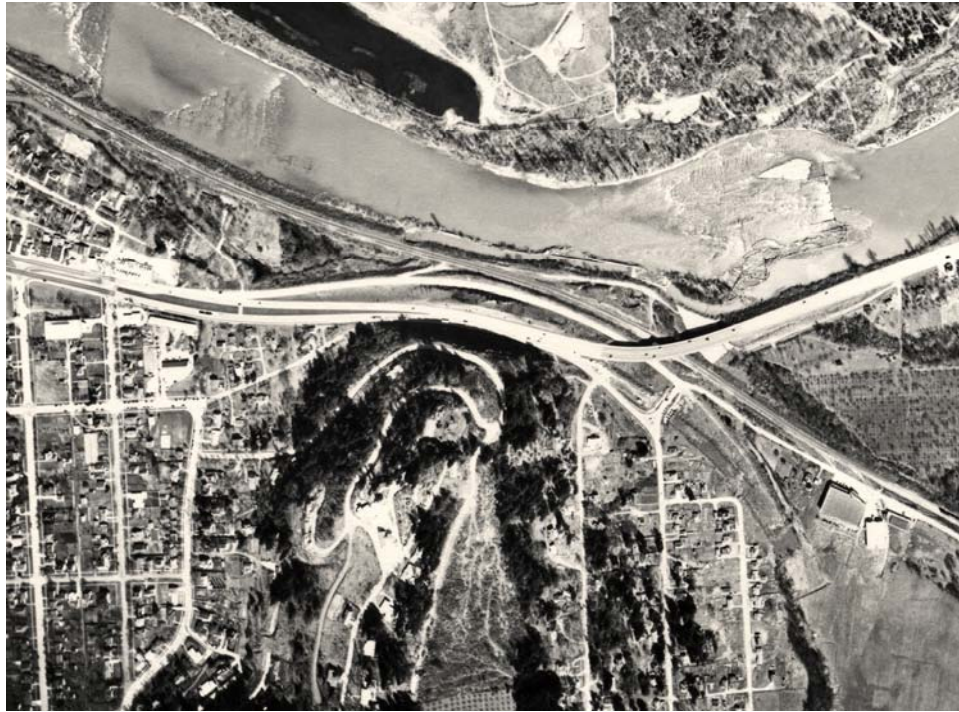
Figure 2. Aerial photograph of the millrace intake in 1951 showing the millrace flowing beneath the railroad overpass west of the project (ODOT JP4-3-51).

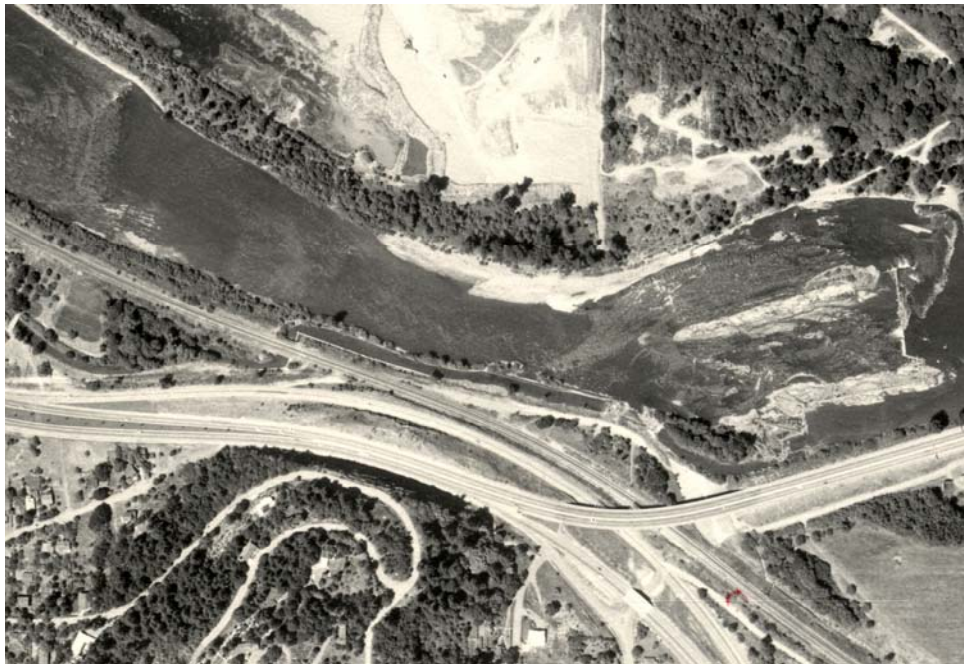
Figure 3. Aerial photograph showing the project area in 1955 (ODOT JP7-12-55).

reportedly augmented the flow through the overpass (see Figure 3). The relationship between the conduit and the channel remains unclear.

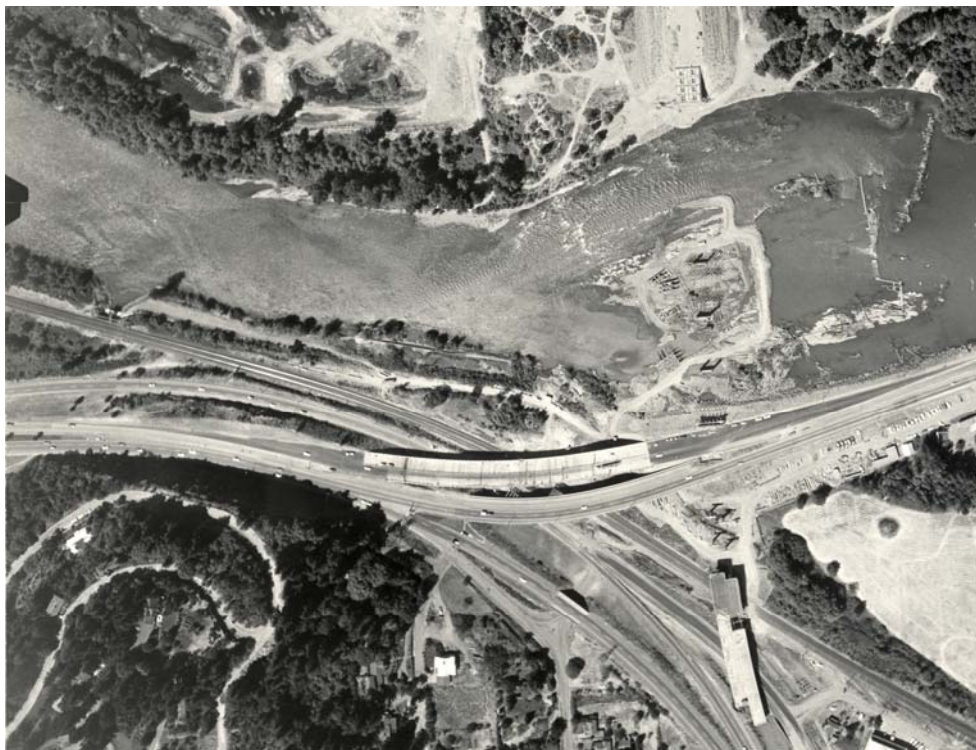
Figure 4. Aerial photograph taken in 1960 showing bridge construction activities in the millrace area, as well as intake relocation and pump house near railroad overpass (ODOT JP8-5-60).

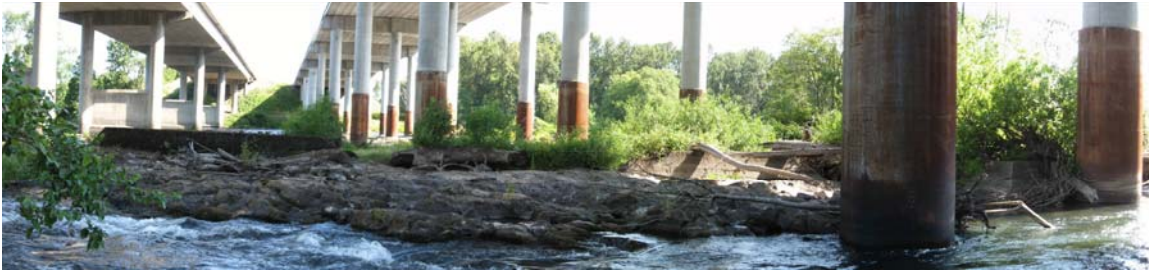
4. Log crib (pre-1910): Extending south from the channel at a downstream angle, this feature appears to be the “log crib” that functioned as a removal gate for log rafts (see Tweedell 1949:12). This feature is assumed to have been part of previous dam construction, damaged in the 1928 flood, and possibly modified to provide flow through 1942 (Figure 6).

Figure 6. View to north from south shore of revetments and features associated with the intake gate (#5) and log crib (#4) beneath original I-5 bridge (left) and detour bridge (right).

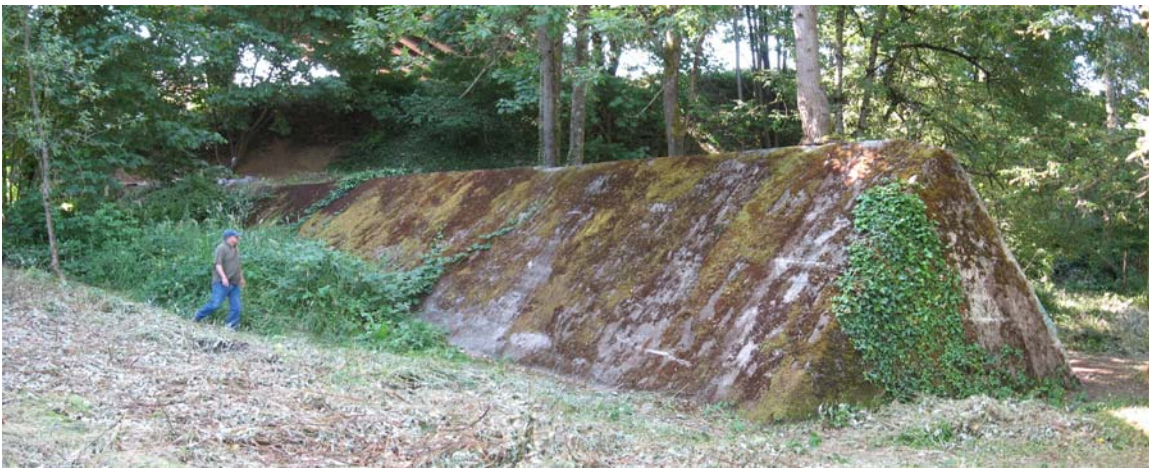
5. Intake gate (pre-1910): As modified following floods, this element almost certainly funneled water into the channel after 1928 and through 1942. An angled concrete wall constricts the water and directs the water flow into the millrace proper, just downstream from the log crib (Figure 6). This element had a downstream extension, perhaps for strength, that *may* be the buttressed wall exhibiting modern graffiti that is visible from the bike path (Figures 7 and 8).

6. Channel remnants (c. 1910): Continuing to the west (downstream), various concrete walls likely relate to the 1910 improvements to the channel and the increase in “head” pre-1910. Large portions of this wall appear to be damaged or missing from repeated flooding. Based on historical data, they may have been repaired and provided some function after the 1928 flooding until 1942 when another flood caused the millrace to go “dry.” Aerial photographs as late as 1955 show this channel to be largely intact and carrying water flow into the millrace system (Figures 2 and 3). Substantial sections of the concrete revetments are still within the project area (Figures 7-9).

Figure 7. View to southeast looking toward the original I-5 bridge (in background) showing large revetment marking former millrace channel.

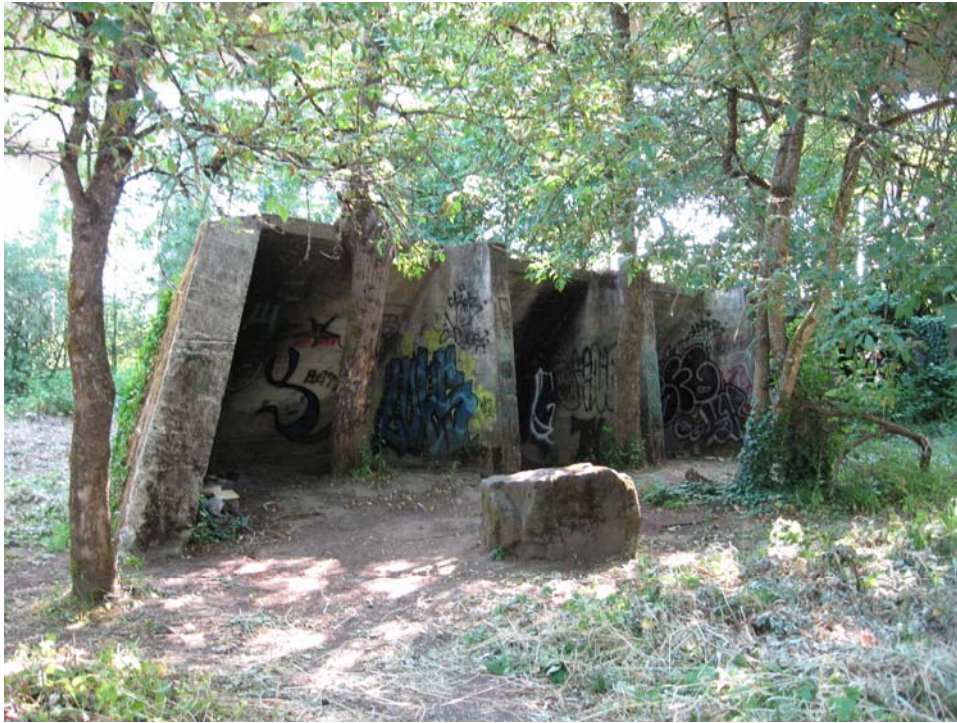
Figure 8. Reverse view of revetment shown in Figure 7 with I-5 bridge visible in upper corner.

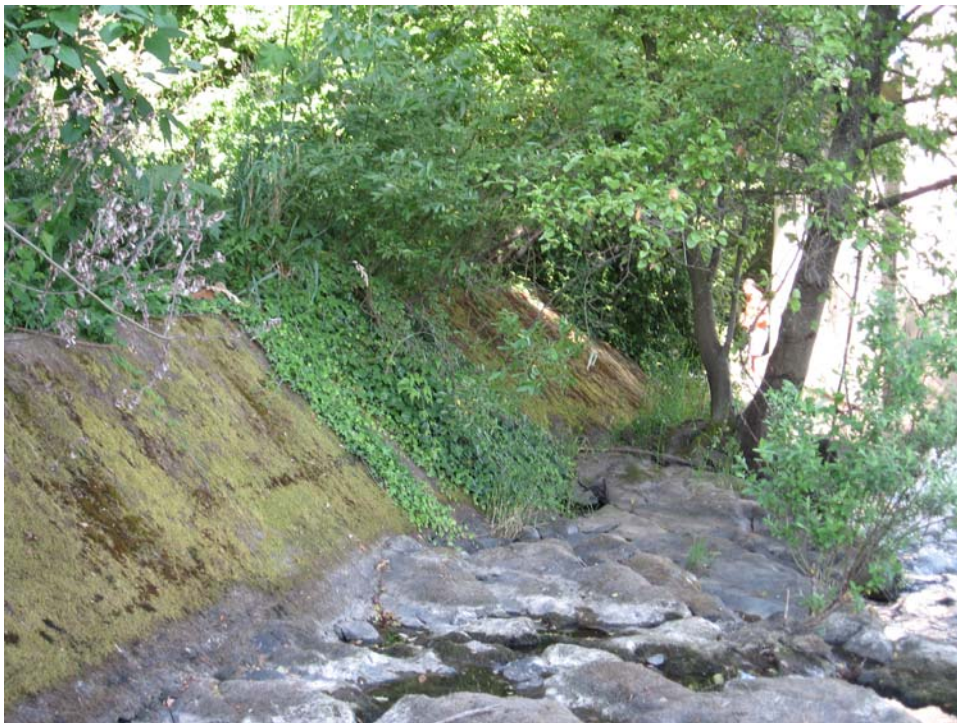
Figure 9. View to northeast of revetment from west side of detour bridge.

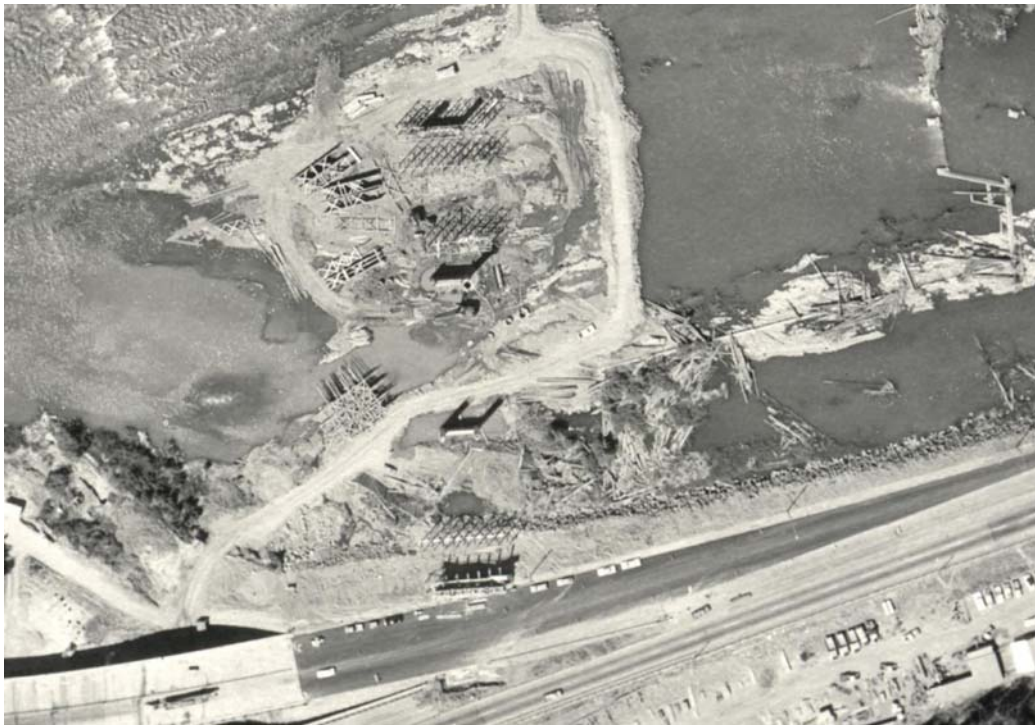
end of the APE, two major breaks in the millrace revetments appear to be attributable to the building of access roads related to I-5 construction, as indicated in the 1960 aerial photograph (Figure 4; enlarged in Figure 13). Considering that extensive construction efforts for both the original I-5 bridge and the detour bridge occurred virtually on top of the Eugene Millrace intake features, its current integrity is remarkable.

Figure 13. Enlargement of 1960 aerial photograph showing avoidance of millrace intake features within the I-5 construction corridor and the breaching of the millrace revetments to the west to allow construction access (ODOT JP8-5-60).
