University of Oregon Huestis Hall

Renovation Feasibility Study

November 2017

Robertson | Sherwood | Architects PC

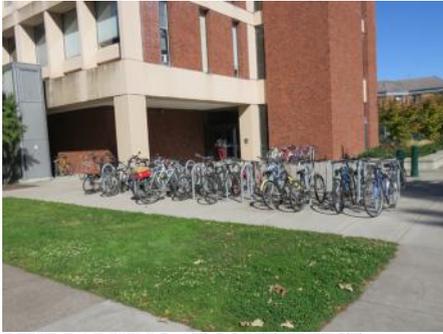
BIKE PARKING AT SOUTHWEST

A number of bike parking options are provided at the southern end of Huestis Hall on both the east and west sides of the building. The bike parking options include uncovered spaces and spaces covered by Huestis Hall's second and third floor overhang. The bike parking styles include single loops and the older, non-code compliant, ribbon-style racks. Over 70 Bike Parking spots are provided.

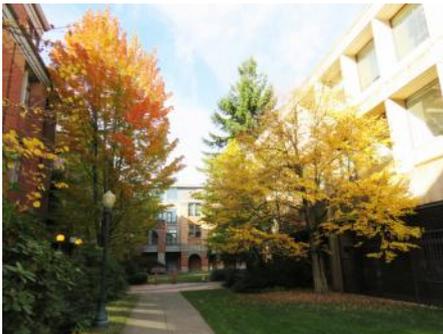
FIRE LANE AT THE WEST

Huestis Hall is located along East 13th Avenue, which provides a convenient path for pedestrians, and delivery vehicles. On the west side of Huestis Hall is Willamette Hall and a walking path that also serves as a fire lane. On the east side of Huestis Hall is a large courtyard. Established deciduous trees and a few evergreen trees are dispersed around the site, along with established planting areas and benches.

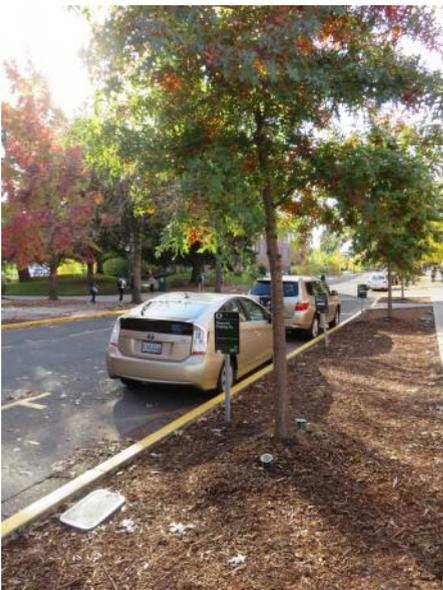
EAST 13TH AVENUE

East 13th Avenue, directly outside of Huestis, is open to vehicles and includes parking spots on both side of the street. These spots are generally filled by people visiting the campus or contractors working on buildings on campus.

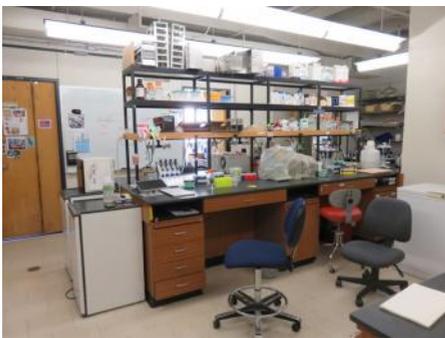
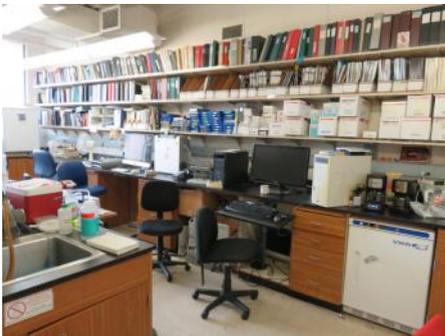
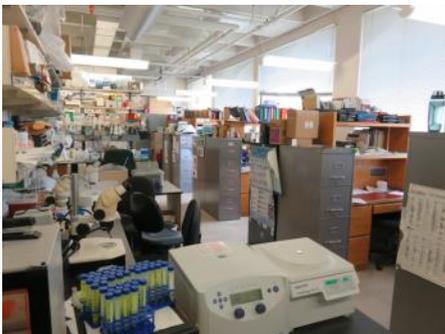
RESEARCH LABORATORIES

The finishes include vinyl asbestos floor tile, dated wood veneer casework, epoxy tops, and open ceilings. The open ceilings are filled with mechanical units, ductwork, and piping. Sinks, electrical plug strips, air turrets, and gas turrets are also distributed around the space.

Two laboratories have recently been renovated, and will mostly be left untouched during any imminent building remodeling project. Another one of the laboratory spaces is being utilized as an office suite. It is assumed this office suite will be relocated to another building when the building is overhauled.

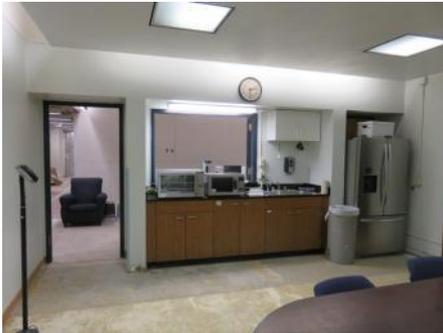
SECOND FLOOR MEETING ROOM

The second floor meeting room is multi-use. It serves as a kitchenette, dining area, break room, and meeting area. This multi-use meeting room also has a direct connection to the informal lounge directly outside the space. This connection is through a large pass-through opening above the kitchenette countertop. The pass-through is flanked on each side by a single wood door leading to the central lounge space. These two spaces have recently been upgraded with new luxury vinyl flooring, paint, and casework.

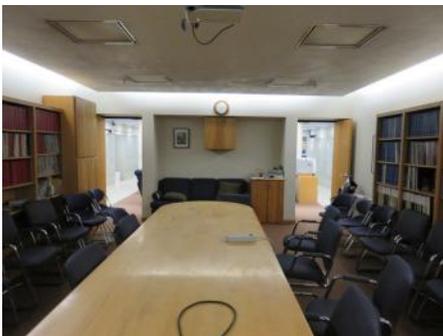
THIRD FLOOR CONFERENCE ROOM

On the third floor the meeting room acts as a formal conference room. The room includes a large central table with tall bookshelves lining the walls. A headwall with marker boards and projection screen occupies one end of the room. The finishes in the space include gypsum/plaster wall finish, out-of-date carpeting, and a floating cloud ceiling.

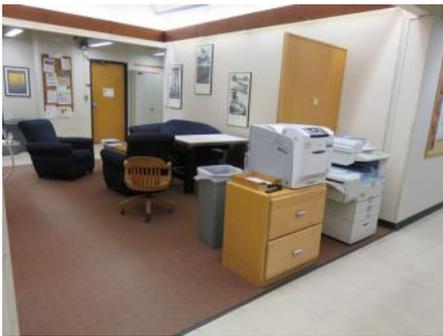
THIRD FLOOR LOUNGE

The informal central lounges on the second and third floor are sandwiched between the corridors, and have an open ceiling with perimeter fluorescent lighting concealed behind dated wood fascia boards offset from the wall with brackets (similar to the lighting in the first floor corridor). The lounges include seating, printers, drinking fountains, and a coffee bar. Over time the lounges have become dated and compromised by the addition of laboratory support equipment, such as printers and freezers. Recently the University has made effort to reclaim and update the second floor central lounge.

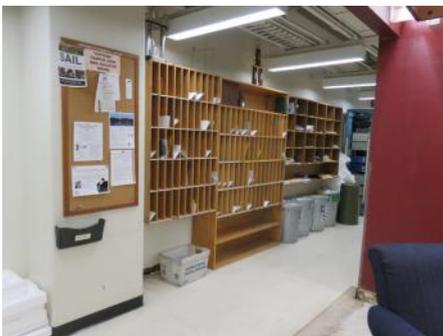
MAIL STATION

A necessary mail area is currently located at the second floor corridor. The mail station is comprised of over 100 mail slots that serve students and faculty. The mail station adds clutter to the corridor, and is proposed to be relocated during the building remodel.

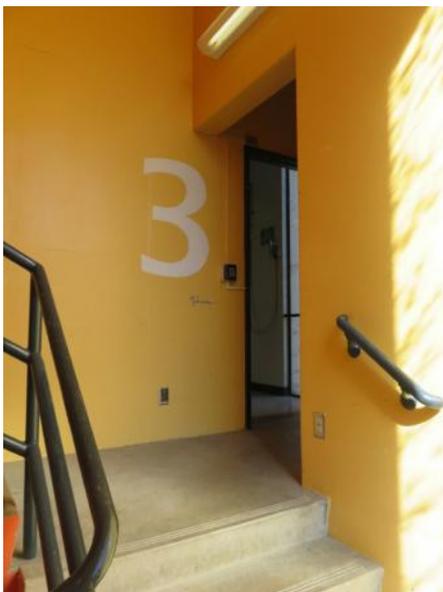
STAIR TOWERS

Fire-rated stair towers bookend the building at the north and south sides. The north stairs allow for uncontrolled connection to all floors, and have a secure access point to the roof. The south stairs provide uncontrolled connection to floors 1 through 3, have a controlled connection to the roof, and provide for egress-only at the basement. The egress-only arrangement at the basement is required due to the level of security required for the Zebra Fish Lab.

The stairs are monolithic concrete. The flights are open to one another with the exception of demising walls separating the stairs to the basement. Simple steel tube guardrails project from the stairs at the side, and non-code-compliant handrails are located on one side. The north stair tower is slightly different from the south stair tower, as a concrete wall projects above the First floor stair flight at the north stair. This concrete wall has a round cutout, which likely was intended for aesthetic interest and provides a visual connection.

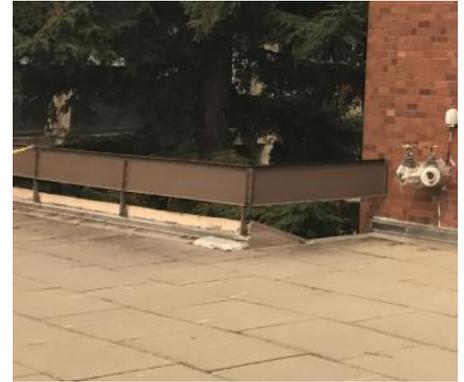
Existing Guardrail

The parapets and rails protecting this area are not tall enough to meet the OSHA regulation for fall protection (42"). Fall control anchors have been installed at locations where microwave antennas have been installed at the roof edge, and maintenance of this equipment will require fall protection for safe access. The remaining roof edge fails to meet regulation.

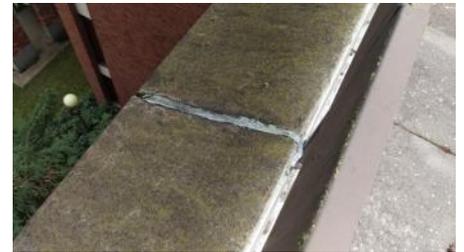
Existing Precast Parapet

Leakage associated with the roof edge is evident. This water infiltration appears to be associated with infiltration through joints of the precast concrete parapet/cornice and absorption through the concrete. Membrane failure at the roof deck and cornice caused by differential building movement along with poor drainage may also be contributing to the leakage.

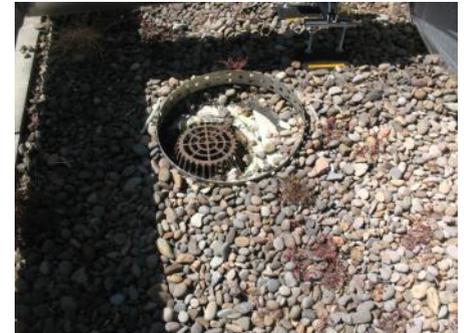
Existing Roof Drain

Roof Area B has two large exhaust hoods concealed by an architectural metal panel screen. There are no noted issues with roof area B. This roof area drains to a single roof drain. It is recommended that this roof drainage remain as is and the area be reroofed at the same time as Area A.

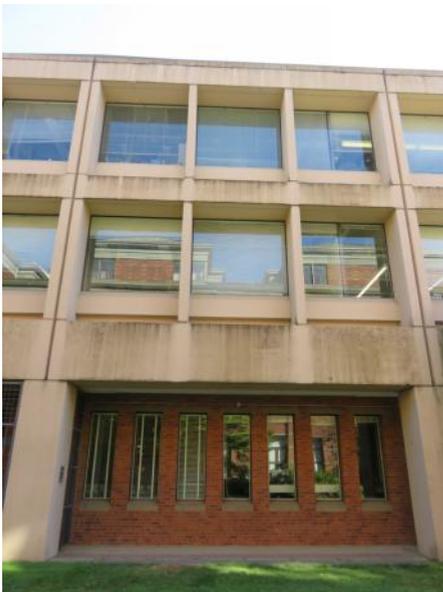
WEST FACADE

The structural concrete frame of Huestis is exposed at the second and third floor and roof beam lines. In addition to this structural concrete, the façade has exposed cast-in-place infill wall panels and precast wall panels, all coated with elastomeric membrane. A lot of this concrete is heavily marred with black stains running down from above.

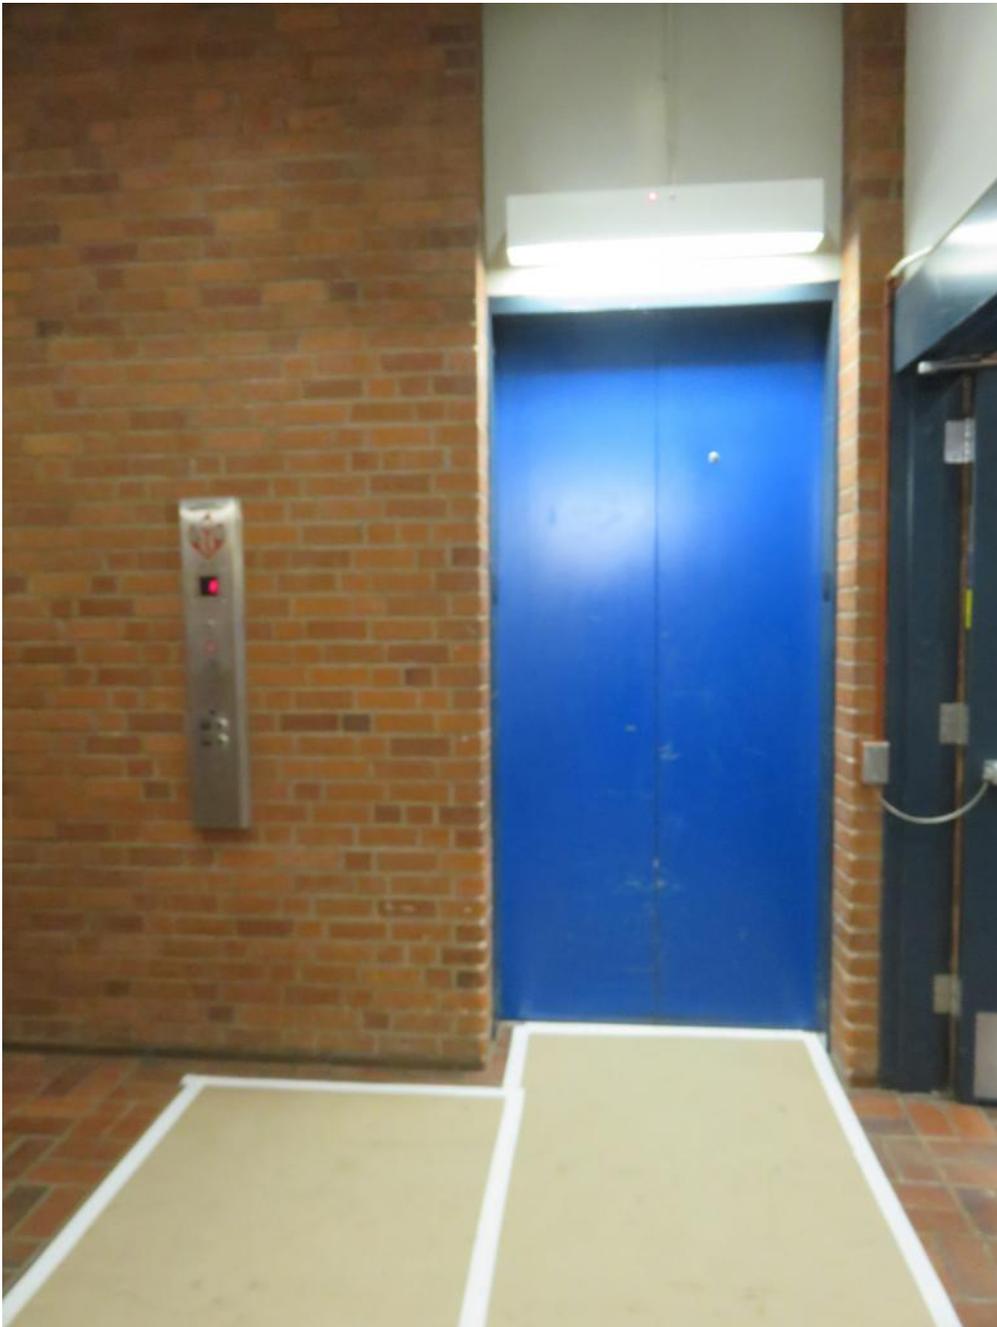
ELEVATOR ENTRANCE

The elevator at Huestis Hall is a basement-set traction elevator with a capacity of 3,000 pounds and speed of 350 feet per minute. The elevator was originally installed in 1971 and received a partial upgrade in 2008. As part of the modernization, the original 1971 hoist machine was retained but received new thrust bearings, worm shaft bearings and sheave seals. The original DC motor and motor generator set was replaced with an AC variable frequency hoist motor. The brake was disassembled, cleaned and reassembled with new pins and brake linings. The original Montgomery relay logic controller was replaced with a new Motion Control Engineering controller. A new over-speed governor, tail sheave, governor ropes, hoist ropes, door operator, door rollers, interlocks, and roller guides were also provided as part of the 2008 upgrade. Other major components were retained and refurbished where required. The elevator equipment appears to be fairly well maintained and in its current condition and configuration should be expected to provide another 10-12 years of reliable service. A detailed report of the current elevator condition is provided in the appendix for further review.

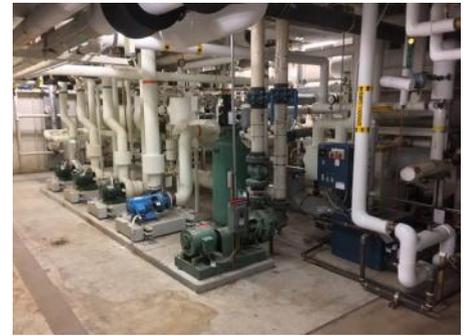
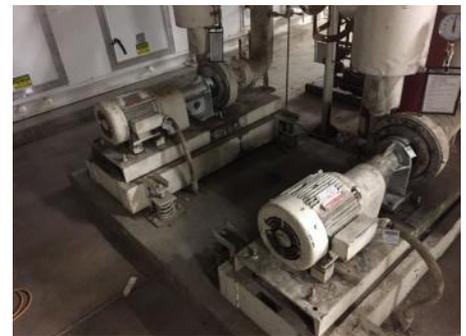
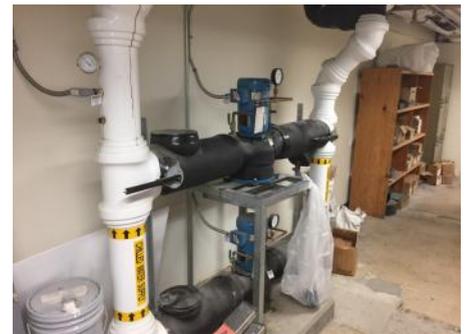
The Lokey Laboratory service originates in the Streisinger building mechanical room north of Huestis. Two steam-to-water converters are installed in Streisinger, and related heating water piping is routed through the campus tunnel system into the Huestis basement and then into the Lokey main fan room. Redundant heating water pumps are installed in the fan room. The Streisinger system is entirely independent of Huestis. Equipment serving the Lokey Laboratory is relatively new, appears to have appropriate redundancy, and can be reused.

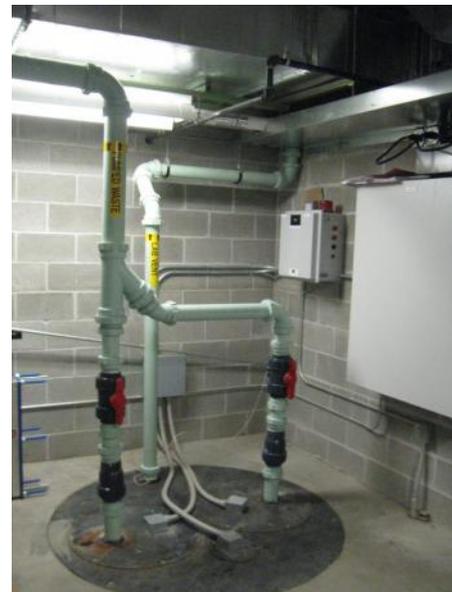
ACID WASTE SEWAGE EJECTOR

The Zebrafish Laboratory has a dedicated acid waste sewage ejector which discharges to site sanitary waste. The acid vent piping from the laboratory connects to the Huestis acid vent system. Since the acid waste sewage ejector is an independent system, it can remain in service throughout the Huestis upgrades. The existing acid vent piping will need to be connected to new acid vent piping prior to complete demolition of the existing Huestis acid vent system.

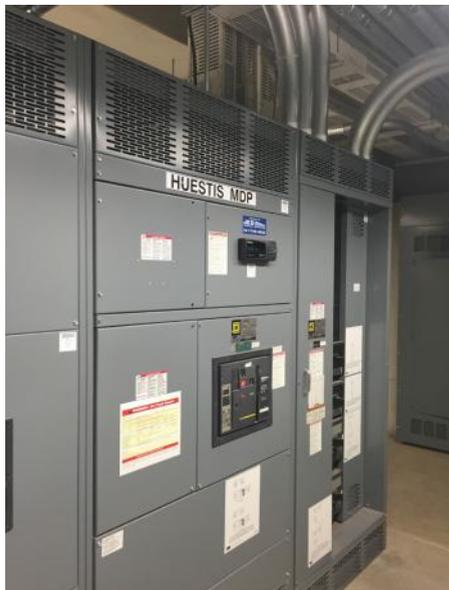
MAIN DISTRIBUTION BOARD

All normal power to Huestis first through third floors is derived off the 4000A, 120/208V main distribution board. Power to all existing normal panelboards is routed through a bus duct system. The bus duct system consists of two (2) 2000A, 120/208V and (2) 1000A, 120/208V bus ducts. The two (2) 2000-amp bus ducts are used to distribute power to the second and third floors and the penthouse. The bus duct runs along the east and west hallway of the second and third floor. All panelboards are fed from the bus duct via fused disconnect. The two (2) 1000-amp bus ducts are used to distribute power to the basement and first floor. The bus duct runs along the east and west hallway of the basement only. The majority of the panelboards in the Zebrafish Laboratory are fed from this bus duct. The penthouse on the roof houses an MCC and two panelboards to serve the mechanical loads located on the roof.

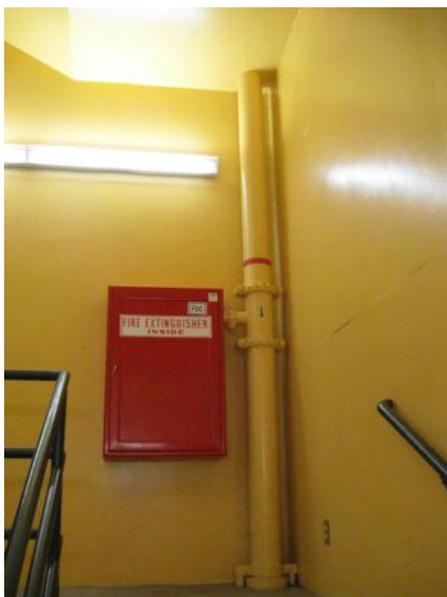
LOKEY LABORATORY

A fire suppression system was provided for the Lokey Laboratory in 2007, and is supplied from the existing Huestis fire service as a separate zone. The existing fire suppression system for the Lokey Laboratory will need to remain in service throughout the Huestis Hall upgrades.

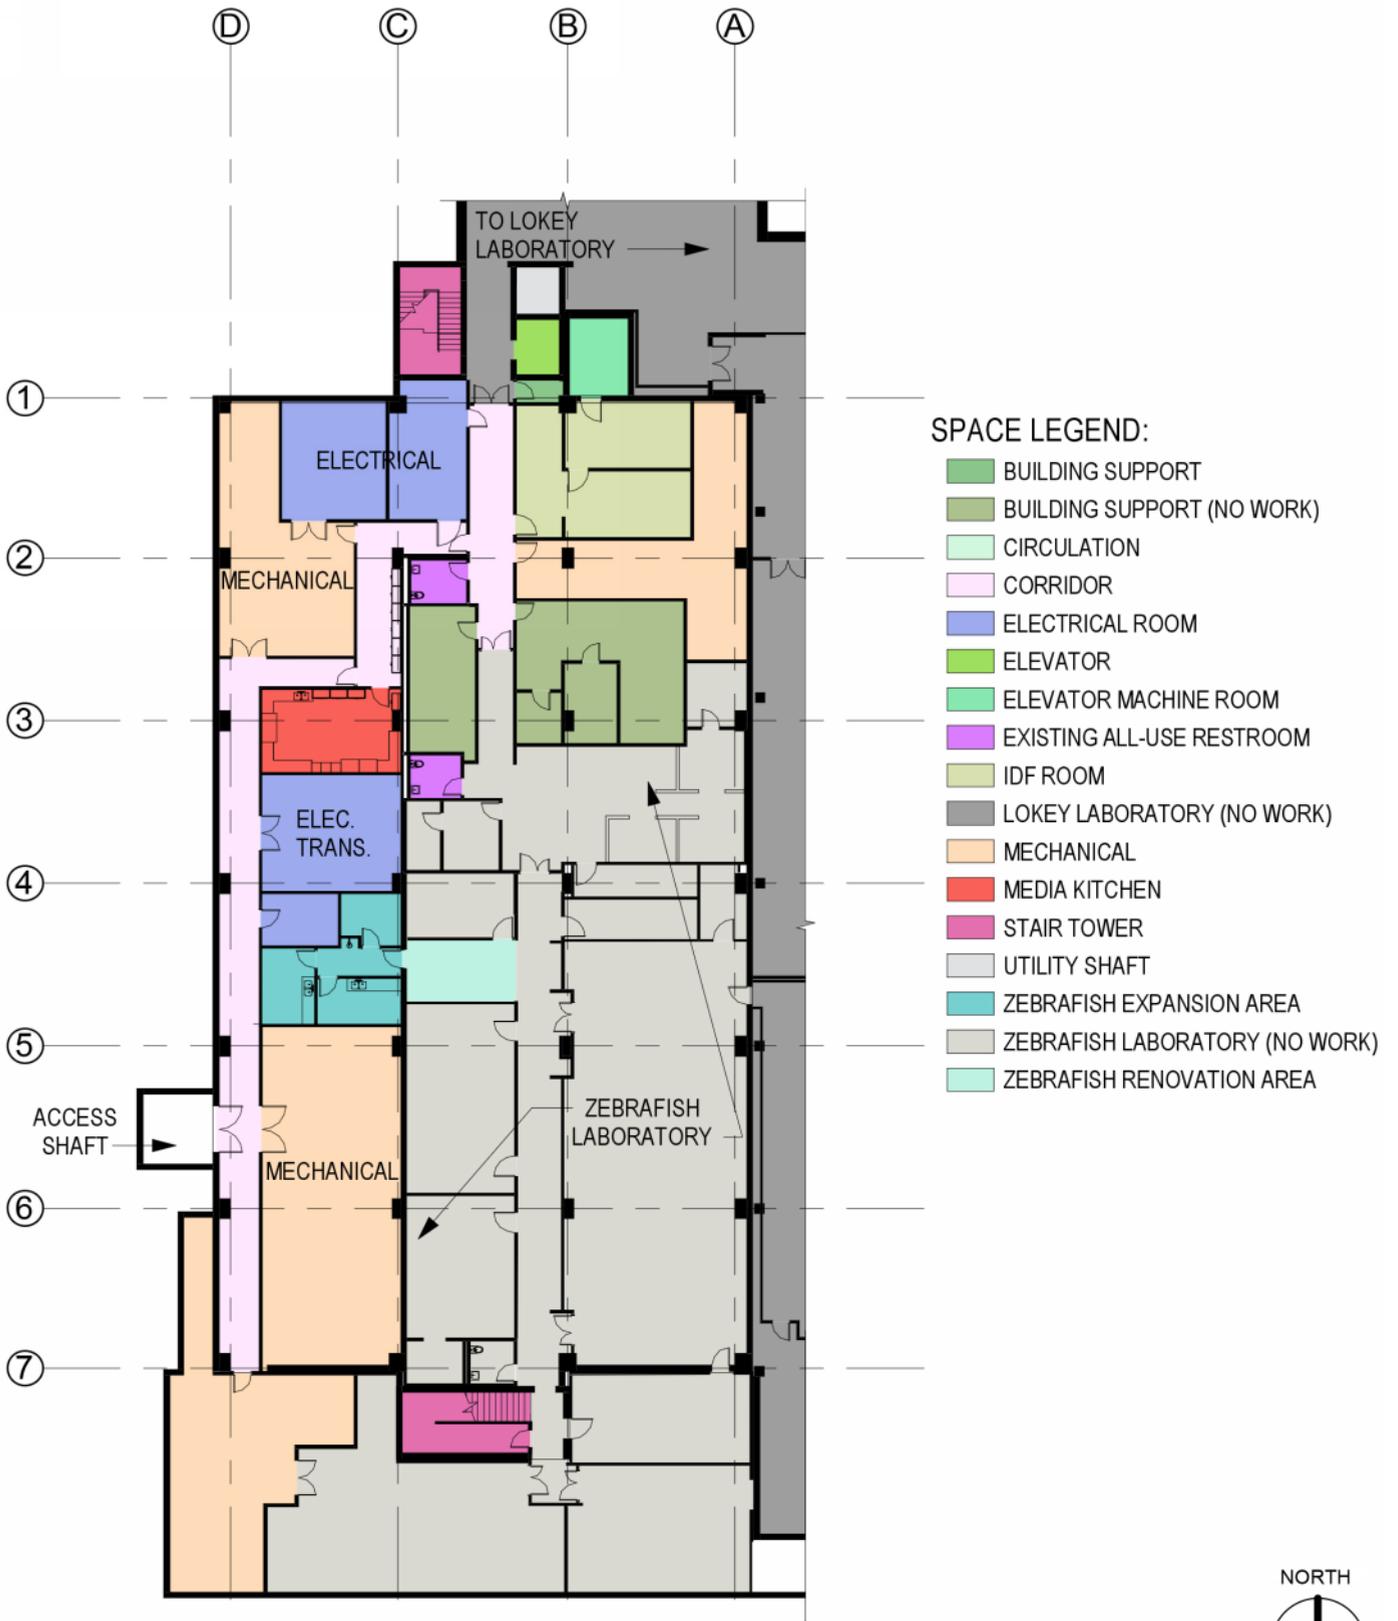
BASEMENT CONCEPTUAL PLAN

To facilitate the removal and installation of the existing and new mechanical and plumbing equipment a new access shaft is proposed on the west side of the building, outside the building foot print. This new shaft will be approximately 12’x12’ and be comprised of concrete retaining walls, with a concrete floor and drain, and capped with a metal grate. To access Huestis Hall new doors double doors should be cut into the existing foundation wall and a direct path though the new corridor should be provided to the mechanical room.

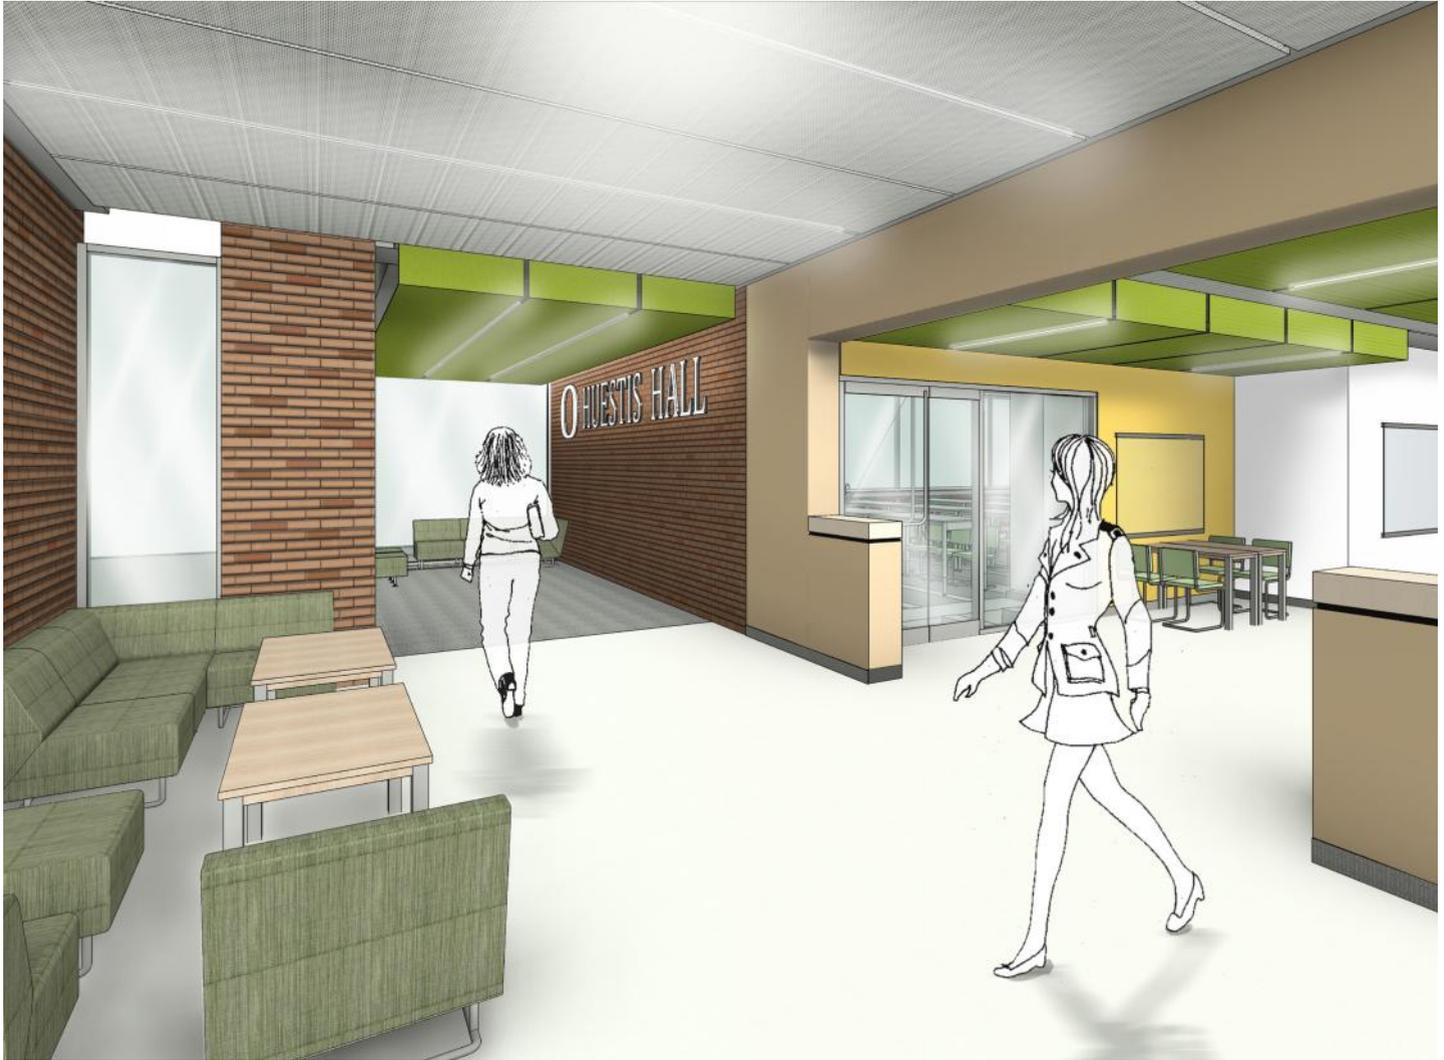
CORRIDOR

Proposed improvements to the corridor include upgrading the sprinkler system to allow the corridor fire rating requirement to be eliminated. This will allow for glazing in the walls and doors, providing visual connections between the laboratory classrooms and the corridors. In addition to adding glazing in the walls, setbacks can be incorporated into the corridor walls between the utility shafts to define the entries to the classrooms and create breakout spaces for students use. The wall articulations will also improve sightlines and help eliminate the present tunnel-like feel. The proposed finishes for the reconfigured corridors include luxury vinyl flooring, linear metal acoustic ceiling planks, and custom metal panel clouds defining classroom entries and breakout spaces.

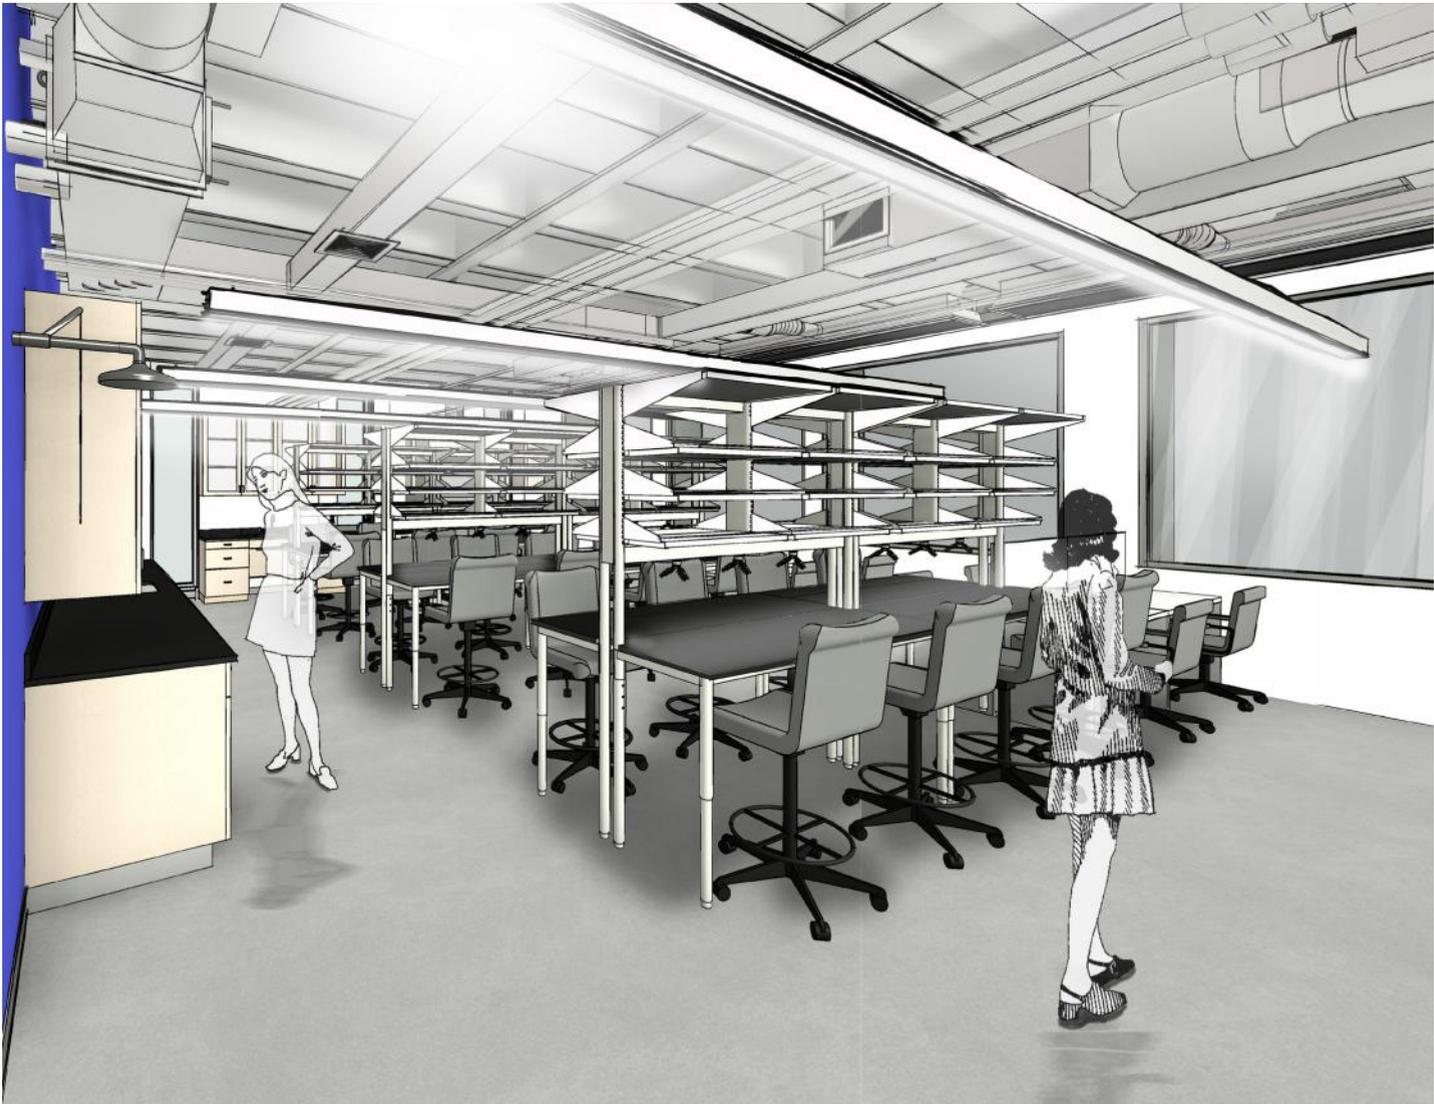
TYPICAL LABORATORY

The built-in elements of the research laboratories are intended to be typical, such that users will be familiar with the configuration of the laboratories, no matter which space they are in. The typical layout is simple in design and includes perimeter casework with storage, sinks, emergency fixtures, and one fume hood per lab. Mobile furniture including work benches can be configured to best suit the users' needs.

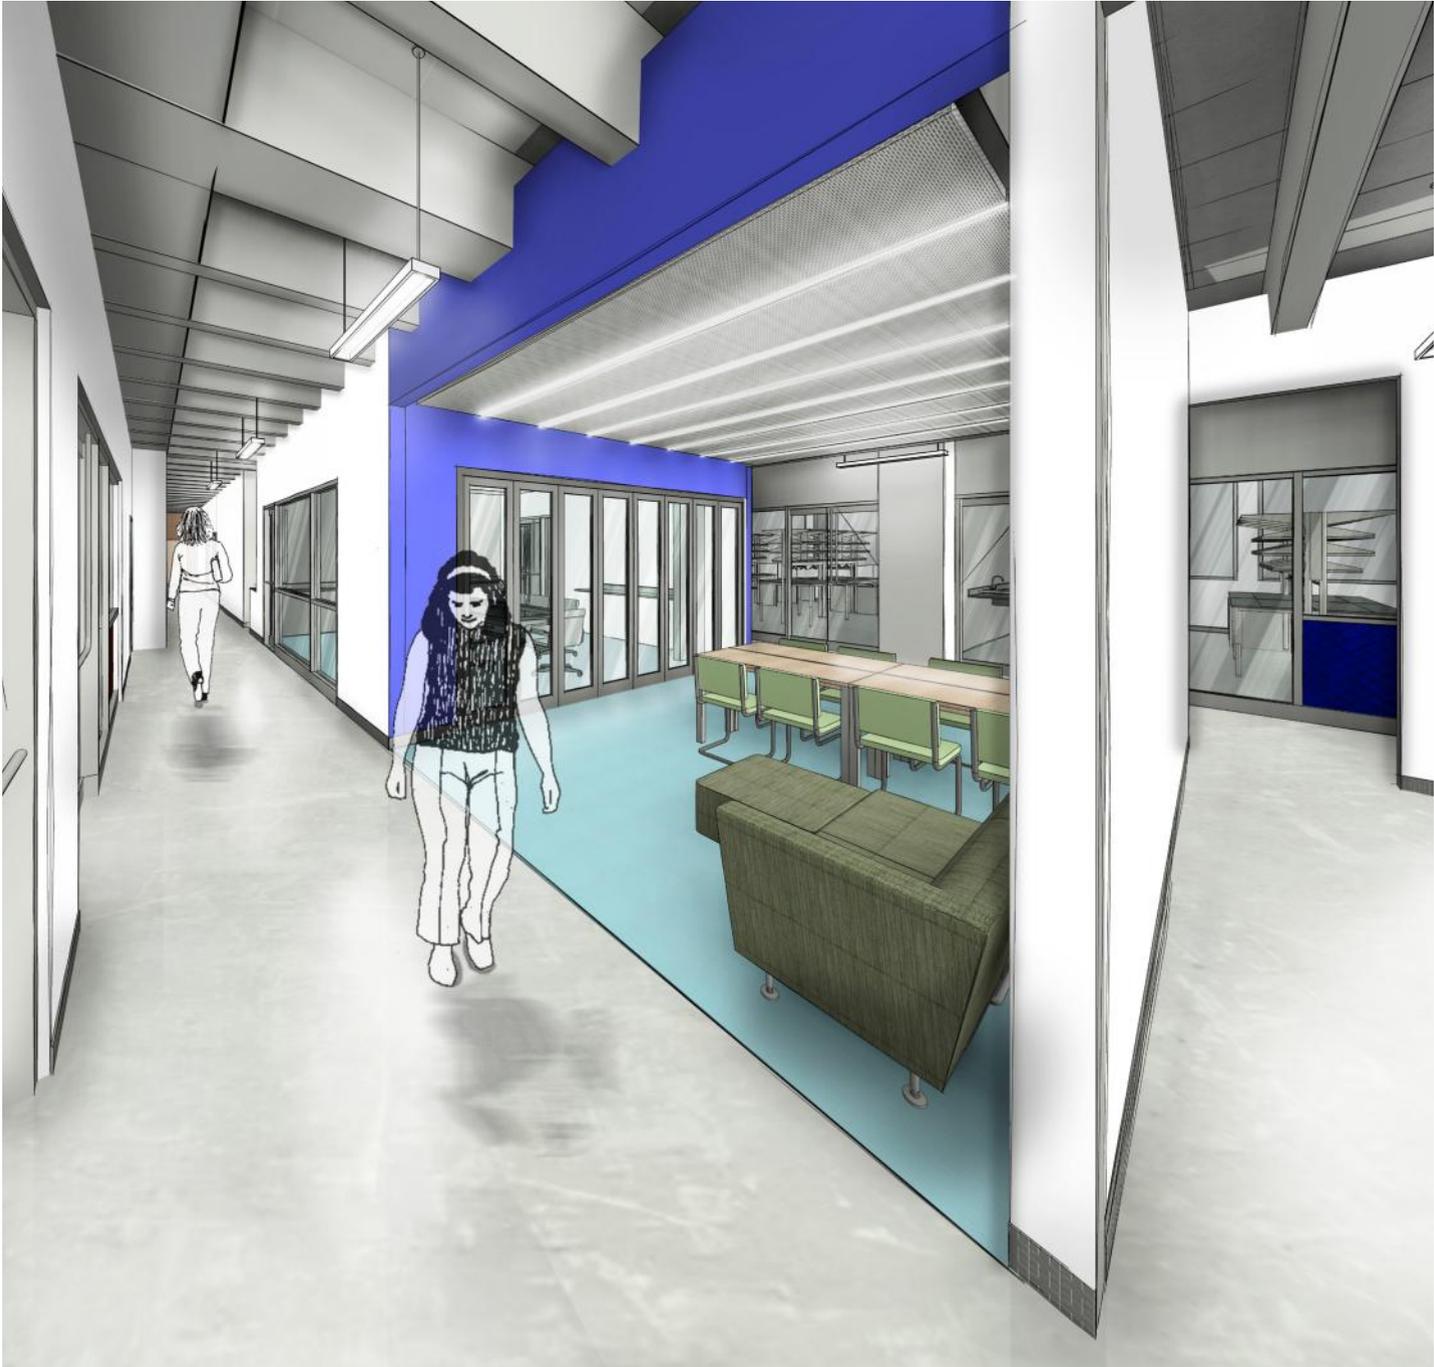
THIRD FLOOR CORRIDOR AT CENTRAL LOUNGE

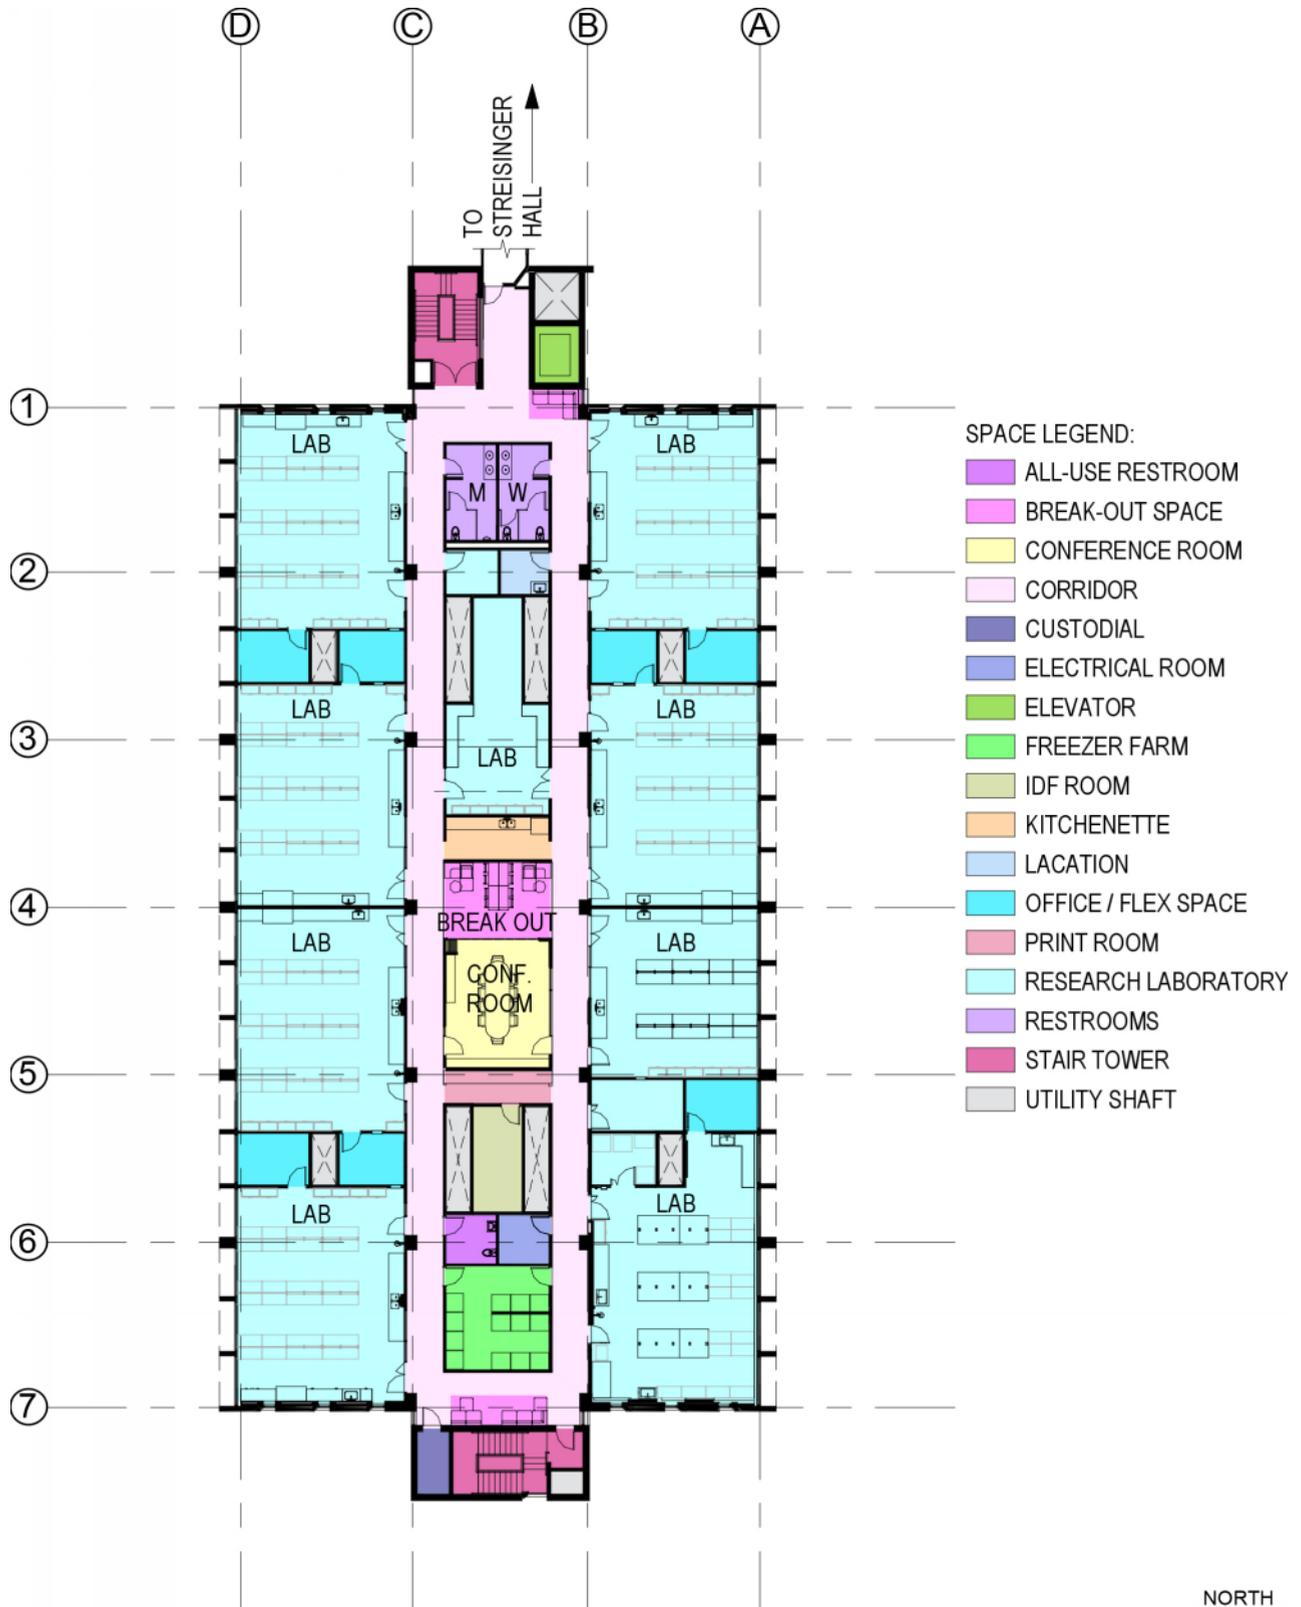
THIRD FLOOR CONCEPTUAL PLAN

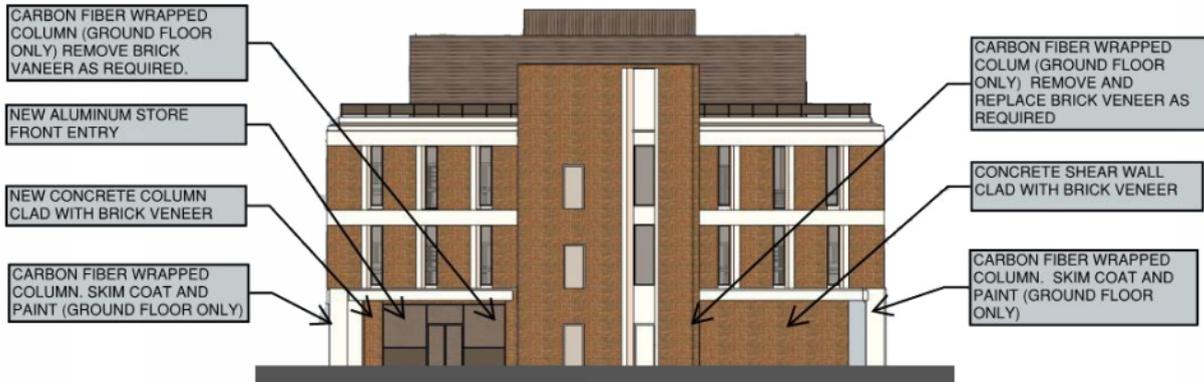
SOUTH ELEVATION (NORTH ELEVATION SIMILAR)

The southwest entry of the building will be modified so that the entry doors to a glass enclosed vestibule will face south and create an understandable entry facing the fronting street and main pedestrian walk. This entry component will be constructed with 2”X6” thermally broken aluminum storefront glazing systems. The lower opaque panels will be 1” insulated metal composite panels with aluminum brake metal enclosure panels on the inside. See images.

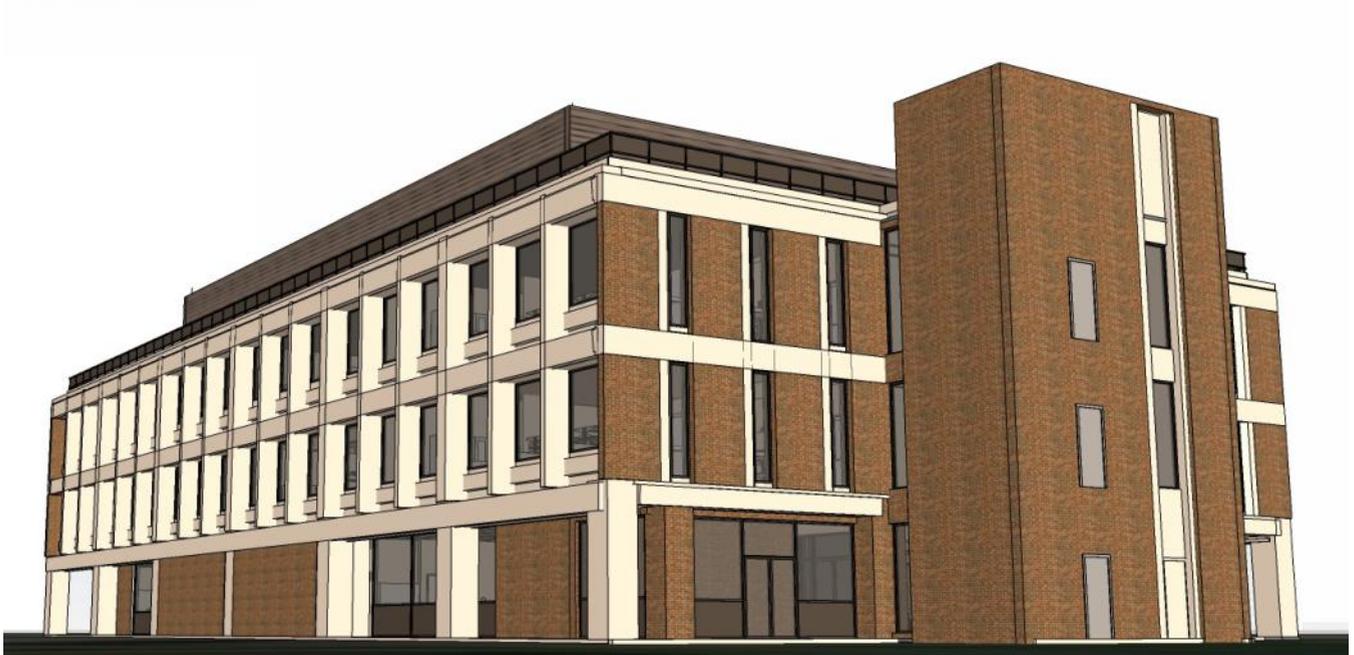
SOUTHWEST CORNER VIEW SHOWING NEW MAIN ENTRANCE

Three of the four existing main entrances are proposed to be altered during the building renovation. The revisions are needed to address upon the existing seismic deficiencies of the building and the desire to give Huestis Hall a clearly identifiable main entrance to let people know how to enter the building, and make the building more welcoming to its users and visitors.

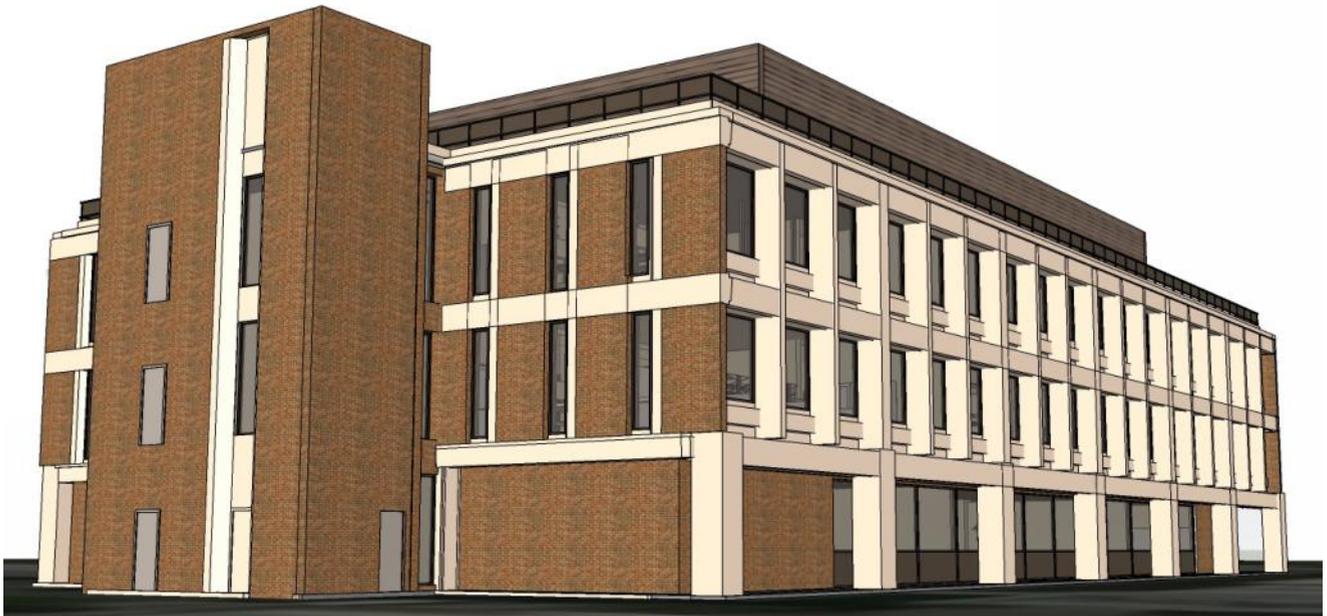
SOUTHEAST CORNER VIEW SHOWING SEISMIC IMPROVEMENTS

The existing south east entrance of the building is proposed to be removed. A new seismic shear wall is proposed at the south end to connect the overhanging second and third floor to the basement foundation wall. In addition to the new seismic shear wall, a wall to the east will be constructed to enclose the exterior space reclaiming the space to be a new interior storage space.

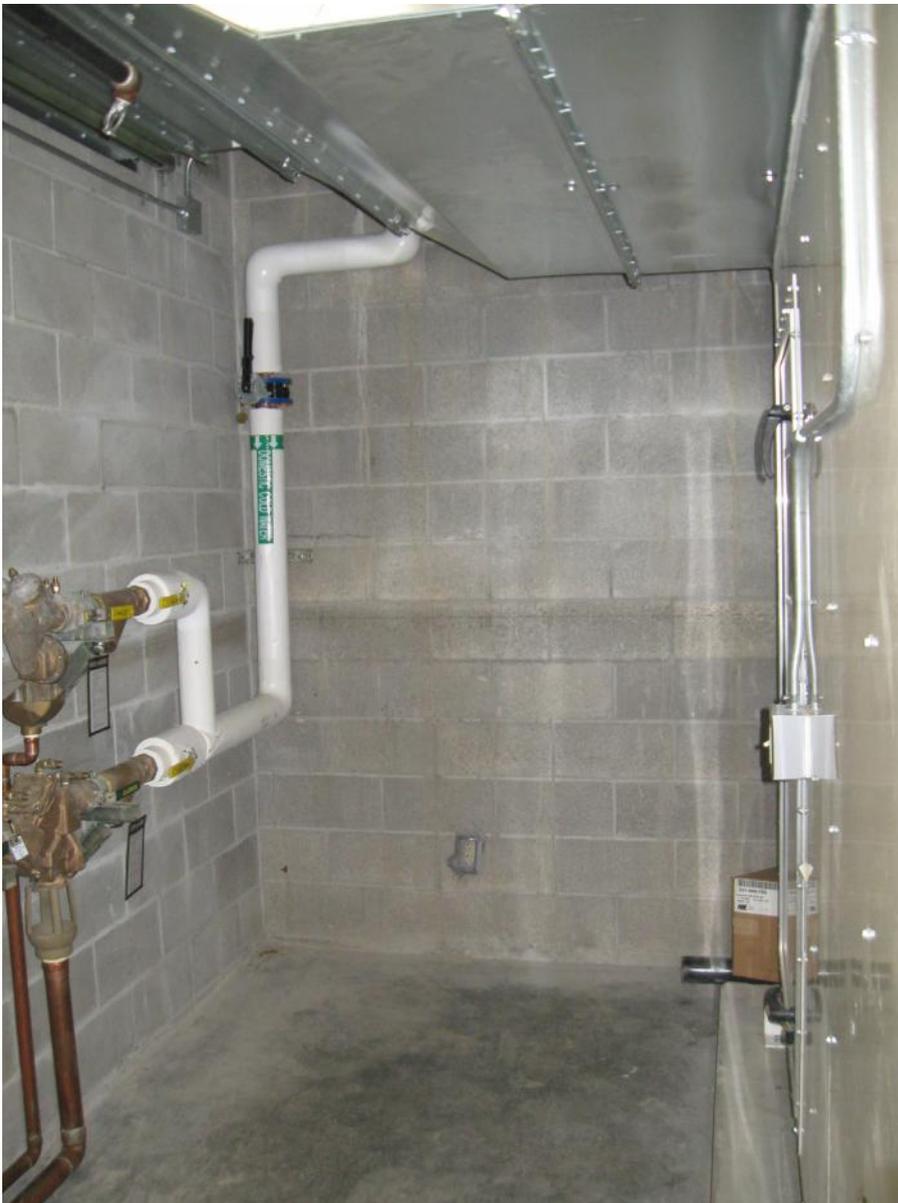
POTENTIAL NEW FIRE RISER LOCATION

Schedule 40 and schedule 10 black steel piping with mechanical couplings and threaded fittings would be used throughout. Overhangs that are four feet and larger will be protected by dry heads connected to the wet pipe system.

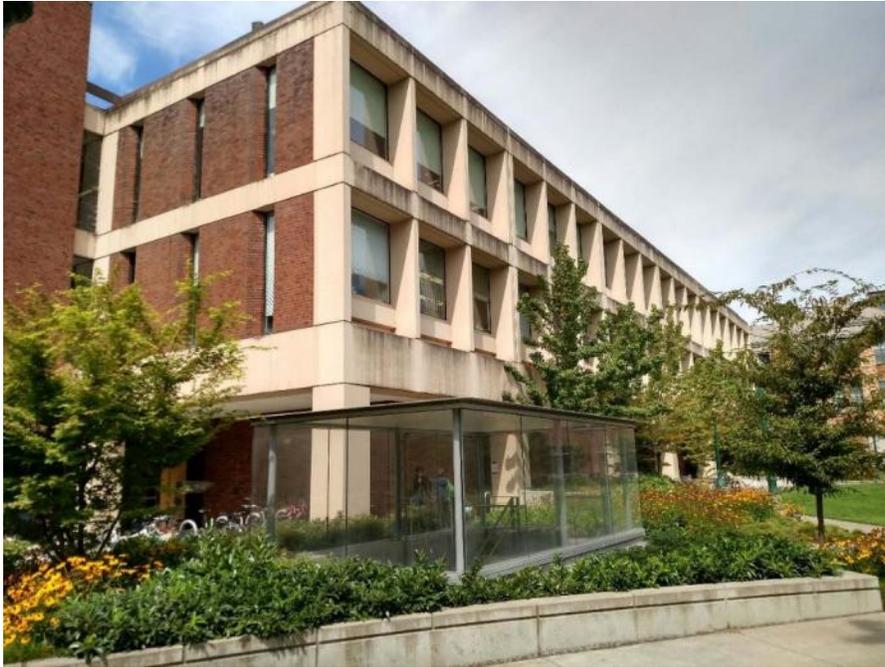
Photo 1 – End Wall w/ Discontinuous Lateral Elements and Unanchored Brick Veneer

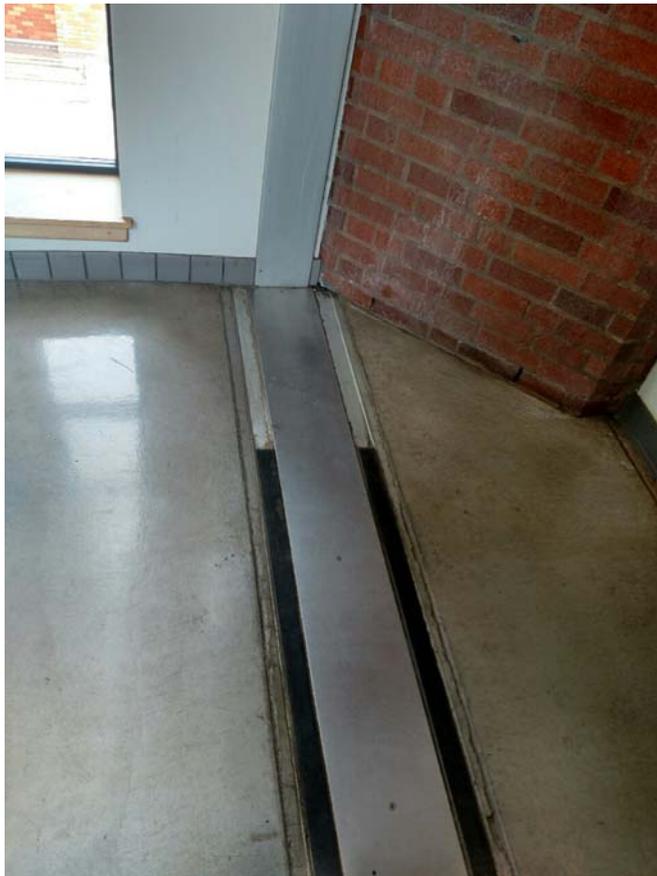
Photo 2 – Seismic Joint at Streisinger Hall
