University of Oregon Huestis Hall

Renovation Feasibility Study

November 2017

Robertson | Sherwood | Architects PC

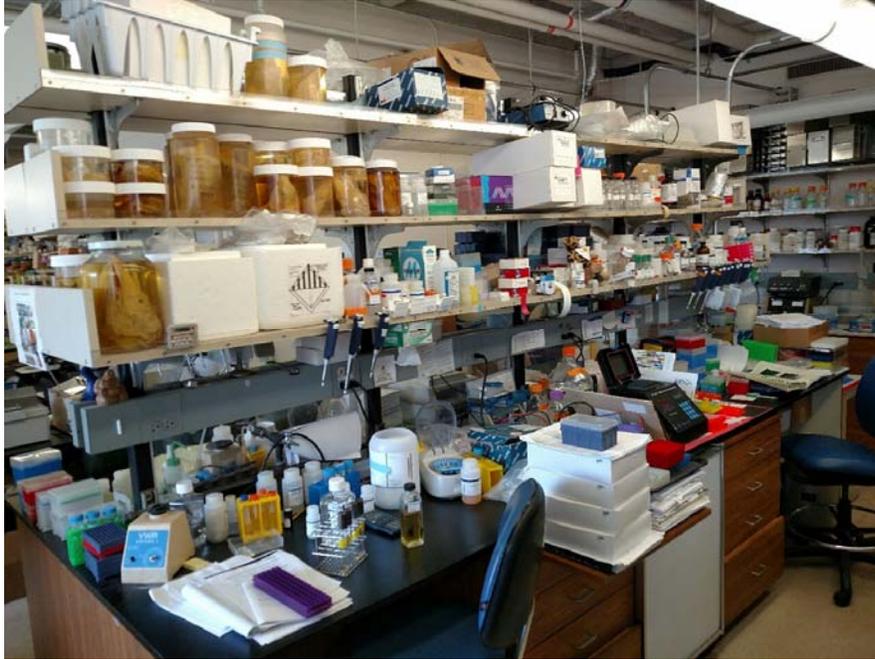
Photo 3 - Fall-Prone Contents in Lab Classroom

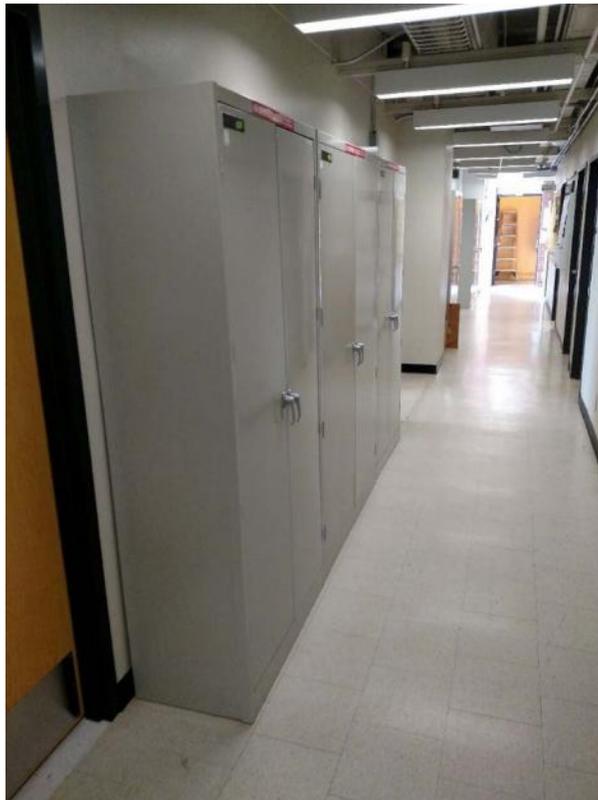
Photo 4 – Tall Unbraced Cabinets in Corridor

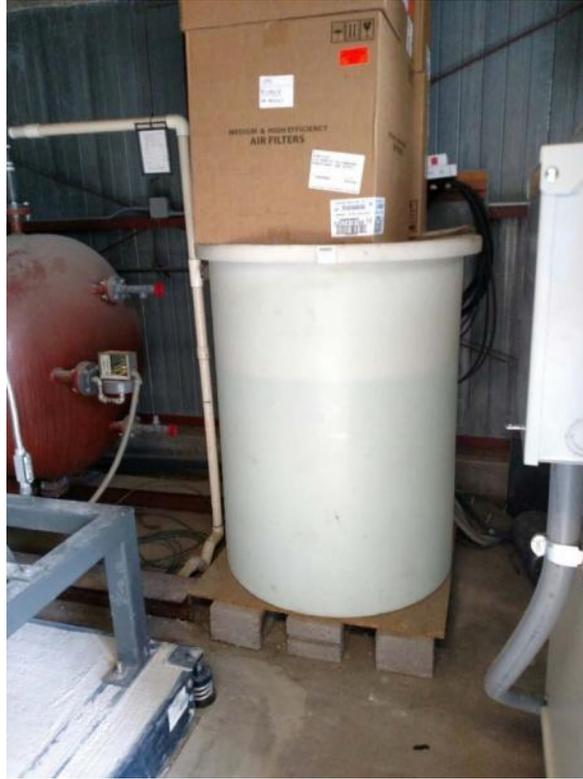
Photo 5 – Unbraced Tank In Mechanical Penthouse

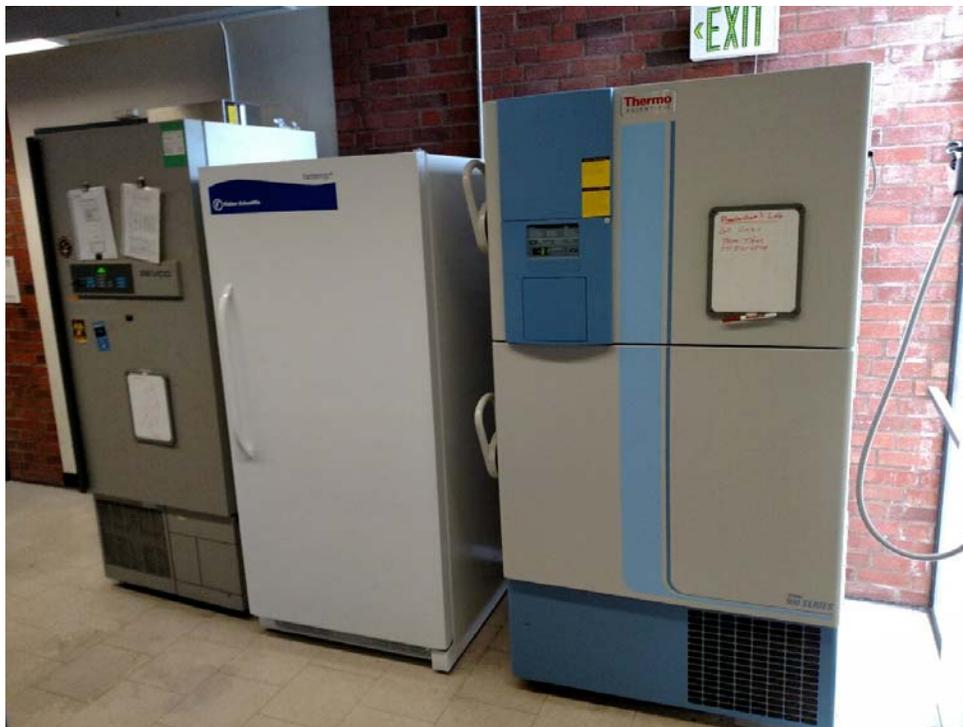
Photo 6 – Unbraced Equipment Adjacent to Exit

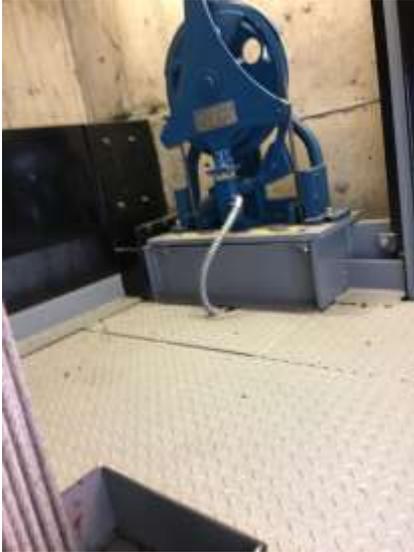
Fig. 1 – Existing governor was replaced in 2008.

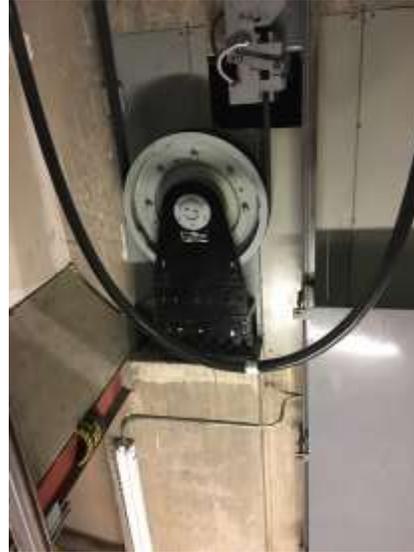
Fig. 2 – Governor tail sheave was replaced in 2008

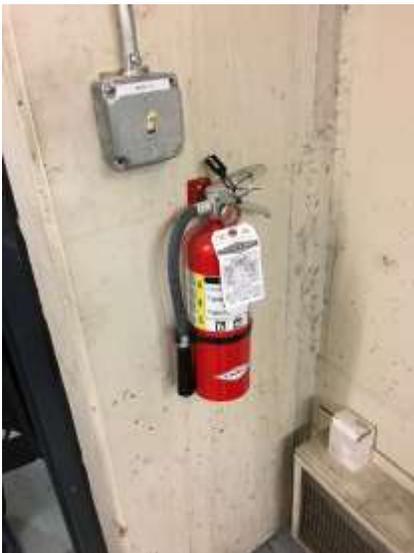
Fig. 3 – Fire extinguisher mounted near door.

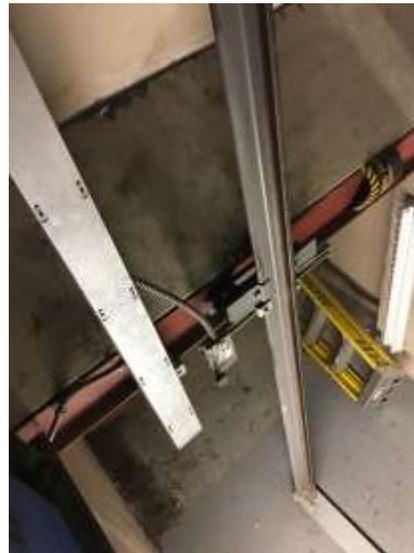
Fig. 4 – Divider beam (red) that can be relocated to the north by 8" to 10".

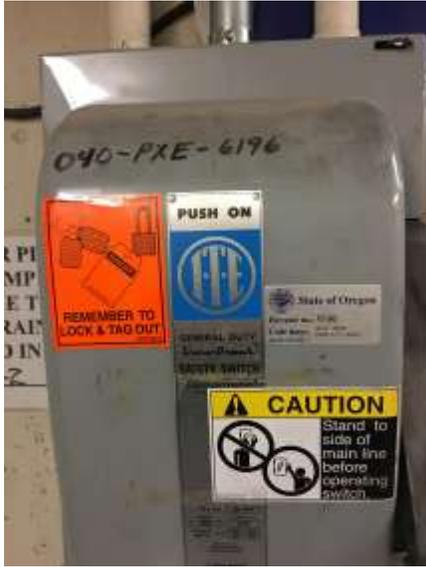
Fig. 5 – Three phase disconnect mounted on hinge side of the door.

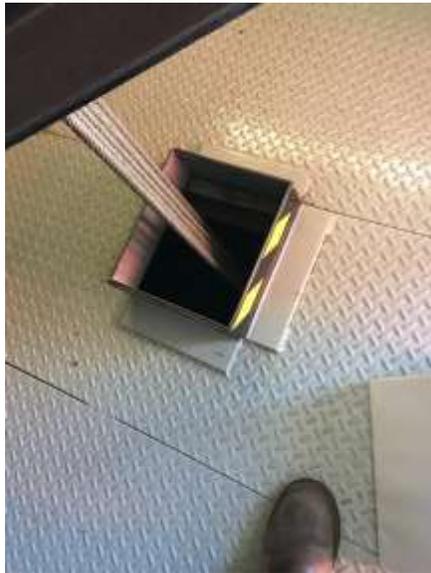
Fig. 7 – Rope drop and cables that were replaced in 2008

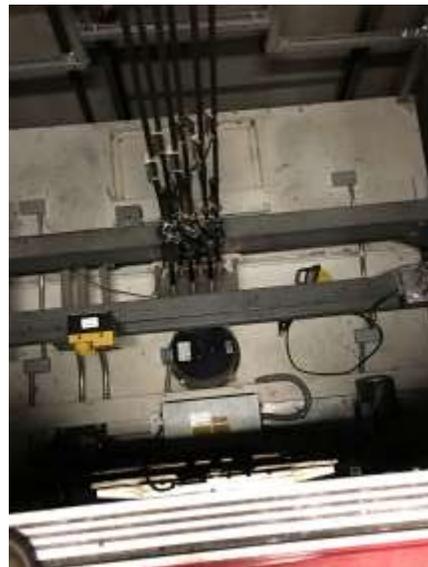
Fig. 8 – Elevator car top

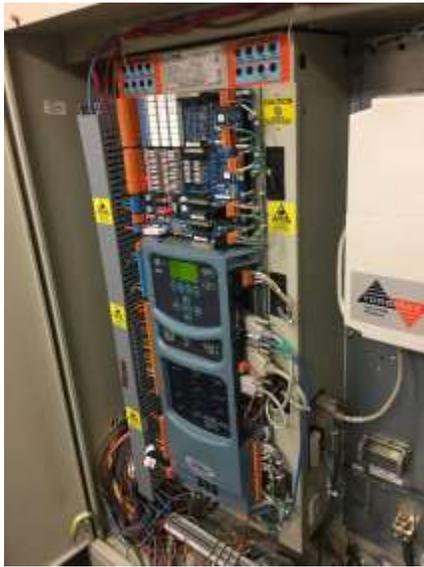
Fig. 9 – Current MCE controller with MAXTORQ drive. Replaced in 2008.

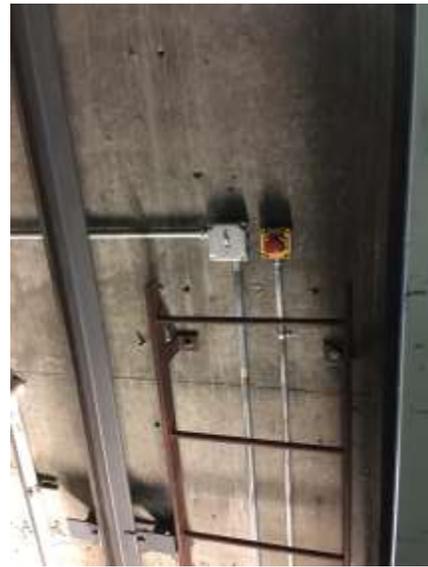
Fig. 10 – Pit ladder needs to be altered to current code – 48” above sill. 12” wide and a minimum of 4.5” from wall.

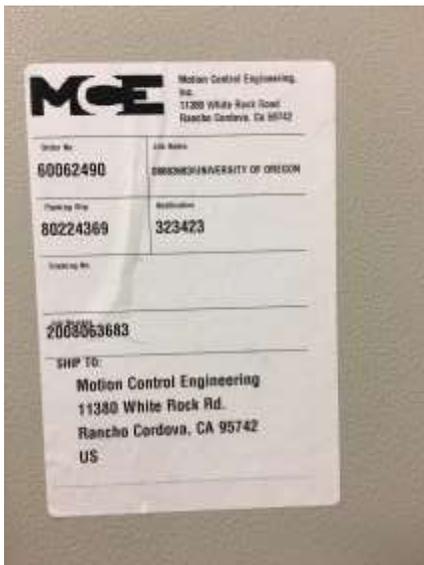
Fig. 11 – Original data tag for MCE controller.

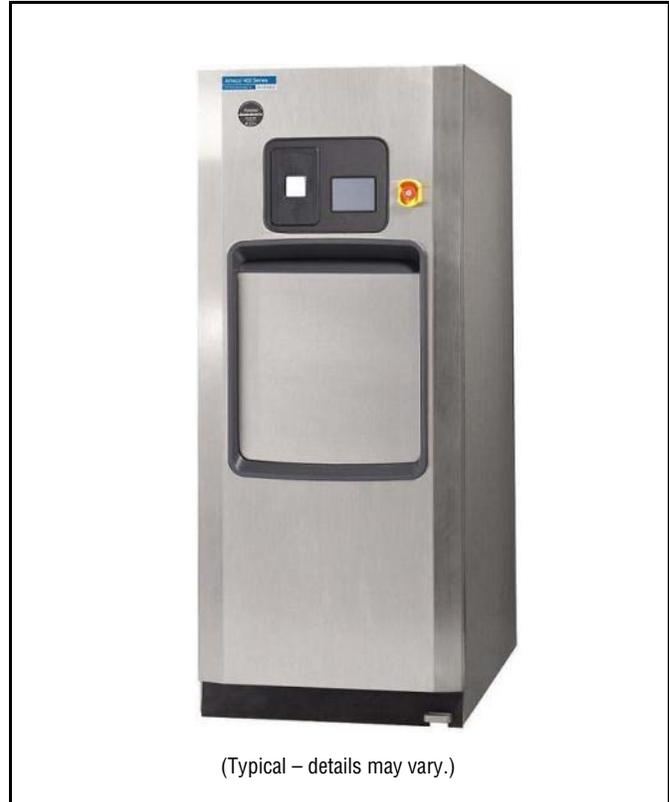
The **control system** for the AMSCO 400 Series Small Steam Sterilizers features enhanced functionality and user-friendly interface screen.

- Touch-screen with 30-line x 40-character display area
- Ink-on-paper impact printer
- Help screens for programming and troubleshooting alarm conditions
- Automatic check of control program and cycle data maintains process integrity
- Service reprogrammable flash ROM memory

- Available with optional water-saving electric **vacuum pump**
- **Vertical sliding door** with hands-free loading and unloading capability.
- Foot pedal activated door opening and closing
- Non-lubricated, steam-activated door seal

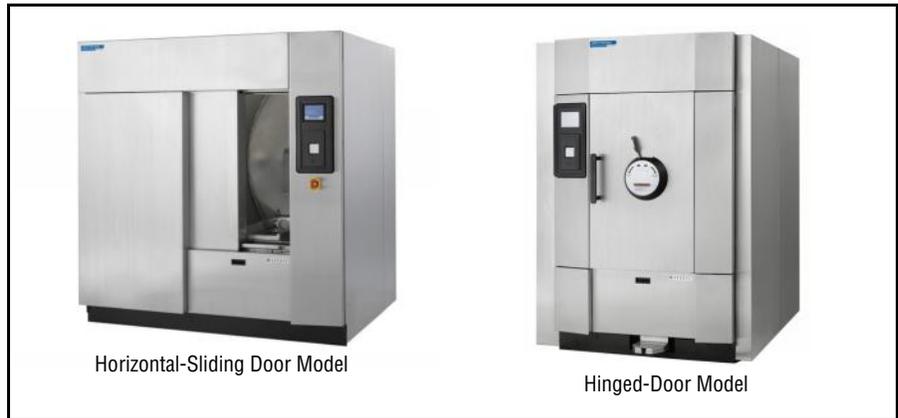
- 26 x 37.5 x 36" (660 x 950 x 910 mm)
- 26 x 37.5 x 48" (660 x 950 x 1220 mm)
- 26 x 37.5 x 60" (660 x 950 x 1520 mm)

36", 48" and 60" configurations include the choice of a single or double door.

- **Hinged door** with fast operating, low-effort door lock mechanism. Door handle lock lever requires a single 30° handle movement to lock or unlock.
- **Horizontal-sliding door** with quiet, motor-driven cable and pulley mechanism. Door travels horizontally right to left to open, and is controlled from the touch screen.
