LANDSCAPE RESOURCE SURVEY
 University of Oregon Campus Heritage Landscape Plan
 Eugene, Lane County, Oregon • Spring 2007

Southwest Campus Axis (ff)

Landscape Resource Survey
SOUTHWEST CAMPUS AXIS

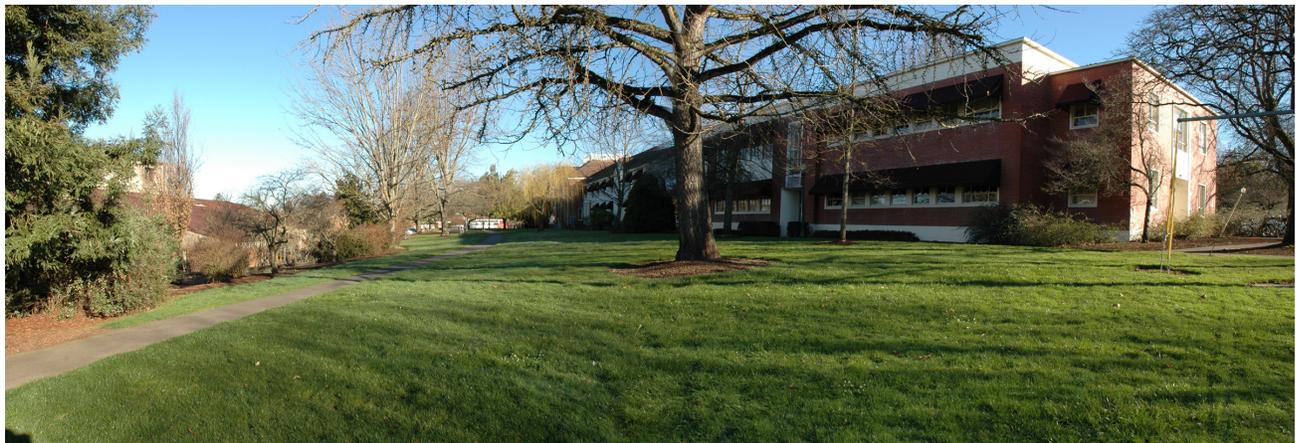
The Southwest Campus Axis, looking north with the Music Building at right.

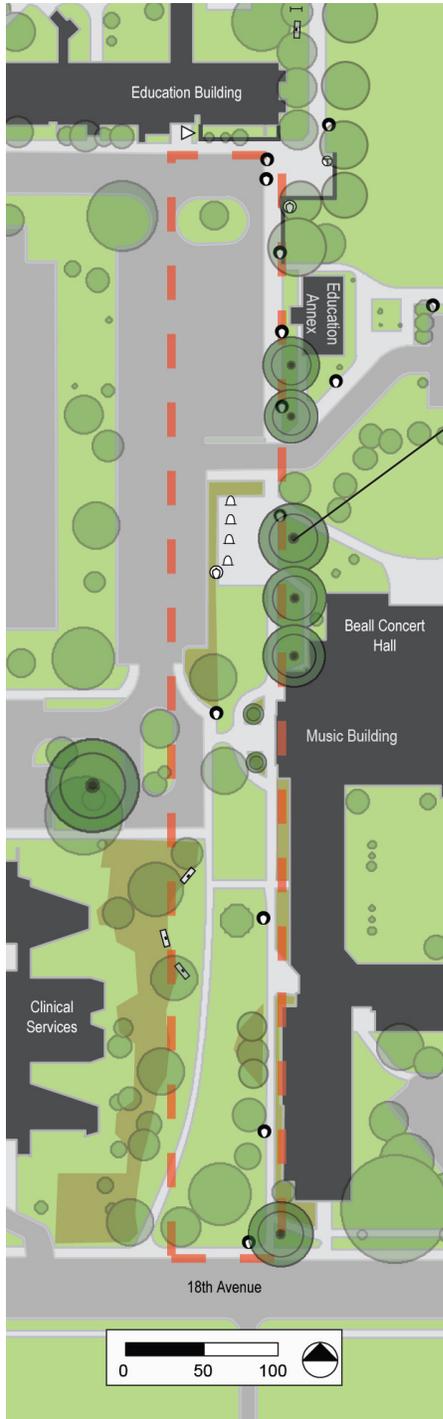
LANDSCAPE AREA SITE MAP — Highlighting existing elements from the period of significance (1876-1974).

This row of Crimson King Norway maples is the most historic landscape feature along the Axis and appears to have been planted shortly before the construction of the Veterans Dorms that once stood nearby.

Very few historic features are present within the Southwest Campus Axis. Part of the site was the location of the Veterans Dorms that have since been removed. Remnants of their foundations are purportedly visible, although not easily discernible. The west turn around and landscape leading to the entrances of Beall Hall and the Music Building has been reconfigured so many times that its current appearance cannot be deemed historic. The only landscape features that date back to the Lawrence/Cuthbert Era are the row of Crimson King Norway maples that line the east edge of the Axis near the Education Annex and Beall Concert Hall.

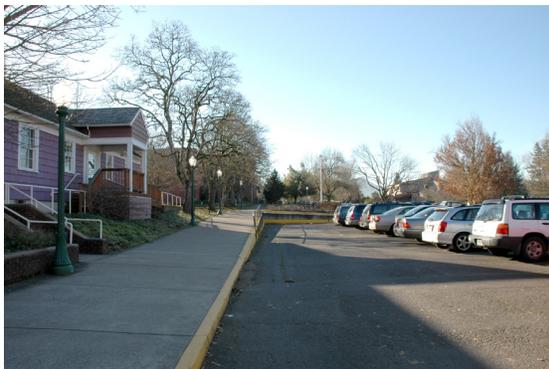
Looking south with the Education Annex at left.

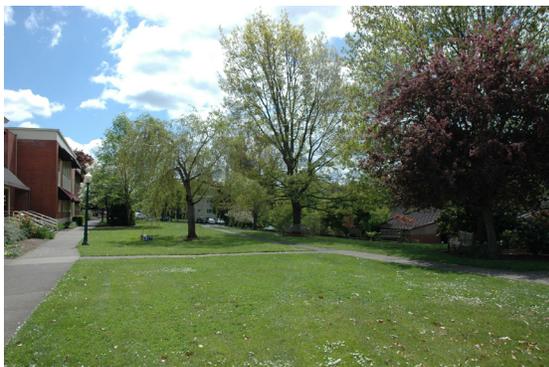
Looking further south down the Axis, with the Music Building at left.

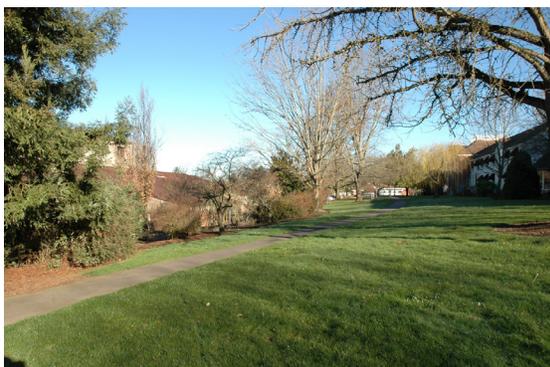
Looking north from 18th Avenue, with the Clinical Services Building at left and the Music Building at right.

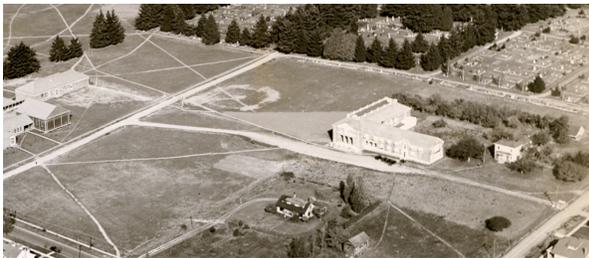
1928 aerial looking northwest, showing the rather casual nature of the Axis at that time.

During this era the university built both the Music Building and the Education Building. These buildings were removed from the rest of campus because of a request by the faculty to be far from the train tracks. By the end of the era the Axis appears to be a dirt path that connected the Education Building to the Music Building, traversing a large open field. This connection was solidified by the line of Crimson King Norway maples on the east side of the Axis. Next to the Music Building the path was made of concrete and extended to 18th Avenue. During this time an entry road connected to 18th Avenue and met a crescent-shaped turn around at the Music Building's west entrance. From here the road continued north to 16th Avenue, eventually connecting to the Pioneer Cemetery. A few small trees reinforced the east edge of the Axis.

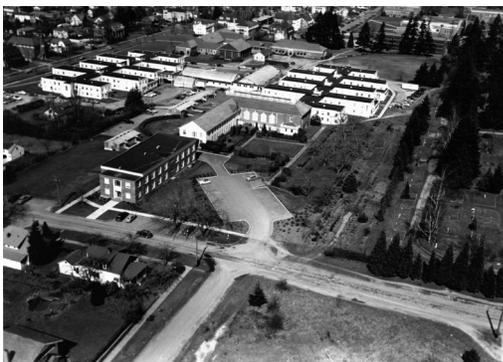
1951 aerial looking roughly north, showing the Veterans Dorms.

In 1946, two wood frame buildings housing 752 men along with a Quonset hut dining hall were moved onto the west and east side of the Axis, immediately north of the Music Building. These buildings dramatically altered the Southwest Campus Axis and the Southwest Campus Green. The dining hall was removed in 1952 and the Veteran's Dorms I and II were demolished in 1970 and 1962, respectively. These sites were converted into parking and tennis courts. The south addition to the Music Building in 1948 replaced trees that previously lined the Axis. Also by the end of the era, the entry drive from 18th avenue had been replaced by an open lawn.

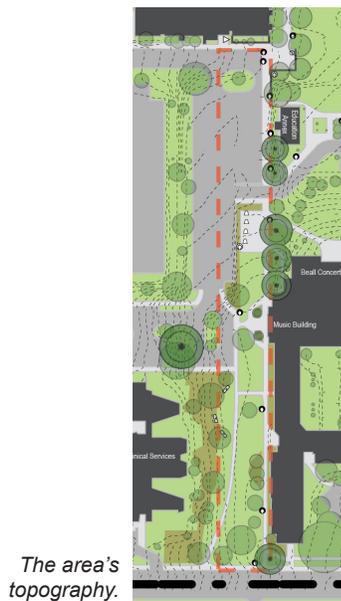
The area's topography.

The Axis rises gently from the Education building to the main west entrance of Beall Hall (see diagram below). At this point the grade flattens out until it connects to 18th Street. A cross slope angling down to the west is discernible along the entire length of the axis.

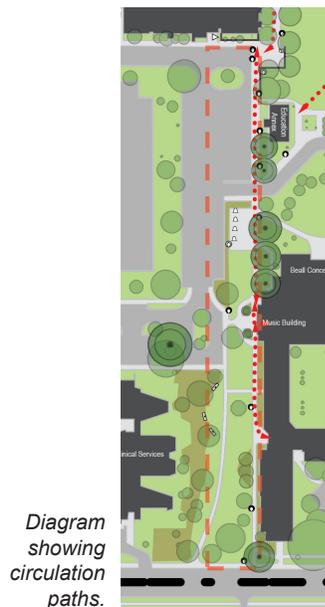
Diagram showing circulation paths.

The Southwest Campus Axis provides pedestrian and bicycle access between 18th Avenue and the main campus (see diagram, pg. 6). The paths are constructed of asphalt and concrete. The south end of the Axis at 18th Avenue is an important pedestrian gateway and entry to the campus. The area also has connections to Alder Street that serve as informal entries to the campus. Vehicular parking is accessible in the northwest portion of the Axis.

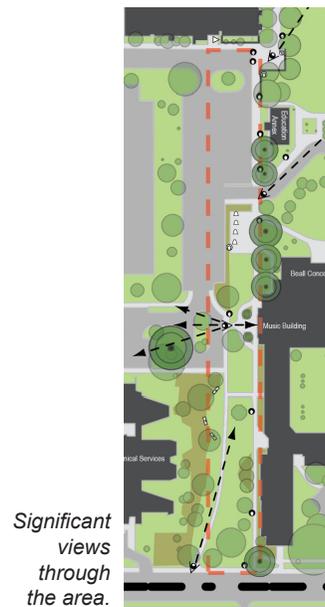
Significant views through the area.

There are long yet poorly-defined views that run north/south in alignment with the Axis (see diagram, pg. 6). From the southern portion of the Axis there is a picturesque westerly view of the south façade of the 1994 addition to the Knight Library, the conifer lined western edge of the Pioneer Cemetery, and the open lawn that is the Southwest Campus Green.
