# MCMORRAN HOUSE PRELIMINARY HISTORIC ASSESSMENT

University of Oregon  
Campus Planning  
Campus Planning and Facilities Management

March 2022

## PRELIMINARY HISTORIC ASSESSMENT

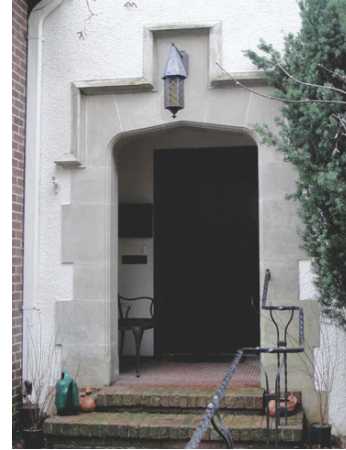
- Prominent front (North) facade
- Steeply-pitched roof and prominent cross gables
- Massive chimneys with decorative brickwork
- Dominant, elaborate front entrance
- Semi-hexagonal oriel window
- Multi-paned casement windows with lead comes

McMorran House, North Entry, 2009

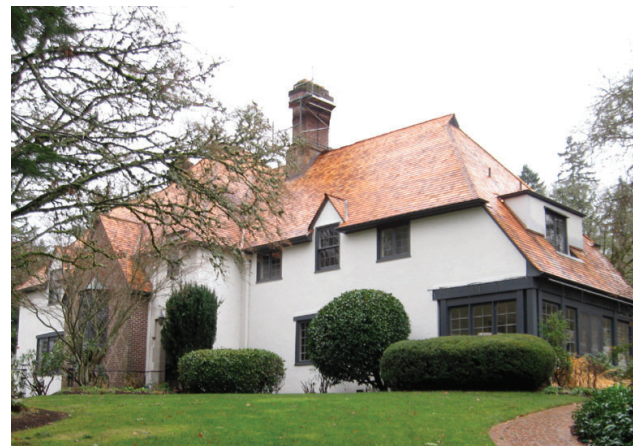
McMorran House, North Elevation, 2009

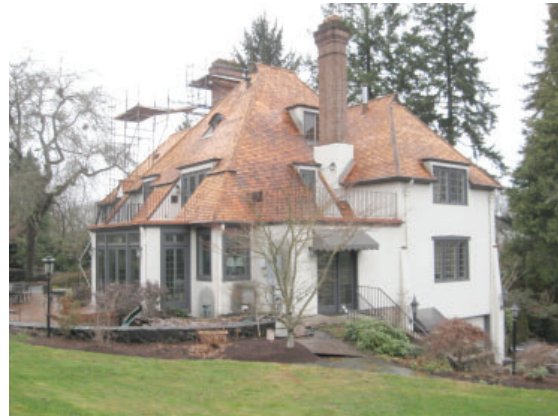
- Steeply-pitched roof and prominent cross gables
- Massive chimneys with decorative brickwork
- Multi-paned casement windows with lead comes

McMorrان House, East Elevation, 2009

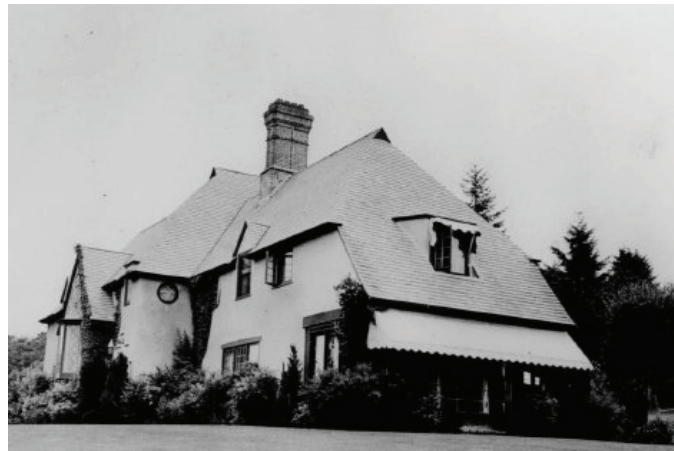
McMorrان House, West Elevation, 2009

- Steeply-pitched roof and prominent cross gables
- Massive chimneys with decorative brickwork
- Multi-paned casement windows with lead comes

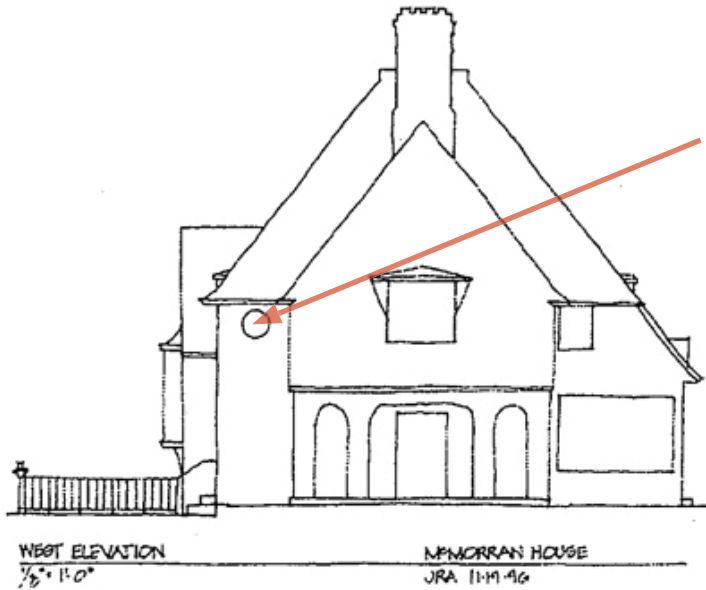
1996 - West Elevation showing a circular window, which is missing from more recent photographs. (Image courtesy of Cindy Cords, Office of the President.)

In addition, the second floor hall bathroom was remodeled around this time (1998?) and the small round window was plastered over.

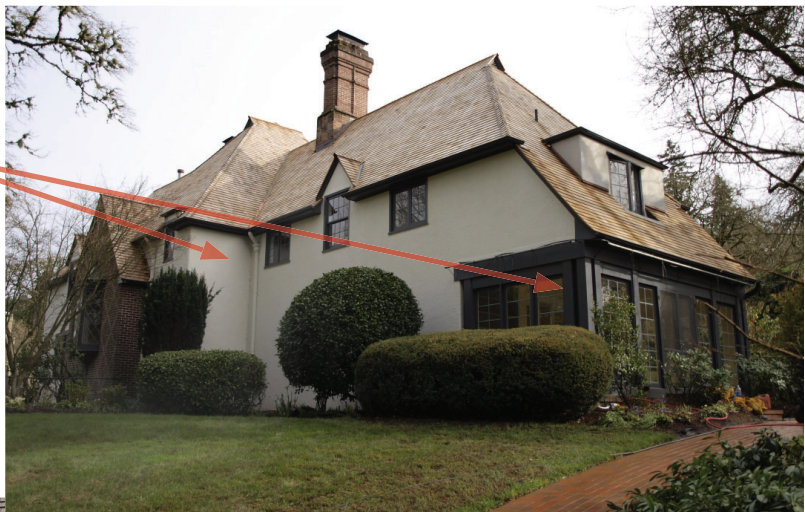
2009 - North/West facade showing circular window missing and living porch is enclosed (date unknown).

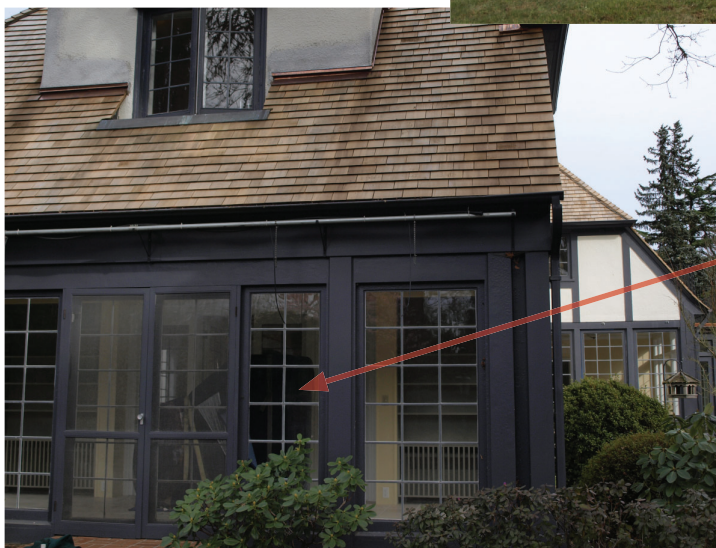
2009 - West facade showing enclosed living porch (date unknown).

2005: The west-facing sunroom was altered (new ceiling, posts, and other work), and the house radiators were boxed in.

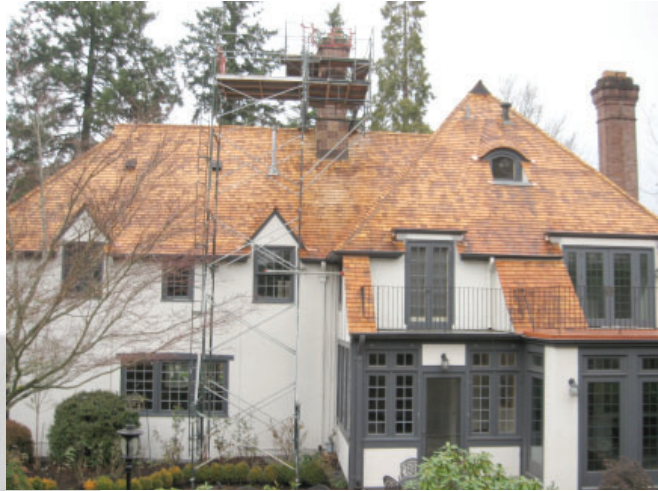
McMorrان House, South Elevation, 2009

- Steeply-pitched roof and prominent cross gables
- Massive chimneys with decorative brickwork
- Multi-paned casement windows with lead comes

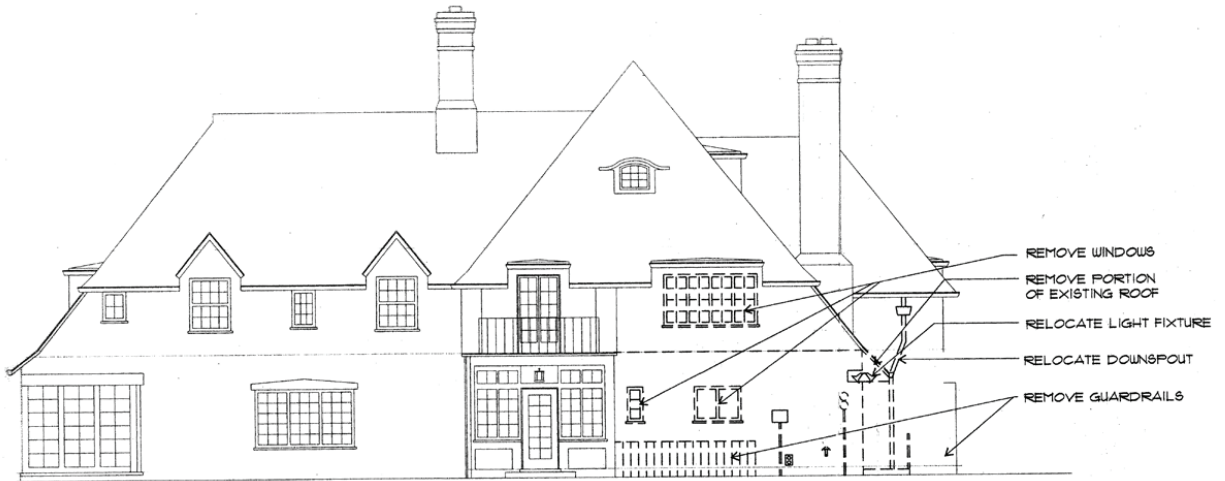
South Elevation Demolitions

Construction drawings showing 1998 remodel / alterations

- The master bedroom and bathroom were expanded to encompass the sleeping porch. Three of the original sleeping porch casement windows were replaced, the stucco was patched, and a new wrought-iron guardrail was added to match the existing one when the roof line on the southeast corner was lowered.

- The original kitchen windows and guardrail on the first floor of the south elevation were removed to accommodate the expansion of the kitchen, and three new windows and doors were added to match those that remained.

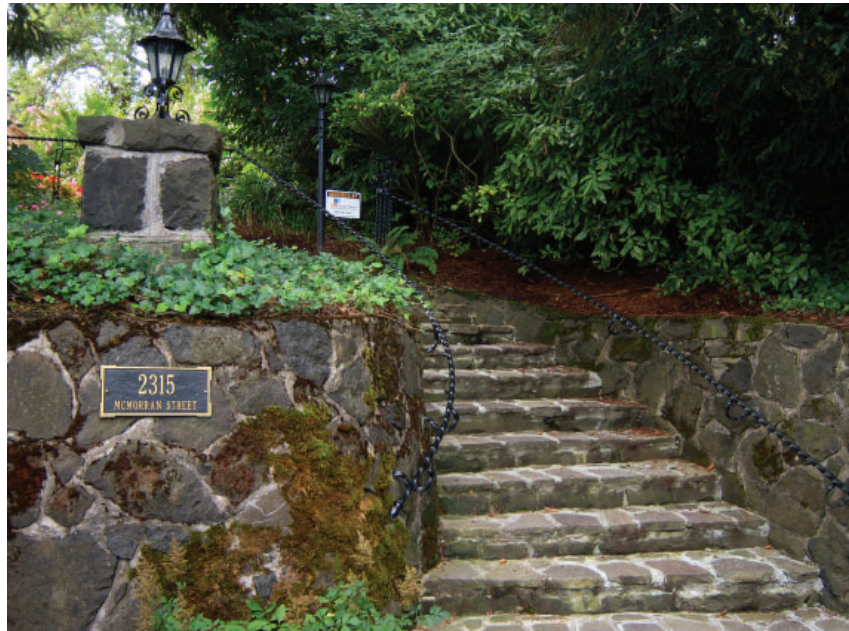
- Basalt wall, steps, and pillars
- Brick walkway
- Iron handrails and baskets

Original basalt steps on the edge of the front (north) garden (2009)

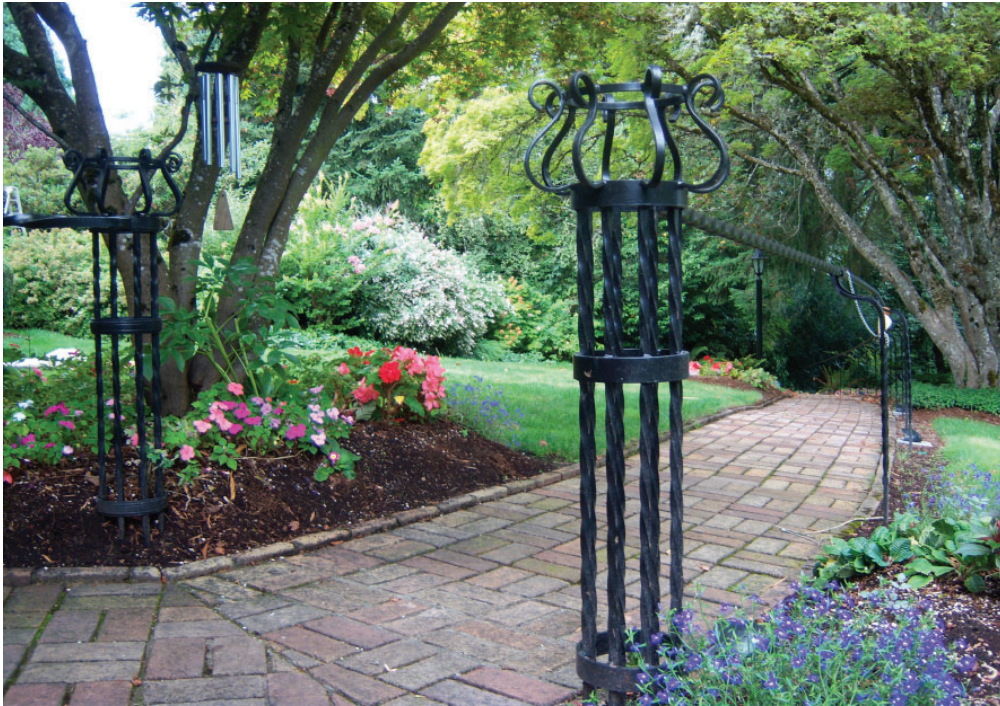
Original walkway and ironwork in the front garden (2009)

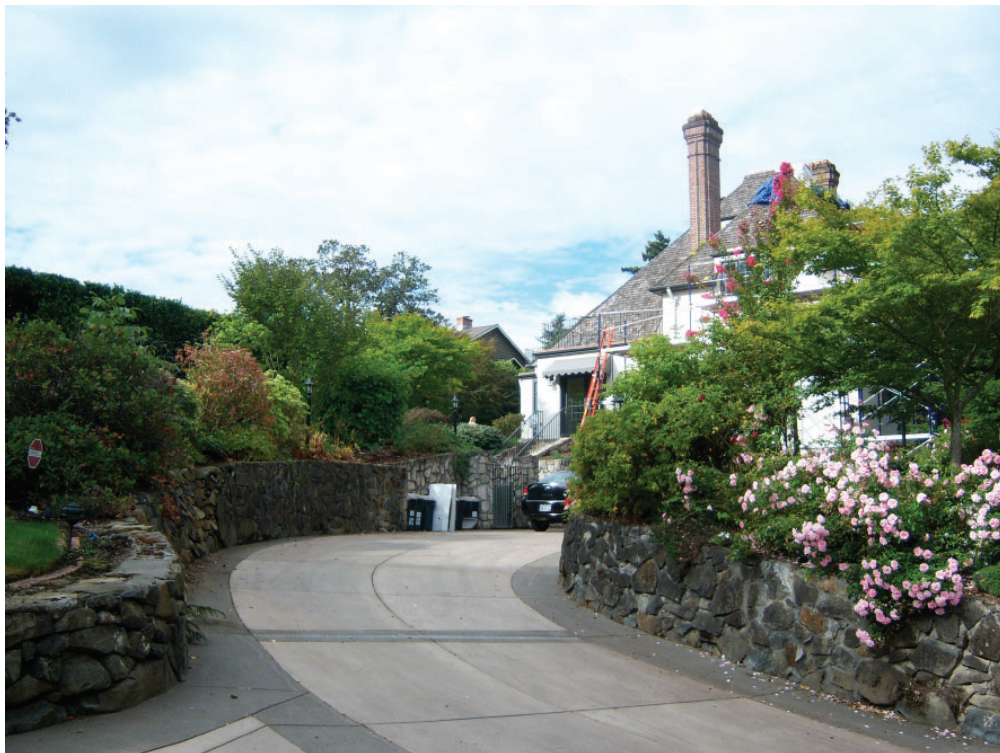
Driveway on the east with parts of the original basalt wall (2009)

2018: Section of the north basalt wall was planned to be replaced by Allen Ash. Intent was to sequentially replace the mortared basalt wall with a more long-lived (likely originally intended) dry-stack wall as the need arose. (Allen Ash replaced many dry stack walls around the Fairmount Neighborhood and is an experienced, renowned stone mason with a specialty in dry-stack walls.)

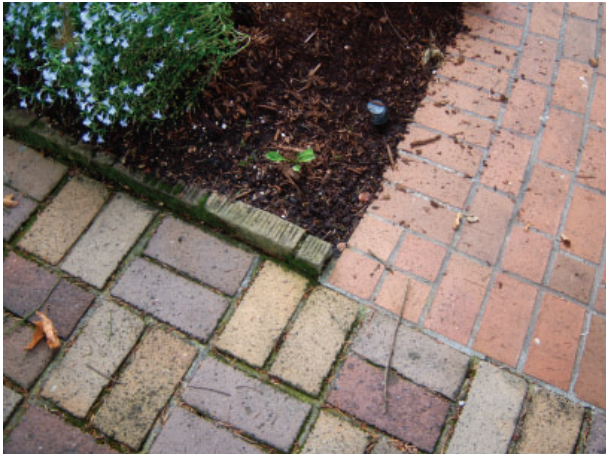
Juncture of Old / New Brick Paths (2009)

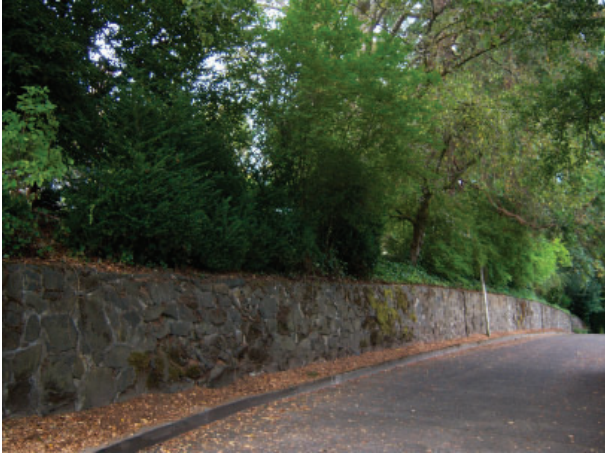
Exterior Basalt Wall (2009)

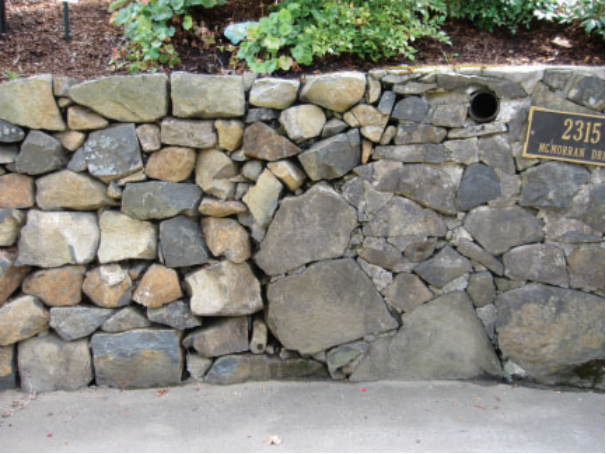
Old / New Basalt Wall (2009)

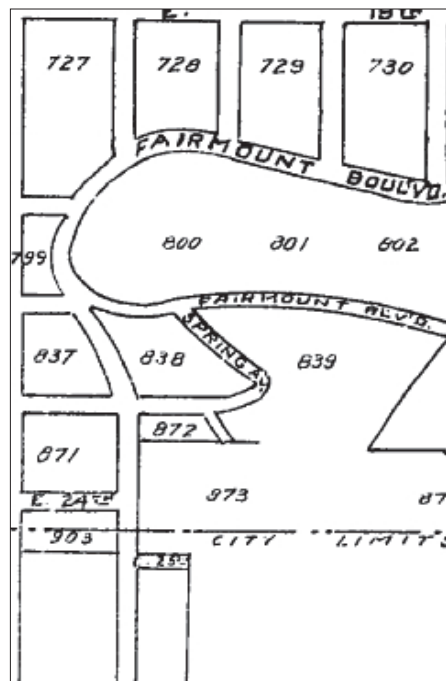
1912 Sanborn Map - Fairmount Loop

The Sanborn map from 1912 shows the properties inside the Fairmount Boulevard loop without any formal subdivisions.

These properties were owned by fruit growers; orchards occupied the land that was later built upon. One apple tree at the east end of the McMorrans House property was the only remnant of the original Gravenstein apple orchard that was on the property (see site plan - p. 9). Unfortunately this tree was removed in 2005 due to disease.

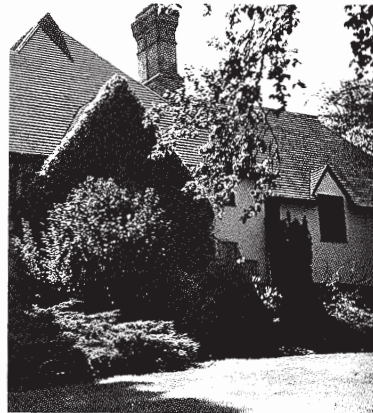
**6 McMORRAN HOUSE c. 1925**  
**2315 McMorran Street**  
**Roscoe Hemenway, architect**

Now owned by the University of Oregon as a residence for its president, this imposing house combines several features of the Norman Farmhouse and English Tudor styles in its steep hip roofs, leaded glass, cut-stone entrance and the brick patterns of its front walls and chimneys.

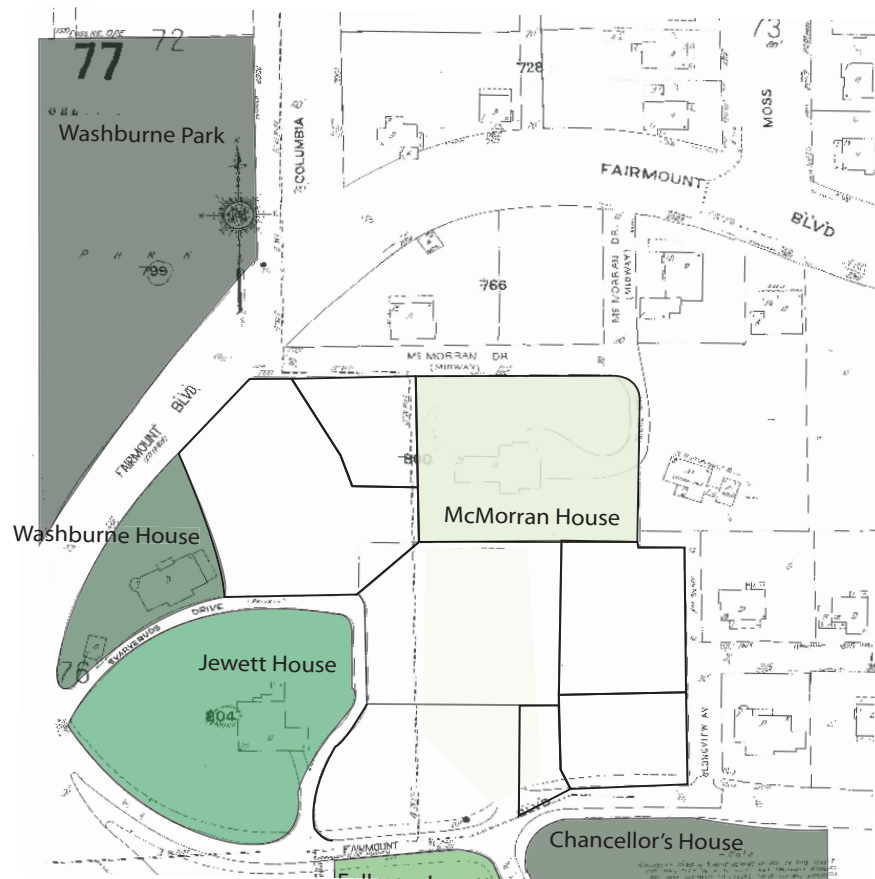
1962 - Sanborn Map (1925 - 62) - Fairmount Loop  
(with overlay showing existing conditions)

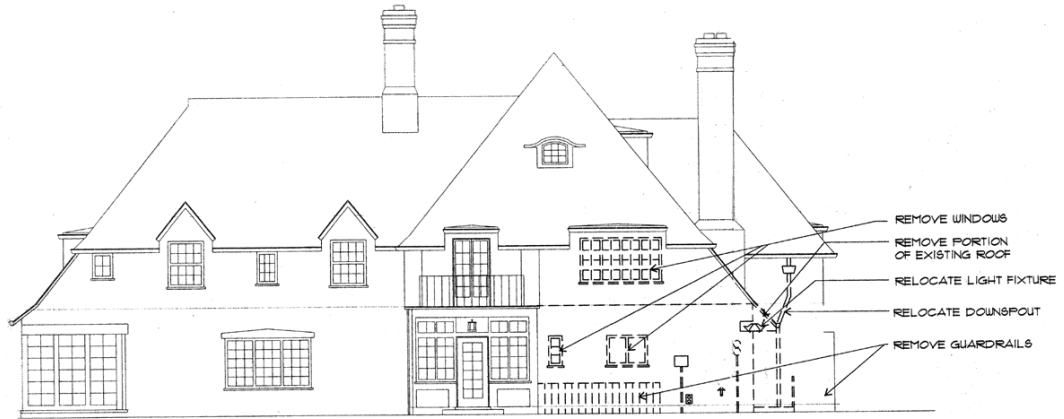
South Elevation Demolitions

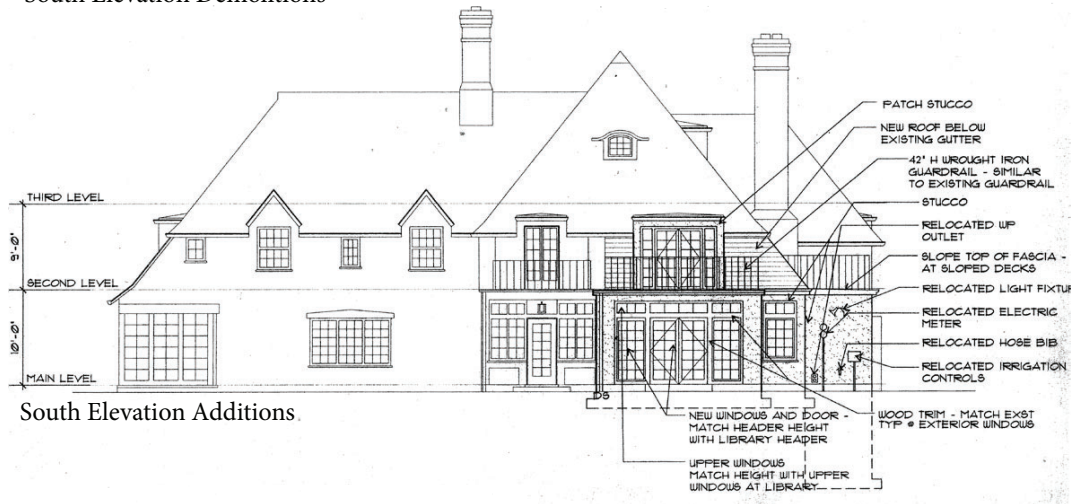
South Elevation Additions
