UNIVERSITY OF OREGON

FRIENDLY HALL ASSESSMENT

FACILITIES ASSESSMENT & FEASIBILITY STUDY

MARCH 2022

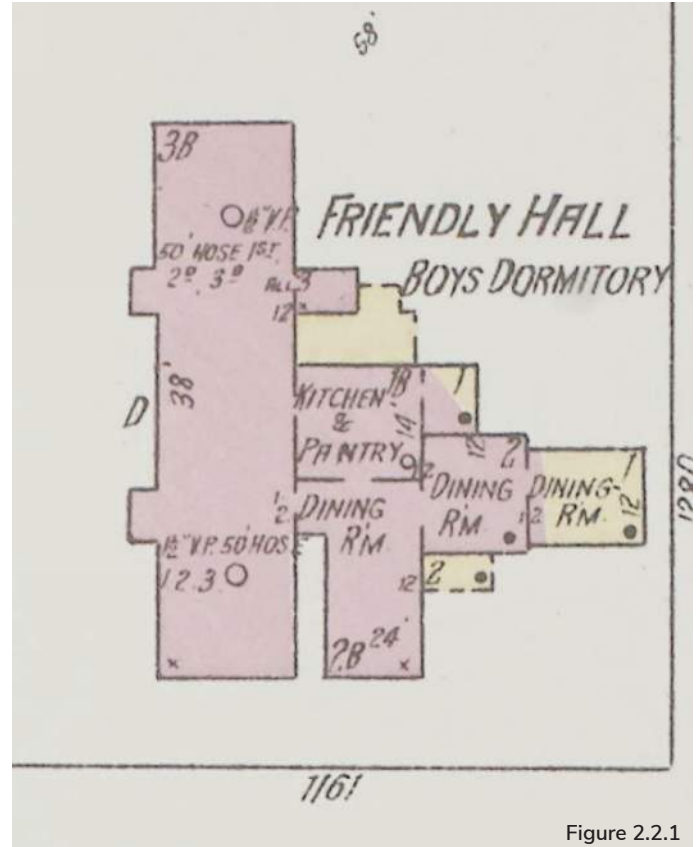
Figure 2.2.1

Another temporary addition was completed in 1920, though there is minimal documentation of the work. The *Daily Emerald* describes the project as "a one-story frame annex 30x30 feet... at a cost of \$1500, it will provide added dining room space." The only drawing that exists is a 1925 Sanborn Map Company fire insurance survey (figure 2.2.1). Reports indicate that this portion of the building was demolished in 1951.

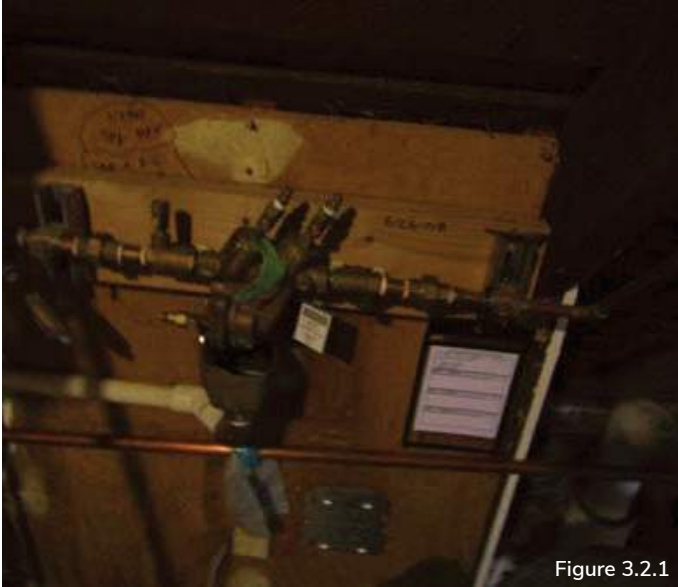
Figure 3.2.1

Friendly Hall is served by an existing 2-inch domestic water line entering the building on the west side. This service has backflow prevention. A 6-inch fire protection service with backflow prevention (figure 3.2.1) enters the building on the south side and connects to the an existing 8-inch EWEB main at 13th Avenue. There

is a wall mounted fire department connection (FDC) on the western wall in the south west corner of the building. The water supply piping is a mix of copper and galvanized steel pipes.

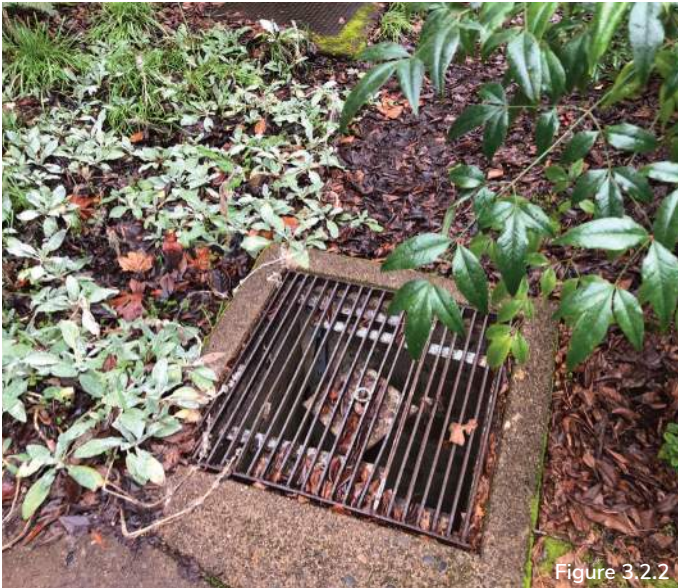
Figure 3.2.2

Stormwater runoff from the landscaped areas is collected by area drains (figure 3.2.2) around the site and brought south to 13th Street or north to an 8-inch main south of Allen Hall. The line running north is considered to be close to capacity and requires a pump station at the southeast corner of Allen Hall to send it north to campus storm lines that eventually outfall into the Millrace. Building roof drains are brought down to the ground floor where they connect to the same storm drain systems running both south and north. Existing storm drainage is not treated to current City of Eugene or University of Oregon stormwater management standards. Roof and site drainage are both piped directly into campus storm piping without water quality treatment or peak flow control.

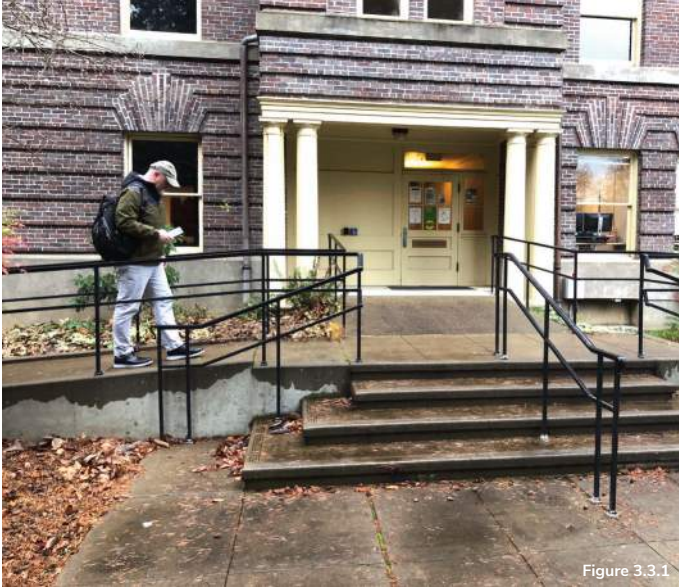
Figure 3.3.1

The exterior circulation surrounding and accessing Friendly Hall is generally in good condition. Presently, Entry 101 (figure 3.3.1) is the only accessible means of ingress. An ADA ramp was previously added in a historically appropriate manner. Two entries to the basement were added on the west facade (figure 3.3.2 shows Entry 005). They are redundant means of egress and damaging to the historic character.

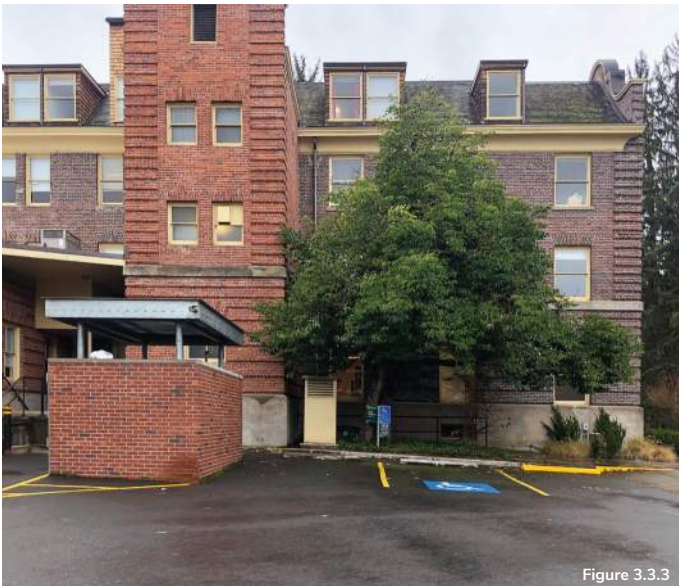
Figure 3.3.3

The parking lot to the northeast of the site (figure 3.3.3) and the driveway which provides vehicular access are in good condition, though underutilized. There are multiple reserved permit spots and one ADA parking spot. While provided, the current accessible parking space exceeds

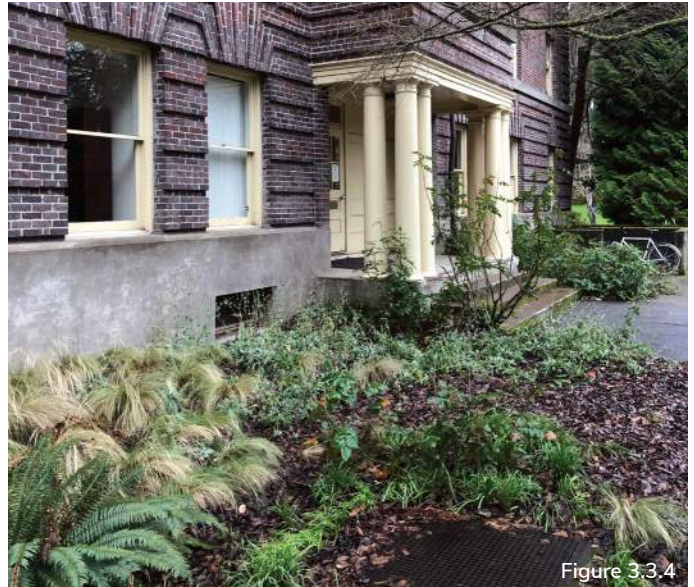
Figure 3.3.4

Friendly Hall's landscape is a mixture of mature trees, foundation plantings which have been heavily pruned, small garden areas as highlights, and extensive groundcover or bare planting beds (figure 3.3.4). The majority of the landscape is congruent with University standards, but there are opportunities to improve the landscape making it more compatible with the surrounding campus. In addition to their aesthetic appeal, plantings should be selected to better fit the scale of their site to reduce pruning and overgrowing their space, they should be selected for low water use and resilience to increasingly hot summers and should be selected to support pollinators and bird populations. Plantings that are too large for their site obstruct views creating conditions that both feel unsafe and present security risks as well as create wayfinding challenges by obstructing signs. Additionally, these overgrown plantings require additional maintenance. It is assumed that new landscape areas will have irrigation installed.

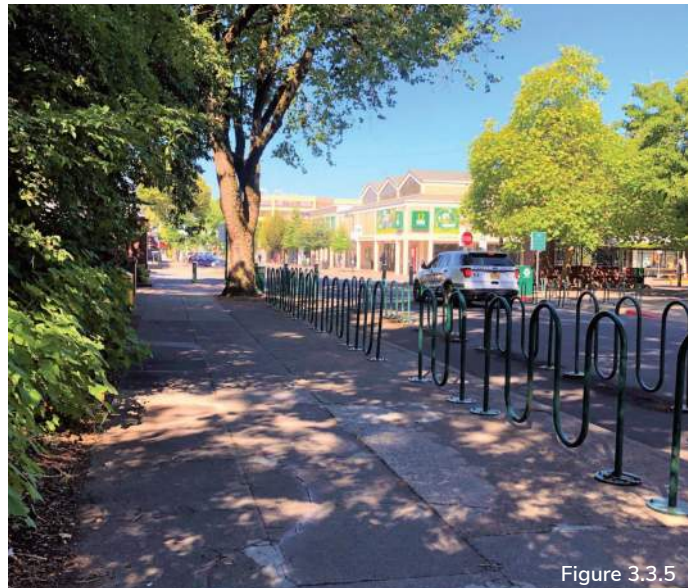
Figure 3.3.5

Presently, two locations exist for bicycle parking. The first is to the north and consists of multiple racks and two canopies. The second location is to the south where bike racks have been installed along 13th Avenue (figure 3.3.5). These racks are sometimes removed for events.

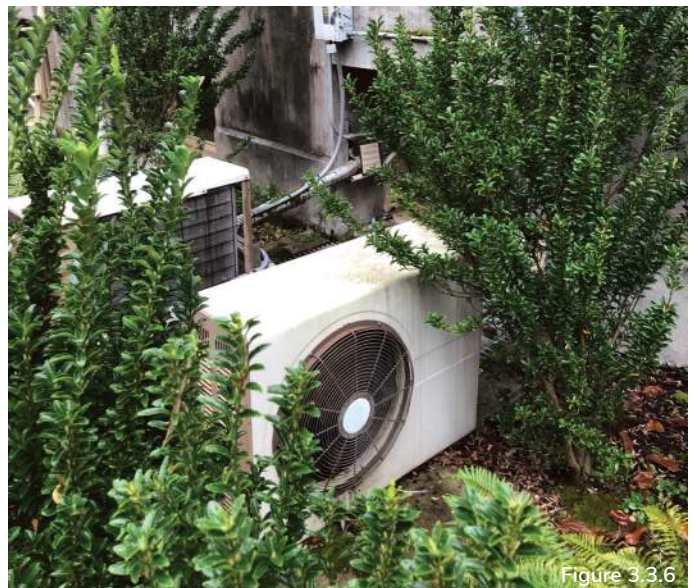
Figure 3.3.6

There are multiple dedicated mechanical units which have been placed on concrete pads outside of the building due to past renovations (figure 3.3.6). These systems do not conform to University standards. There also exist auxiliary enclosure towers for mechanical exhaust from the basement.

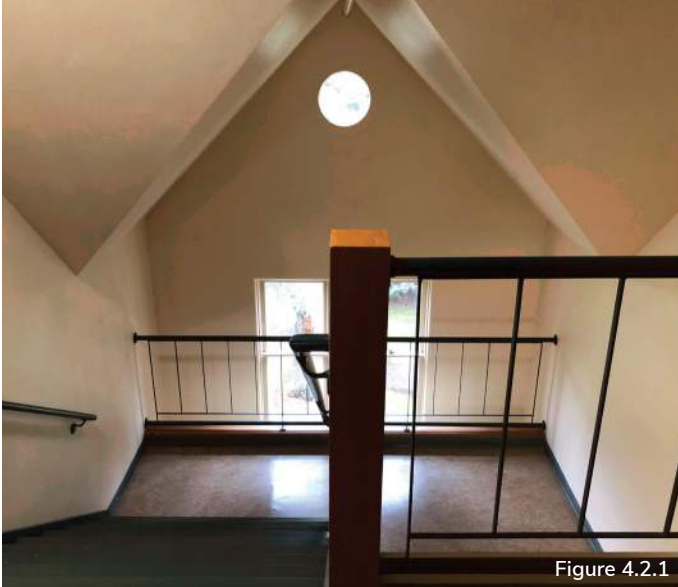
Figure 4.2.1

The building currently has three interior stairways: the two interior stairs in the 1893 West Wing (figure 4.2.1) and the interior stair in the 1914 east extension (figure 4.2.2). The West Wing stairways have fire rated enclosures with fire doors from the adjoining corridors, but non-compliant head height conditions exist and the handrails do not have compliant extensions at the landings. These stairs let out to Entry 101 and 108 which provide egress via an elevated concrete platform with stairs to the Old Campus Quad. Entry 101 has compliant exterior handrails while Entry 108 does not. The 1914 east extension stairway does not have a fire rated enclosure and lacks compliant handrails as well.

- The existing West Wing stairs should be improved to conform to requirements for head heights, handrail configuration and fire rated enclosures.
- The interior stair of the 1914 East Wing Extension will require compliant handrails, egress doors to the exterior and an enclosure with a 1-hour rated assembly including conditions where doors open directly into the stairwell.
- The exterior stair which accesses Entry 201 can be removed once the interior stairs are made code compliant. Its removal will improve the historic appearance of the building.
- Exterior stairs including basement access stairs and stairs to the elevated entries on the first floor should be equipped with code compliant handrails and guardrails

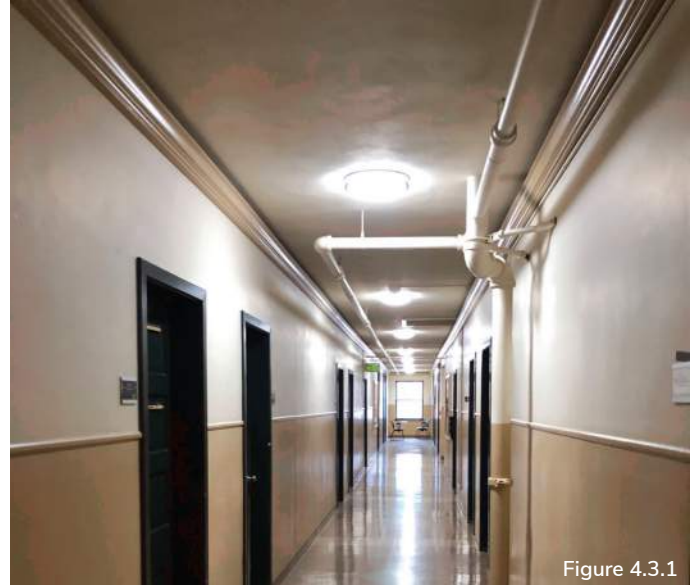
Figure 4.3.1

All interior spaces are protected by a wet-pipe fire suppression system equipped with fusible link sprinklers for water dispersion. Plumbing serving the sprinklers exists below the plane of the ceiling (figure 4.3.1). The fire suppression system has flow and tamper switches tied to the fire alarm system. The current fire suppression system is satisfactory and no upgrade is required.

- The removal and reconfiguration of all the interior partitions during the required structural upgrade will necessitate reconfiguration of the existing system.
- The renovation will allow existing ceiling mounted sprinkler lines to be concealed above the ceiling to create a more appealing and appropriate interior aesthetic.
- The renovation will afford an opportunity to move standpipes to the interior of the building thereby improving the appearance of the building and preserving its historic character.

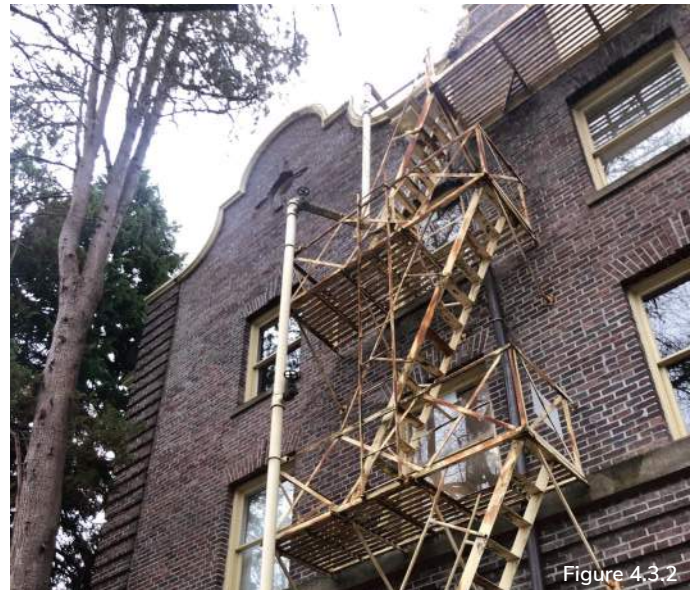
Figure 4.3.2

The existing fire system standpipe runs along the exterior in various locations, including the existing fire escapes (figure 4.3.2). This is damaging to the historic appearance of Friendly Hall.

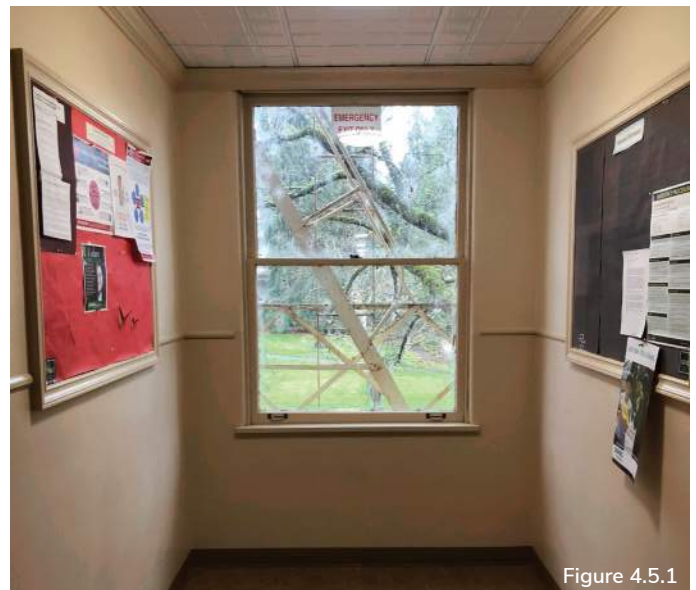
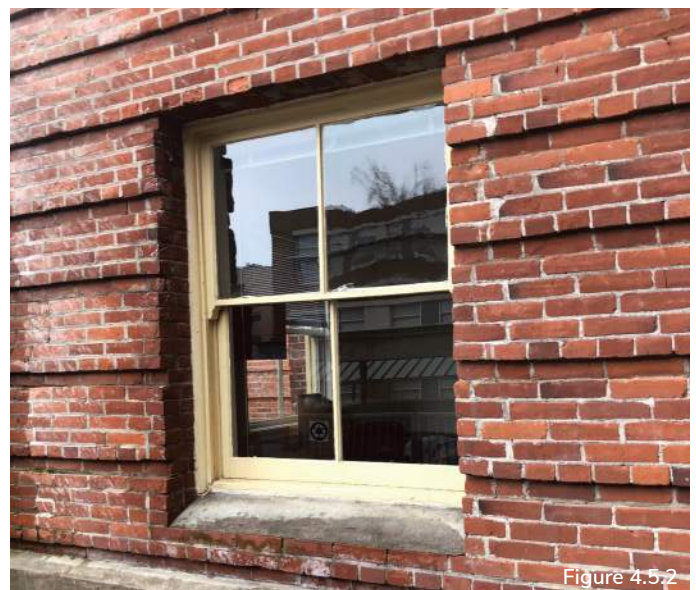
Friendly Hall does not presently satisfy the 2021 Oregon Efficiency Specialty Code (OEESC) requirements nor does it meet energy efficiency goals of the University. Although the documentation is limited, based on familiarity with buildings of the period it is unlikely that the original 1893 building and the subsequent additions have insulation between the load-bearing brick walls and the lath and plaster interior wall finish. The wood double hung windows are single pane throughout (figure 4.5.1-2).

In the absence of interior insulation and vapor barriers, the brick and interior plaster of the load bearing masonry walls have been drying to both the inside and exterior. Adding insulation to the interior surfaces could potentially alter the manner in which moisture moves through the wall assembly. Reduced drying, particularly on the north face, could result in accelerated degradation of the brick.

- Installation of stud walls will require alternation to the jambs of the existing windows. Interior jamb extensions will be required to compensate for the increased wall thickness.
- Reroofed areas of the building will include the addition of R30 rigid insulation above the roof deck.
- The original wood double hung windows should have storm windows applied that improve energy performance with minimal impact to the appearance of the window. Recent projects at the University have utilized the SLIP system for applied storm windows.

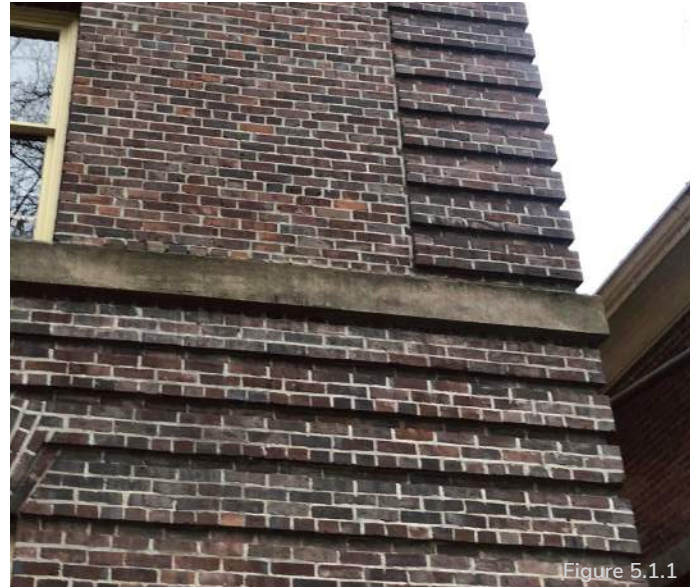
Figure 5.1.1

The exterior walls of Friendly Hall indicate the original structure and its two major additions. All three major constructs use an American or Common bond. A dark brick is used on the original portion (figure 5.1.1), while the additions are clad with a red brick (figure 5.1.2). The 1914 addition on the east also has a different coursing pattern than the other two constructs (figure 5.1.3). The face brick is embellished with quoins, jack arches, and rusticated reveals on the first floor.

The face brick appears intact and in good condition, with limited examples of damage or spalling. A visual inspection showed no indication of rising damp.

- The exterior masonry should be maintained.
- During the proposed seismic upgrade, interior faces of the brick walls will be exposed and additional inspection and testing should be performed.
- All brick, mortar or concrete elements should be cleaned with hot water and brushed where required following best practices for maintenance of historic brick facades.
- Areas of mortar deterioration and cracking should be identified and repointed.
 - o All deteriorated mortar joints should be ground using the appropriate grinder profile back to sound material prior to repointing.
 - o New mortar shall match the existing in color, texture, composition, and tooling profile. It is recommended that several small test areas be reviewed for visual match prior to commencing with larger areas of repointing.

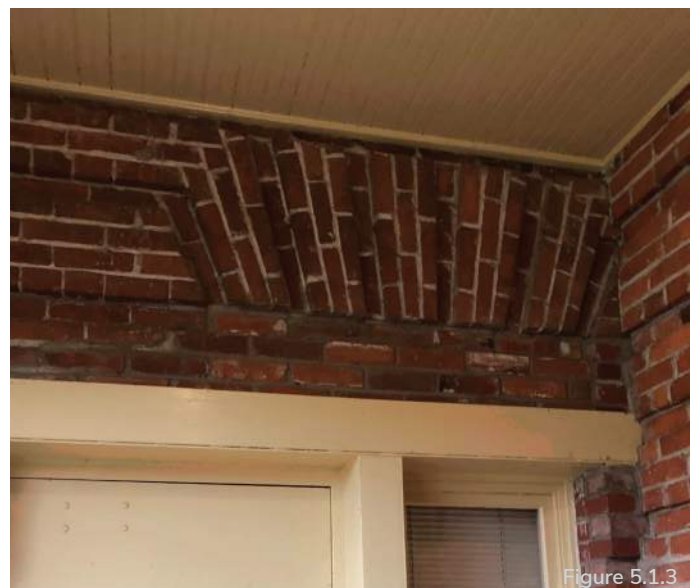
Figure 5.1.3

Mortar joints are generally intact and in good condition. There are some areas of previous repointing that are an inadequate match to the historic mortar color and texture (figure 5.1.3) which should be replaced.

- Brick that is fractured, chipped, or spalling should be removed and replaced with brick that matches the original size, shape, color, and texture.
- The south exit stair should be removed and the underlying brick should be repaired to restore the historic appearance.

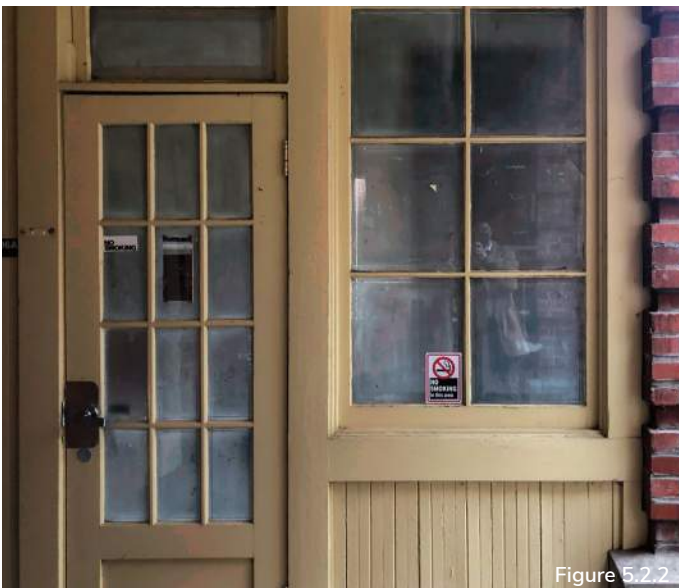
Figure 5.2.2

The wood trim is an important character defining feature around the exterior of the building. It is used as accents and detailed ornament. In some locations, it has experienced water damage, but no significant structural damage or rot was observed. Wood elements include

- Columns, capitals, and entablatures at the west facade entries (figure 5.2.1).
- Decorative wood paneling at exterior entries (figure 5.2.2)
- A decorative cornice at the underside of roof overhangs.

- At areas with visible wear or water damage, wood elements should be refinished and restored, if possible.
 - If restoration is not possible, matching historic elements should be used as replacements.
- Paint analysis should be performed to determine the original color.

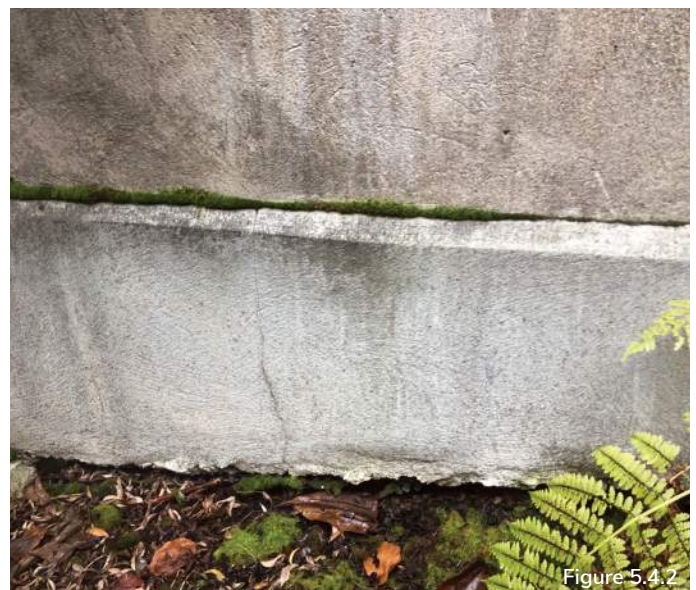
Figure 5.4.2

Building occupants noted that there have been instances of water leakage in the basement floor of the West Wing. Such water intrusion is not unexpected given the age of the building and the limited options for below grade waterproofing available during its construction.

During a walkthrough, areas of organic growth and superficial cracking were observed (figure 5.4.1-2).

Water leakage through the basement or foundation walls can be remediated via two approaches, positive side and negative side remediation.

- Positive Side: A membrane system placed on the exterior face of the structural foundation system.
 - o The highest level of protection would be afforded by excavating the entire perimeter of the building to expose the foundation walls. The exterior wall surfaces would be cleaned, and a new waterproofing membrane would be installed along with new subgrade drainage.
 - o The lowering of the basement floor will necessitate perimeter excavation providing an opportunity for positive side waterproofing treatments.
- Negative Side: A treatment on the interior surfaces of the foundation system.
- Exposed concrete on other exterior areas should be cleaned as necessary.

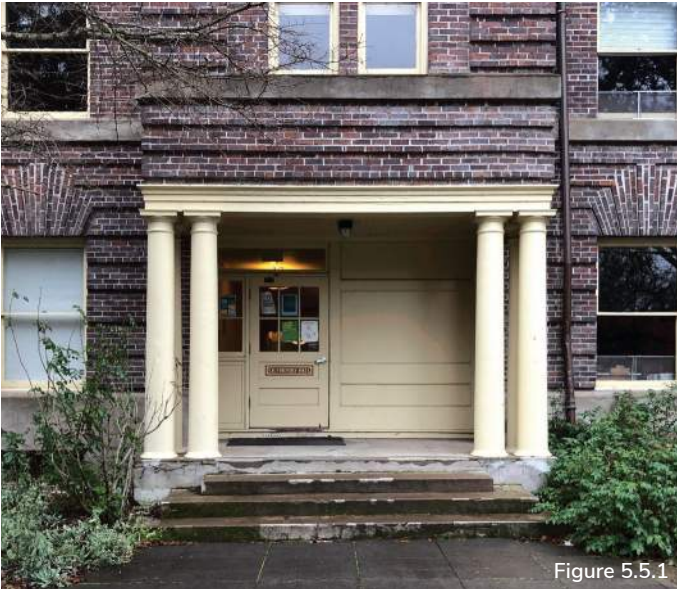
Figure 5.5.1

Generally, the historic exterior doors on the building have been maintained and are functionally adequate (figure 5.5.1). Some have experienced slight aesthetic deterioration which is expected on elements of this age. At exterior basement entries, character compromising doors were installed at some point during previous renovations (figure 5.5.2).

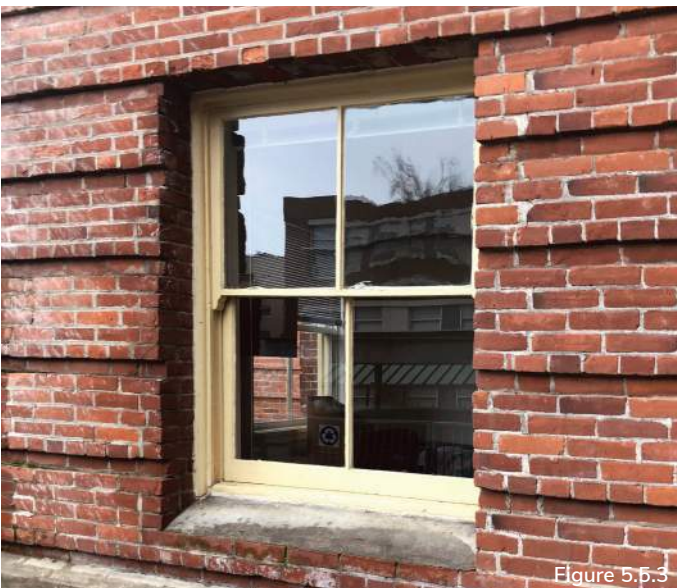
Figure 5.5.3

The exterior windows on Friendly Hall are generally in good condition (figure 5.5.3). A restoration of all exterior windows was performed by Soderstrom Architects in 2009 so areas of paint or wood deterioration are limited. However, the existing single pane vision glass does not provide adequate environmental performance.

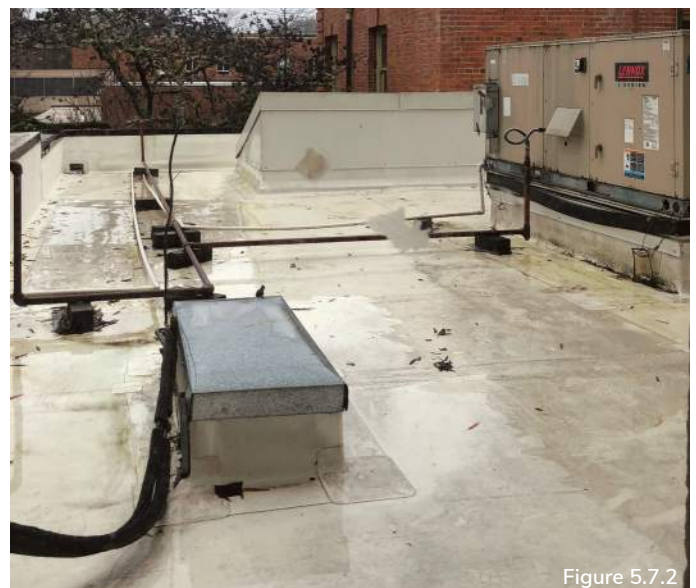
Figure 5.7.2

The existing roofing consists of TPO membrane at low-slope conditions (figure 5.7.2) and wood shingle roofing at the remaining areas. Both types of roofing were fully replaced in 2009 and are generally in good condition with about half of their expected lifespan remaining.

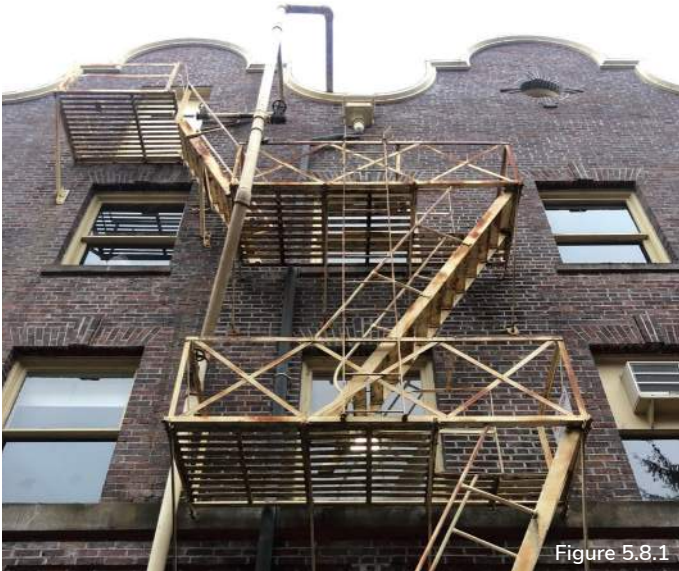
Figure 5.8.1

The historic fire escapes at the north and south facades of the building have aged and deteriorated substantially (figure 5.8.1). There are also instances of deformation near the ground level.

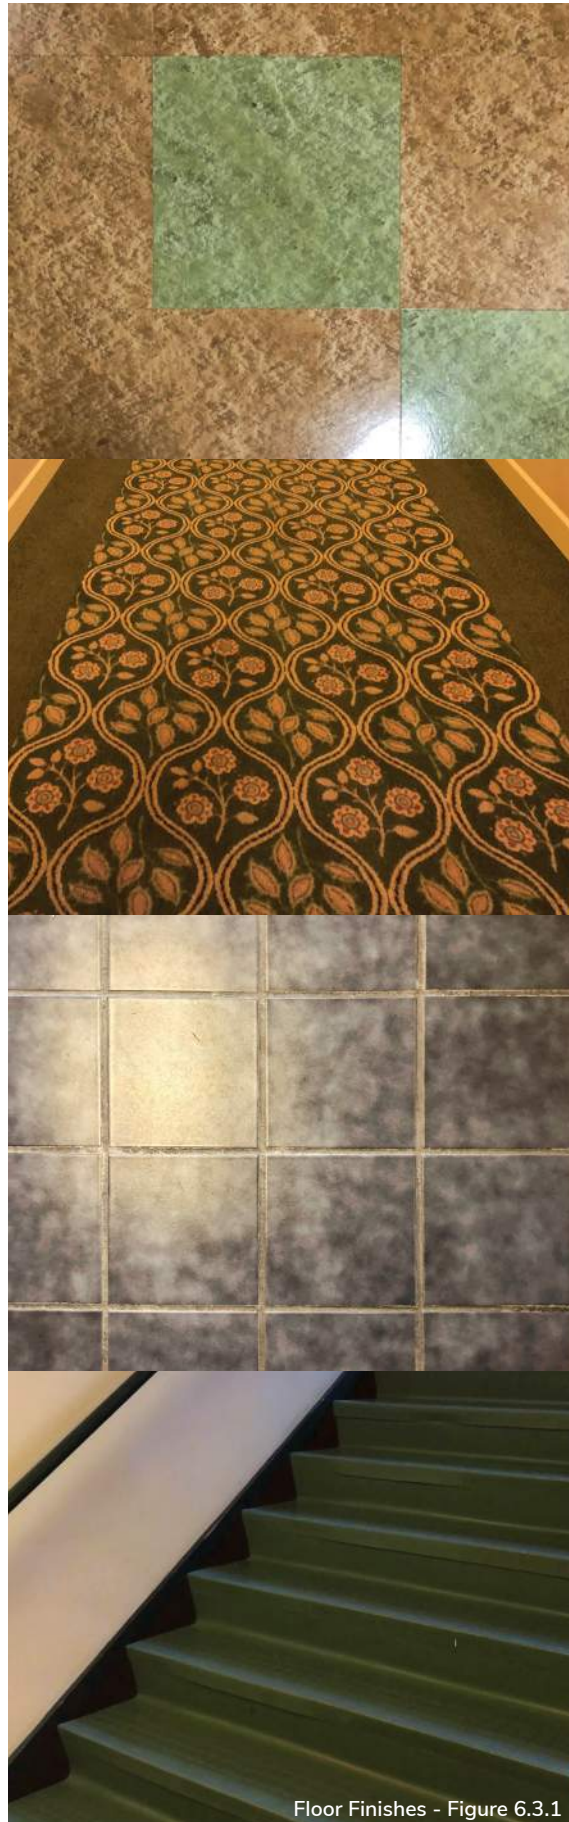
Floor Finishes - Figure 6.3.1

- o Flooring finishes are non-continuous and, in many instances, disruptive to the historic character (figure 6.3.1).
 - o Ceilings have been installed at different points in the building's history resulting in inconsistent appearances (figure 6.3.2).

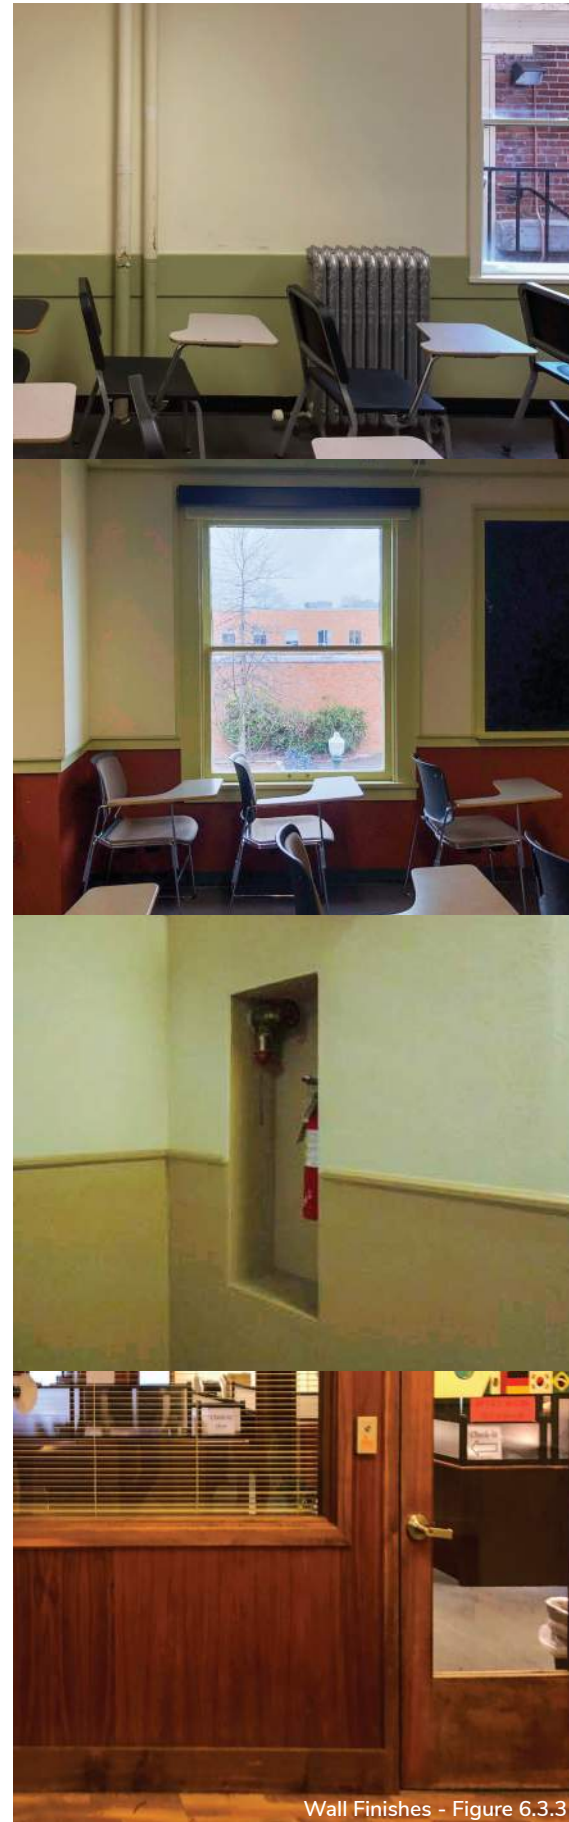
Wall Finishes - Figure 6.3.3

- o Wall finishes (including wall material, texture, color, bases, moldings, and wainscoting) have been applied haphazardly due to previous renovations (figure 6.3.3).

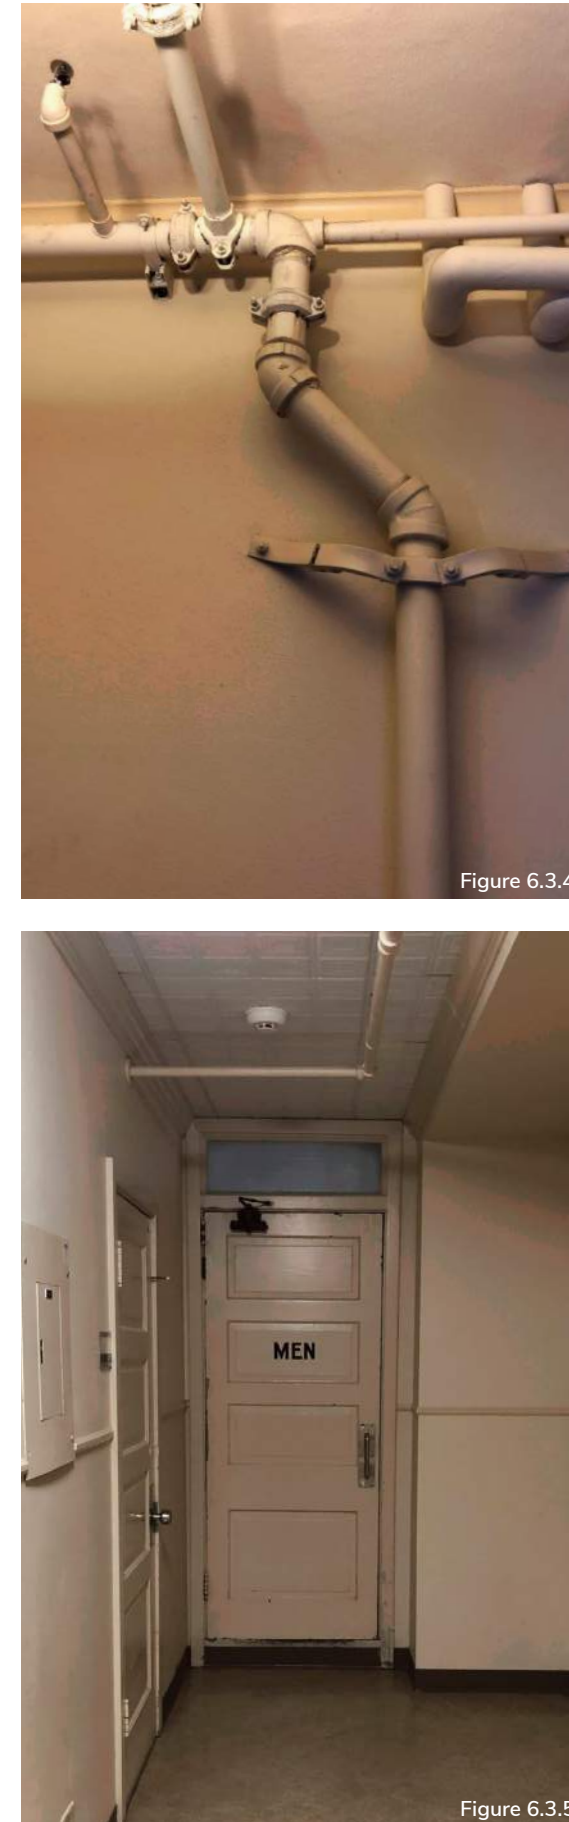
Figure 6.3.4

- The original design did not account for modern building systems such as fire sprinklers, ventilation air registers, electrical conduit, and plumbing components (figure 6.3.4).

- The construction of new partitions and ceilings will allow building systems (fire sprinklers, ventilation air registers, electrical conduit and plumbing components) to be properly concealed.

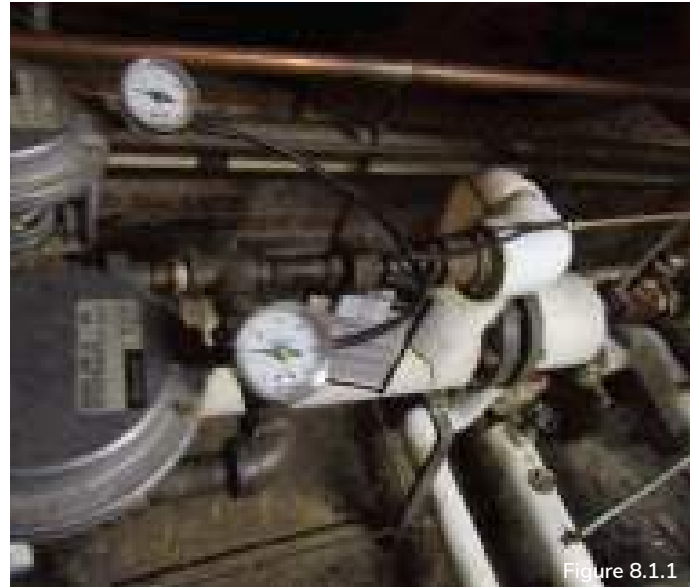
Figure 8.1.1

The heating media is provided by a central steam loop. A heat-exchanger (figure 8.1.1) covers the steam energy to heating hot water. An expansion tank and two condensate return systems (figure 8.1.2) support the heating system, and pump equipment distribute the heating hot water. Two indoor air handling units with hot water coils provided tempered air to the corridors. Distribution equipment consists of metal ductwork. Controls are a hybrid configuration with pneumatic and digital inputs, and a local compressor provided control air (figure 8.1.3). Permitter radiators support the system and utilize the heating hot water. Rooftop package units (figure 8.1.4), ductless split systems (figure 8.1.5), an indoor Trane split system, and window air conditioning units (figure 8.1.6) serve select rooms provide either heating, cooling, or both. An inline centrifugal fan, utility set fans and propeller fans (figure 8.1.7-9) serve smoke exhaust, restrooms, and general exhaust needs. The HVAC system varies in age and appears in adequate condition, but most of the equipment is at or near the end of its lifecycle and should be replaced to improve performance and energy efficiency and to reduce maintenance.

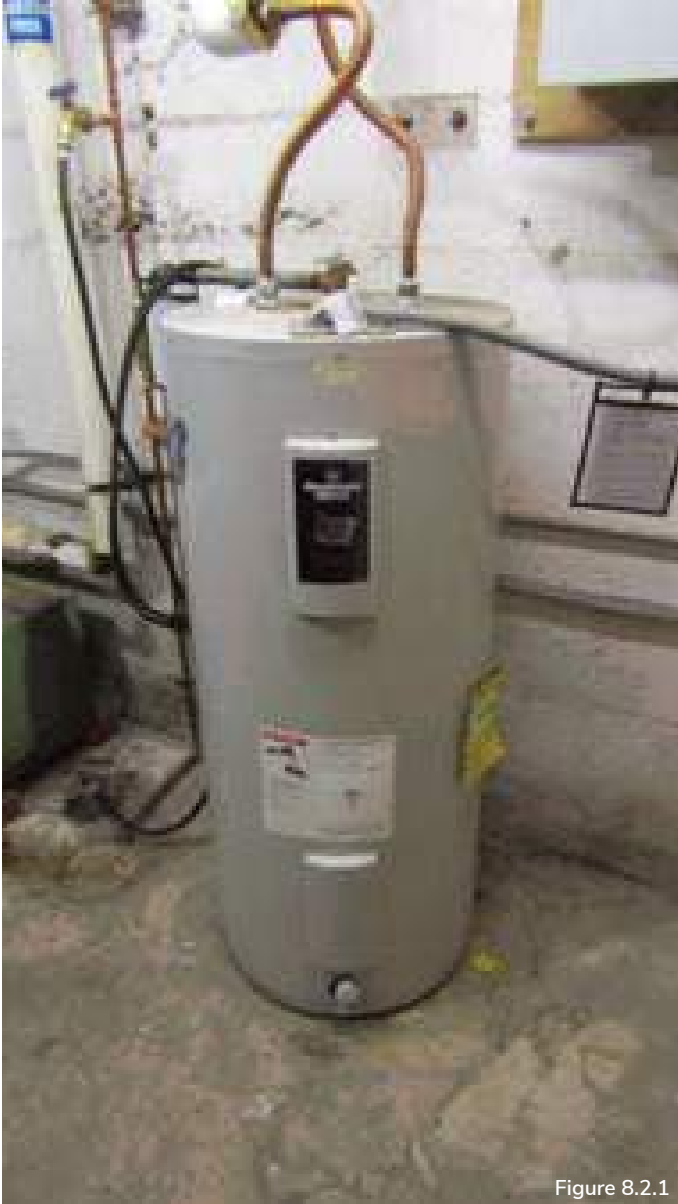
Figure 8.2.1

Domestic hot water is provided by a 2017 Bradford White, residential-grade, electric water heater (figure 8.2.1). It has a tank capacity of 50 gallons.

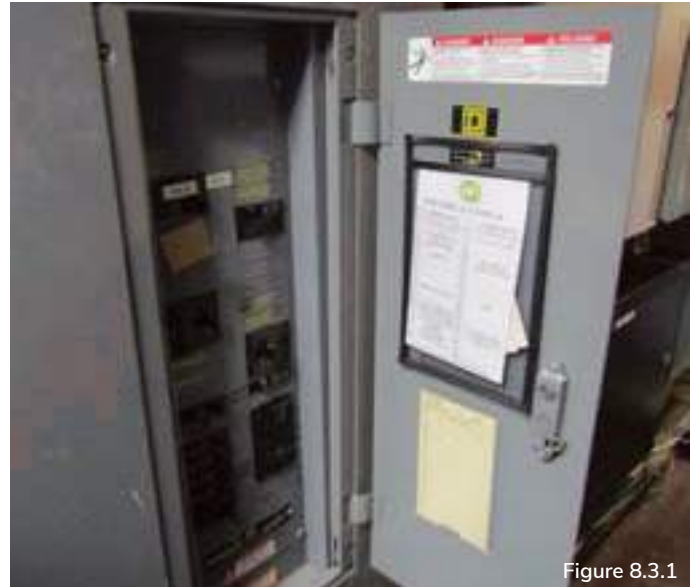
Figure 8.3.1

The building is served by a 208Y/120V, 3-phase, 4-wire, 800A Main Distribution Panelboard (figure 8.3.1) and supplied by a medium voltage step-down, on-grade, pad-mount transformer (figure 8.3.2) located outside the lower floor electrical room. The main panelboard has a rated capacity of 800A originally installed around 1975 and has reached the end of service life. The electrical distribution system consists of several panelboards located on each floor that provide 208Y/120V for mechanical, lighting, and general-purpose loads. These other branch panelboards appear to have been installed in 1975 and are also approaching the end of service life. Additionally, these panelboards were observed to have limited room for future growth.

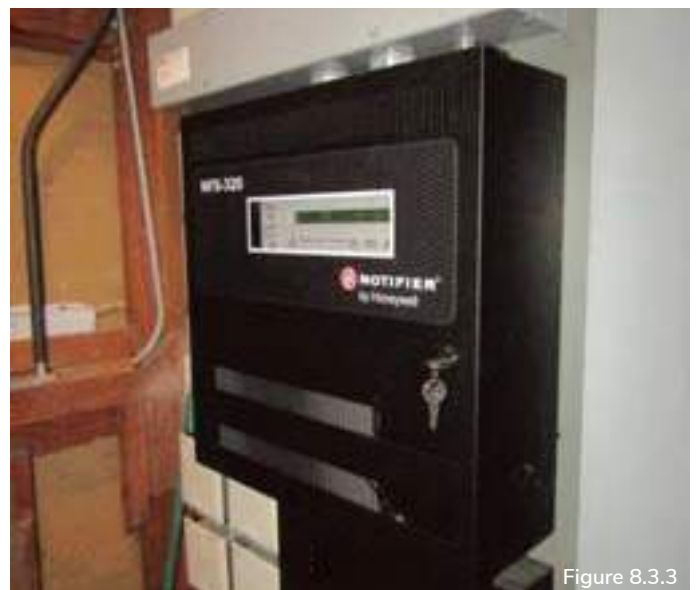
Figure 8.3.3

The facility is served by an addressable fire alarm system manufactured by Notifier. The main panel is in room 015 (figure 8.3.3). There are pull stations and smoke detectors for activation as well as strobes for notification. The system appears to be a combination of a newer panel and aged devices. Many devices have reached the end of their lifecycles and the main panel is approaching the end of service life.

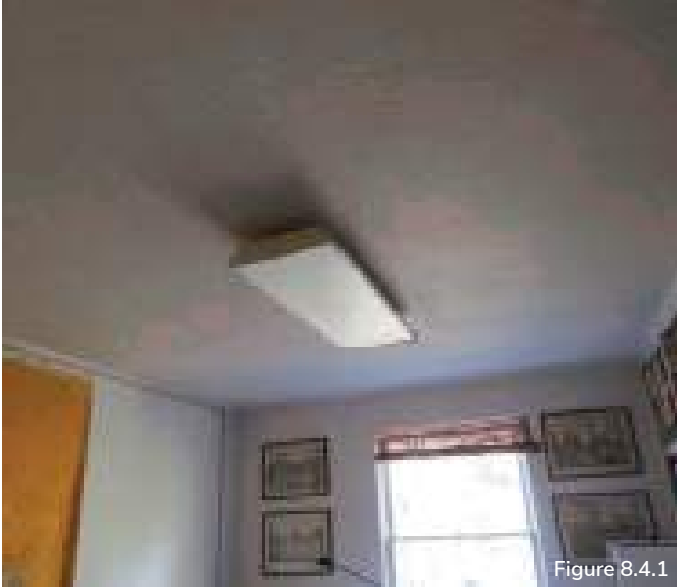
Figure 8.4.1

The interior lighting is showing significant signs of wear and age. It consists of mostly lay-in and surface-mounted fixtures with acrylic, parabolic, or no lenses and T8 fluorescent or compact fluorescent bulbs. The interior lighting varies in age; older fixtures can be found throughout (figure 8.4.1) while some contemporary fixtures exist in previously renovated spaces (figure 8.4.2). Additionally, decorative surface mounted fixtures have been installed in corridors (figure 8.4.3) though they are not original.
