Friendly Hall

Preliminary Historic Assessment

University of Oregon
Campus Planning
Campus Planning and Facilities Management

October 2022

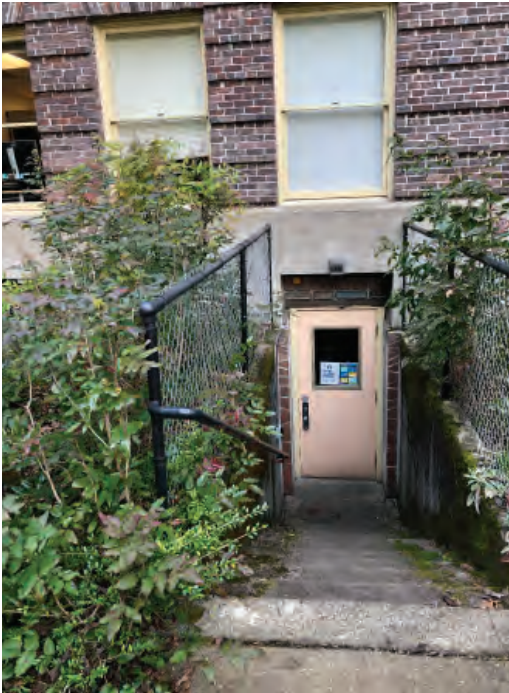
Light fixture above basement door is not original. Fenced stairwell is not original.

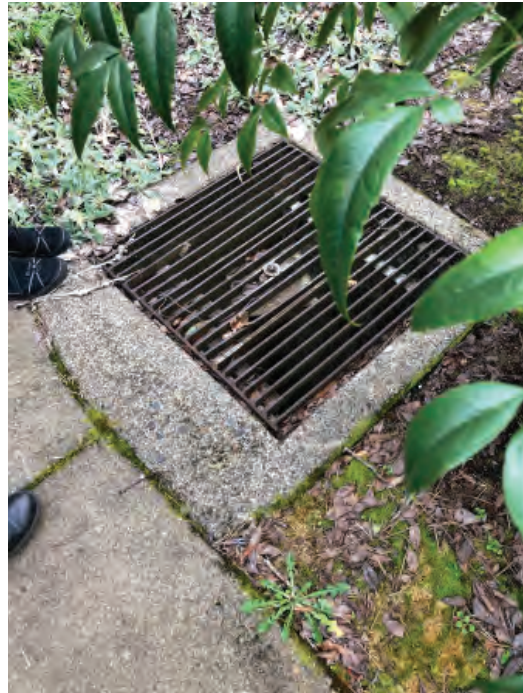
Storm drain inlet location in landscape, not original.

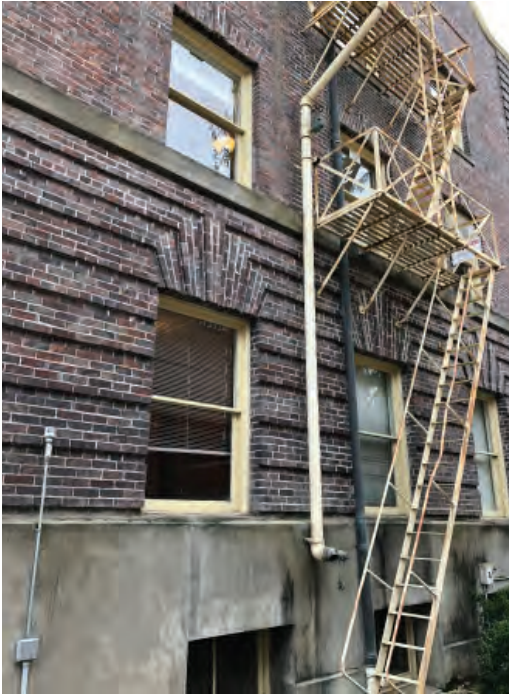
Fire escapes are not original, further research needed to determine date added. Fire sprinkler standpipes are not original.

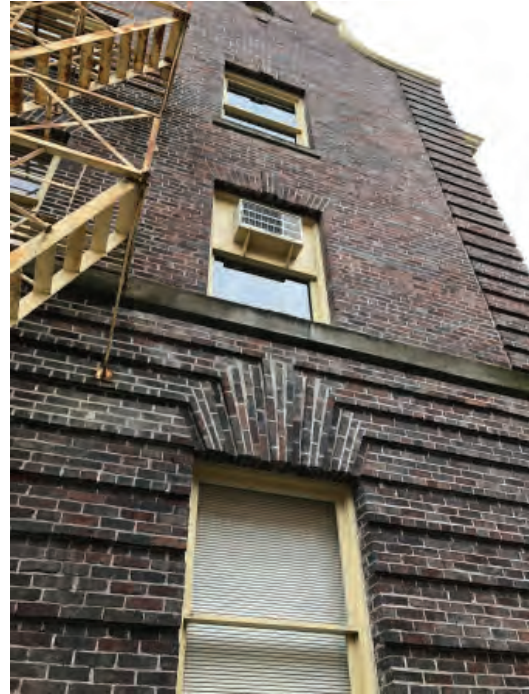
AC units installed in windows, not original.

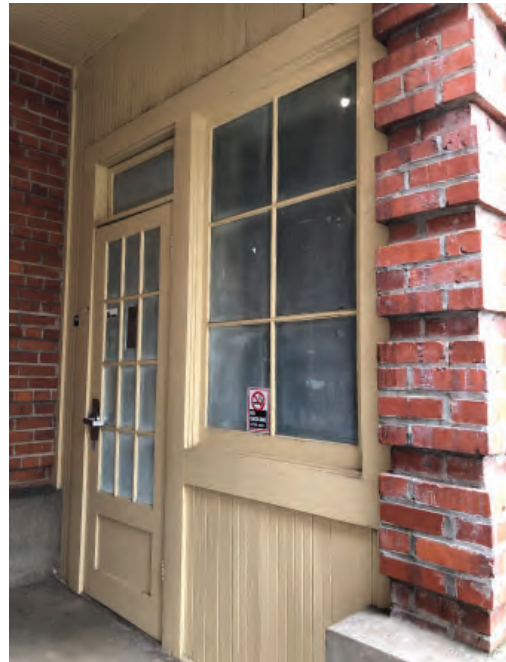
Original doors and windows.

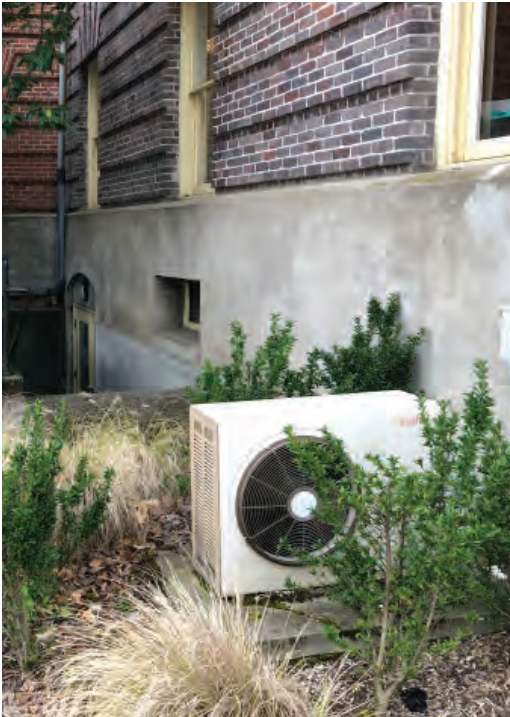
Mechanical systems added to exterior facade in exposed location.

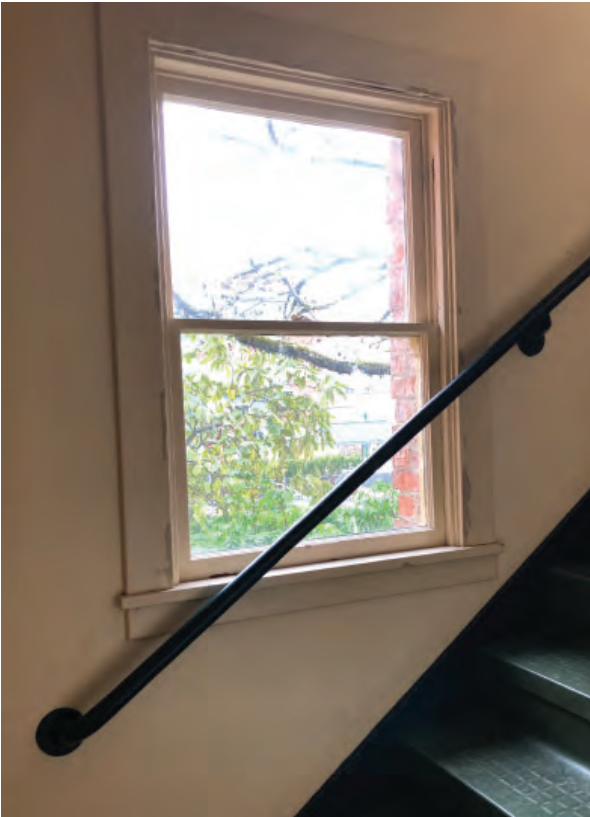
First Floor Stairwell (Railing intersects window)
