# CHAPMAN HALL

## PRELIMINARY WINDOW ASSESSMENT

University of Oregon  
Campus Planning  
Campus Planning, Design and Construction

June 2015 (updated January 2016)

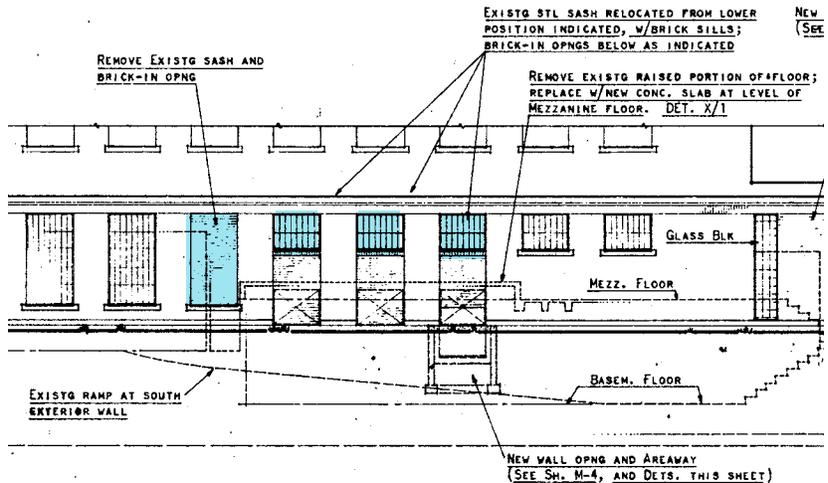
1966 south elevation drawing showing infilled window and three relocated windows.

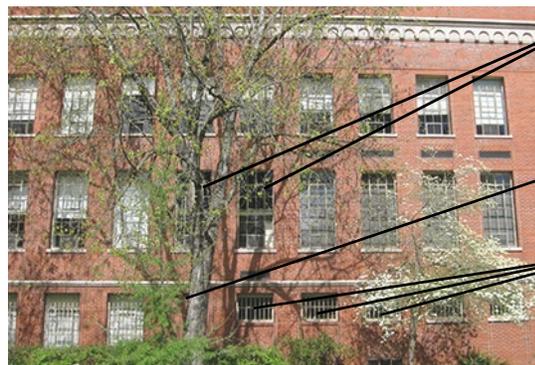
GLAZING ABOVE DROPPED CEILING DARKENED AND VENTS INSERTED DURING 2001 REMODEL

WINDOW INFILLED DURING 1966 REMODEL

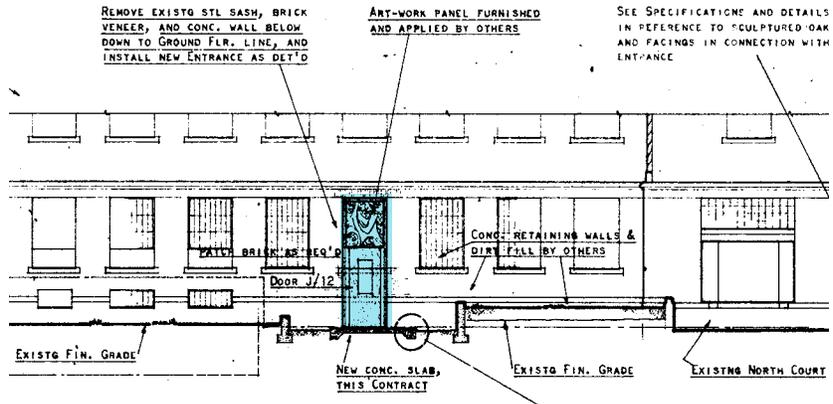
1966 north elevation drawing showing removal of old window and the new second north entry

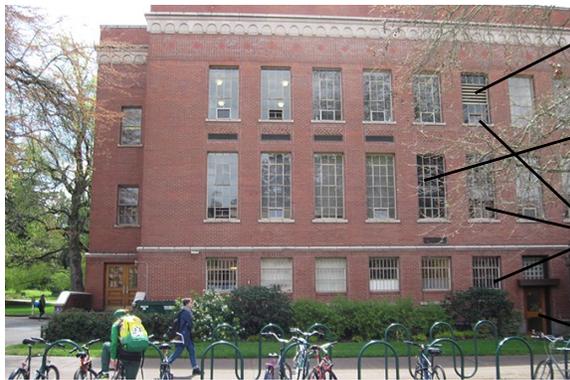
WINDOW ALTERED TO INSTALL VENTILATION GRILL FOR NEW ELEVATOR DURING 1990 REMODEL  
 GLAZING DARKENED AND VENTS INSERTED DURING 2001 ROOM 207 REMODEL  
 GLAZING PAINTED A GLOSS BLACK AFTER INSTALLATION OF NEW ELEVATOR SHAFT DURING 1990 REMODEL  
 1966 SECONDARY NORTH ENTRY WITH 2010 ALTERATIONS

Existing north facade and its major window alterations.

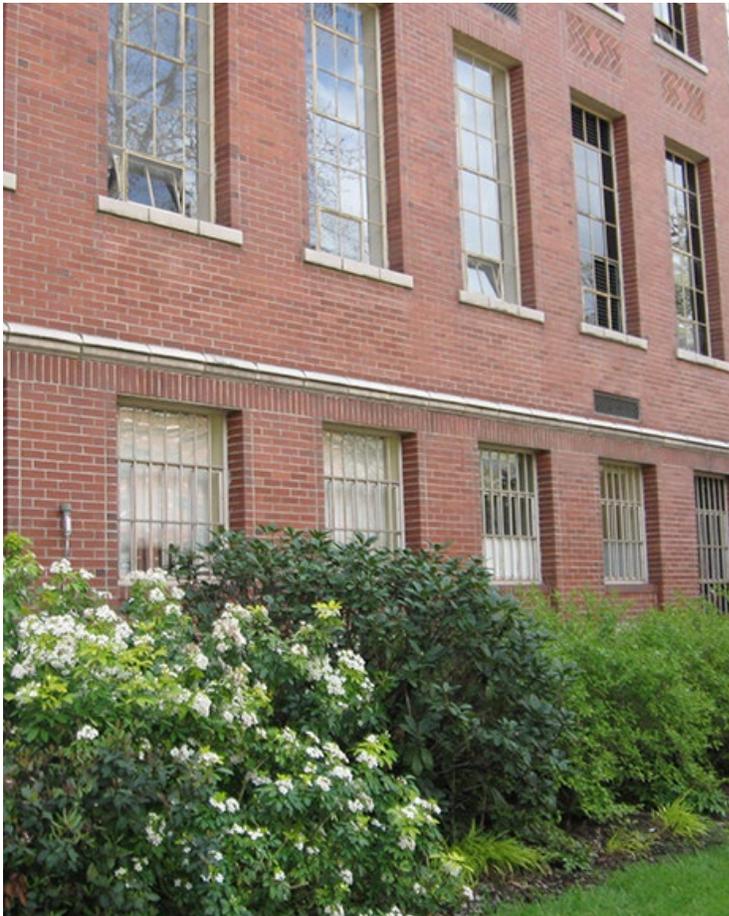
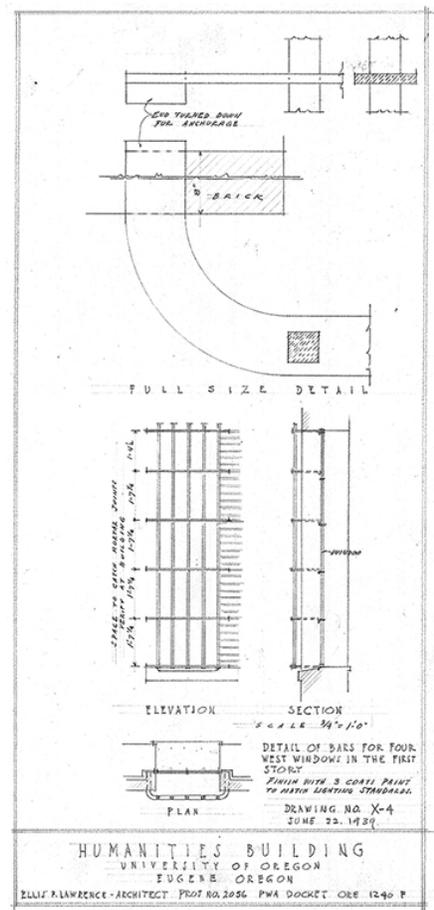
Incorporated into the window sash are the security bars. The construction of these bars match the original elevation drawings but not the

original detail drawings (see below). Rather than functioning as a separate element and being imbedded into the brick as they were drawn, they are a part of the window sash itself. The current bars appear to be original despite this discrepancy.

Photo of existing, but presumed original, security bars (left) and the original detail drawings for the security bars (right).

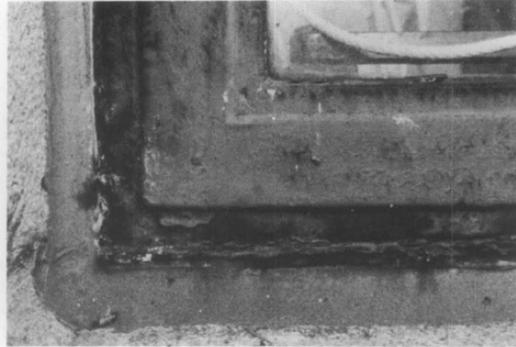
Fig. 6 b. View from the exterior showing the deteriorated condition of the lower corner of a window prior to repair. While the sash was in relatively good condition, the frame behind was rusted to the point of inhibiting operation.

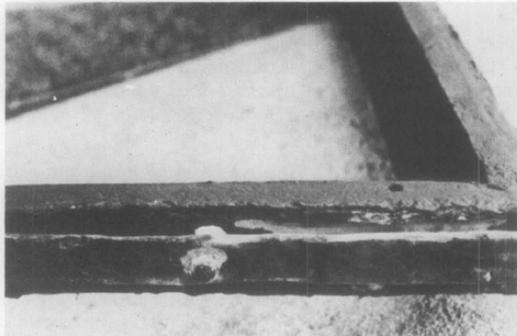
Fig. 6 c. View of the rusted frame which was unscrewed from the subframe and removed from the window opening and taken to a workshop for sandblasting. In some cases, severely deteriorated sections of the frame were replaced with new sections of milled bar steel.

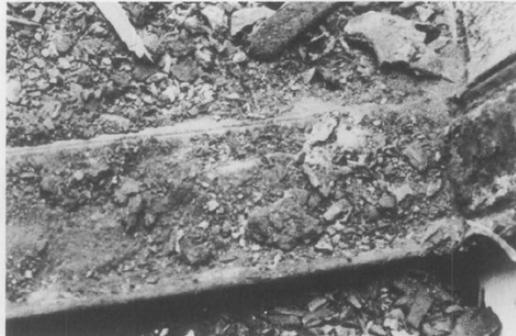
Fig. 6 d. View looking down towards the sill. The subframes appeared very rusted, but were in good condition once debris was vacuumed and surface rust was removed, in place, with chemical compounds. Where necessary, epoxy and steel filler was used to patch depressions in order to make the subframe serviceable again.

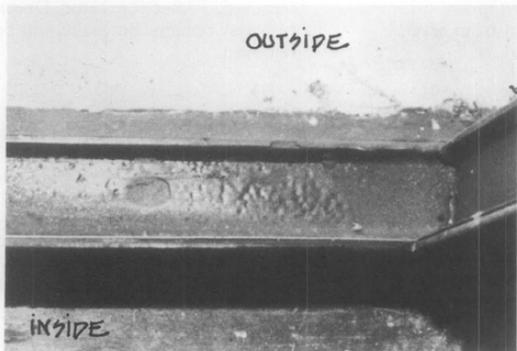
Fig. 6 e. View looking down towards the sill. The cleaned frame was reset in the window opening. The frame was screwed to the refurbished subframe at the jamb and the head only. The screw holes at the sill, which had been the cause of much of the earlier rusting, were infilled. Vinyl weatherstripping was added to the frame.

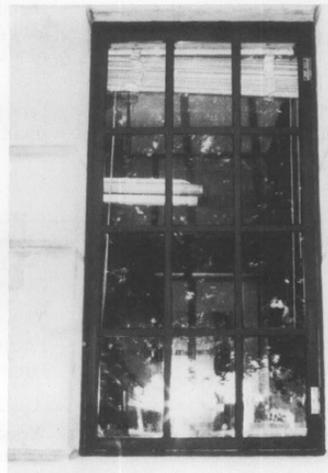
Fig. 6 f. View from the outside of the completely refurbished window. In addition to the steel repair and the installation of vinyl weatherstripping, the exterior was caulked with polyurethane and the single glass was replaced with individual lights of thermal glass. The repaired and upgraded windows have comparable energy efficiency ratings to new replacement units while retaining the historic steel sash, frames and subframes.

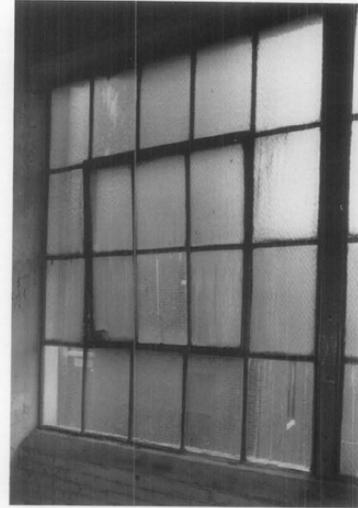
Since the Lippincott Building was used for a long time as a storage facility, the windows had not been painted, oiled, reglazed, or caulked, nor had missing or damaged parts been replaced in well over twenty years (see figure 1). Naturally, many of the windows exhibited problems typically found on inadequately maintained steel windows, including corrosion, bent and bowed metal sections, non-operable ventilators, missing or non-functional hardware and broken glazing. Furthermore, some of the original windows had been removed and replaced with double-hung aluminum windows, and other window openings had been infilled with glass and concrete block, metal louvered air vents, ductwork and other mechanical equipment (see cover photo).

Figure 1. Typical multi-light steel window with ventilator as seen from the interior. This window exhibits typical pre-rehab conditions including sill corrosion, missing hardware and a poorly operating ventilator. Photo: Clio Group.

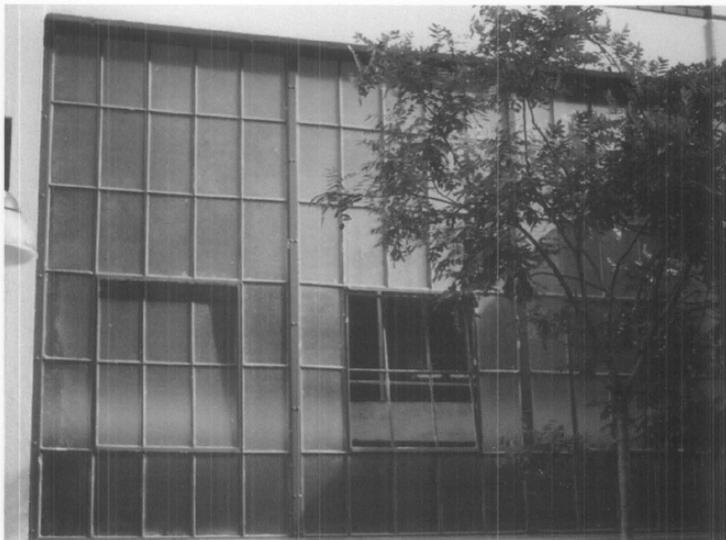
Figure 4. First floor, garage level showing the frosted glass and the center ventilator without glazing. Photo: Robert Powers.

To accommodate the first floor lobby and parking garage, the decision was made to repair and reglaze with frosted glass the existing steel windows in the garage area, and to install new windows in the newly created lobby area where no windows previously existed. The garage windows retained their operable pivoting sash, since compliance with energy requirements was not applicable. To provide for adequate garage ventilation, glazing was omitted from a number of the ventilators (see figure 4).

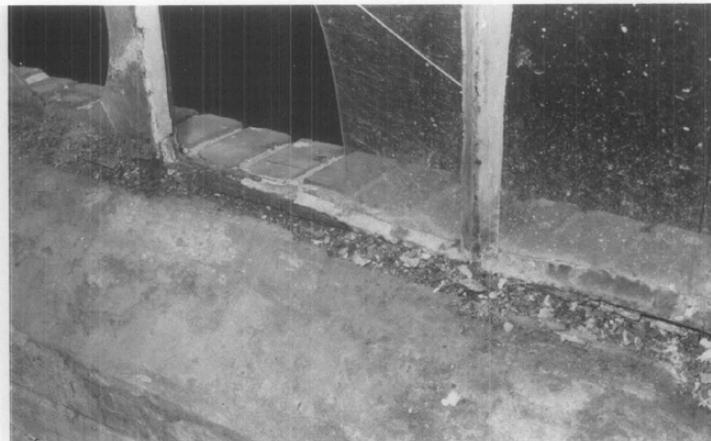
Figure 5. Sill corrosion typically found on 95% of the windows. Photo: Clio Group.

Generally employing three crews of three to four men, each contractor began by cutting out all the severely corroded and/or heavily bent metal sections from each window. Severe corrosion occurred primarily in the sill areas where the original steel sill section was embedded in concrete—a condition existing in approximately 95% of the window sills to be repaired (see figure 5). The spalled concrete and the corroded metal sill sections were chopped out with a portable band saw. In addition to the corrosion in the sill areas, extensive deterioration typically extended up the window muntins approximately three to six inches. These members were cut at a 45 degree angle with a five-inch grinding wheel using a five-inch disk, usually at a point four to seven inches from the sill or where the steel was no longer corroded.

Once the muntins and mullions were set plumb, the final steps in the steel repair process began. In most of the sill areas, lengths of new steel sections were installed to replace the original corroded members. The new cavetto-shaped steel sections did not match exactly the bullnose profile of the historic windows (see figures 9 and 10). However, the original profile was no longer available and the new profile was close enough so that the overall proportions, profile, and shadow lines were compatible with the historic window appearance. The new steel sections at the sill and the lengths

extending up into the muntins were welded together, installed in the appropriate location and then clamped and welded to the remaining original window. All welds were ground smooth and primed immediately with a rust-inhibiting primer. The concrete sills were then patched. Concurrent with the splicing-in of the new members, the ventilator jambs were also retrofitted to accept the new projecting ventilator. Similar to the work on the ventilators, the bullnose trim piece on the upper portion of the exterior side rails was cut off and a new steel angle was installed on the interior of the side and bottom rails and the hinges were attached.

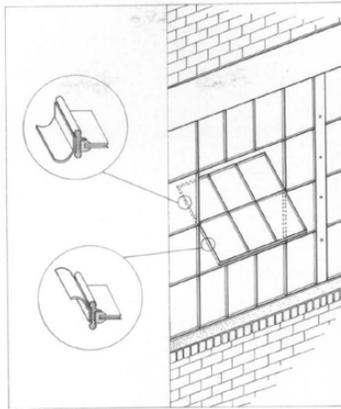
Figure 6. Pivot ventilators prior to retrofitting on the upper floors. Bullnose trim pieces to be modified as part of the retrofitting from pivot to projecting ventilators. Drawing: Martha Raymond.

Concurrent with the cutting out of the window's corroded steel members, each of the existing pivot window ventilators on floors two through six were cut from their jambs, labeled and brought to an on-site work station. At the work station, the pivoting ventilators were modified to operate as projecting windows (see figure 6). This was accomplished by cutting off the bullnose outside face of the side and bottom rails on the sash and riveting a new water-shed steel angle at the same locations. To allow the ventilators to swing out, two 16", heavy duty, 6 bar, zinc chromate plated steel, TRUTH hinges were screwed to each ventilator (see figure 7). New right-hand, cast iron, bronze lacquered, locking handles were installed on the bottom rail by face-mounting and screwing to each ventilator.

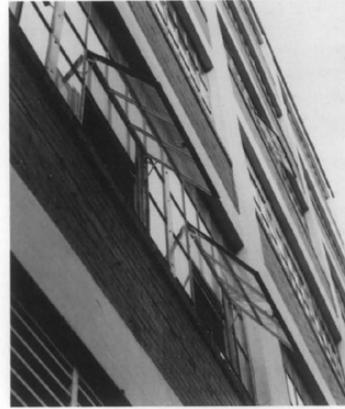
Figure 7. Retrofitted projecting ventilator with the TRUTH hinges. Photo: Robert Powers.

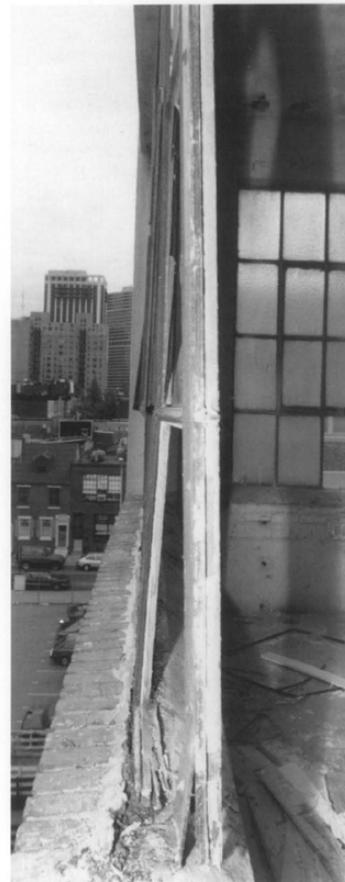
In addition to the retrofitting of the ventilators, many of the window muntins and structural mullions needed to be straightened, patched and repaired (see figure 8). Members that were seriously bowed and could not be adequately straightened were cut off using grinding wheels and salvaged;

Figure 8. Bowed and corroded window during construction. Photo: Clio Group.

replacement members were welded into place. Two relatively simple techniques were used to straighten the less seriously bent and bowed steel members. With mullions, a wooden brace (usually a two-by-four) was attached to the mullion; a wire cable was wrapped around the wooden brace and the mullion; and slowly the cable was pulled with a "come-along" winch hooked to the ceiling of the building. Since the mullions had typically bowed toward the exterior, the member was pulled in the direction opposite its bowing, towards the inside of the building. To straighten out bent and bowed muntins, the contractor applied constant pressure through the use of 14" bar-type clamps on the muntin. All indentations and gouges left in the steel members were filled with an auto-body patching compound containing steel fibers and an epoxy binder, sanded smooth and primed with a rust-inhibiting primer.

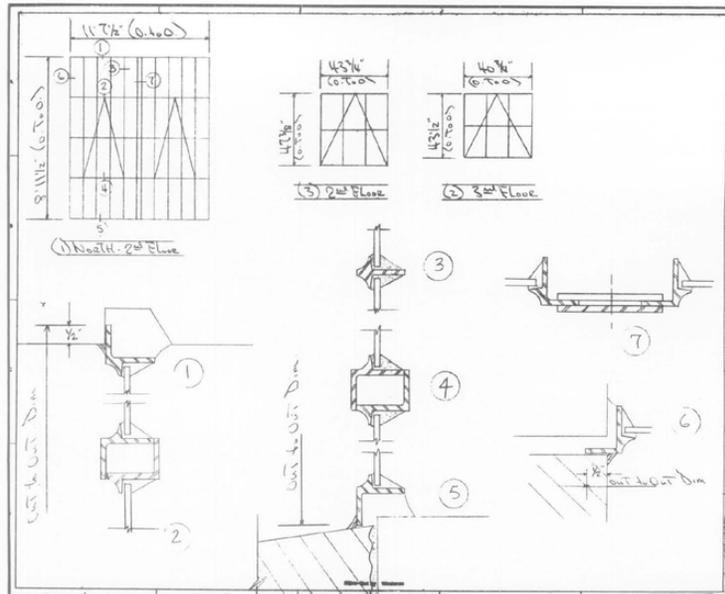
Figure 9. Sectional drawings of replacement window manufactured by A & S Window. Drawing: Winderco, Inc.

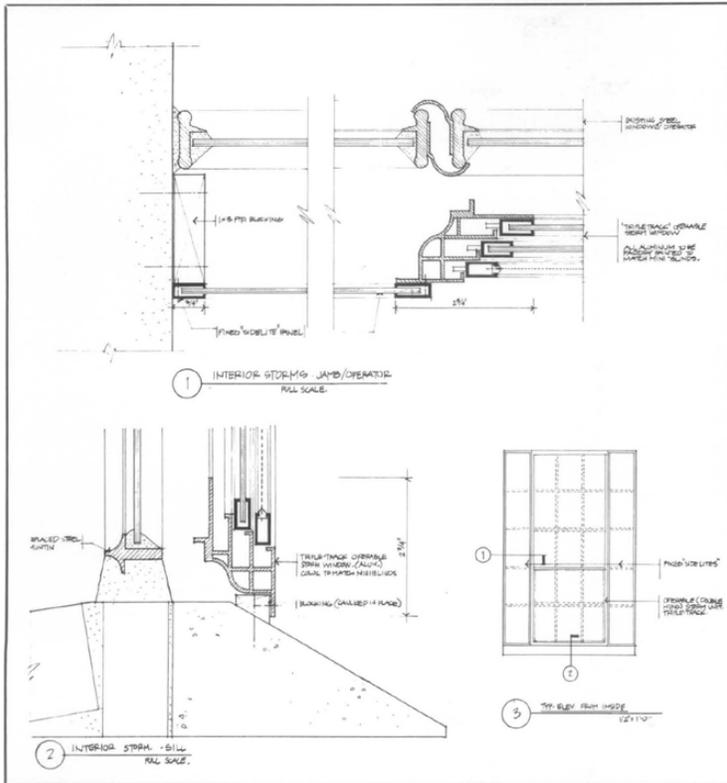
Figure 11. Interior storm window drawings, showing the alignment of the storm and steel window members. Drawings: H2L2 Architects.

the existing steel windows in and of itself was not sufficient in bringing the windows up to code. The development of an interior storm window system provided the additional thermal performance for code compliance. The solution involved an aluminum, triple-track, interior storm unit with flanking, fixed "sidelites" (see figure 11). A major consideration in the development of this storm system was the desire to minimize the outside visibility of the storm unit by aligning as closely as possible the meeting rails and other aluminum members with the steel window members (see figure 12). The exterior face of the storm windows was painted the same color as the steel windows so as to be as inobtrusive as possible (see figure 13). Although, the aluminum members do not match exactly the width of the opposite steel members, the storm windows were not readily visible from the exterior.

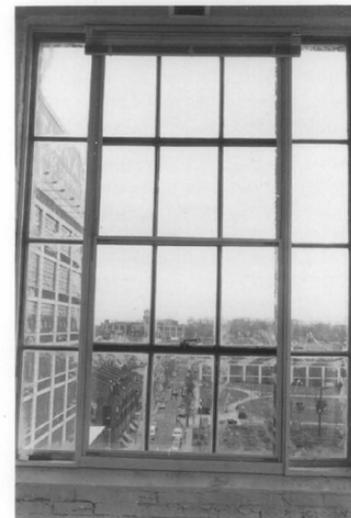
Figure 12. Installed interior triple-track storm window with fixed sidelights. Photo: Clio Group.

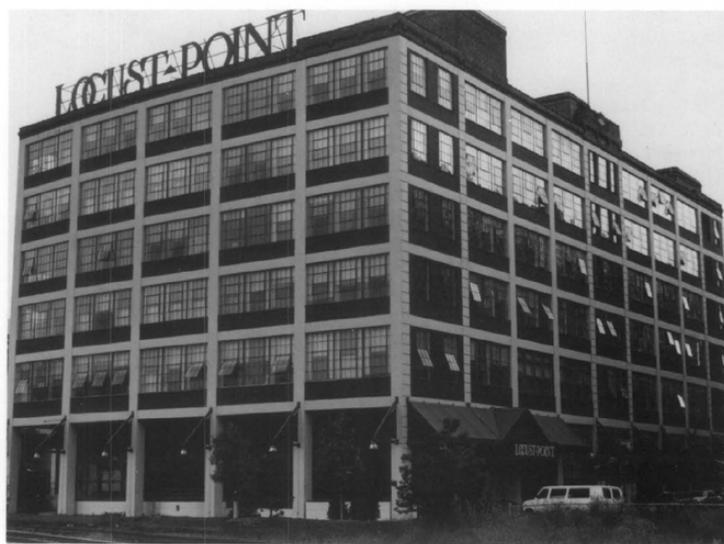
Figure 13. Lippincott Press Building (now Locust Point) after repair of the multi-light steel windows. Photo: Robert Powers.
