UNIVERSITY OF OREGON

FRIENDLY HALL ASSESSMENT

FACILITIES ASSESSMENT & FEASIBILITY STUDY

MARCH 2022

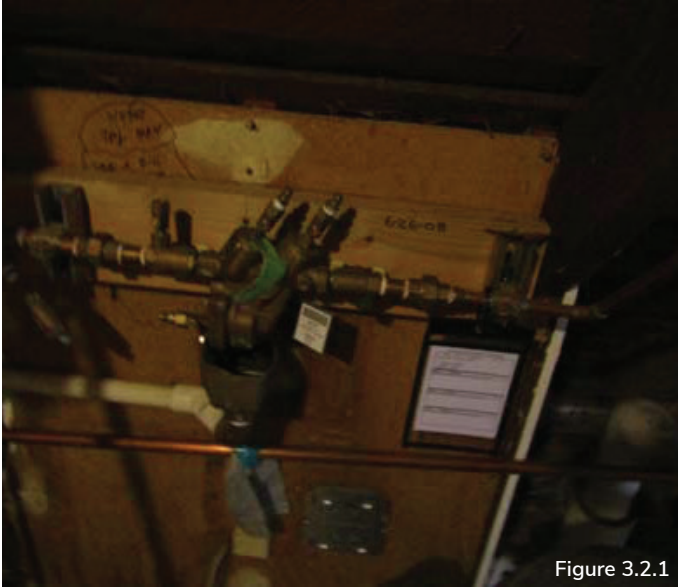
Figure 3.2.1

Friendly Hall is served by an existing 2-inch domestic water line entering the building on the west side. This service has backflow prevention. A 6-inch fire protection service with backflow prevention (figure 3.2.1) enters the building on the south side and connects to an existing 8-inch EWEB main at 13th Avenue. There

is a wall mounted fire department connection (FDC) on the western wall in the south west corner of the building. The water supply piping is a mix of copper and galvanized steel pipes.

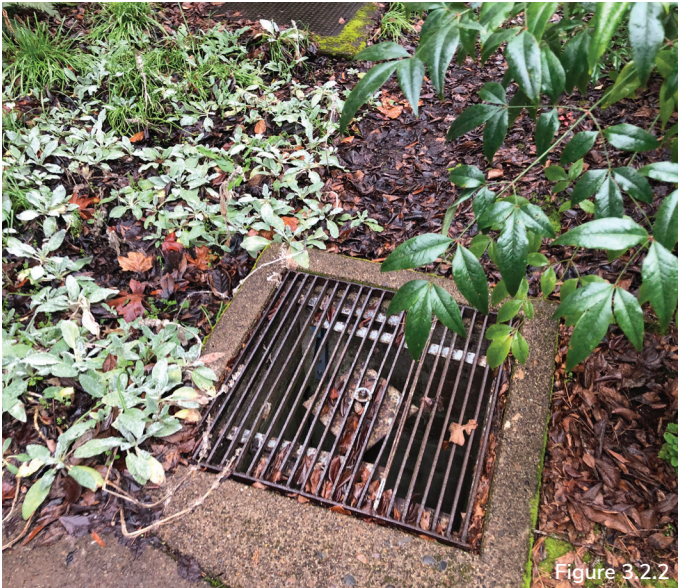
Figure 3.2.2

Stormwater runoff from the landscaped areas is collected by area drains (figure 3.2.2) around the site and brought south to 13th Street or north to an 8-inch main south of Allen Hall. The line running north is considered to be close to capacity and requires a pump station at the southeast corner of Allen Hall to send it north to campus storm lines that eventually outfall into the Millrace. Building roof drains are brought down to the ground floor where they connect to the same storm drain systems running both south and north. Existing storm drainage is not treated to current City of Eugene or University of Oregon stormwater management standards. Roof and site drainage are both piped directly into campus storm piping without water quality treatment or peak flow control.

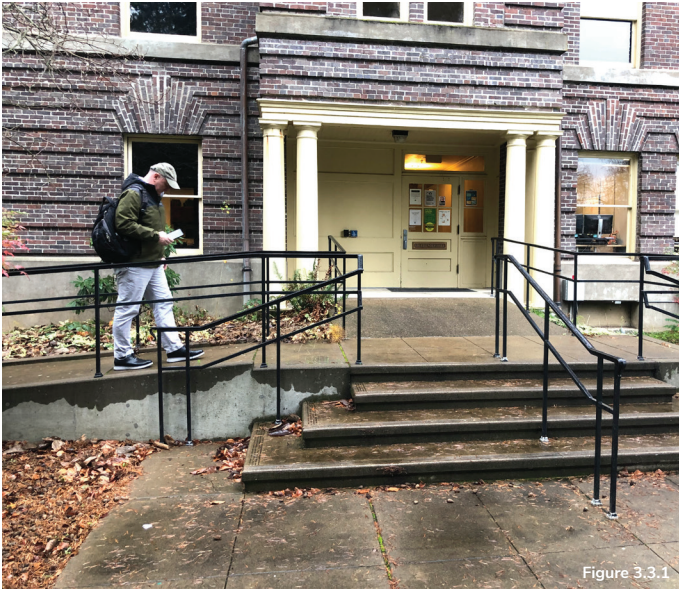
Figure 3.3.1

The exterior circulation surrounding and accessing Friendly Hall is generally in good condition. Presently, Entry 101 (figure 3.3.1) is the only accessible means of ingress. An ADA ramp was previously added in a historically appropriate manner. Two entries to the basement were added on the west facade (figure 3.3.2 shows Entry 005). They are redundant means of egress and damaging to the historic character.

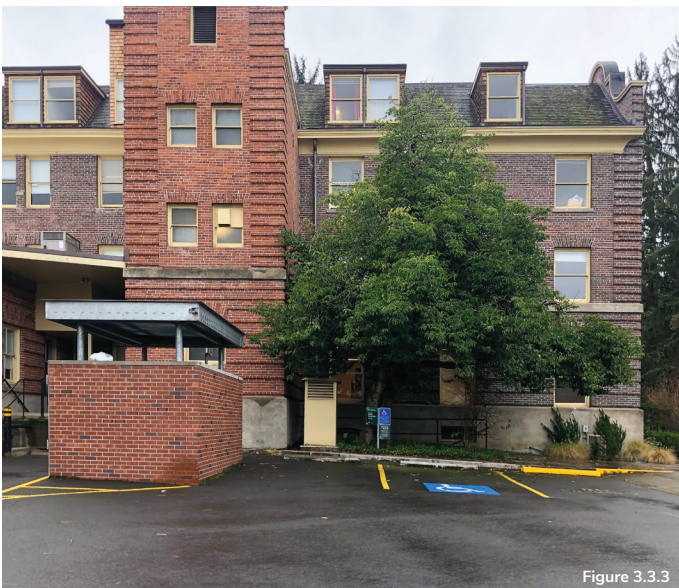
Figure 3.3.3

The parking lot to the northeast of the site (figure 3.3.3) and the driveway which provides vehicular access are in good condition, though underutilized. There are multiple reserved permit spots and one ADA parking spot. While provided, the current accessible parking space exceeds

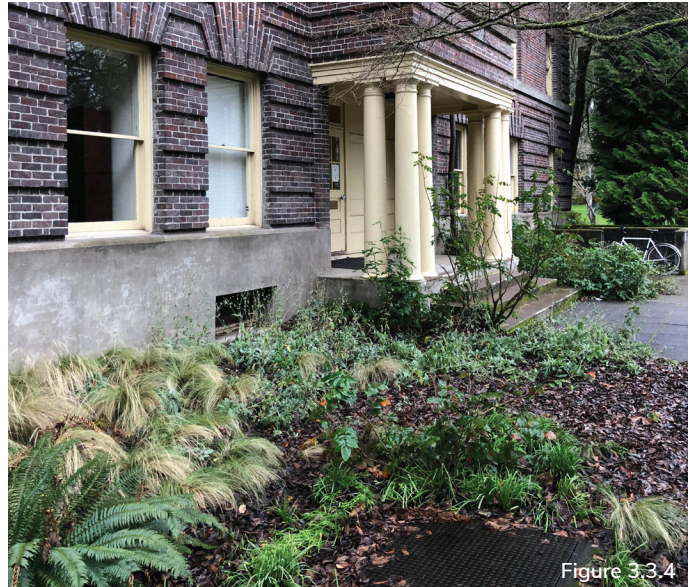
Figure 3.3.4

Friendly Hall's landscape is a mixture of mature trees, foundation plantings which have been heavily pruned, small garden areas as highlights, and extensive groundcover or bare planting beds (figure 3.3.4). The majority of the landscape is congruent with University standards, but there are opportunities to improve the landscape making it more compatible with the surrounding campus. In addition to their aesthetic appeal, plantings should be selected to better fit the scale of their site to reduce pruning and overgrowing their space, they should be selected for low water use and resilience to increasingly hot summers and should be selected to support pollinators and bird populations. Plantings that are too large for their site obstruct views creating conditions that both feel unsafe and present security risks as well as create wayfinding challenges by obstructing signs. Additionally, these overgrown plantings require additional maintenance. It is assumed that new landscape areas will have irrigation installed.

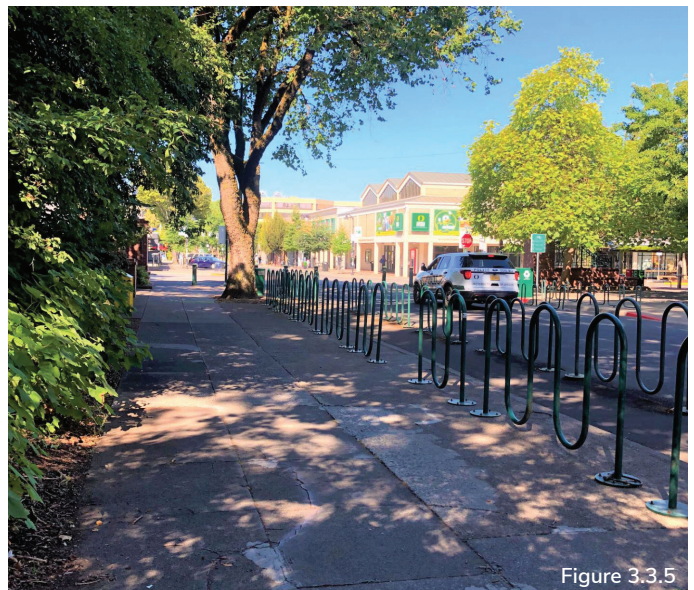
Figure 3.3.5

Presently, two locations exist for bicycle parking. The first is to the north and consists of multiple racks and two canopies. The second location is to the south where bike racks have been installed along 13th Avenue (figure 3.3.5). These racks are sometimes removed for events.

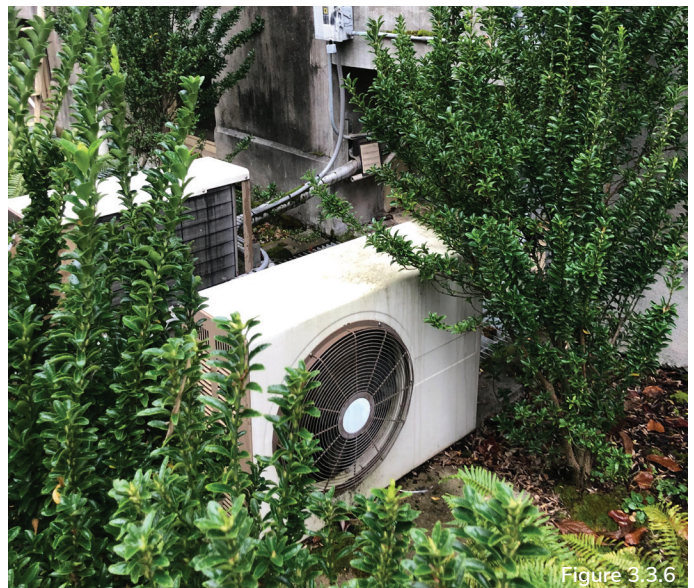
Figure 3.3.6

There are multiple dedicated mechanical units which have been placed on concrete pads outside of the building due to past renovations (figure 3.3.6). These systems do not conform to University standards. There also exist auxiliary enclosure towers for mechanical exhaust from the basement.

- o Add code compliant guardrails due to vertical drops of more than 30".
- Northern Pedestrian Corridor
 - o Retain building access and circulation.
 - o Remove mechanical equipment due to the proposed centralized and expanded mechanical systems.

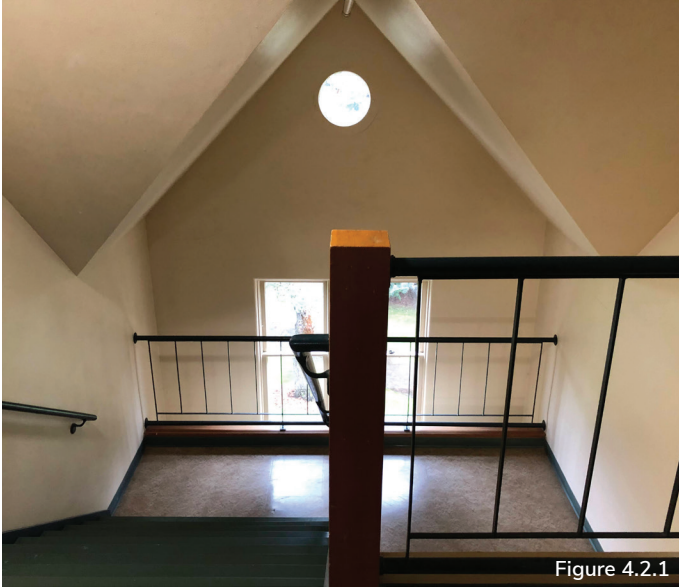
Figure 4.2.1

The building currently has three interior stairways: the two interior stairs in the 1893 West Wing (figure 4.2.1) and the interior stair in the 1914 east extension (figure 4.2.2). The West Wing stairways have fire rated enclosures with fire doors from the adjoining corridors, but non-compliant head height conditions exist and the handrails do not have compliant extensions at the landings. These stairs let out to Entry 101 and 108 which provide egress via an elevated concrete platform with stairs to the Old Campus Quad. Entry 101 has compliant exterior handrails while Entry 108 does not. The 1914 east extension stairway does not have a fire rated enclosure and lacks compliant handrails as well.

- The existing West Wing stairs should be improved to conform to requirements for head heights, handrail configuration and fire rated enclosures.
- The interior stair of the 1914 East Wing Extension will require compliant handrails, egress doors to the exterior and an enclosure with a 1-hour rated assembly including conditions where doors open directly into the stairwell.
- The exterior stair which accesses Entry 201 can be removed once the interior stairs are made code compliant. Its removal will improve the historic appearance of the building.
- Exterior stairs including basement access stairs and stairs to the elevated entries on the first floor should be equipped with code compliant handrails and guardrails

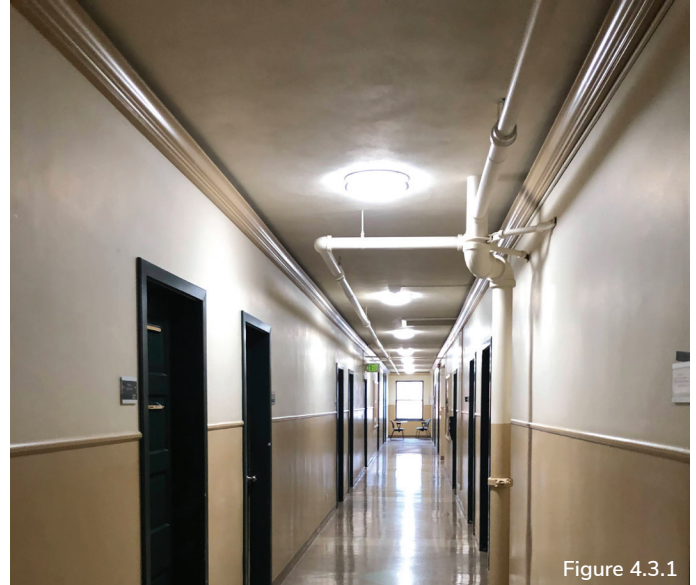
Figure 4.3.1

All interior spaces are protected by a wet-pipe fire suppression system equipped with fusible link sprinklers for water dispersion. Plumbing serving the sprinklers exists below the plane of the ceiling (figure 4.3.1). The fire suppression system has flow and tamper switches tied to the fire alarm system. The current fire suppression system is satisfactory and no upgrade is required.

- The removal and reconfiguration of all the interior partitions during the required structural upgrade will necessitate reconfiguration of the existing system.
- The renovation will allow existing ceiling mounted sprinkler lines to be concealed above the ceiling to create a more appealing and appropriate interior aesthetic.
- The renovation will afford an opportunity to move standpipes to the interior of the building thereby improving the appearance of the building and preserving its historic character.

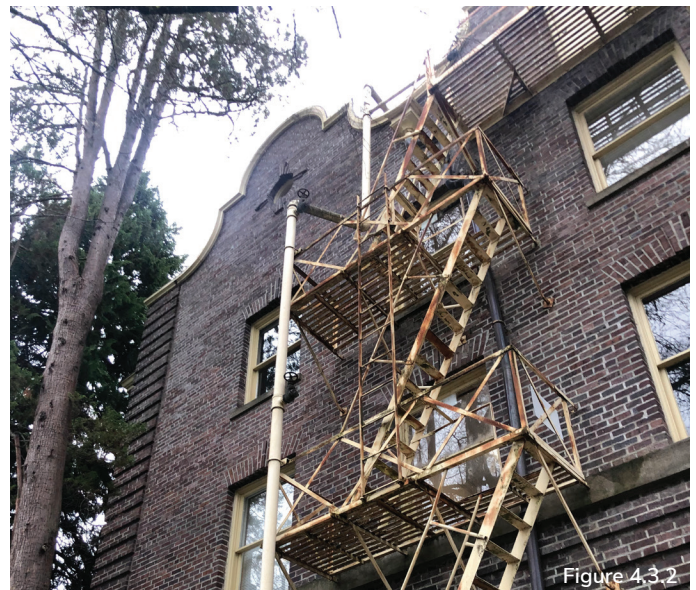
Figure 4.3.2

The existing fire system standpipe runs along the exterior in various locations, including the existing fire escapes (figure 4.3.2). This is damaging to the historic appearance of Friendly Hall.

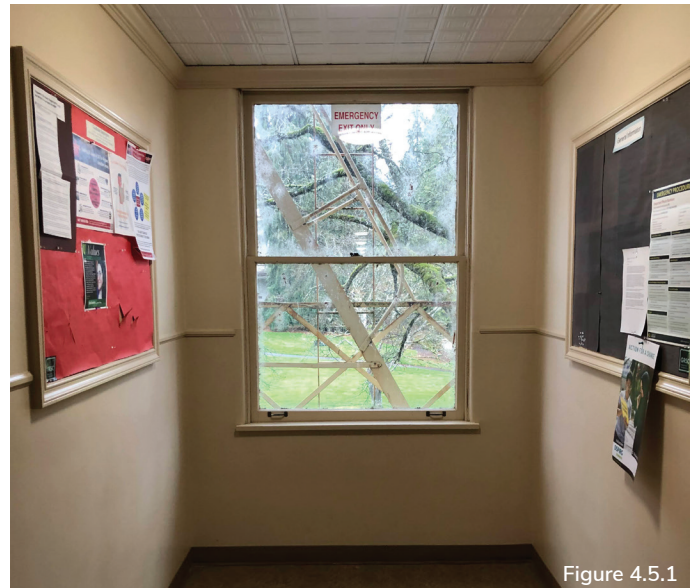
Figure 4.5.1

Friendly Hall does not presently satisfy the 2021 Oregon Efficiency Specialty Code (OEESC) requirements nor does it meet energy efficiency goals of the University. Although the documentation is limited, based on familiarity with buildings of the period it is unlikely that the original 1893 building and the subsequent additions have insulation between the load-bearing brick walls and the lath and plaster interior wall finish. The wood double hung windows are single pane throughout (figure 4.5.1-2).

- Installation of stud walls will require alternation to the jambs of the existing windows. Interior jamb extensions will be required to compensate for the increased wall thickness.
- Reroofed areas of the building will include the addition of R30 rigid insulation above the roof deck.
- The original wood double hung windows should have storm windows applied that improve energy performance with minimal impact to the appearance of the window. Recent projects at the University have utilized the SLIP system for applied storm windows.

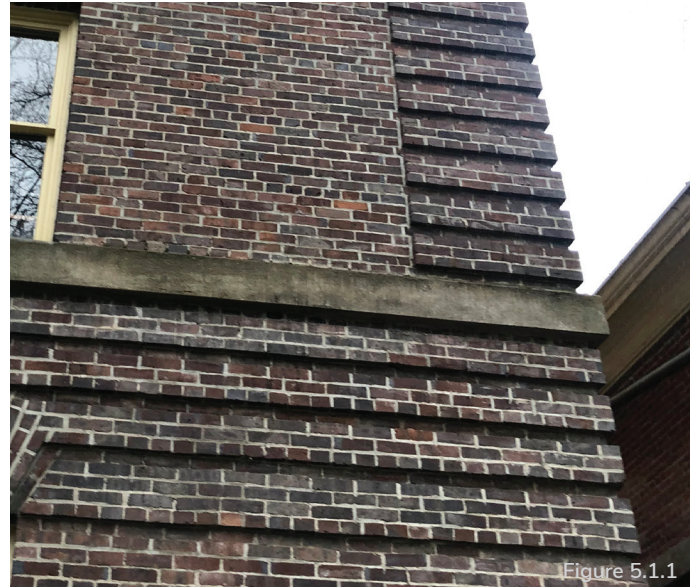
Figure 5.1.1

The exterior walls of Friendly Hall indicate the original structure and its two major additions. All three major constructs use an American or Common bond. A dark brick is used on the original portion (figure 5.1.1), while the additions are clad with a red brick (figure 5.1.2). The 1914 addition on the east also has a different coursing pattern than the other two constructs (figure 5.1.3). The face brick is embellished with quoins, jack arches, and rusticated reveals on the first floor.

The face brick appears intact and in good condition, with limited examples of damage or spalling. A visual inspection showed no indication of rising damp.

- The exterior masonry should be maintained.
- During the proposed seismic upgrade, interior faces of the brick walls will be exposed and additional inspection and testing should be performed.
- All brick, mortar or concrete elements should be cleaned with hot water and brushed where required following best practices for maintenance of historic brick facades.
- Areas of mortar deterioration and cracking should be identified and repointed.
 - o All deteriorated mortar joints should be ground using the appropriate grinder profile back to sound material prior to repointing.
 - o New mortar shall match the existing in color, texture, composition, and tooling profile. It is recommended that several small test areas be reviewed for visual match prior to commencing with larger areas of repointing.

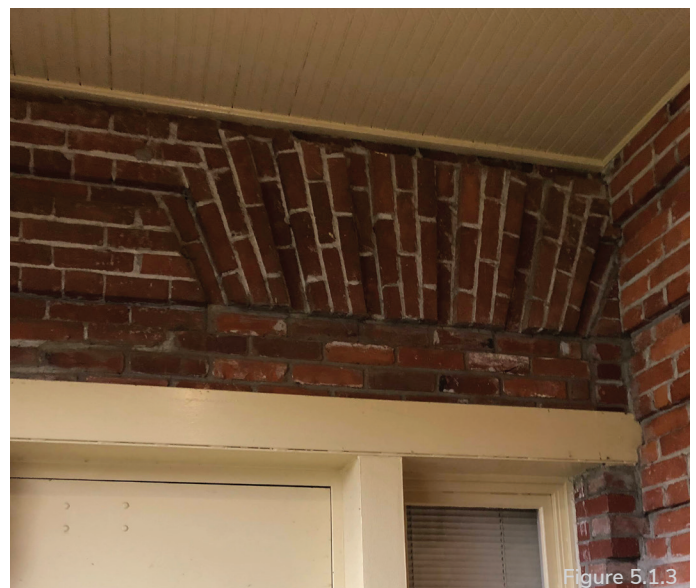
Figure 5.1.3

Mortar joints are generally intact and in good condition. There are some areas of previous repointing that are an inadequate match to the historic mortar color and texture (figure 5.1.3) which should be replaced.

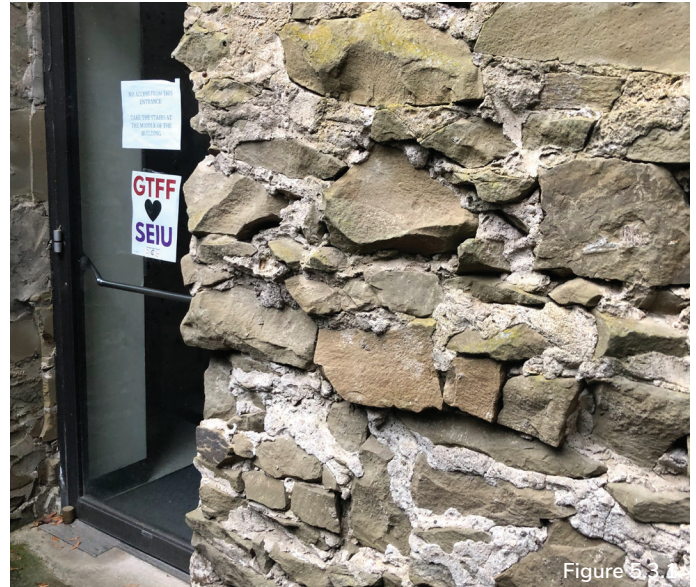
Figure 5.3.1

The West Wing of the building was constructed with a stone foundation that has been exposed in some locations (figure 5.3.1). It is generally in good condition, though the original design did not intend for any stone to be exposed.

- Existing areas of visible stone on the basement level should be refinished as necessary to improve the interior spaces.
- Exterior stone should be cleaned as necessary where exposed.

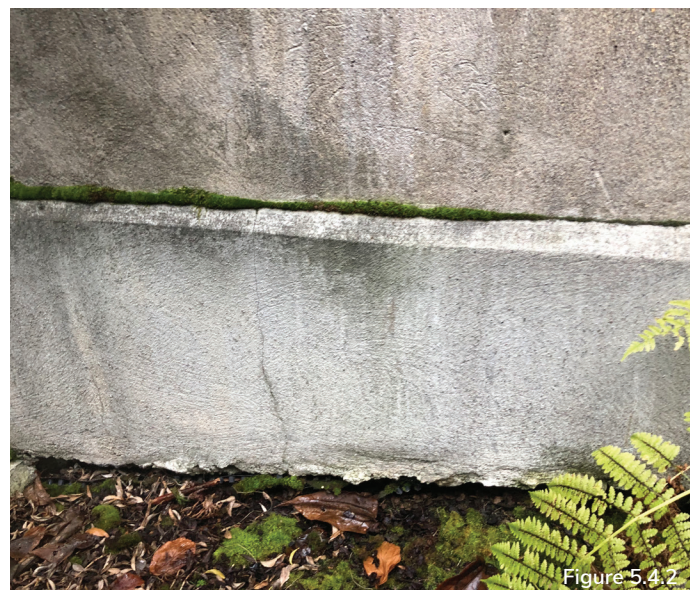
Figure 5.4.2

Building occupants noted that there have been instances of water leakage in the basement floor of the West Wing. Such water intrusion is not unexpected given the age of the building and the limited options for below grade waterproofing available during its construction.

During a walkthrough, areas of organic growth and superficial cracking were observed (figure 5.4.1-2).

Water leakage through the basement or foundation walls can be remediated via two approaches, positive side and negative side remediation.

- Positive Side: A membrane system placed on the exterior face of the structural foundation system.
 - The highest level of protection would be afforded by excavating the entire perimeter of the building to expose the foundation walls. The exterior wall surfaces would be cleaned, and a new waterproofing membrane would be installed along with new subgrade drainage.
 - The lowering of the basement floor will necessitate perimeter excavation providing an opportunity for positive side waterproofing treatments.
- Negative Side: A treatment on the interior surfaces of the foundation system.
- Exposed concrete on other exterior areas should be cleaned as necessary.

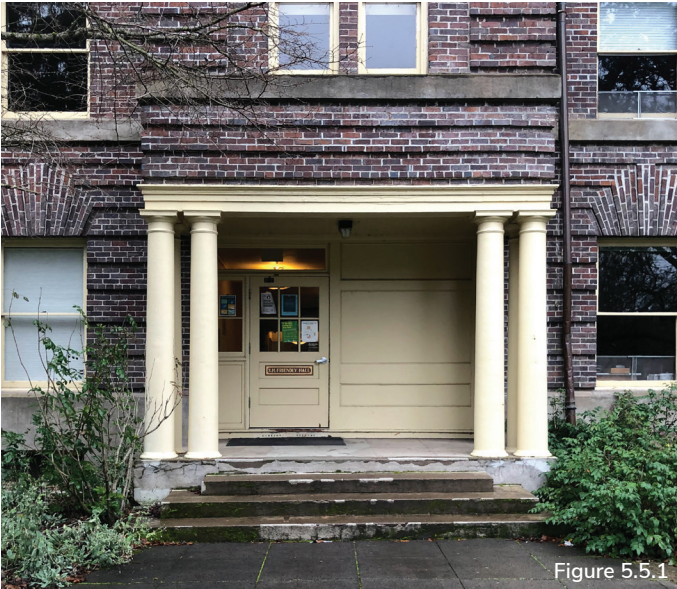
Figure 5.5.1

Generally, the historic exterior doors on the building have been maintained and are functionally adequate (figure 5.5.1). Some have experienced slight aesthetic deterioration which is expected on elements of this age. At exterior basement entries, character compromising doors were installed at some point during previous renovations (figure 5.5.2).

- The exterior wood doors should be restored and refinished.
 - Modern, accessible and historically complementary hardware should replace the existing brushed steel hardware.

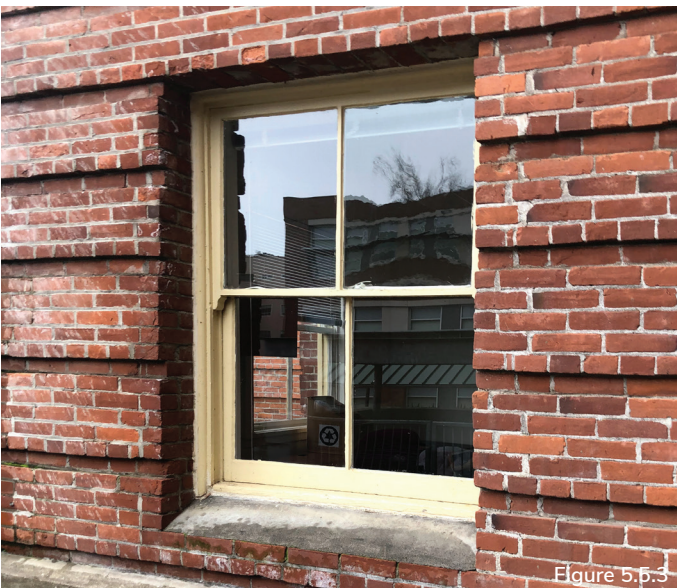
Figure 5.5.3

The exterior windows on Friendly Hall are generally in good condition (figure 5.5.3). A restoration of all exterior windows was performed by Soderstrom Architects in 2009 so areas of paint or wood deterioration are limited. However, the existing single pane vision glass does not provide adequate environmental performance.

- Exterior windows should be cleaned and repaired as necessary.
- Low emissivity film will be added to reduce heat transfer without compromising the appearance of the historic windows.

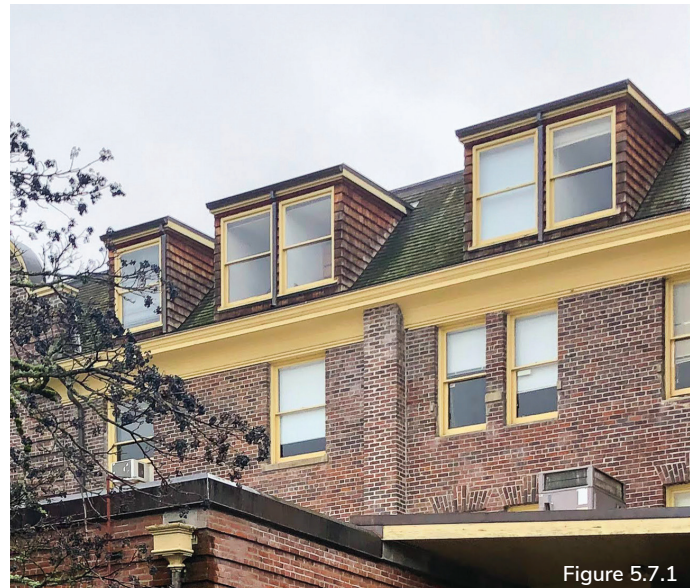
Figure 5.7.1

The fourth floor dormers received new shingle siding during the 2009 re-roofing project and currently appear in good condition (figure 5.7.1).

- The existing roof will remain, but should be cleaned and treated to preserve the appearance.
 - Exceptions are at specific locations where rooftop mechanical units will be removed. Their removal will necessitate a new roofing membrane.

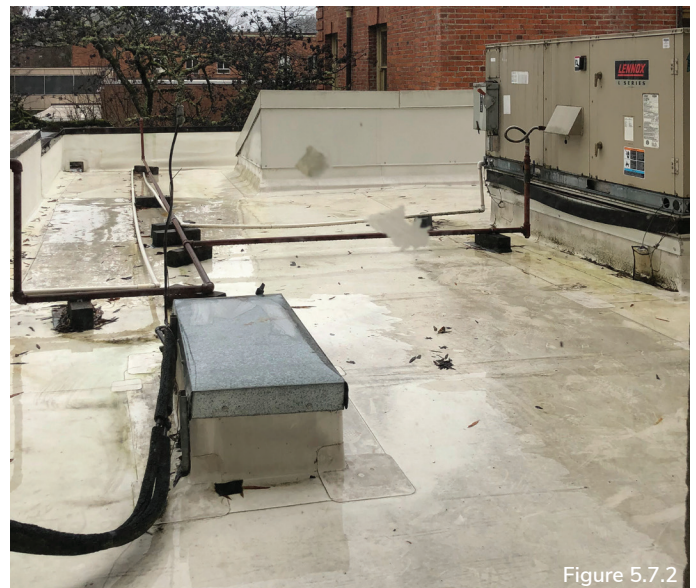
Figure 5.7.2

The existing roofing consists of TPO membrane at low-slope conditions (figure 5.7.2) and wood shingle roofing at the remaining areas. Both types of roofing were fully replaced in 2009 and are generally in good condition with about half of their expected lifespan remaining.

The skylights over the first floor office suite (figure 5.7.2) were added during a 1999 renovation and generally appear in good condition with no reports of issues.

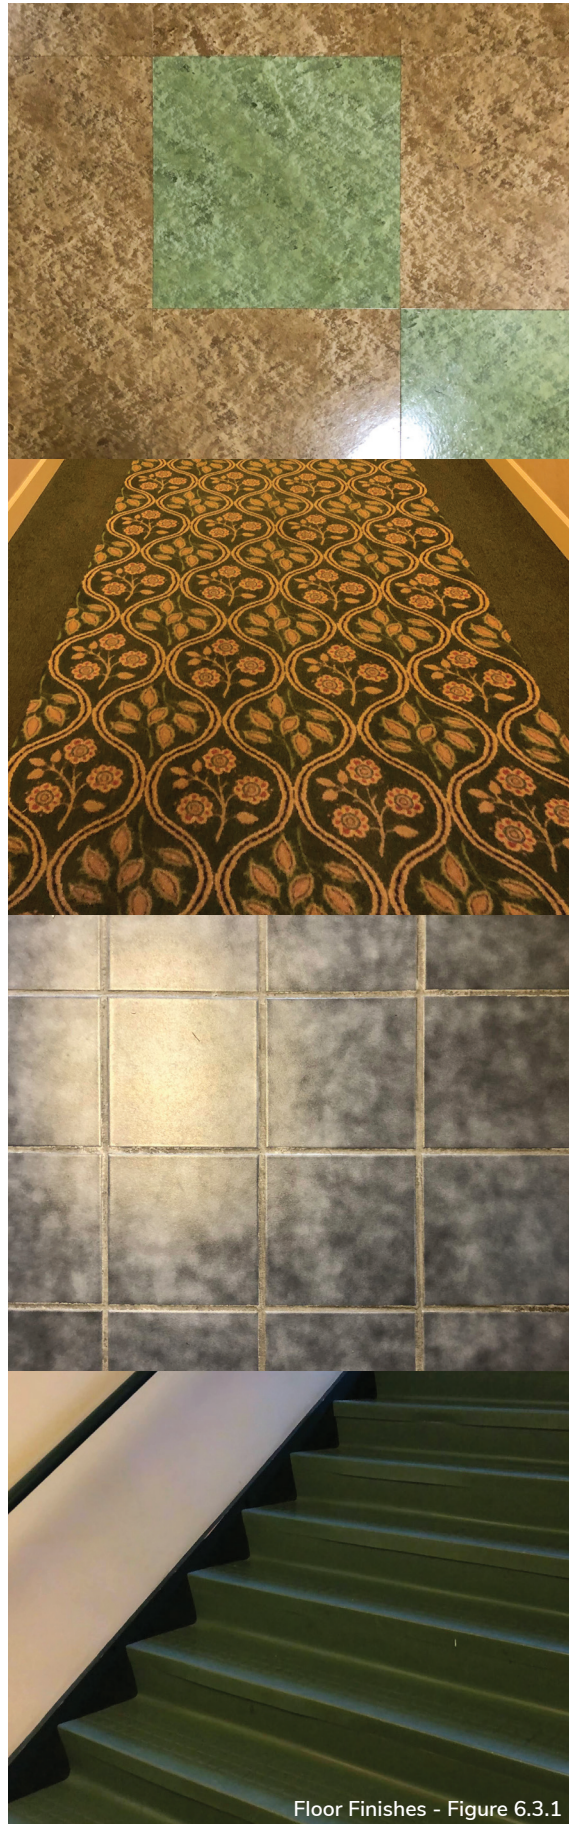
Floor Finishes - Figure 6.3.1

- o Flooring finishes are non-continuous and, in many instances, disruptive to the historic character (figure 6.3.1).
 - o Ceilings have been installed at different points in the building's history resulting in inconsistent appearances (figure 6.3.2).

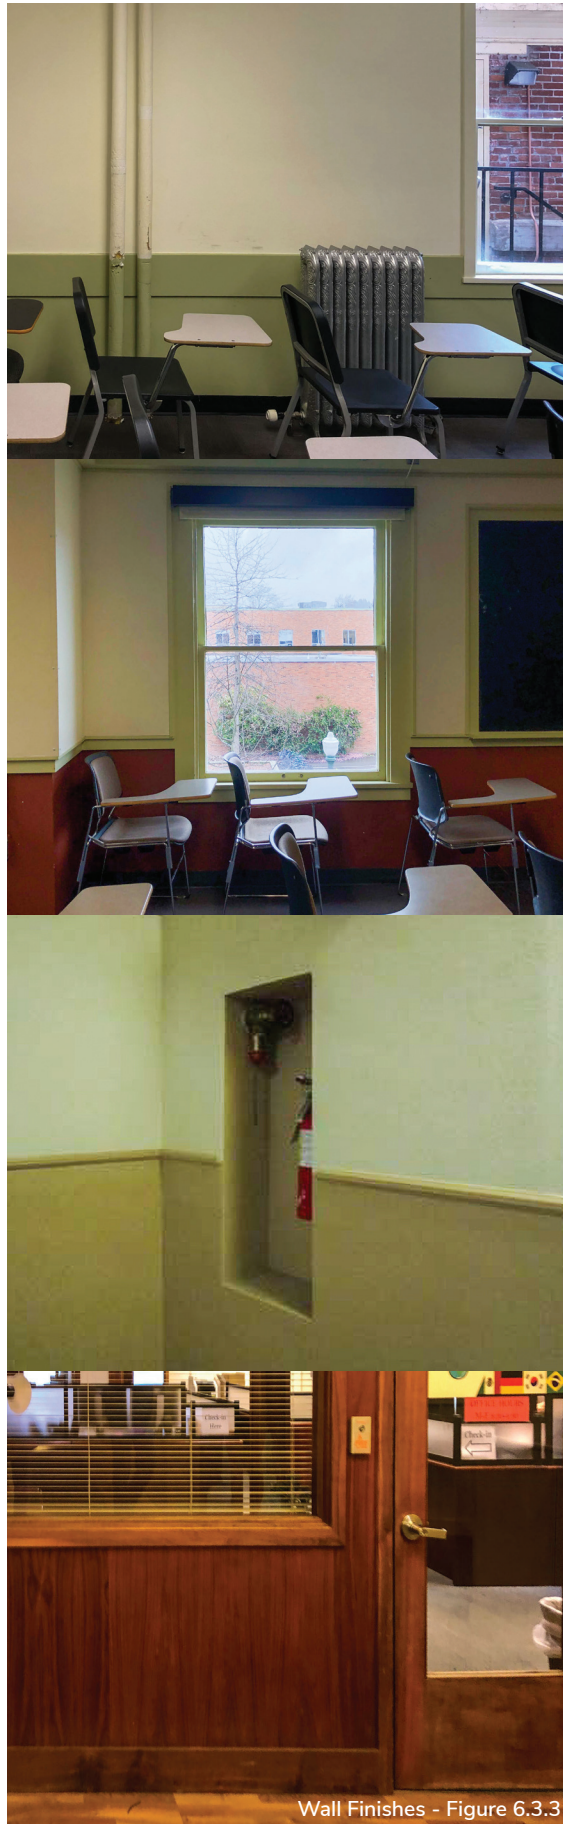
Wall Finishes - Figure 6.3.3

- o Wall finishes (including wall material, texture, color, bases, moldings, and wainscoting) have been applied haphazardly due to previous renovations (figure 6.3.3).

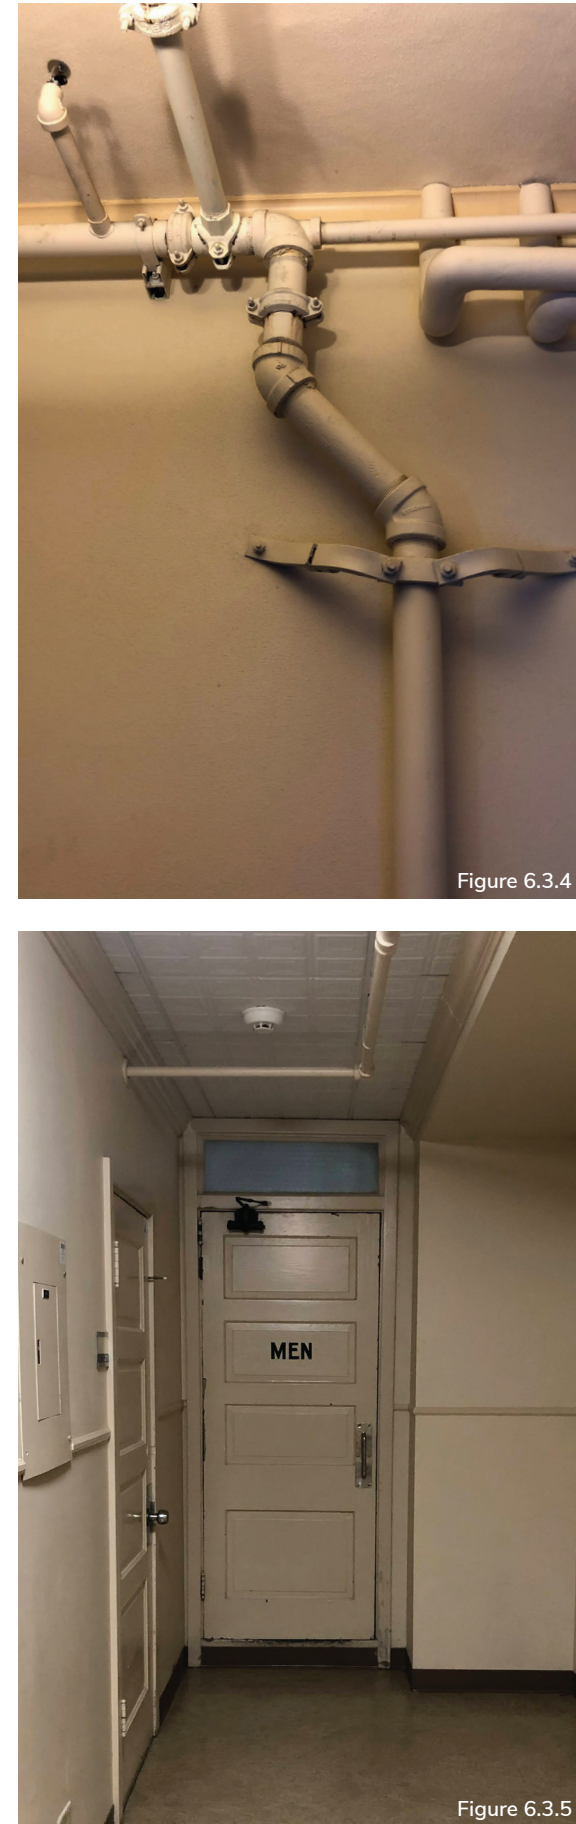
Figure 6.3.4

- The original design did not account for modern building systems such as fire sprinklers, ventilation air registers, electrical conduit, and plumbing components (figure 6.3.4).

- The construction of new partitions and ceilings will allow building systems (fire sprinklers, ventilation air registers, electrical conduit and plumbing components) to be properly concealed.

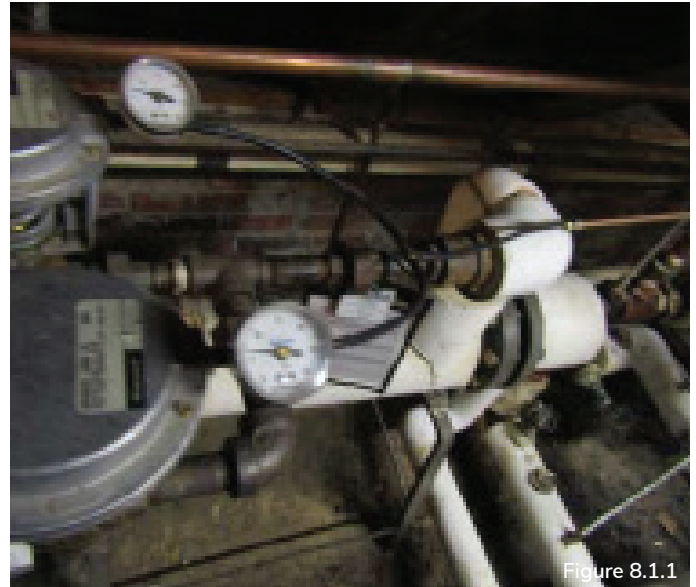
Figure 8.1.1

The heating media is provided by a central steam loop. A heat-exchanger (figure 8.1.1) covers the steam energy to heating hot water. An expansion tank and two condensate return systems (figure 8.1.2) support the heating system, and pump equipment distribute the heating hot water. Two indoor air handling units with hot water coils provided tempered air to the corridors. Distribution equipment consists of metal ductwork. Controls are a hybrid configuration with pneumatic and digital inputs, and a local compressor provided control air (figure 8.1.3). Permitter radiators support the system and utilize the heating hot water. Rooftop package units (figure 8.1.4), ductless split systems (figure 8.1.5), an indoor Trane split system, and window air conditioning units (figure 8.1.6) serve select rooms provide either heating, cooling, or both. An inline centrifugal fan, utility set fans and propeller fans (figure 8.1.7-9) serve smoke exhaust, restrooms, and general exhaust needs. The HVAC system varies in age and appears in adequate condition, but most of the equipment is at or near the end of its lifecycle and should be replaced to improve performance and energy efficiency and to reduce maintenance.

- All HVAC systems to be replaced with a single integrated hydronic system utilizing hot and chilled water throughout.
 - o Terminal devices will be a combination of hot water radiators and chilled beams.
 - o The system will be managed by all new DDC controls so that adjustments and reprogramming can be made remotely through the Building Automation System (BAS).
- Cooling will be added to the entire building to extend the habitability of the building in the swing seasons

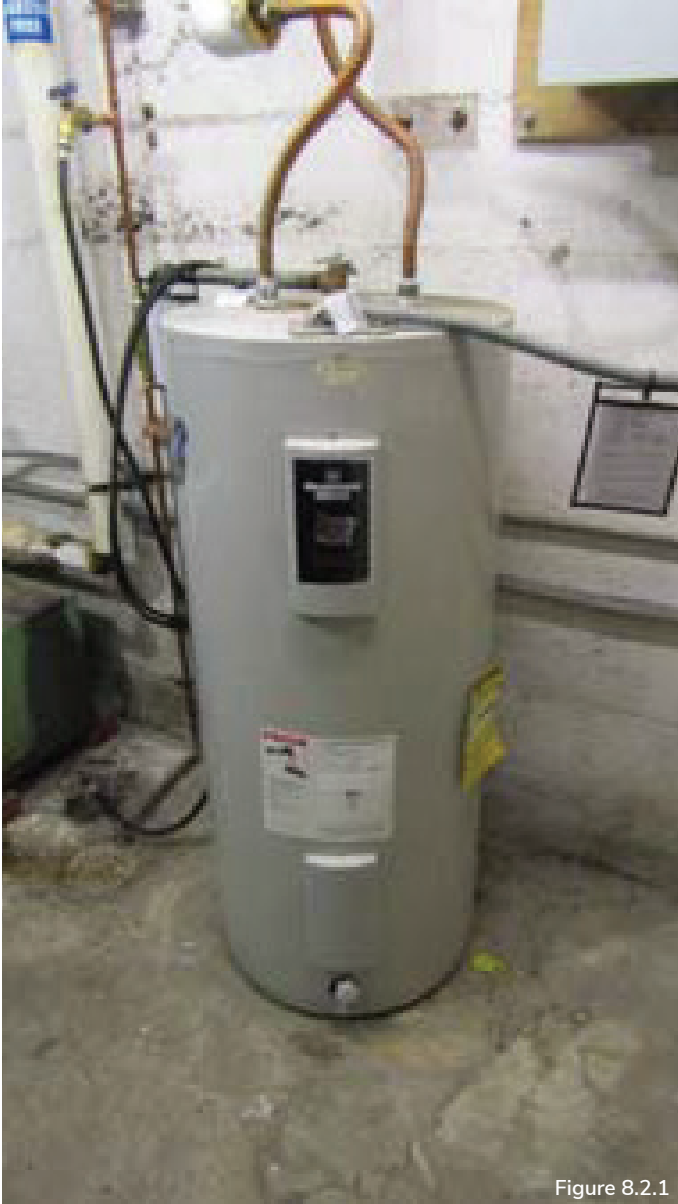
Figure 8.2.1

Domestic hot water is provided by a 2017 Bradford White, residential-grade, electric water heater (figure 8.2.1). It has a tank capacity of 50 gallons.

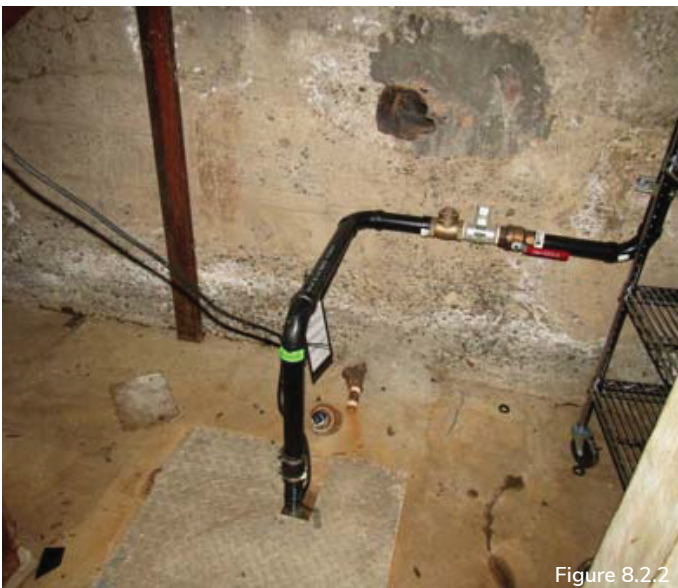
Figure 8.2.2

There are two sump pumps (figure 8.2.2) – one in the basement and one on the site. One unit is believed to be new and appears in better condition.

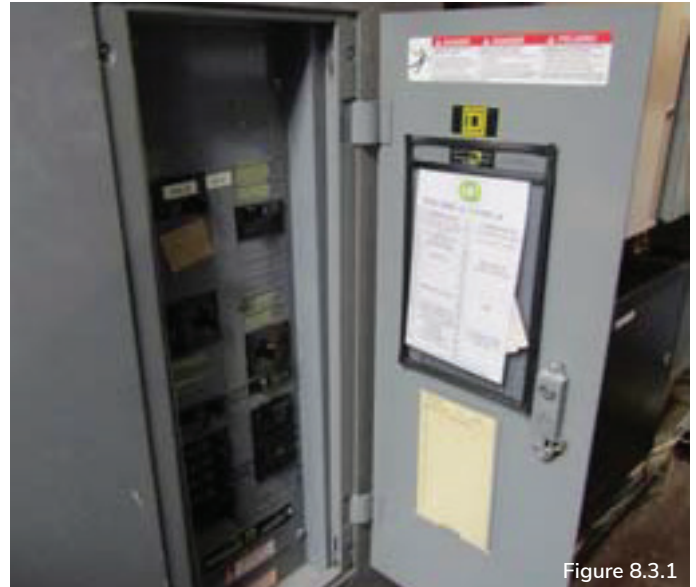
Figure 8.3.1

The building is served by a 208Y/120V, 3-phase, 4-wire, 800A Main Distribution Panelboard (figure 8.3.1) and supplied by a medium voltage step-down, on-grade, pad-mount transformer (figure 8.3.2) located outside the lower floor electrical room. The main panelboard has a rated capacity of 800A originally installed around 1975 and has reached the end of service life. The electrical distribution system consists of several panelboards located on each floor that provide 208Y/120V for mechanical, lighting, and general-purpose loads. These other branch panelboards appear to have been installed in 1975 and are also approaching the end of service life. Additionally, these panelboards were observed to have limited room for future growth.

- Replace the existing main distribution and branch panelboards.
- Where interior walls are being removed or rebuilt, degraded branch circuit conductors and wiring devices (receptacles, switches) should be replaced.
- Replace entire existing electrical distribution equipment and wiring.
- Replace existing building fire alarm system to meet AHJ requirements and/or match campus standard.

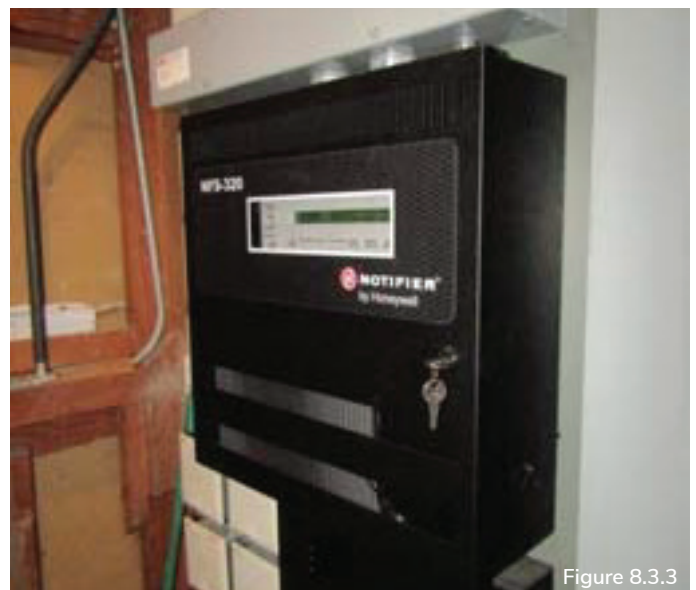
Figure 8.3.3

The facility is served by an addressable fire alarm system manufactured by Notifier. The main panel is in room 015 (figure 8.3.3). There are pull stations and smoke detectors for activation as well as strobes for notification. The system appears to be a combination of a newer panel and aged devices. Many devices have reached the end of their lifecycles and the main panel is approaching the end of service life.

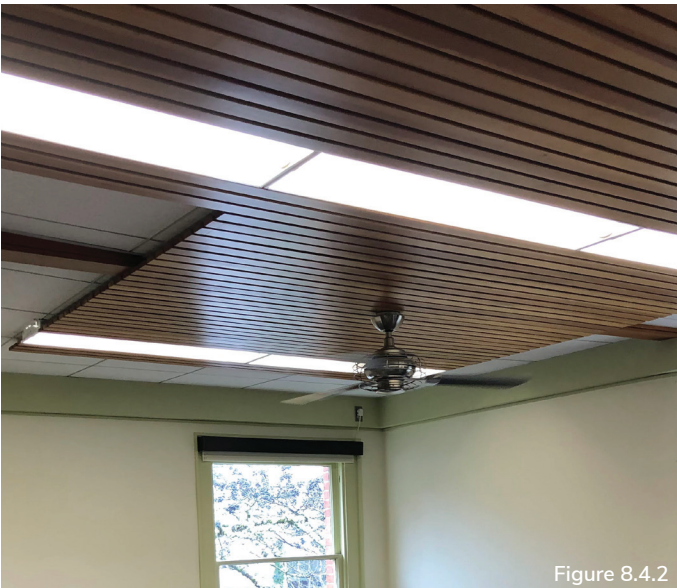
Figure 8.4.2

The interior lighting is showing significant signs of wear and age. It consists of mostly lay-in and surface-mounted fixtures with acrylic, parabolic, or no lenses and T8 fluorescent or compact fluorescent bulbs. The interior lighting varies in age; older fixtures can be found throughout (figure 8.4.1) while some contemporary fixtures exist in previously renovated spaces (figure 8.4.2). Additionally, decorative surface mounted fixtures have been installed in corridors (figure 8.4.3) though they are not original.

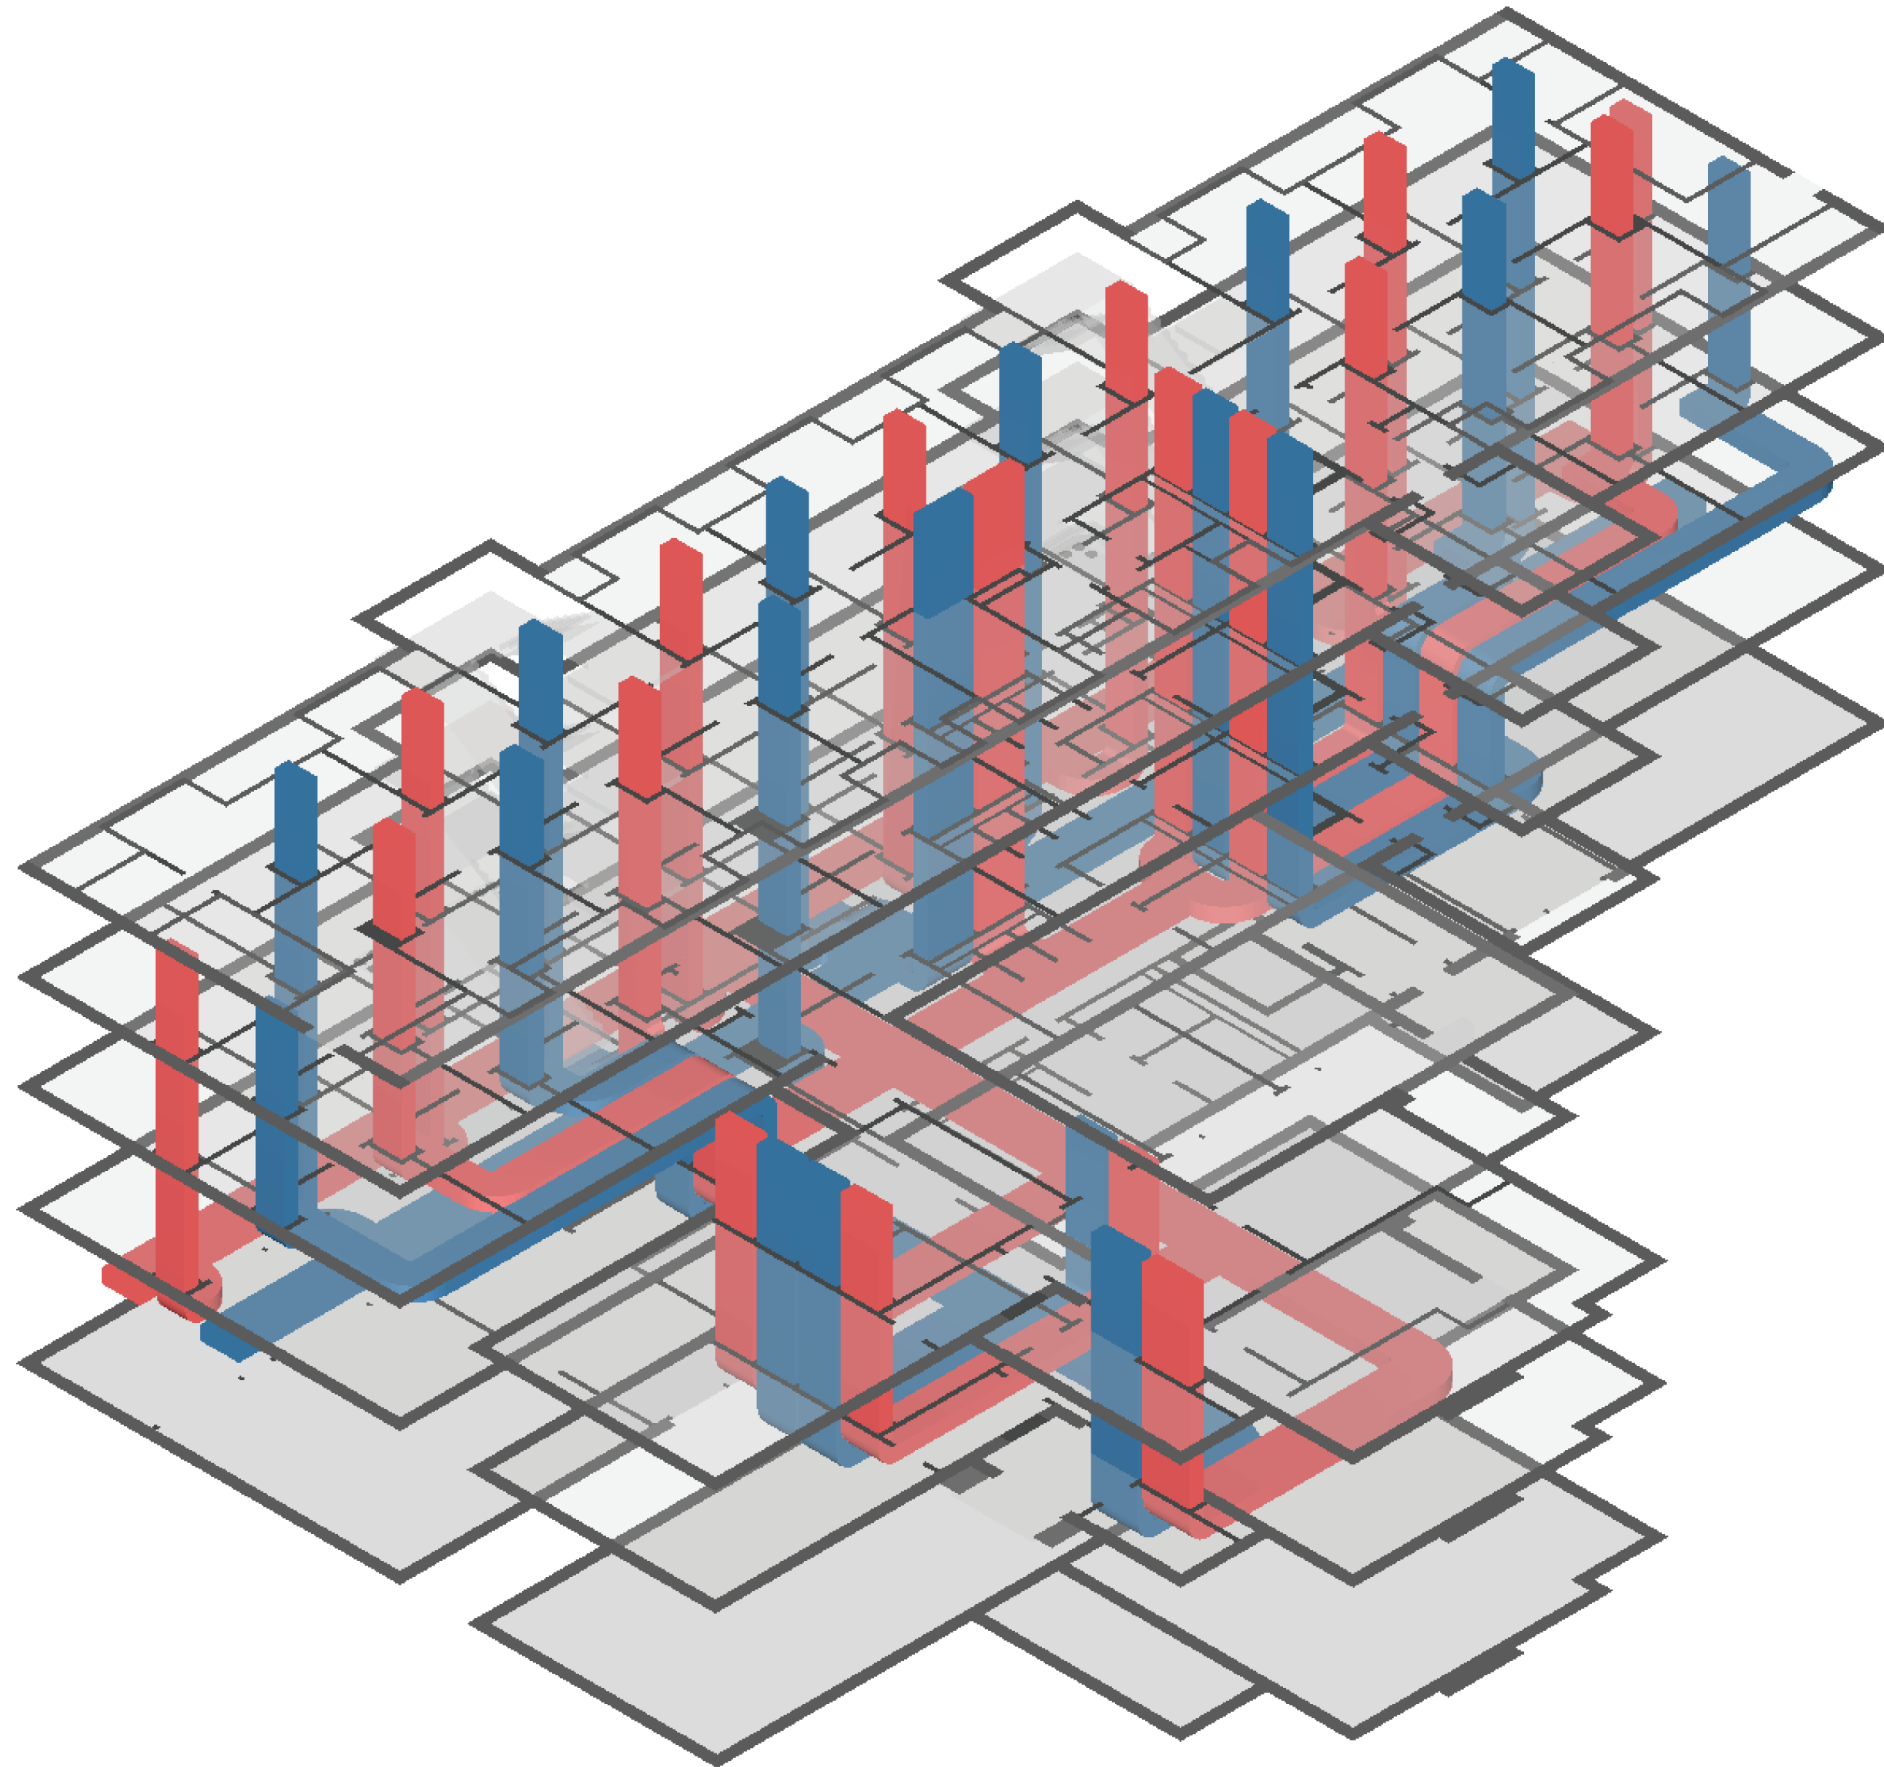
Friendly Hall's original use as a dormitory resulted in low floor-to-floor heights in most of the spaces. To add modern mechanical systems, ducting and chases must first be run laterally in the basement. From there, steam, chilled water and ventilation air will be distributed to each room through vertical shafts as shown in the conceptual diagram.

Each separate space has two adjoining shafts, one for supply air and one for return air. The shafts are also shared with adjacent rooms which results in an alternating configuration of supply and return shafts.
