STRAUB HALL INTERIORS PRELIMINARY HISTORIC ASSESSMENT

CAMPUS PLANNING, DESIGN AND CONSTRUCTION
JANUARY 2011 (UPDATED JANUARY 2016)

This assessment identifies Straub Hall's historically significant interior finishes, features, and spaces.

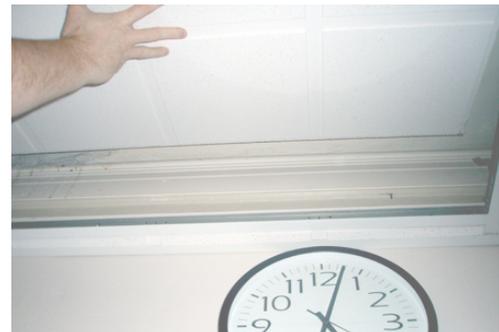
The ceiling was lowered using an acoustical tiling system. The original wood picture rail moldings at the original ceiling height are evident above the ceiling tiles along the north wall.

^ ORIGINAL WOOD TRIM ABOVE THE CEILING TILES.

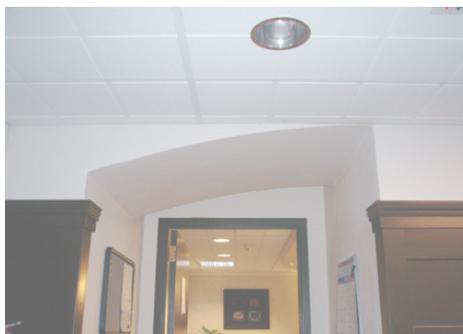
Alterations: The south half of the archway was filled in to allow for new standard 3' doors on the exterior and interior entrances. Carpeting was installed (it is unclear if the original taupe linoleum flooring remains underneath). All window casings, the fireplace, and the wood paneling on the walls are original but have been refinished and painted throughout the years. Some wood paneling has been added and made to look original.

^ ENTRY ARCHWAY.

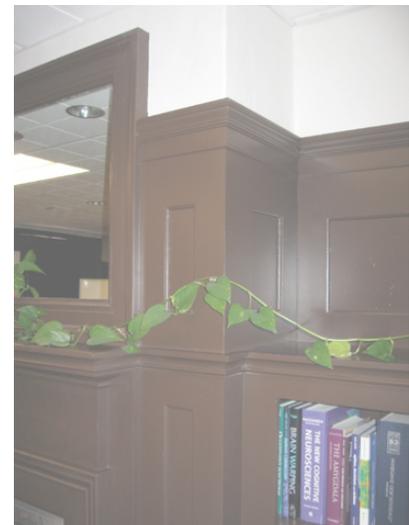
^ WOOD PANELING.

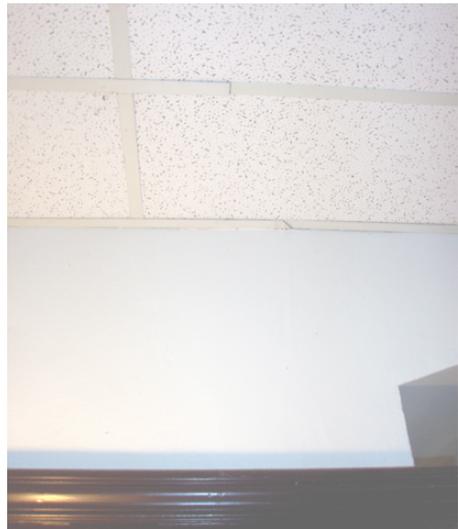
At one point the room was split into two offices, which is still evident in the remaining scars in the ceiling panels and on the walls. The room was returned to its original configuration some time ago.

^ SCARS FROM PREVIOUS DIVISION.

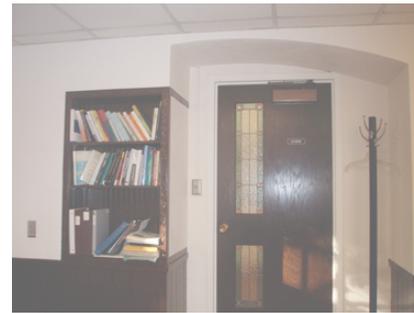
^ ENTRY ARCHWAY.

Alterations: Half of the archway was filled in, and the room was divided into two spaces.

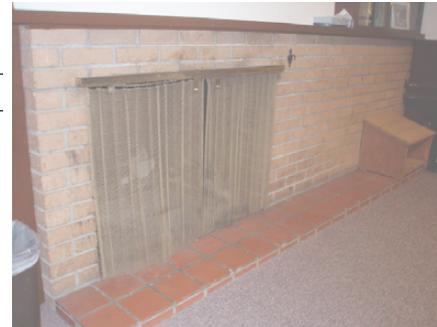
^ FIREPLACE.

All of the wainscoting, doors, and hardware have been replaced. Also, the bricks surrounding the fireplace and the terra-cotta tiles are thought to be of a different era.

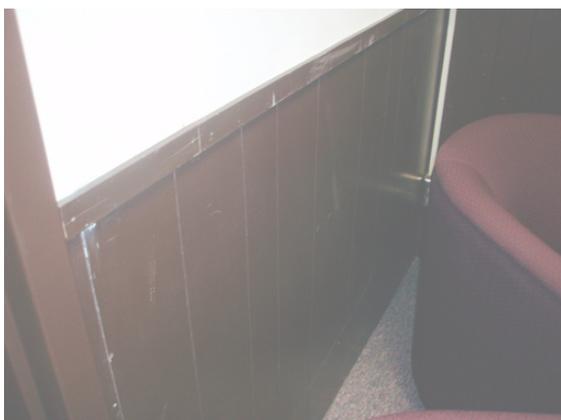
^ WAINSCOTING DETAIL.

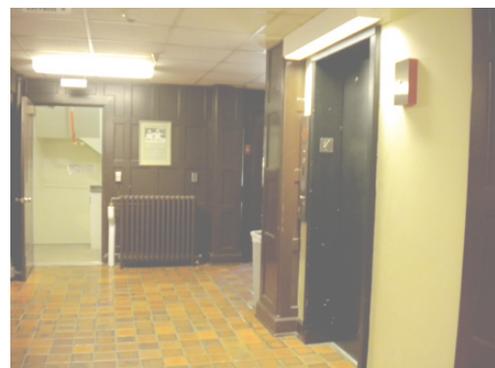
The original ceiling was covered by an acoustical suspended tile system. In 1974 an elevator was added between two existing structural columns, which were maintained.

^ HALLWAY ELEVATOR.

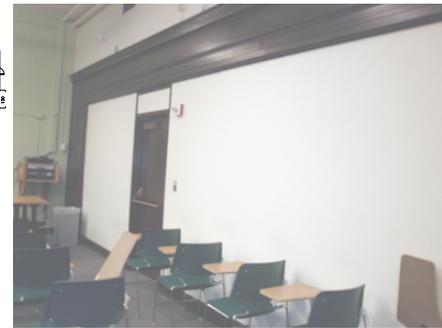
^ NEW SOUTH WALL.

The wall that splits this space in two is new, as well as the infill of a window in room 143 on the north wall due to the addition of a space on the other side of the wall (Earl Hall). The newer panelling used to fill the original window in this room is evident due to the drastic change in the inset panel squares.

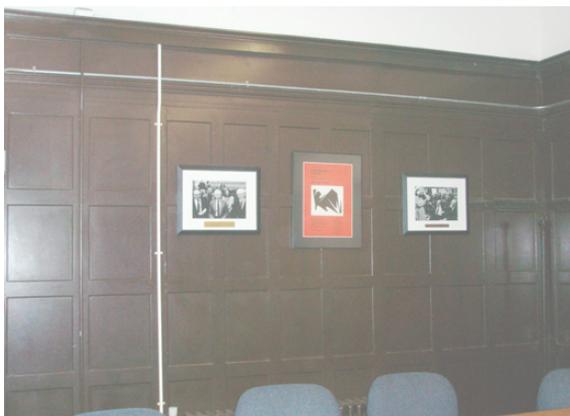
^ FILLED WINDOW.

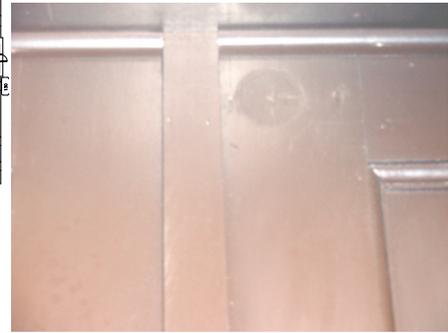
^ BATON AND BUMPER SCAR DETAIL.

The paneled walls of this space are the original accordion walls. They have been fixed into place and the joints have been covered with battens. The original scars from the bumpers and the walls scraping against the moldings are still visible on the accordion panels.

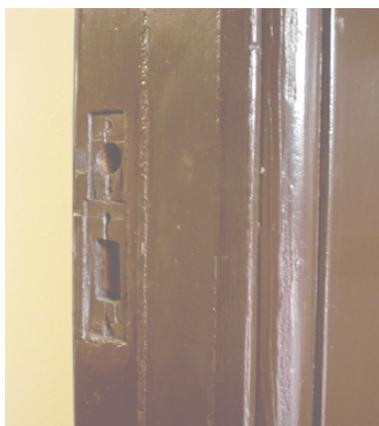
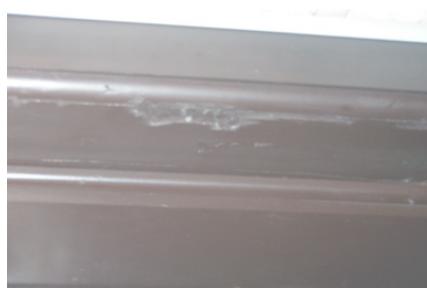
< WALL SCAR DETAILS. ^

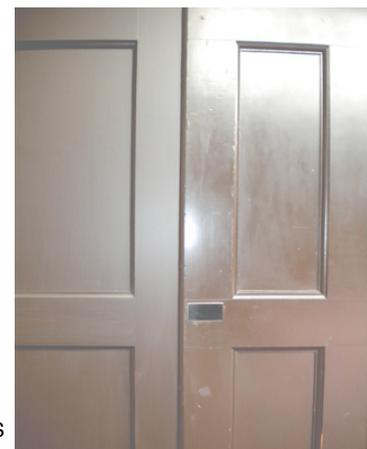
EXAMPLE OF DIFFERENT FINISHES (NEW VS ORIGINAL). >

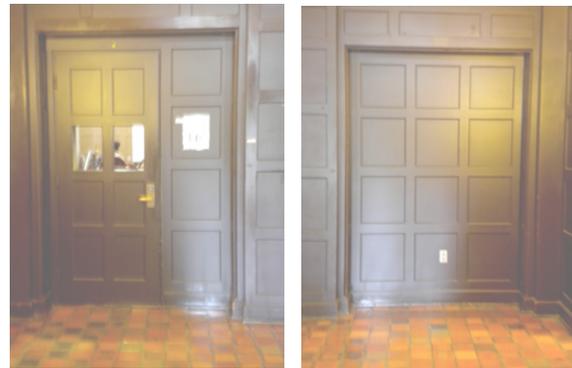
The east wall was originally the entrance to the dining hall, which mirrored the main entrance to the building with three sets of double doors. In changing this room to a lecture hall, the entries were sealed. The infills were designed to match the existing columns, creating a seemingly original wall. Sitting here, too, is a bust of John Straub, in memoriam.

^ EAST INFILLS. ^

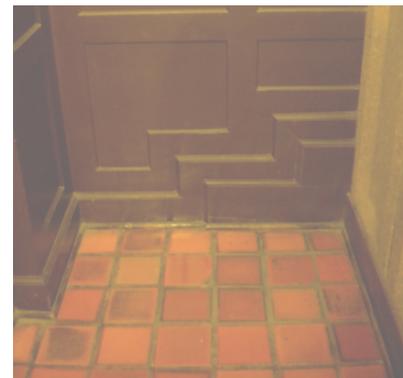
The original stairs were removed to add a ramp, making the Straub Hall lobby ADA compliant. The ramp is the most noticeable change in the space, since it clearly is not part of the original design. The baseboard that originally lined the stairs can still be seen.

^ STAIR BASEBOARD AND TILE DETAIL.

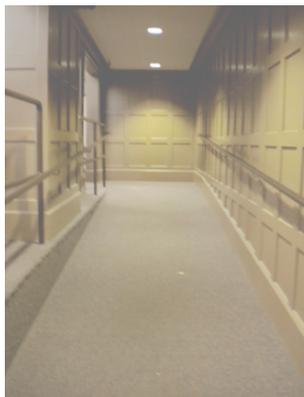
The main entry/foyer on the west wall was altered for ADA compliance in 1974. A ramp and new stairs were added to the foyer. The built-ins that now stand with the foyer columns were added when this room was converted into a classroom, as was the tiered/stepped floor for enhanced seating. Carpeting was installed. It is unclear if the original clear maple flooring remains under the carpet. Salvaged quarry tile from the lobby was used at the entries.

^ ADA RAMP.

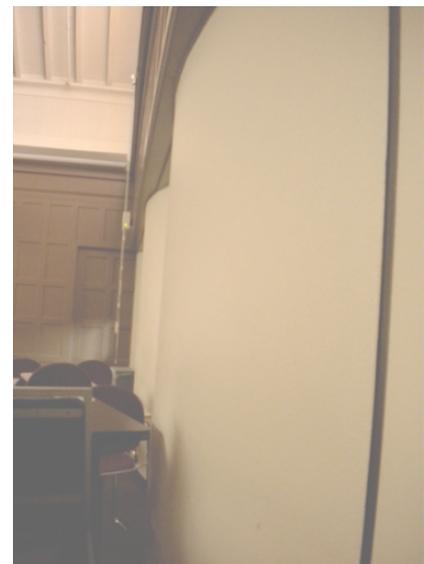
^ SOUTH WALL - ACOUSTICAL PANELS.

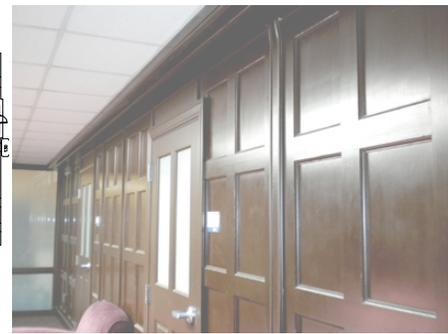
^ WALL DETAIL - NEW PANELING.

Alterations: The most notable change is the ceiling material and wall paneling.

Again, the panelling that you see is the original folding wall. When the battens are removed, the sections (complete with hardware scars) are visible.

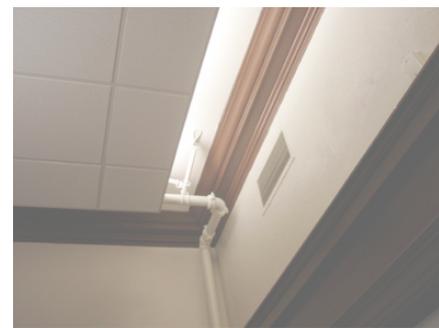
^ DROP CEILING REVEAL.

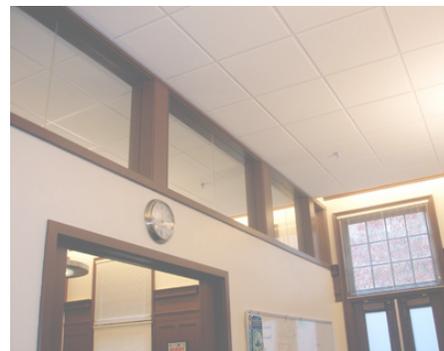
Alterations: Originally this space was one large room with a smaller room at the back (156D). The large room has been split into three rooms with the fourth still at the back. The partition walls, moldings, ceiling tiles, and carpeting all are new. Also, the original north accordion wall, which can be seen from the hallway, was modified to accommodate two new doors. The ceiling was lowered a significant amount to hide HVAC units above. Carpeting was installed in 154, 155, and 156B (originally clear maple flooring), and in 156D (originally grey linoleum). It is unknown if either original flooring materials remain under the carpet.

^ NEW PARTITION WALL.

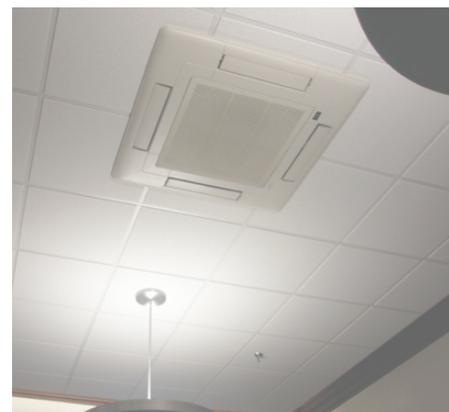
^ DROP CEILING DETAIL.

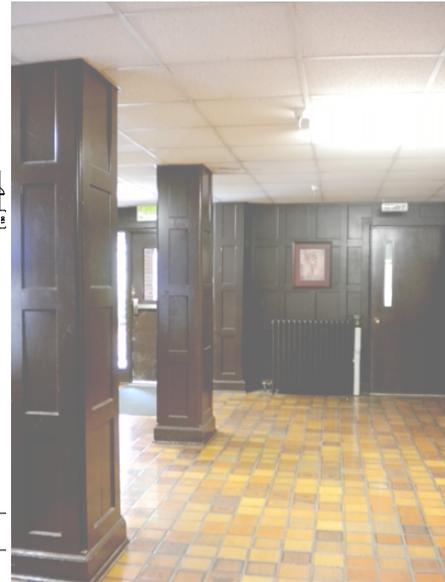
^ HALLWAY MATERIALS.

Alterations: The most notable change is the ceiling material and east wall (room 154).

The original ceiling has been covered by a suspended acoustical tile system.

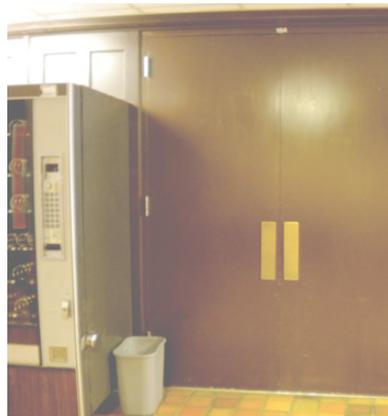
The east wall’s material and double doors are not original but were added in the 1974 remodel and have been preserved since then. A door to what was a trunk room (now a collection of small offices and subject run rooms) has been sealed, but the molding remains. The doors throughout the space are all different, only one being the original style (north of the skylight, first door to the east).

^ ROOM 154 - New (UNUSED) DOORS.

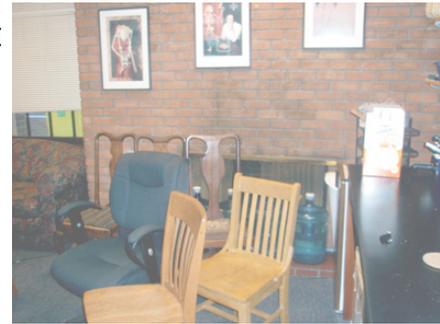
^ FIREPLACE CONTEXT.

Alterations: This room has been divided into two rooms, bisecting the fireplace's tiles. The bricks surrounding the fireplace and the wainscoting have been replaced, along with the addition of the office door. The ceiling tiles have been glued onto the original ceiling; no moulding remains.

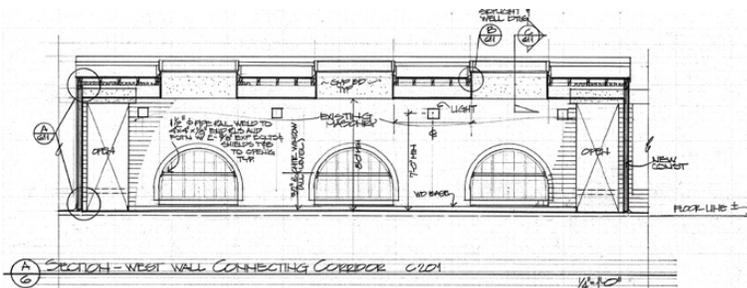
Alterations: This space was not part of the original design. When the connecting corridor was added the west wall, which is the upper portion of the main lobby, was preserved. However the north, south, and east walls (as well as the ceiling and skylights) all are new construction from 1974.

The only alterations to the west wall seem to be the additions of the steel piping across the windows, baseboard heaters, and the electrical light fixtures.

^ SECTION - WEST WALL CONNECTING CORRIDOR, 1974.

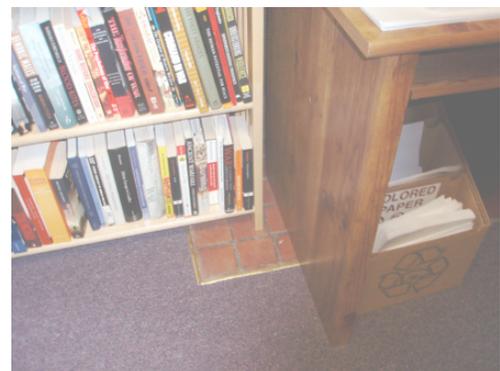
Alterations: The space was divided into three offices. All wall, floor, and ceiling finishes were altered. The fireplace's brick and tile work may have been removed and replaced.

^ FIREPLACE TILING DETAIL.

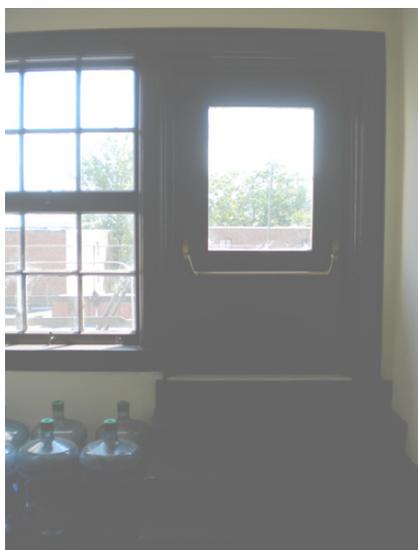
Alterations: All exposed piping, electrical, and mechanical units were added, as were fire doors and a fire escape door. In 1984 new carpeting was installed. It is unclear if the original taupe linoleum remains under the carpet. A few doors have been replaced as well (*see North Hallway 4th Floor New vs. Old Door*).

^ NORTH HALLWAY 4TH FLOOR FIRE ESCAPE.
