University of Oregon

2017 Deferred Maintenance Building Assessment
Villard Hall/ Miller Theatre Complex

November 3, 2017

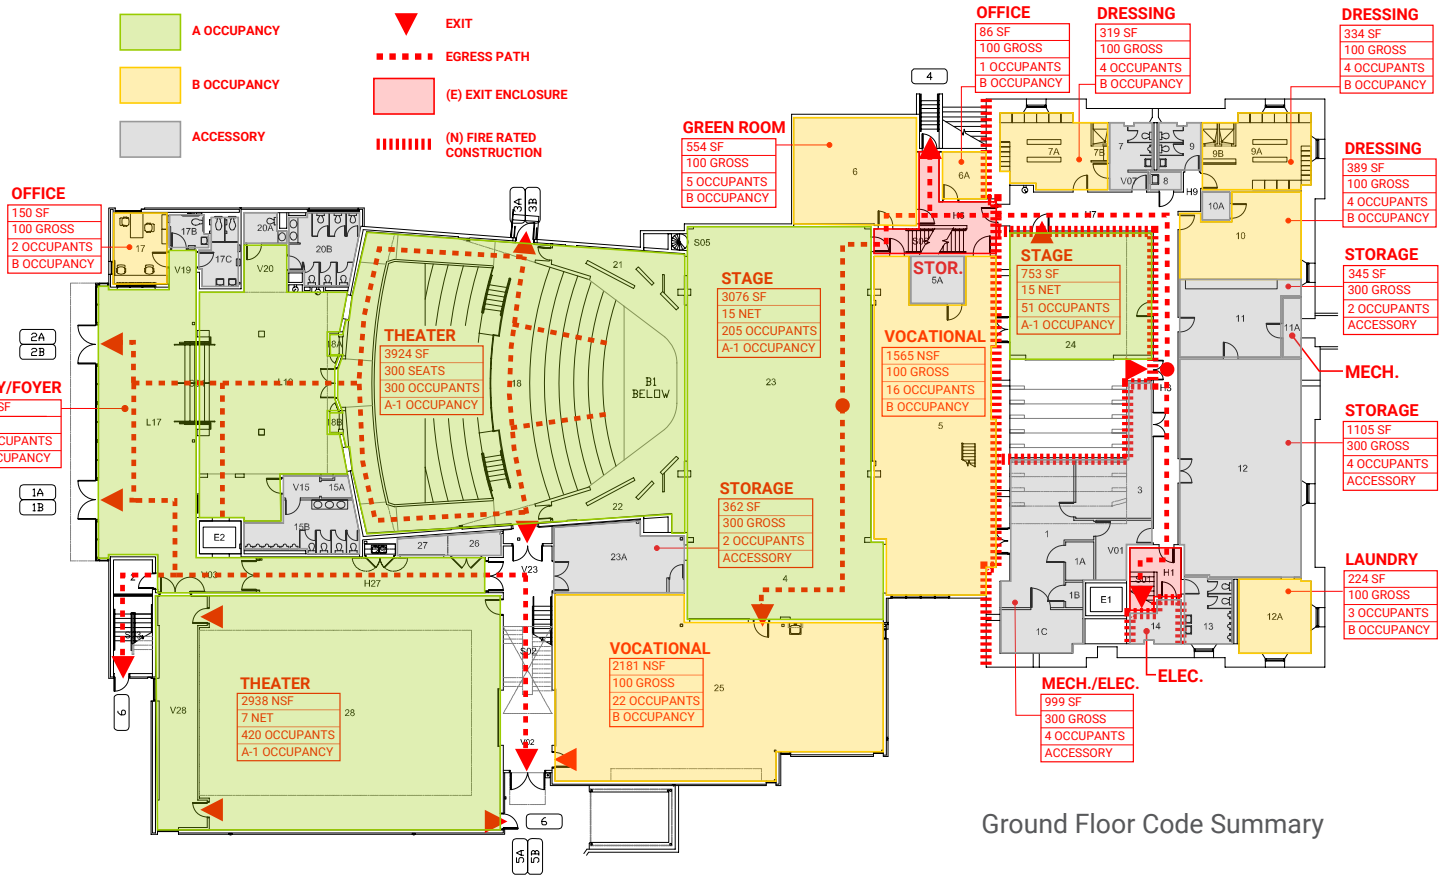
Ground Floor Code Summary

The Miller Theatre Complex egress paths and exits for the Robinson Theater audience areas were revised for code compliance with the 2009 addition project. However, the backstage areas were not revised and still present some egress issues. All Ground Floor (Level 1) backstage areas are provided with two exits but the egress path from Stage 23/Scene Shop 5 to the north stair tower exterior door is routed through an intervening space Green Room 6 rather than into a protected exit enclosure. **Modifying the wall layout within Green Room 6 is recommended to rectify this deficiency.** The Theater 18/Stage 23 exit at the north wall of the theater discharges into a sunken paved area in the exterior landscape without an accessible path leading away from the building. **While an accessible exit is provided elsewhere in the Miller Theatre, this exit should be revised to provide a more universal access approach for theater exiting.**

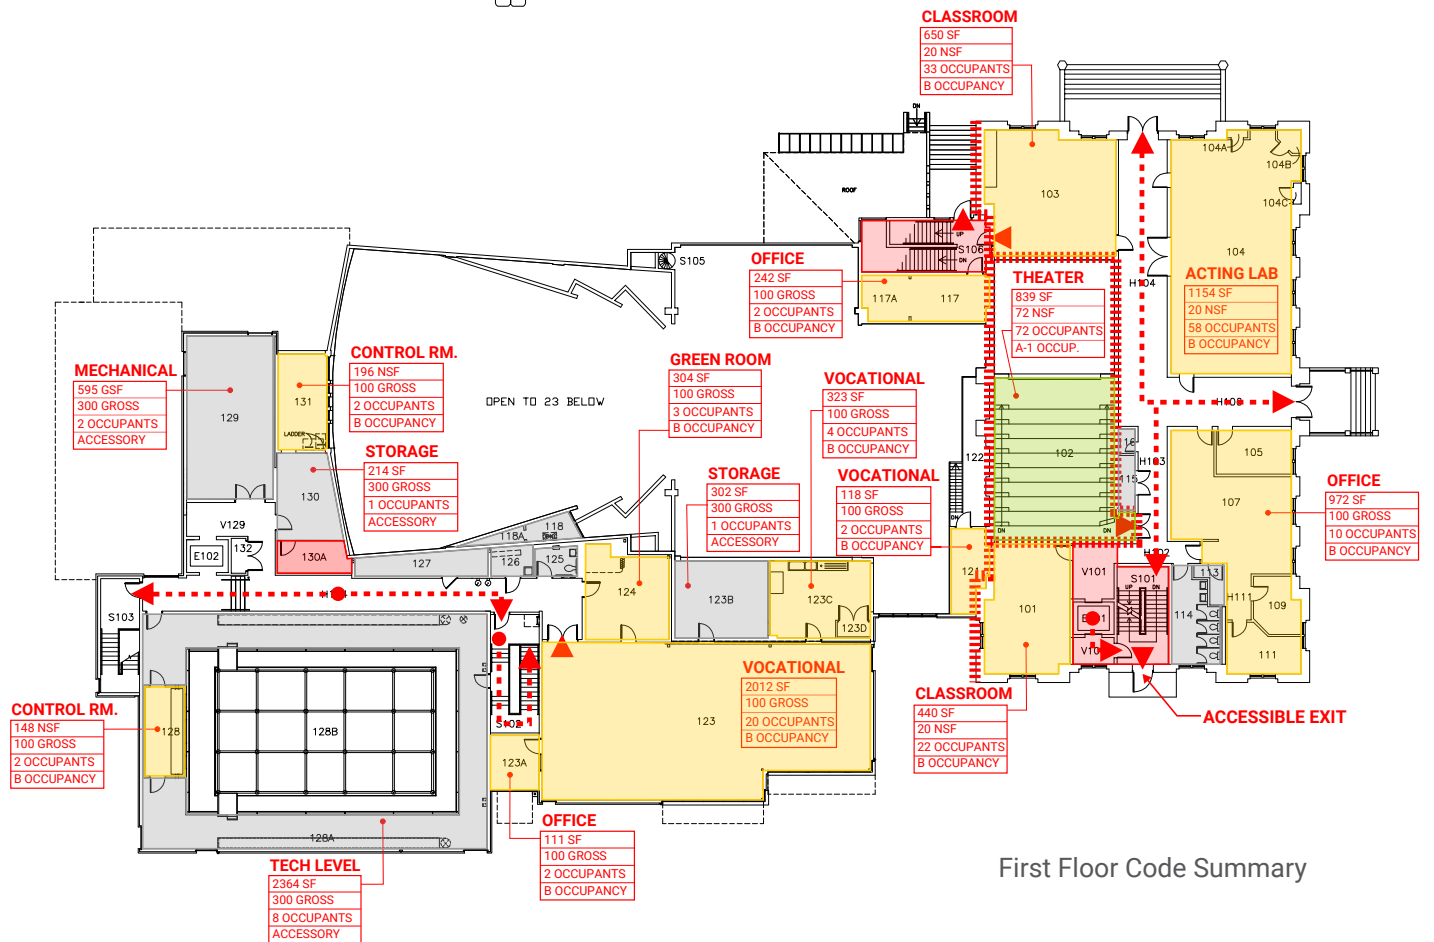
First Floor Code Summary

The ground floor level of Villard (First Floor as indicated on plan drawings) provides multiple exit routes with line of sight egress towards the north, east and south. All three exits at the ground floor require occupants to traverse down a flight of stairs to reach exterior grade. The accessible egress path from the building at all floors requires the use of the elevator located at the south end of the building. The south stairway is the only circulation stair located within the historic walls of Villard Hall. The stair walls and treads are constructed of concrete and stair doors appear to be older versions of fire-rated doors. Basement entry to the south stairway is not protected with a fire-rated door. The north stairway is located outside the historic walls and provides egress for both Villard Hall and the backstage areas of Robinson Theater. The north stairway walls and treads are constructed of concrete and stair doors are older versions of fire-rated doors. Egress capacity width is adequate for the occupant count at all exits. **Although stair construction, width, and fire protection appear adequate, stair handrails at both north and south stairways do not meet current 2012 OSSC building code and should be replaced.**

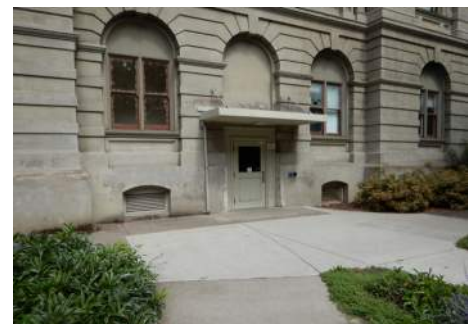
Existing Accessible Entrance at South Elevation

In an effort to apply universal design principles across campus facilities, it is recommended to replace the existing south entry into Villard Hall and replace it with a fully accessible path of travel. Exterior grading would be modified to accommodate a ramped approach to the raised south exterior door allowing for direct entry by wheelchair users into the first floor. The exterior ramp would be designed comprehensively with south plaza site improvements to provide a celebrated entry and gathering space commensurate with the historic Villard Hall and other campus building entries.

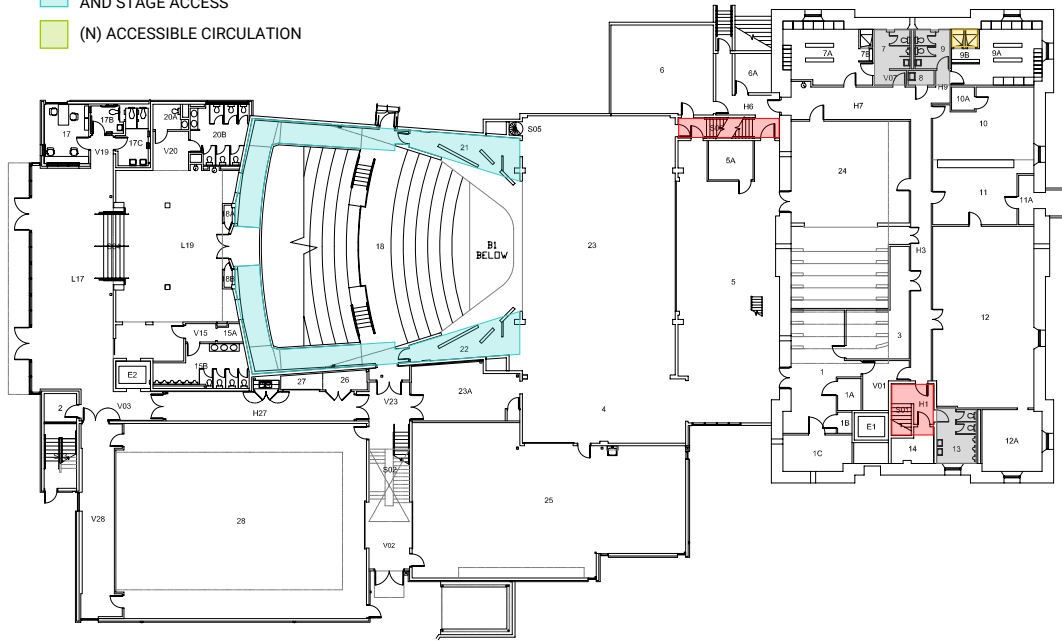
Ground Floor ADA Summary

- NONCOMPLIANT STAIRS
- NONCOMPLIANT RESTROOMS
- NONCOMPLIANT SHOWERS
- NONCOMPLIANT SEATING AND STAGE ACCESS
- (N) ACCESSIBLE CIRCULATION

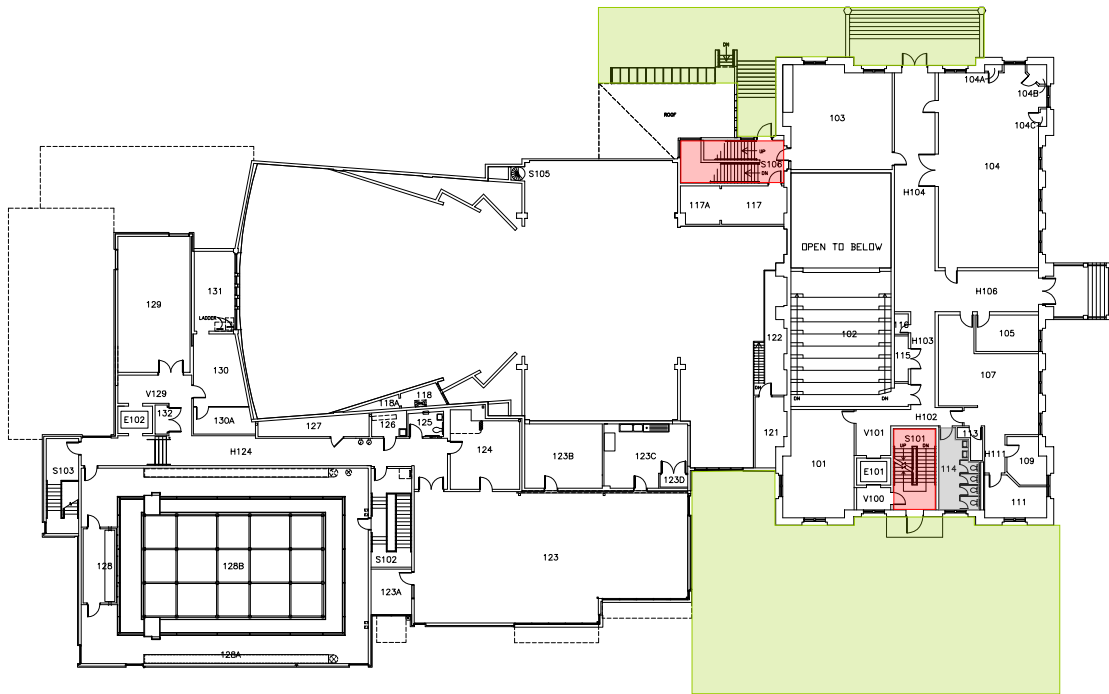
First Floor ADA Summary

- NONCOMPLIANT STAIRS
- NONCOMPLIANT RESTROOMS
- NONCOMPLIANT SHOWERS
- NONCOMPLIANT SEATING AND STAGE ACCESS

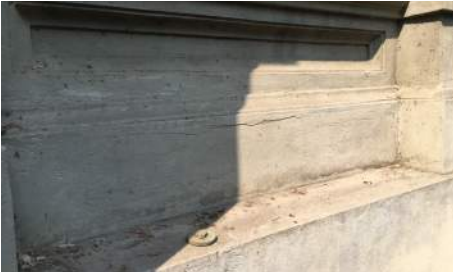
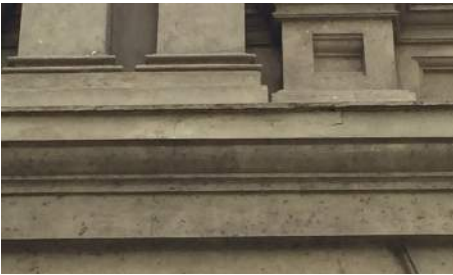
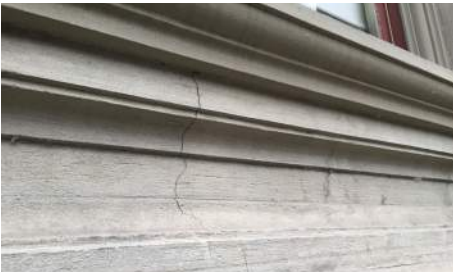
Overall, the stucco paring coat is performing quite well despite the building's age. Cracking (TFG01-TFG03) and spalling (TFG04-TFG05) were noted at various areas throughout the building; however, this type of cracking of a building of this vintage is to be expected due to normal building movements and thermal expansion and contraction over time. Considering the stucco is in generally good condition, TFG recommends only spot repairs and cleaning per the recommendations noted below as opposed to an extensive tear off.

Cracking

- Rout out cracks to form a "V" shaped groove.
- Repair crack with a knife-grade, acrylic elastomeric patching compound.
- Feather the patching compound at the edges of the crack.

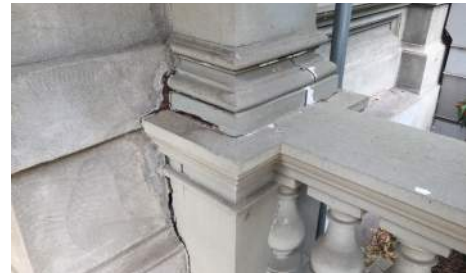
TFG07

At four locations on the east elevation, at the interfaces of the corner elements (TFG06), the columns (TFG07), and the main wall area, there are large cracks extending up from foundation to the underside of the mansard roof and entrance roof/canopy. This cracking also occurs on the west elevation on either side of the interface with the Miller Theater Expansion. It appears as though this cracking has occurred over time, likely due to differential settling of the building.

- Rout out cracks to form a consistent-width joint with straight edges. Joint should be no wider than 5/8".
- Install bond breaker tape on the face of underlying substrate
- Install silicone sealant to joint. Color to match cleaned stucco color as much as possible
- Broadcast sand into the wet sealant to provide textured aesthetic.

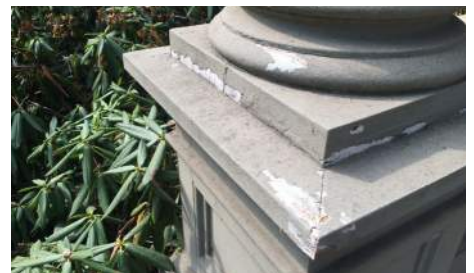
TFG10

The balustrades at the base of the mansard roof (TFG08), the railing at the east entry (TFG09), and columns (TFG10-TFG11) at the east entry are wood framed and coated with a cementitious waterproofing coating to provide a stone/stucco finish similar to the rest of the wall. The coating is deteriorating in the form of cracking and spalling due to loss of adhesion with the underlying wood. As a result, with the coating not providing protection at numerous areas around the building, the underlying wood has started to deteriorate. In several cases, large gaps in the wood seams and joints were observed (TFG12).

- Remove all cementitious waterproofing coating down to sound substrate.
- Where wood is found to be unsalvageable, replace with new wood in-kind.
- Apply new cementitious coating to all wood surfaces.

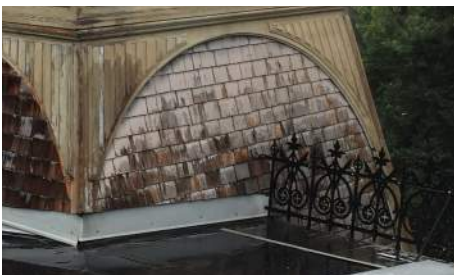
TFG14

The steep-sloped portions of the building are covered with painted wood shingles on all sides. A coating procedure was completed reportedly back in the late 1990's. At the north mansard and the northeast/northwest corner elements, the paint is failing badly (TFG13-TFG16). This may be due to the notion that the shingles were not back primed. Spot coating failure was noted at other limited locations throughout the roof. Coating flaking and deterioration of the underlying wood shingles were noted. Other areas of the mansard roof, notably the east elevation, saw the highest concentration of moss growth on the building (TFG17).

- Remove all shingles and coating at all areas affected by paint deterioration.
- Install new cedar shingles matching the size and profile of the existing shingles.
- Fully prime each shingle on all sides to prevent water vapor passage and deterioration of the coating.
- Apply new paint coating over all shingles. Paint to match existing in color.

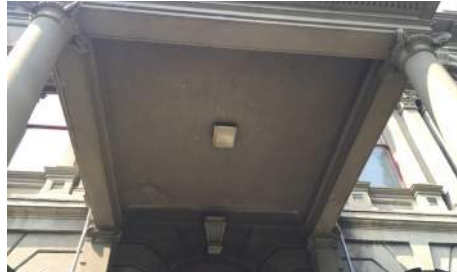
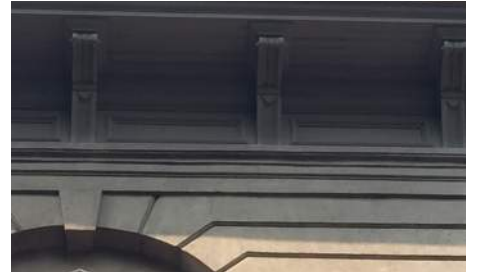
From the vantage point at street level, the soffit looked to be in generally fair condition with a few areas of deteriorated paint (TFG19-TFG20)

- Scrape all deteriorated paint to sound substrate.
- Paint all wood soffits, color to match existing.

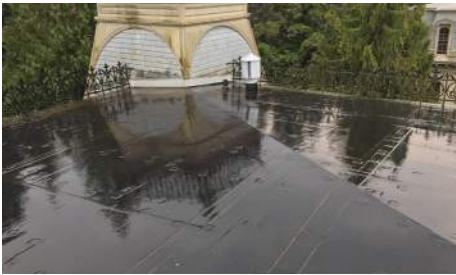
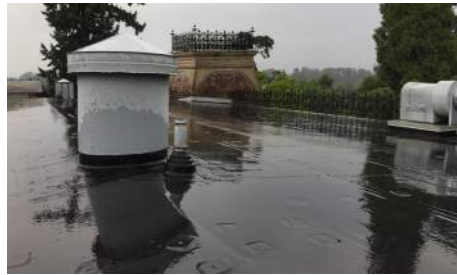
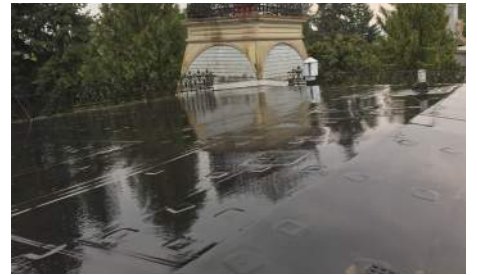
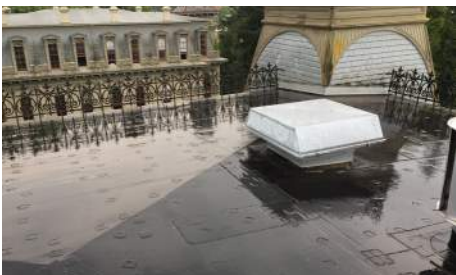
The main roof is a Firestone 60mil ethylene-propylene diene monomer (EPDM) roof; sometimes referred to as a rubber roof. The roof is in very good condition (TFG21-TFG24) with a few areas requiring general seam maintenance and penetration seals (TFG25). Metal flashings were generally found to be in serviceable condition.

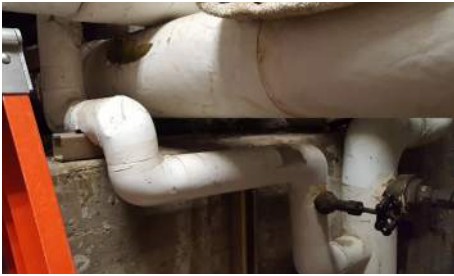
Chilled Water and Steam entering the building from the tunnel system

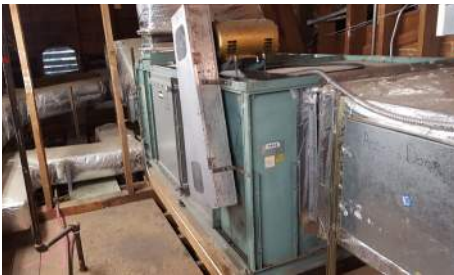
Typical AHU in Villard Hall Attic

The attic of Villard Hall houses an array of ductwork and three air handling units, one of which is abandoned in-place. The air handling units serve the third floor and a portion of the second floor and were originally installed during the 1949 Robinson Theater addition. A renovation in 1965 removed these units and replaced them with new units providing both heating and cooling.

All of the mechanical equipment in the Villard Hall is well beyond life expectancy and shows signs of fatigue and failure. The current system types are out of date and very inefficient by current standards. The university has invested significant resources into the existing campus heating and cooling systems. These systems are still a viable source for heating and cooling the building and should be utilized to improve overall HVAC performance. There are two options to consider for utilizing these systems and provide an energy efficient building system.

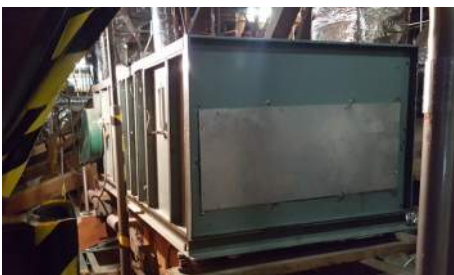
Abandoned AHU in Villard Hall Attic

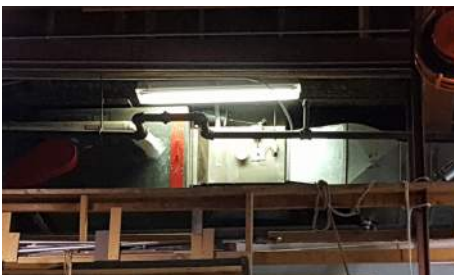
Minor Theater Air Handling Unit

Included in the 1949 renovation was a heating and ventilation unit dedicated to the "minor theater" (**Theater 102**). This space is still served by a heating and ventilation unit but available information does not indicate when or if it has been replaced suggesting it may be the original unit installed in 1949.

In addition to the two options above, the small theater located in Villard Hall will be served by a new air handler dedicated to serve that space. Heating and cooling will be provided to the air handler by the building hot water and chilled water systems, respectively.

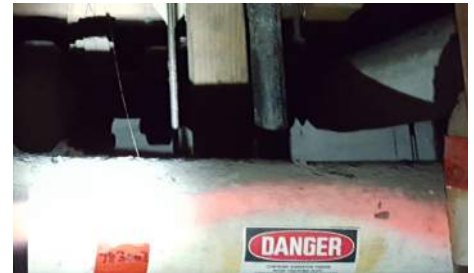
Asbestos Covered Piping

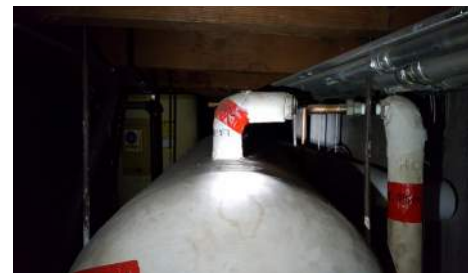
Asbestos Covered Equipment

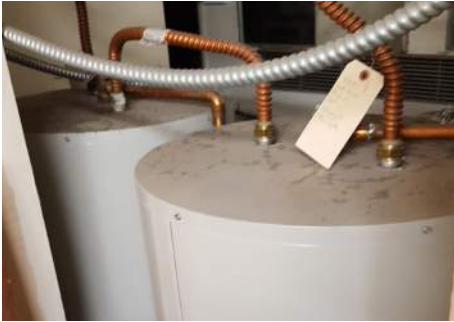
Electric Hot Water Heaters in Villard Hall

A new electric domestic hot water heater is recommended with a storage tank and circulating pump system and no dead legs. A circulating pump system will ensure that the temperature stays a constant 140 Degrees F and minimizes any potential water-borne bacteria from forming. A mixing valve at each fixture will ensure that the hot water is mixed down to 120 Degrees F to prevent scalding. As an alternate steam could be used as the heat source in lieu of electric.

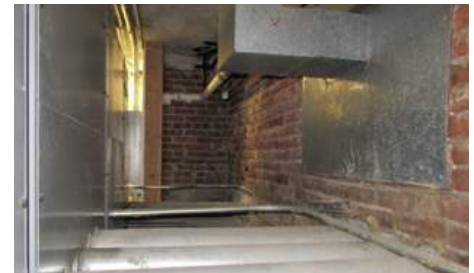
The main electrical service is rated at 1600A capacity, 208Y/120V, 3 phase, 4 wire. The main Siemens switchboard is dated 09/1993 and is 24 years old; only about 40% useful life remaining. The main switchboard has had a Square D Powerlogic PM8000 digital meter installed, possibly in 2007 when the installation was last inspected by the City (12/04/2007). The current basis-of-design for the campus metering system is the Powerlogic ION 7650. The current load observed while on site was 75 amps (serving a mostly unoccupied building).

Main service conduits coming into main gear

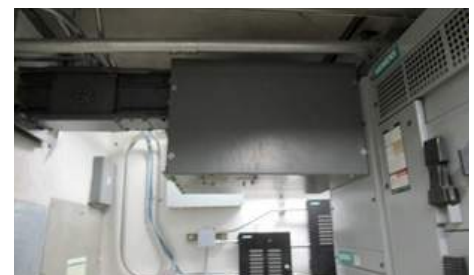
The main switchboard was not able to be installed against the exterior wall due to very tight clearances and an awkward HVAC duct located directly behind the gear. This locates the gear so there is only the minimal 4 feet clearance for the front of the gear. Due to the high arc flash hazard, greater clear space is needed. There appeared to be no seismic support installed for the main gear line-up either.

Working clearance issues in main electrical room (Bus-riser pictured)

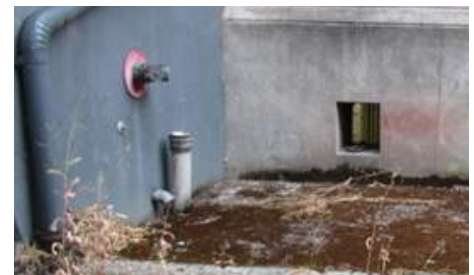
Opening into main electrical room

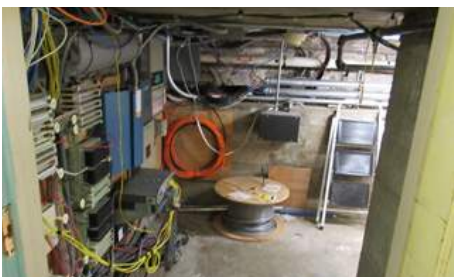
Current demark location for low voltage services

The main MDF/IDF room is located at the south side of the building beneath the Ground Floor stair flight in a space with limited head height and access. The main telecom switch for the building is located in this space as well as the Altronix power supplies, telephone gear, and low voltage control panels. The space is unconditioned and does not have the required working clearances.

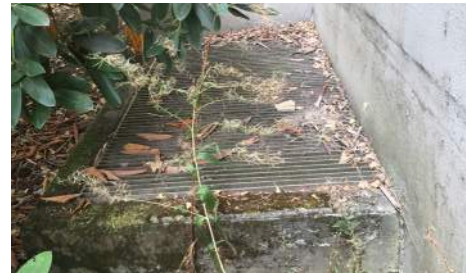
TFG43

There is an approximately 10-15’ deep mechanical well at the north elevation (TFG43-TFG44). The well is surrounded by concrete on the soil side and has a mechanical louver at the bottom of the well on the building side. The condition of the louver is unknown as we did not have access to this area. A bar grating with deteriorating paint finish is installed atop the opening to prevent fallen objects or people. Unfortunately, there is a lot of debris and some trash at the base of the well.

- Remove bar grating. Scrape and paint prior to resetting.
- Clean all debris and trash from bottom of well.
- Assess mechanical louver for functionality. If not functional and needed, recommend removing and infilling the space with concrete.

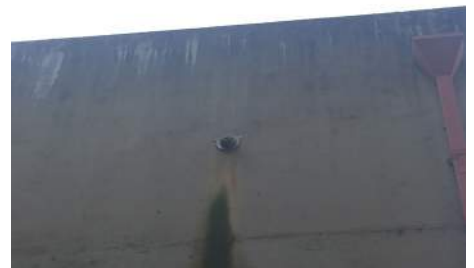
TFG45

The entry door at the north elevation has been changed since the original construction. It is presumed that this change took place as an add-on to the 2009 expansion. The entry is composed of a single, hollow metal door and flanked on both sides by stucco infill. The door has a canopy above. While we could not access the roof directly, it was noted from other vantage points that there was considerable moss growing on the surface (TFG45).

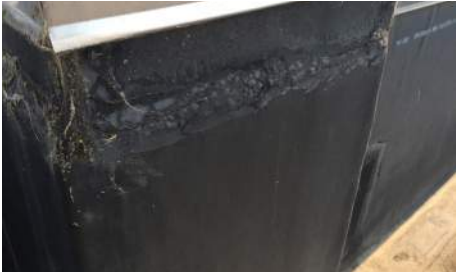
TFG48

All roofing at the Robinson Theater Expansion is Firestone 60-mil EPDM roofing similar to the main roof at Villard Hall. The roofs are in generally good condition with only deferred maintenance and minor roof repairs required (TFG48-TFG51) with the exception of the connector roof covering the connection of Miller to Villard Hall. At this connector (TFG52), TFG and FFA noticed that water was under the roof system and had presumably reached that location through that hole (TFG53-TFG54). The extent of the underlying damage to the insulation is unknown as we did not open the roof membrane here; however, the substrate directly under the roof felt “spongy” which typically signals extensive moisture intrusion to the insulation layers.

- While these roofs are in generally good condition, maintenance needs to be performed to address the beginnings of failed seams and patches.
- Engage a roofing subcontractor knowledgeable in Firestone EPDM systems and perform general seam/patch sealing for approximately 50% of the roof surface.

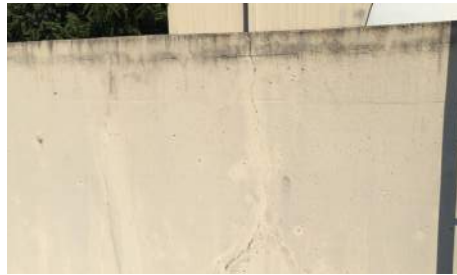
TFG55

The parapets each of these roofs is a continuation of the concrete wall below. At each of these roofs, cracking at approximately 6” below the top of parapet was noted and vertically in limited locations (TFG55-TFG56). This is likely due to corrosion of the reinforcing bars within the wall. Additionally, on the south and west parapet walls, the north and east facing side are exhibiting excessive moss growth signaling that water is on these surface for extended periods of time (TFG57).

- Rout out cracks to form a “V” shaped groove.
- Repair crack with a knife-grade, acrylic elastomeric patching compound.
- Feather the patching compound at the edges of the crack.

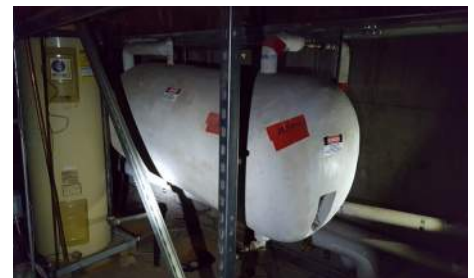
Abandoned water heater and storage tank.

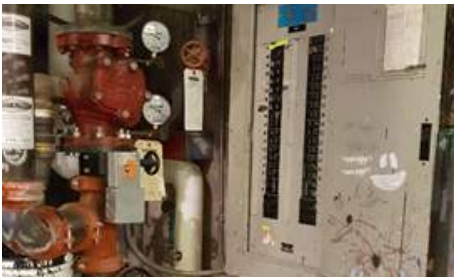
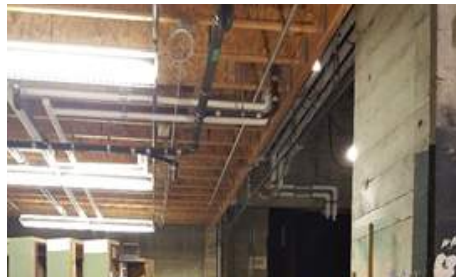
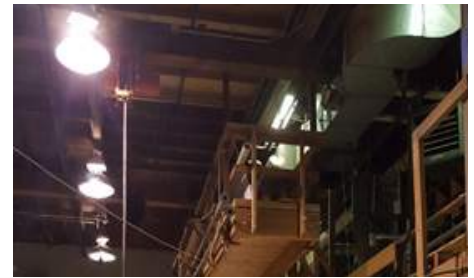
Existing Metal Halide and Fluorescent fixtures used at Theater backstage area

It is recommended that the existing branch circuit panels associated with the dated electrical equipment to be replaced with new due to age and conditions. New controls and switching should be provided for lighting at the theater backstage area rather than using circuit breakers as switching means. Although not required, but there are newly LED fixtures available for existing Metal Halide and Fluorescent fixtures that could be a saving in energy cost and maintenance. All spaces associated with the 2009 renovation appeared to be in compliance with current code and in great condition.

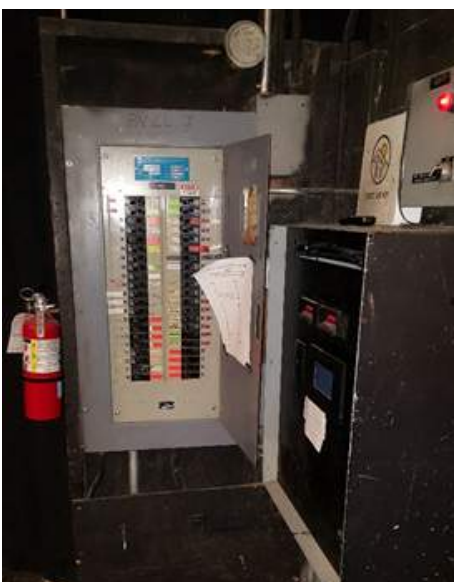
Existing Panel "I" (above) and Panel "J" (below) serving backstage lights, receptacle cord/reel, paint shop, and receptacles above the theater.
