Fenton Hall Window Condition Assessment

May 5, 2010 (updated January 2016)
University of Oregon
Campus Planning, Design and Construction

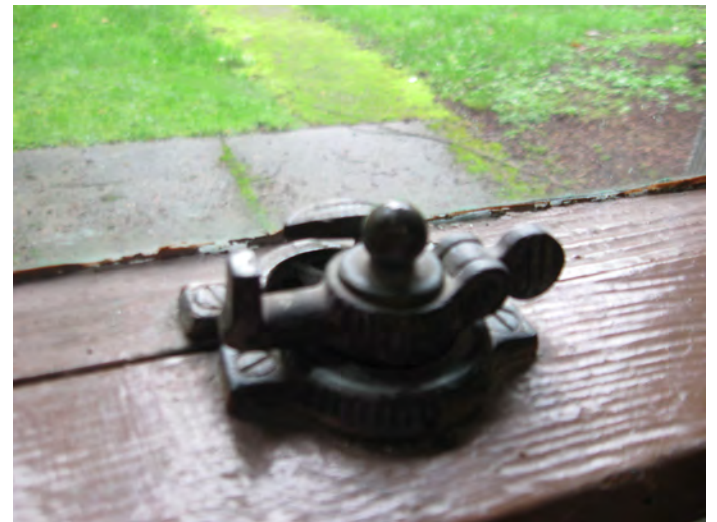
Window #	Window Type	Conditions							Facing Elev.	Comments	Photo
		Paint	Window Parts	Concrete Sill Cond.	Hardware	Operability	Dry Rot	Overall			
118a	Wood vent in window opening	Excellent	J-Excellent IC-Excellent RS-Excellent St-NA Si-NA	Excellent	None Present	Not operable	None observed	Excellent	North	This is a vent that takes up the entire opening, it is in excellent condition. Conditions assessed from the exterior.	
119a	Double hung, wood	Excellent	J-Excellent IC-Fair RS Excellent St- Excellent Si- Excellent	Excellent	In addition to original hardware, an L bracket was added to stop window being raised	Yes, minimally functional currently	None observed	Excellent	East	Interior stops loose on both sides, appears repair to weights was attempted	yes
119b	Double hung, wood	Excellent	J-Excellent IC-Excellent RS-Excellent St-Excellent Si-Excellent	Excellent	In addition to original hardware, an L bracket was added to stop window being raised	Yes, functional	None observed	Excellent	East
