# Friendly Hall

## Preliminary Historic Assessment

University of Oregon  
Campus Planning  
Campus Planning and Facilities Management

October 2022

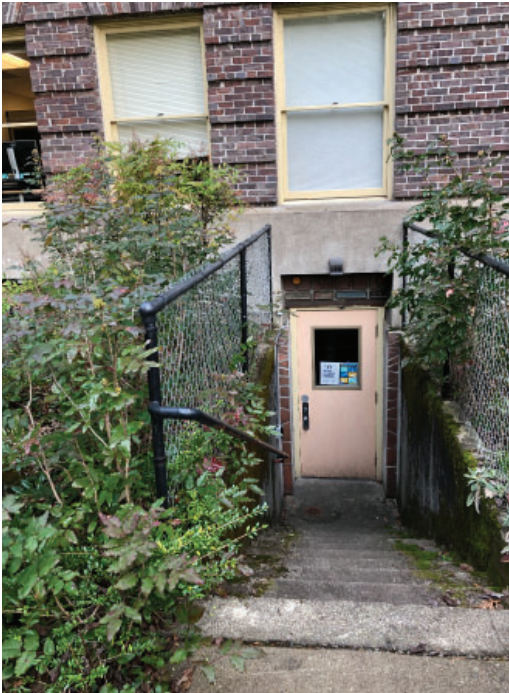
Light fixture above basement door is not original. Fenced stairwell is not original.

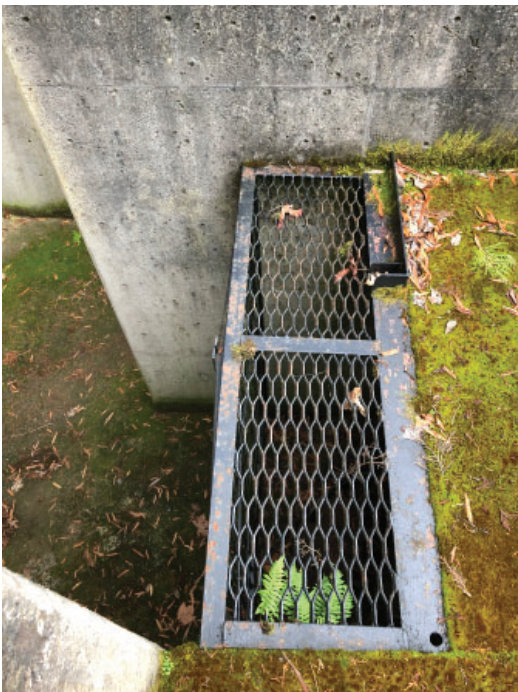
Original accessibility lift is currently not operable and not original.

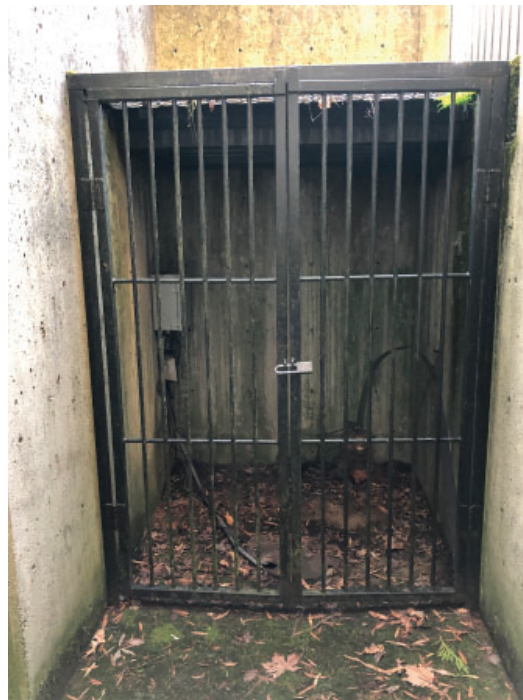
Gated storage on west facade below grade is not original.

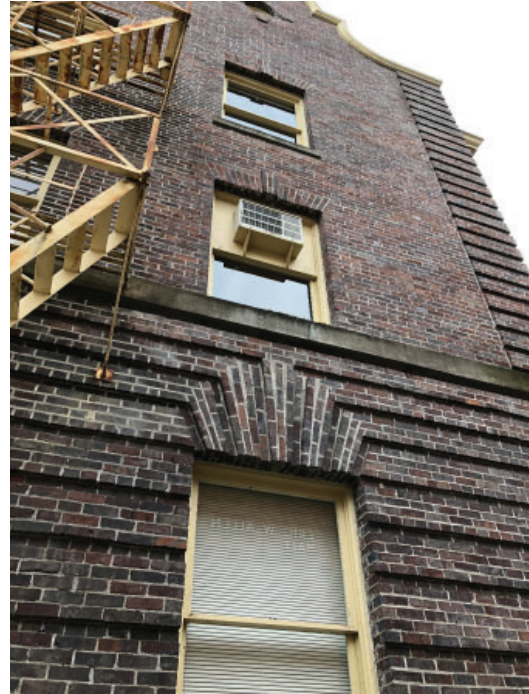
AC units installed in windows, not original.

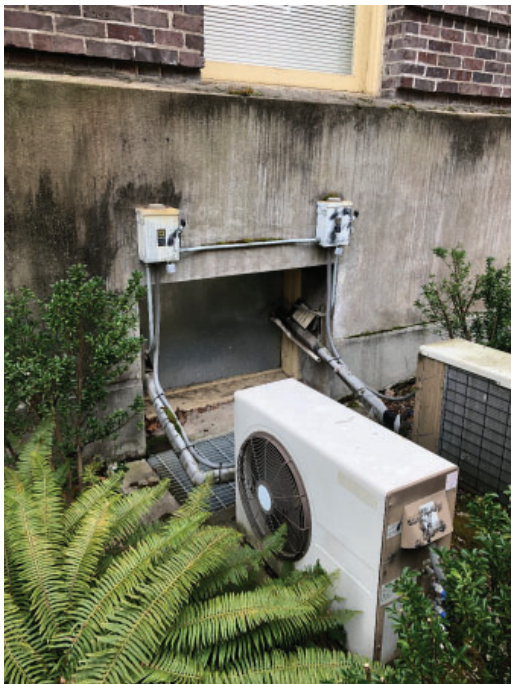
Mechanical equipment added to exterior with exposed connections.

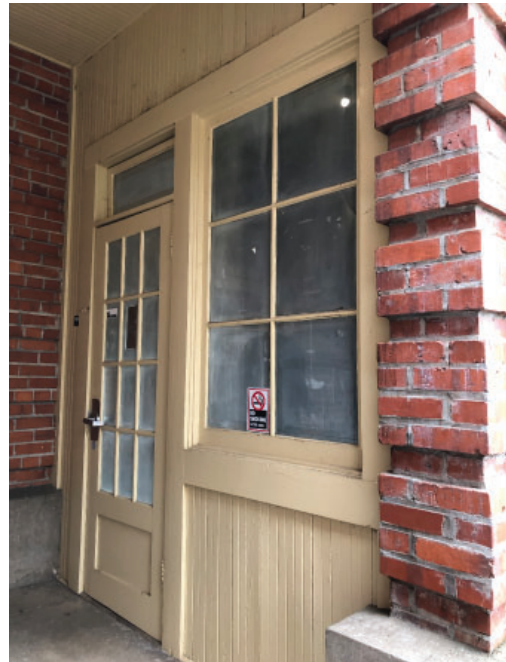
Original doors and windows.

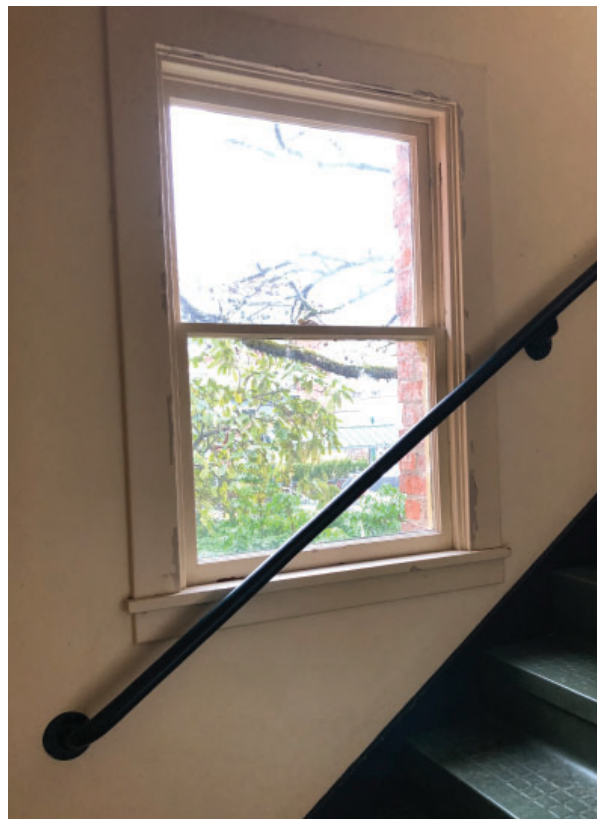
First Floor Stairwell (Railing intersects window)

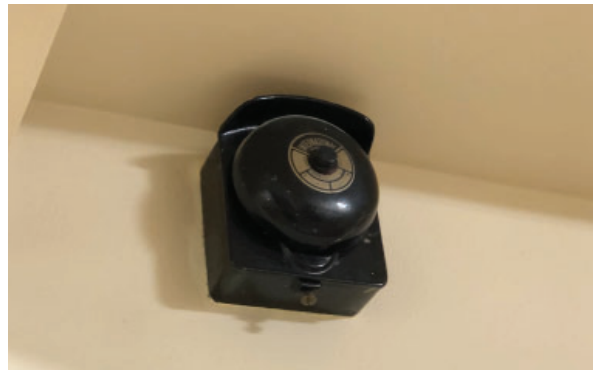
Third Floor Hallway (Old Fire Alarm)
