## Millrace (Inlet to Millrace Drive)

<b>Basin:</b>	Willamette River
<b>SW System Map Page(s):</b>	79
<b>General location:</b>	West from pump station downstream from Knickerbocker Bridge to Millrace Drive.
<b>Upstream terminus:</b>	Outlet of pump station into Franklin Park.
<b>Downstream terminus:</b>	Inlet of box culvert under Millrace Drive, node point #74801.
<b>Approximate length:</b>	3,100'
<b>Flow persistence:</b>	Perennial

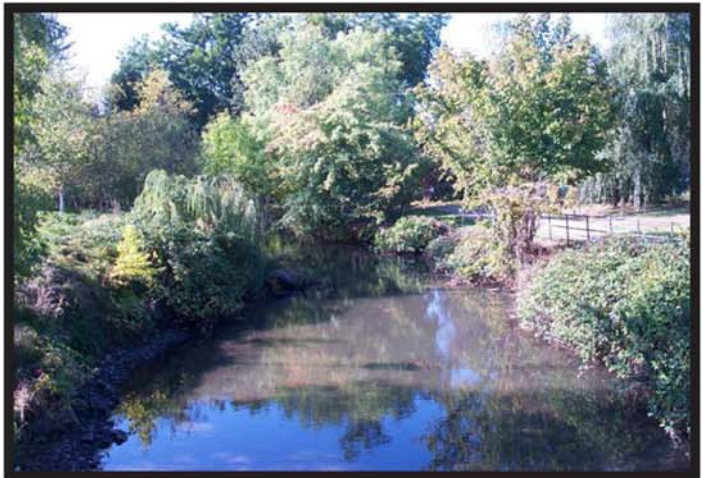
# Millrace

(Millrace Drive to Franklin)
