HISTORIC RESOURCE SURVEY FORM

University of Oregon Cultural Resources Survey Eugene, Lane County, Oregon Summer 2006, Updated 2025

Current building name: Peterson Hall Historic building name: Education Building, Oregon Hall, Gilbert West Building address: 955 East 13th Ave. Ranking: Secondary

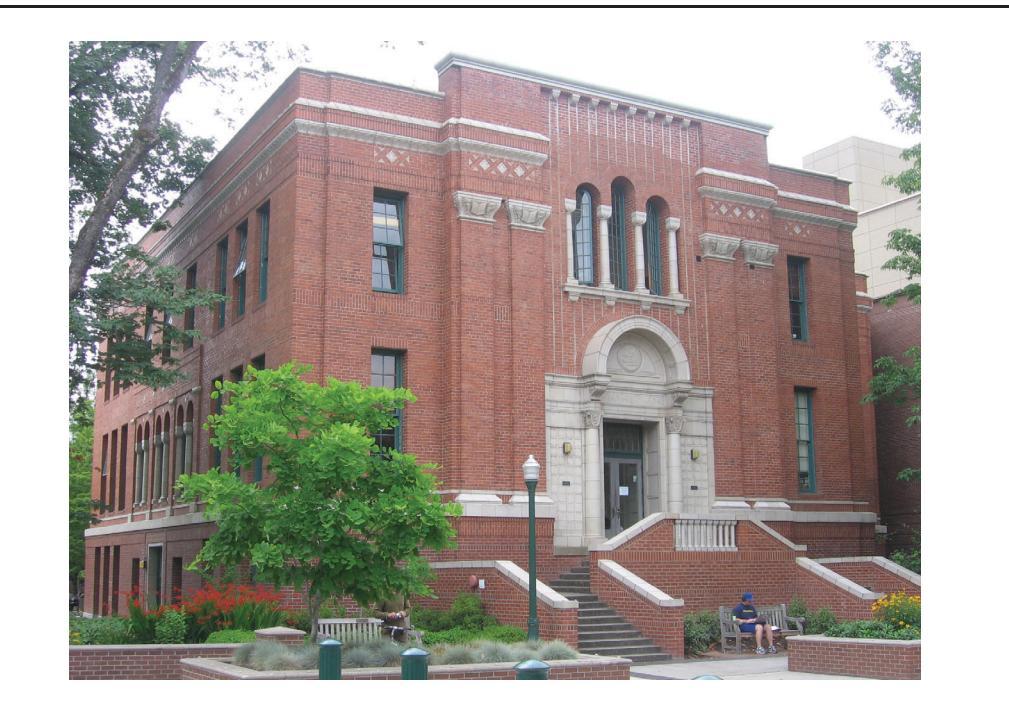
PHOTOGRAPH

Comments: Peterson is a brick building most noted for its staircase entryway on the east façade of the building. This staircase and entryway faces into the courtyard and mirrors the image of Gilbert Hall, which is located directly across from the courtyard of Peterson.

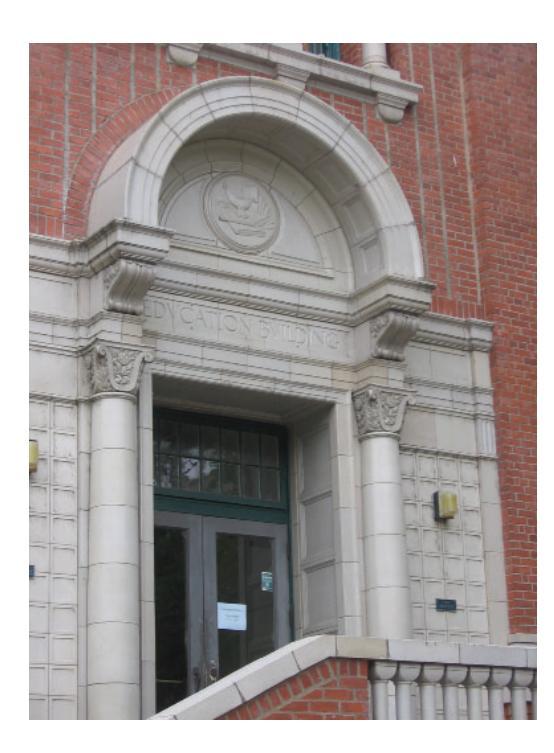
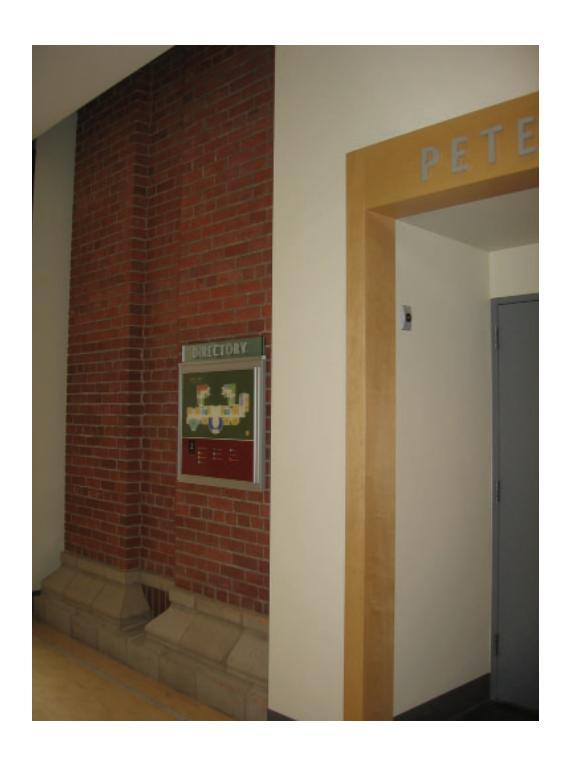
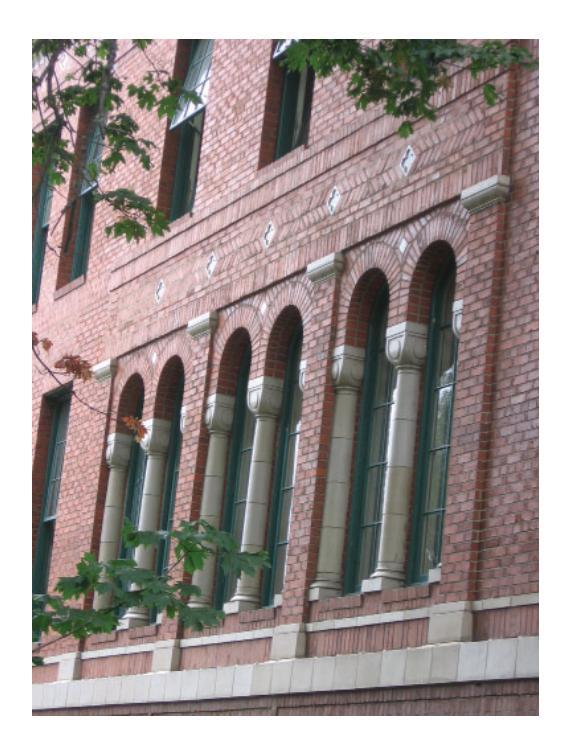
Clockwise from top left:

Peterson Hall's main entry detail, south façade detail, interior connection to Lillis Hall (looking back at Peterson's façade)
