**HISTORIC RESOURCE SURVEY FORM**  
University of Oregon Cultural Resources Survey  
Eugene, Lane County, Oregon  
Summer 2006

Current building name: Deady Hall

**Continuation Sheet 1**

**Continuation Sheet 2**Section Historical Associations and SignificancePage 2

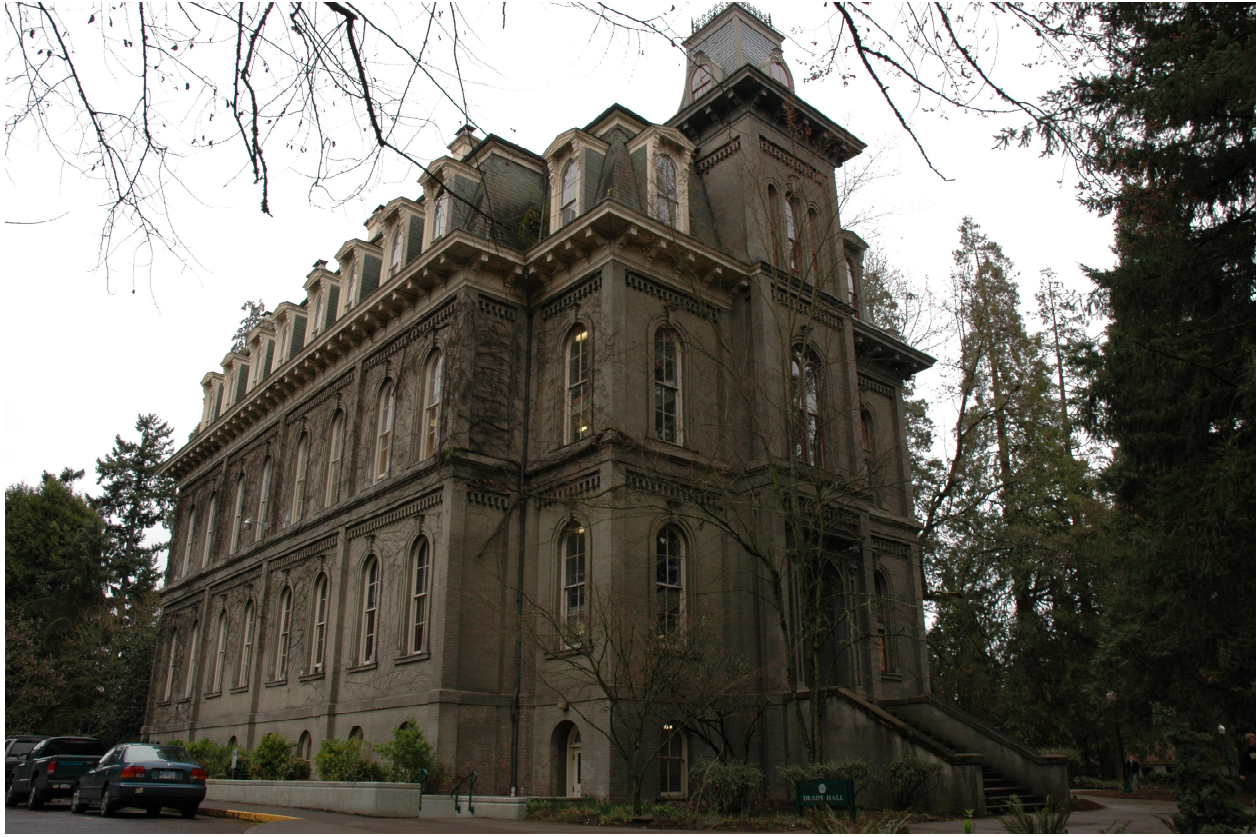
**PHOTOGRAPH**

Architectural style classification: Second Empire

Primary exterior wall material: Brick

Roof configuration/type: Mansard

Decorative features and materials: Mansard towers with cast iron cresting, dentil course, keystones punctuate window arches, strip molding, cornice, and modillions
