HISTORIC RESOURCE SURVEY FORM

University of Oregon Cultural Resources Survey Eugene, Lane County, Oregon Summer 2006

Current building name: Villard Hall

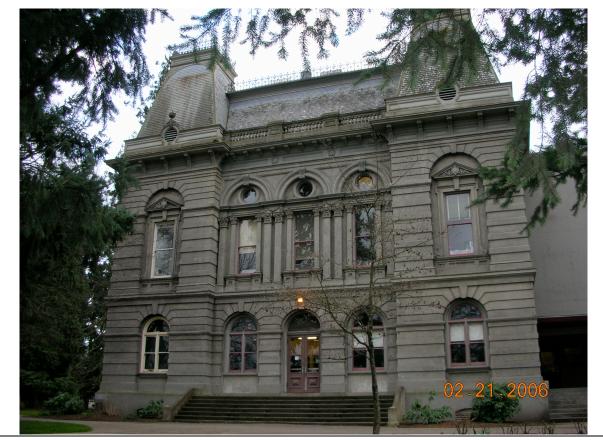
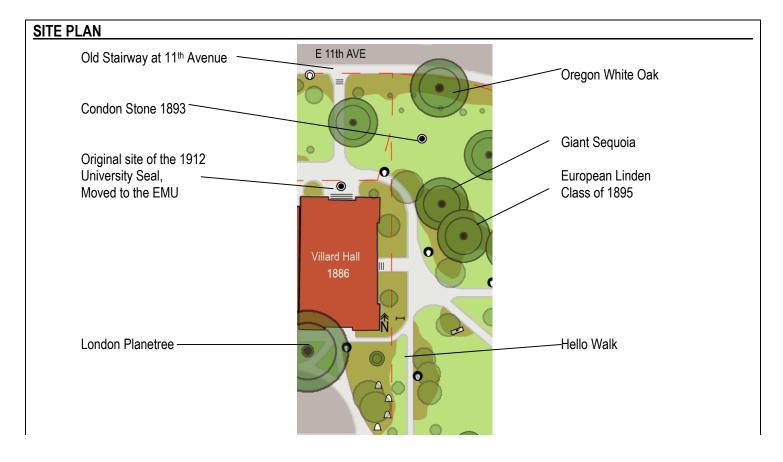
PHOTOGRAPH

Historic Significance (check one): <u>X</u> High _ Medium _ Low Very Low or None Integrity (check one): _ Excellent X Good _ Fair _ Poor Condition (check one): _ Excellent X Good _ Fair _ Poor
Building designation: _ City Landmark X National Register X National Historic Landmark _ Not listed
<u>Preliminary National Register eligibility findings</u> Building is potentially eligible: _ Individually or _ As a contributing resource in a district only If eligible individually, applicable criteria (check all that apply):
X A. Associated with significant events X C. Distinctive architecturally
_ B. Associated with significant persons _ D. Archaeologically important
If applicable, building qualifies under NR Criterion Considerations: _ Yes _ No If yes, which apply:
Building is NOT eligible: _ Intact but lacks distinction or _ Altered/loss of integrity or _ Not 50 years old
