HISTORIC RESOURCE SURVEY FORM
University of Oregon Cultural Resources Survey
Eugene, Lane County, Oregon
Summer 2006, Updated 2025

Current building name: Hendricks Hall
Historic building name: Hendricks Hall
Building address: 1408 University St.
Ranking: Primary

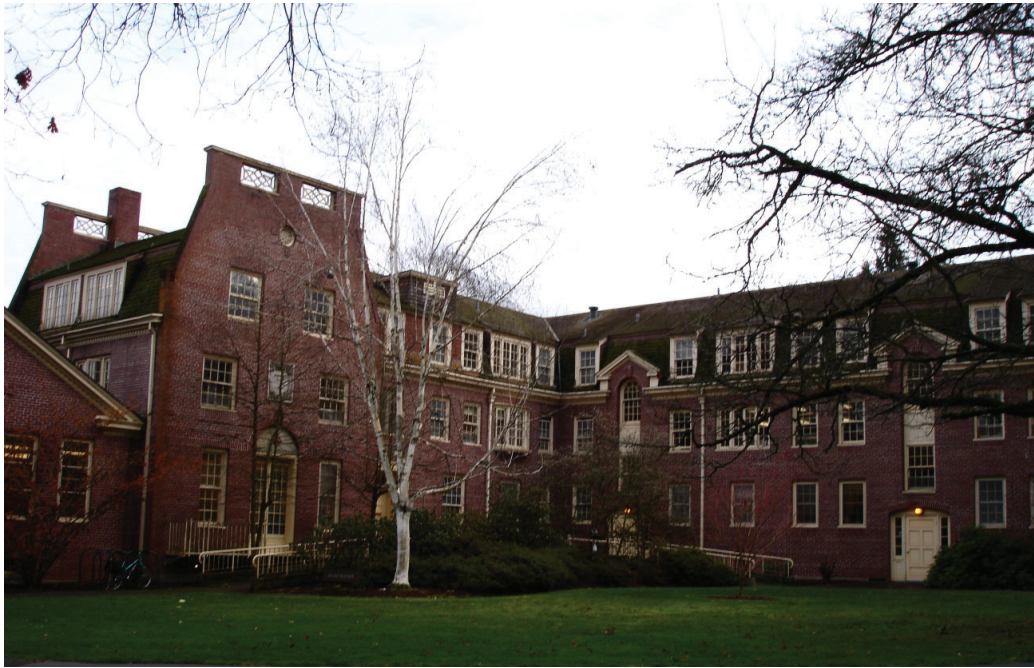
PHOTOGRAPH

Hendricks is in fair condition. Hendricks has excellent integrity, with the exception of the lost refectory porch and cornice balustrade. If increased integrity is desired, the awnings and roof addition could be removed and the other architectural features repaired. The exterior holds to be very similar to the original design by Lawrence.
