HISTORIC RESOURCE SURVEY FORM
University of Oregon Cultural Resources Survey
Eugene, Lane County, Oregon
Summer 2006, Updated 2025

Current building name: Esslinger (Arthur A.) Hall
Historic building name: Physical Education
Building address: 1525 University Street
Ranking: Tertiary

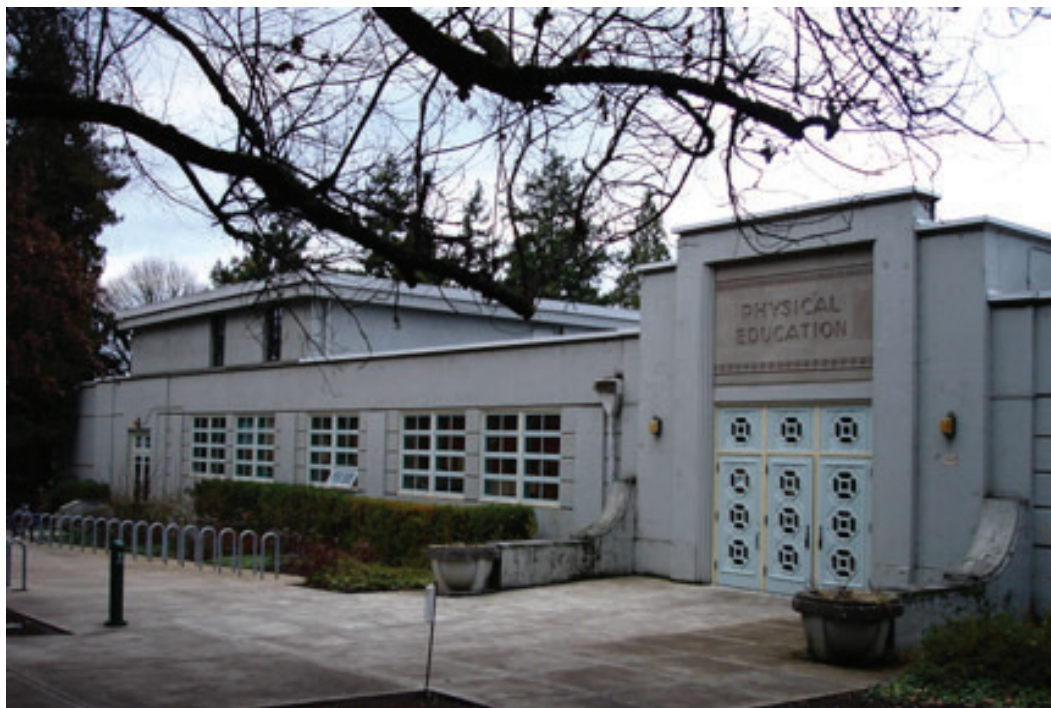
Photo number or name: Esslingercropped.jpg

Architectural style classification: Moderne
Building plan (footprint shape): Irregular L- shaped
Number of stories: 1.5
Foundation material(s): Poured concrete
Primary exterior wall material: Poured concrete with stucco finish
Secondary exterior wall material: N/A
Roof configuration/type: Flat
Primary roof material: Elastic sheet roofing
Primary window type: Grouped hinged sash
Primary window material: Wood
Decorative features and materials: Doors, concrete detailing around doors, gutters, paneling of concrete, planters at main entrance
Landscape features: Oaks at the entrance and shrubs in planting strip alongside west elevation, cast stone urns by PWA artist Walter Pritchard, bike racks on North Side
Associated resources: University Street Axis, connected to McArthur Court at southwest and Student Recreation Center at the northeast
Comments: The building is a low, horizontal, poured concrete structure that is simply but elegantly detailed. The building's decoration is furnished by the groupings of windows, geometric patterns in the doors and transom panels above the doors, and patterns in the concrete.

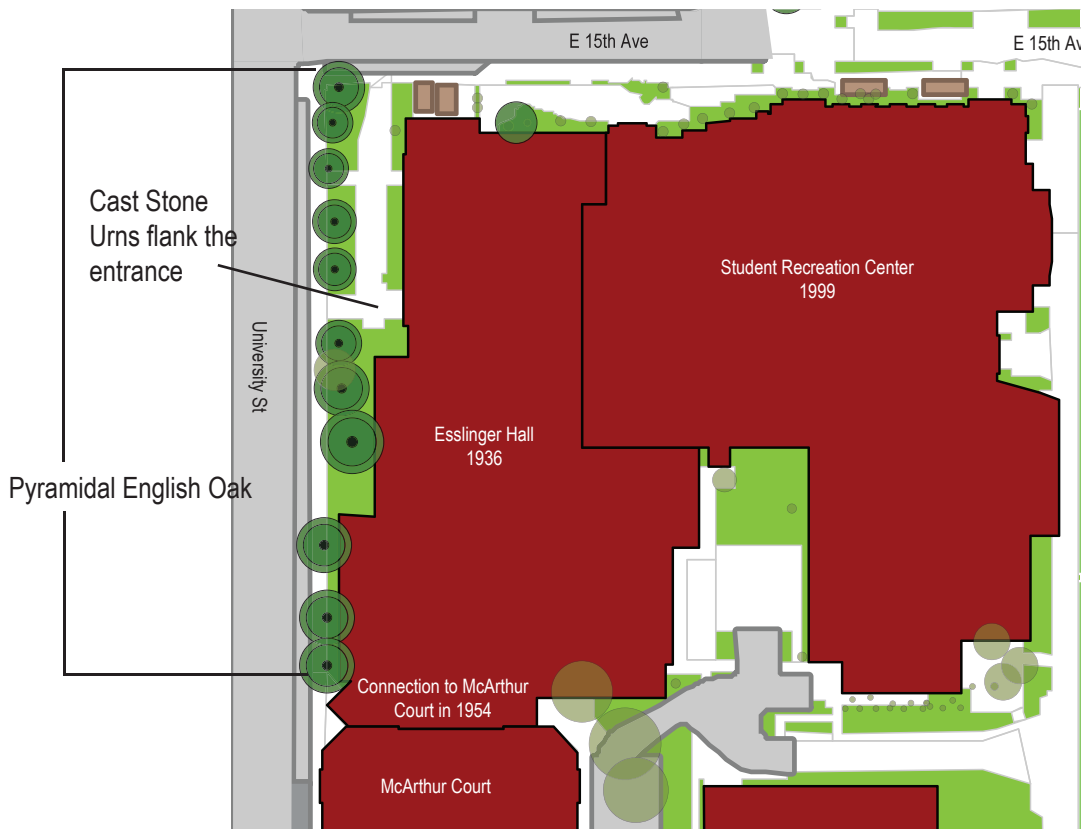
SITE PLAN

The original building contained two basketball courts, eight handball/squash courts, locker rooms, and office space. During construction, the building was attached to the existing McArthur Court by a set of doors at the southwest corner. Modifications include the addition of a second story administrative wing in 1954, construction of the swimming pool in 1958, and the remodeling of the second story to repair damage resulting from the 1971 fire. In 1975, the University renamed the building in honor of the contributions of Arthur A. Esslinger during his service as Dean of the College of Health, Physical Education, and Recreation from 1953 until 1971. The continuing growth of athletics and physical education at the University prompted the construction of the Student Recreation and Fitness Center in 1999 (designed by TBG Architects of Eugene and Cannon-Parkin of Los Angeles) which is attached to Esslinger Hall at the northeast corner.
