HISTORIC RESOURCE SURVEY FORM
University of Oregon Cultural Resources Survey
Eugene, Lane County, Oregon
Summer 2006

Current building name: Hendricks Hall
Historic building name: Hendricks Hall
Building address: 1408 University St.
Ranking: Primary

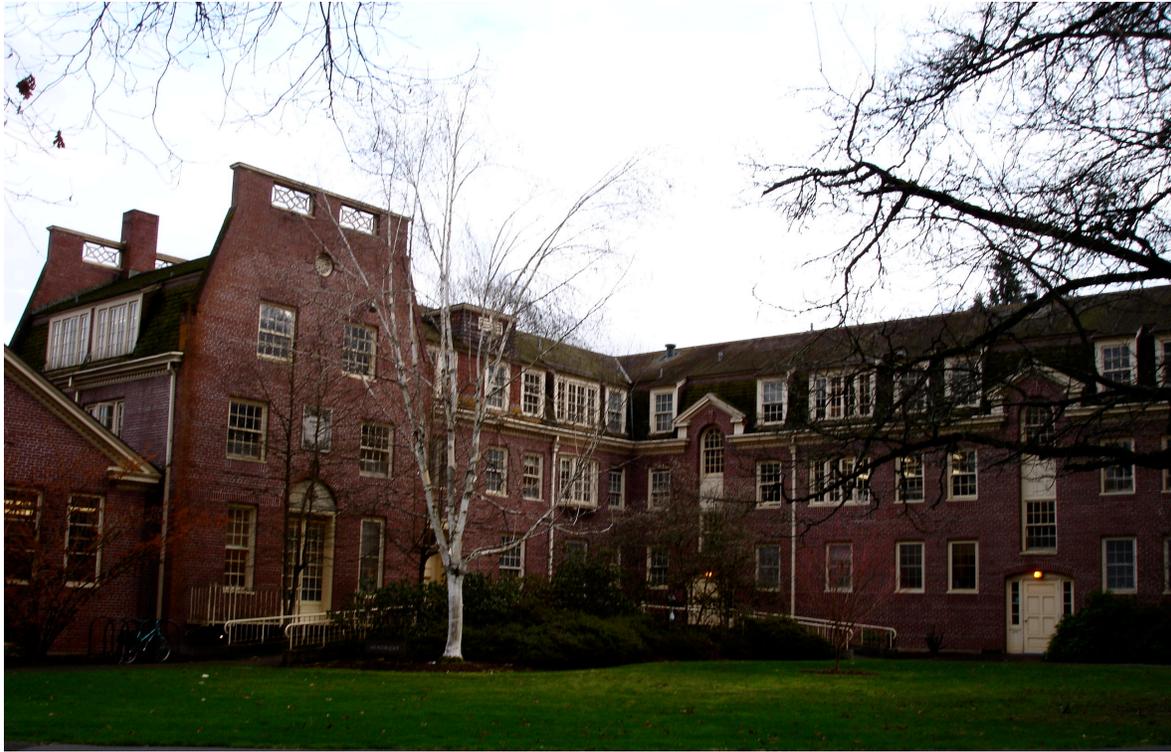
PHOTOGRAPH

Architectural style classification: Georgian Colonial
Building plan (footprint shape): Irregular "L"
Number of stories: 2.5
Foundation material(s): Concrete
Primary exterior wall material: Brick
Secondary exterior wall material: Wood
Roof configuration/type: Gambrel with shed dormers
Primary roof material: Wood shingle
Primary window type: Double Hung & Casement 6/6, 8/8
Primary window material: Wood (originally)
Decorative features and materials: Parapets, moldings, wood at cornice line, guttering around building, brickwork on east ends, green awnings over windows (additions)
Landscape features: Plantings surrounding building, mature trees, brick and cast stone walls and stairs
Associated resources: Pioneer Mother statue by A. Phimister Proctor, Pioneer Axis, University Street Axis, Knight Library Axis, Women's Memorial Quad, Gerlinger Hall, Susan Campbell Hall
Comments: Nominated for National Register in 1992 in accompaniment with the Women's Quadrangle, Hendricks and Susan Campbell Halls are symmetrical in shape. Hendricks is a brick building with original wooden, double hung windows. Hendricks and Susan Campbell are most recognizable visually due to large brick parapets at the ends of the east and west wings of the building.

Hendricks is in fair condition. It is in need of some basic maintenance and repairs, such as addressing the increasing moss and lichen problem on the roof and brick walls. Hendricks has excellent integrity, with the exception of the lost refectory porch and cornice balustrade. If increased integrity is desired, the awnings and roof addition could be removed and the other architectural features repaired. The exterior holds to be very similar to the original design by Lawrence.
