# **Collier House**

## **Preliminary Historic Assessment**

University of Oregon  
Campus Planning  
Campus Planning and Facilities Management

March 2025

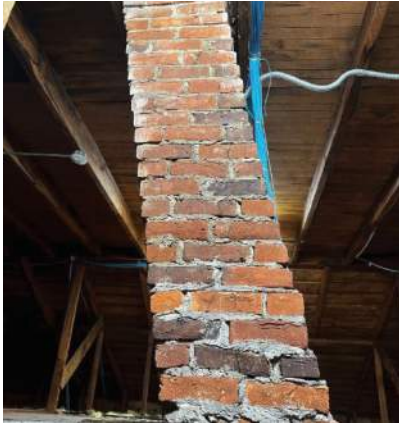
Brick chimney

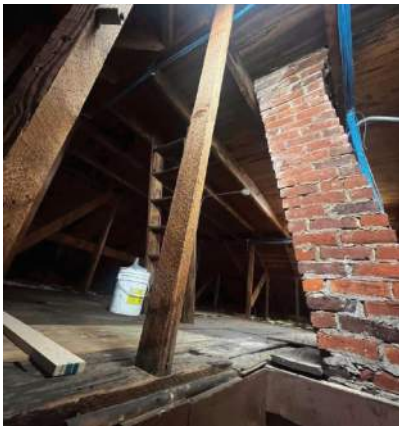
Wood ladder to roof access

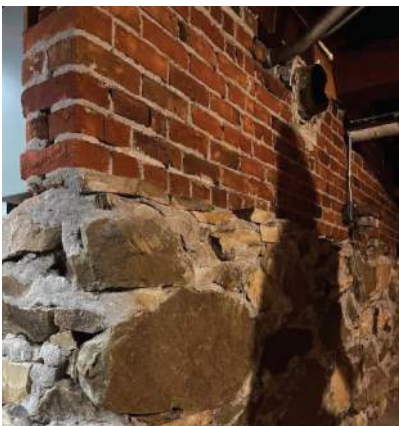
Stone and brick details

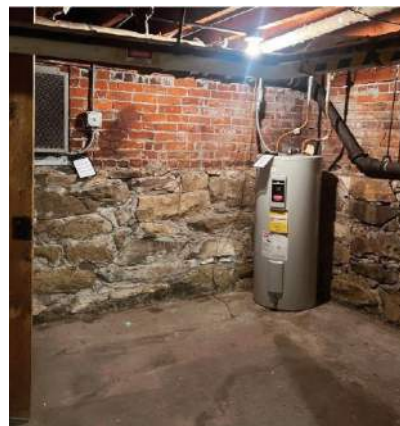
Heavy stone foundation; brick masonry walls
