# **Collier House**

## **Preliminary Historic Assessment**

University of Oregon  
Campus Planning  
Campus Planning and Facilities Management

July 2025

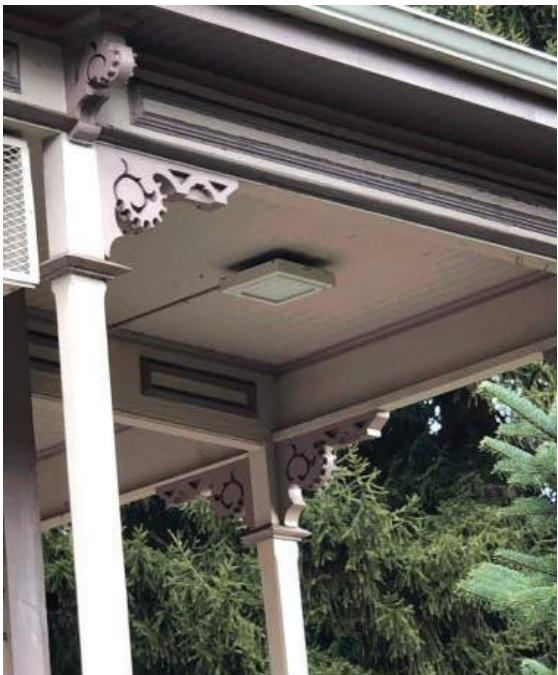
Incompatible light fixture

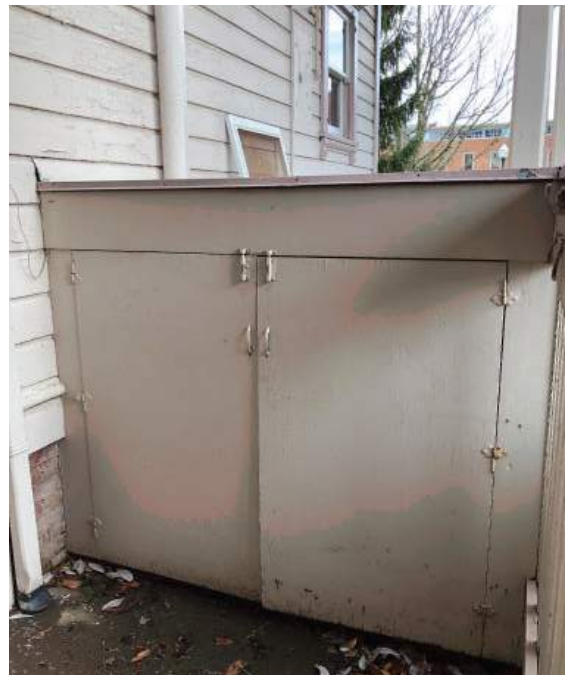
Exterior shed
