Friendly Hall

Preliminary Historic Assessment

University of Oregon
Campus Planning
Campus Planning and Facilities Management

October 2022

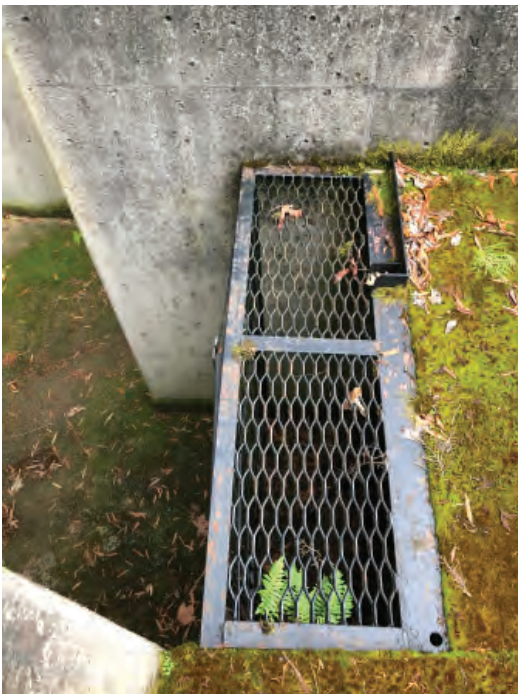
Original accessibility lift is currently not operable and not original.

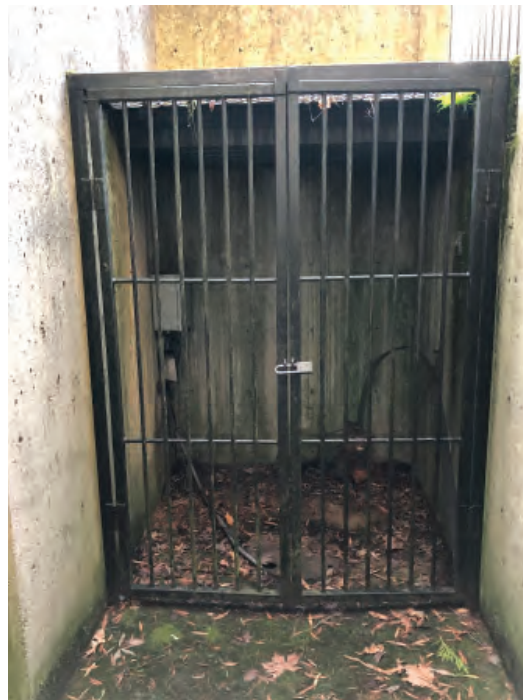
Gated storage on west facade below grade is not original.

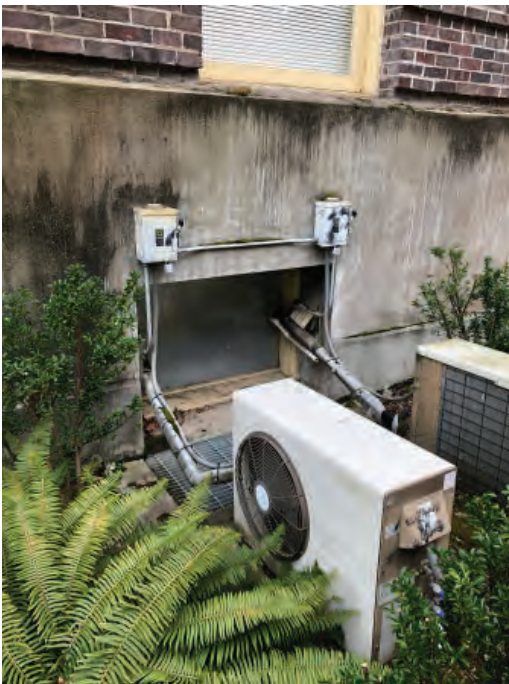
Mechanical equipment added to exterior with exposed connections.

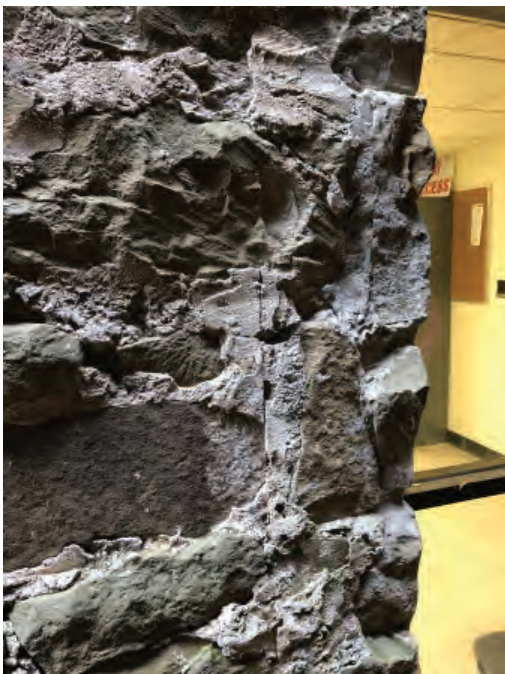
Original stone foundation throughout
basement level.

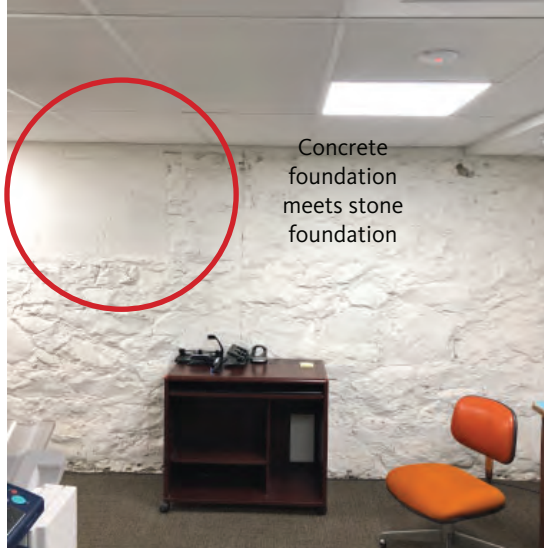
Room 20 (Painted Stone Foundation)

Concrete
foundation
meets stone
foundation

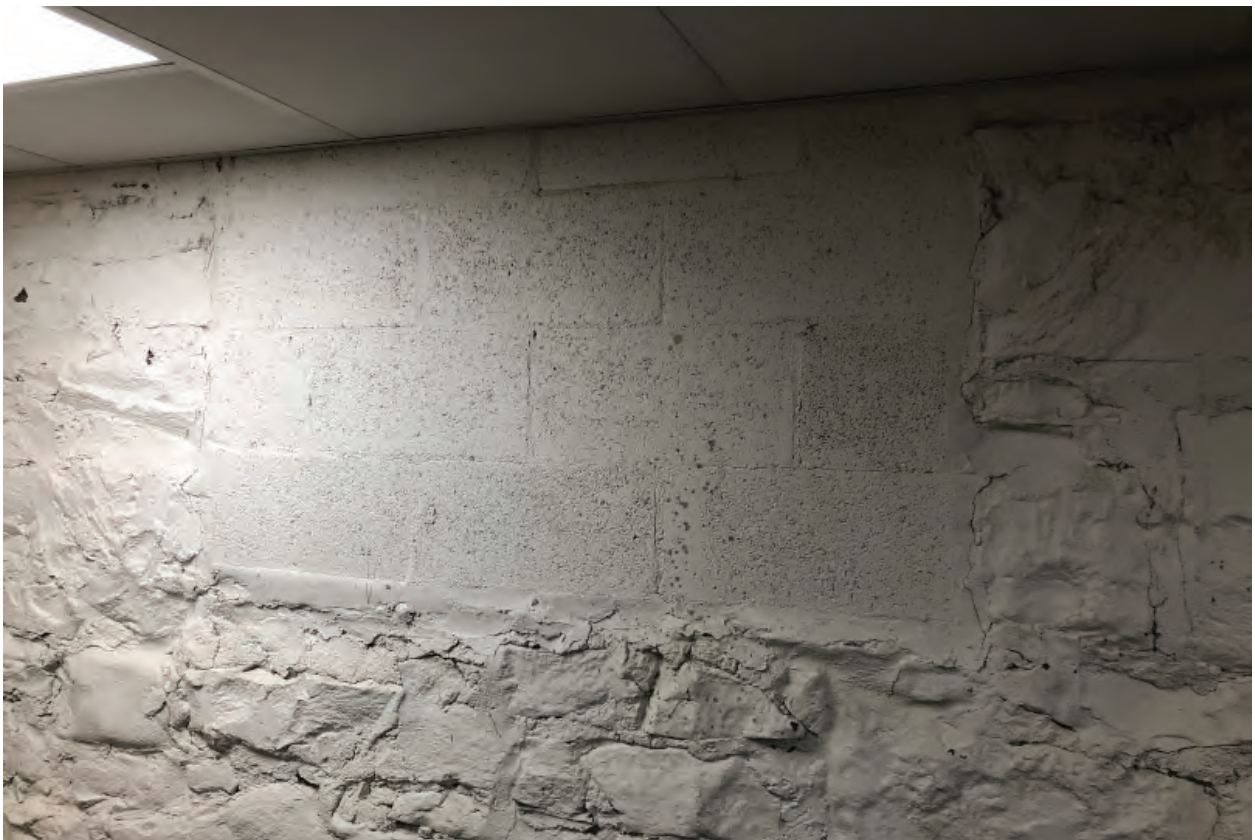
Room 20 (Old vs. New Foundation)

Note: Being of three and a half story brick bearing walls, the original portion has a foundation mystery. According to the architecture professor Donald Peting, Friendly, University and Villard Hall all have parged masonry foundation. The 1914 building plans for Friendly Hall indicate a mix of brick and concrete foundations at that time.

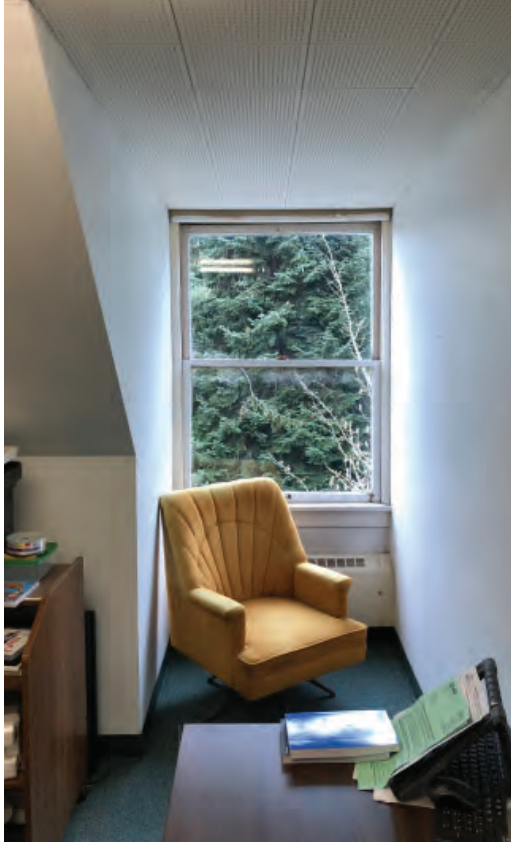
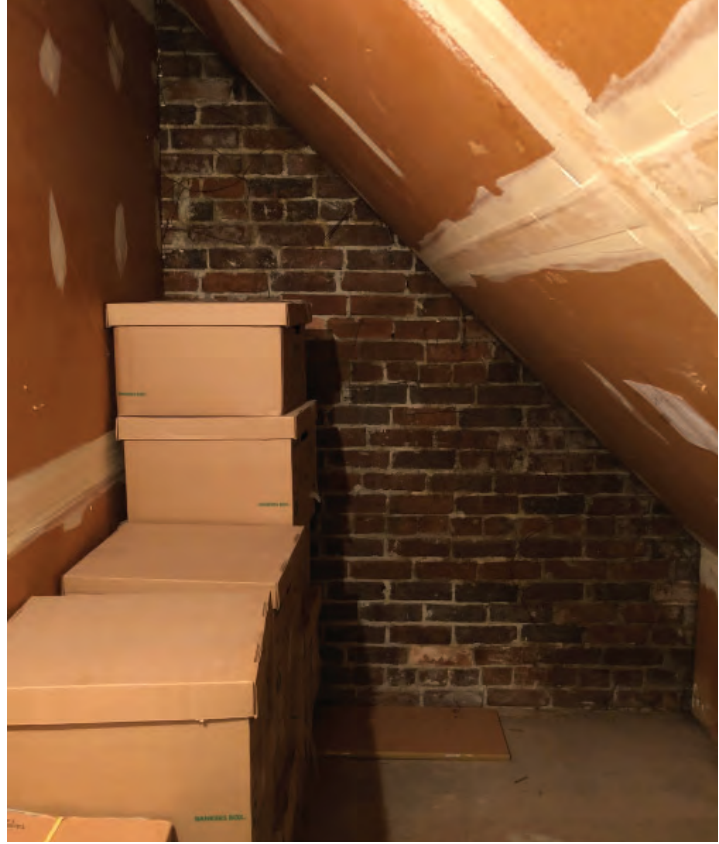
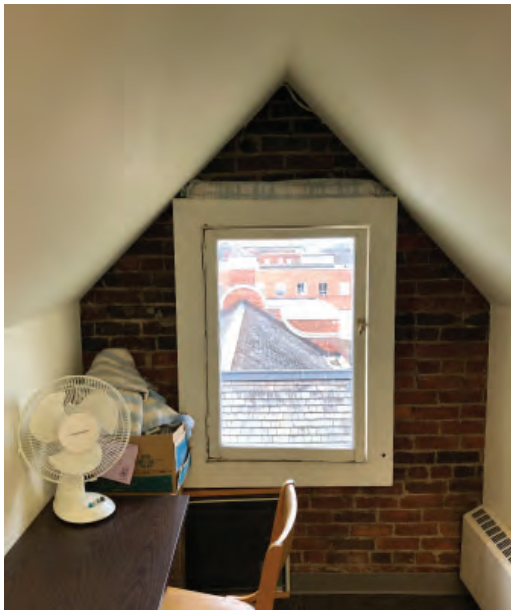
LEVEL OF HISTORIC SIGNIFICANCE: **VERY LOW**

LEVEL OF INTEGRITY: **POOR**

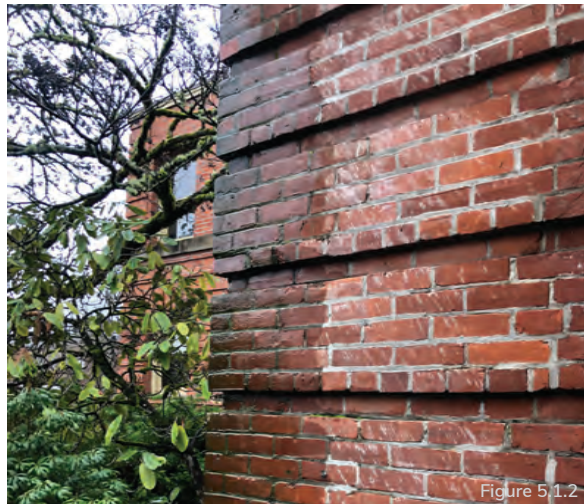
Figure 5.1.2

The exterior walls of Friendly Hall indicate the original structure and its two major additions. All three major constructs use an American or Common bond. A dark brick is used on the original portion (figure 5.1.1), while the additions are clad with a red brick (figure 5.1.2). The 1914 addition on the east also has a different coursing pattern than the other two constructs (figure 5.1.3). The face brick is embellished with quoins, jack arches, and rusticated reveals on the first floor.

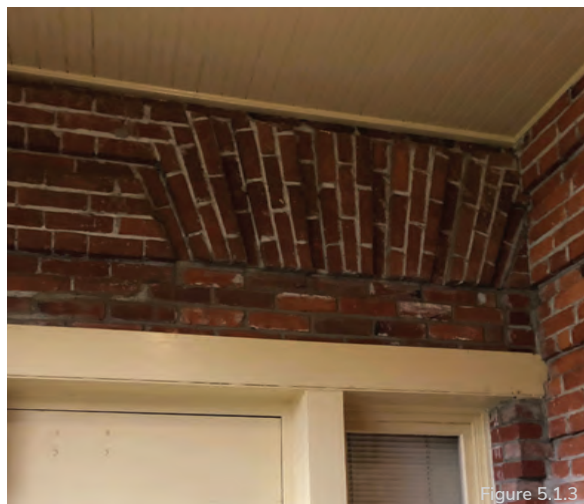
Figure 5.1.3

Mortar joints are generally intact and in good condition. There are some areas of previous repointing that are an inadequate match to the historic mortar color and texture (figure 5.1.3) which should be replaced.

- Where there is evidence of deterioration in the mortar joints of the masonry walls and other masonry features, repair by re pointing the mortar joints. Repair masonry features by patching, piecing-in, or consolidating the masonry using recognized preservation methods. Repair may also include the limited replacement in kind--or with compatible substitute material--of those extensively deteriorated or missing parts of masonry features when there are surviving prototypes. Where possible, preserving exterior finish in areas that are still intact.

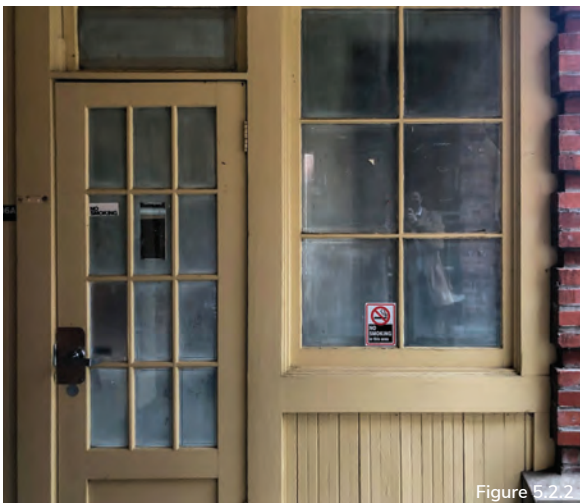
Figure 5.2.2

- Columns, capitals, and entablatures at the west facade entries (figure 5.2.1).
- Decorative wood paneling at exterior entries (figure 5.2.2)
- A decorative cornice at the underside of roof overhangs.

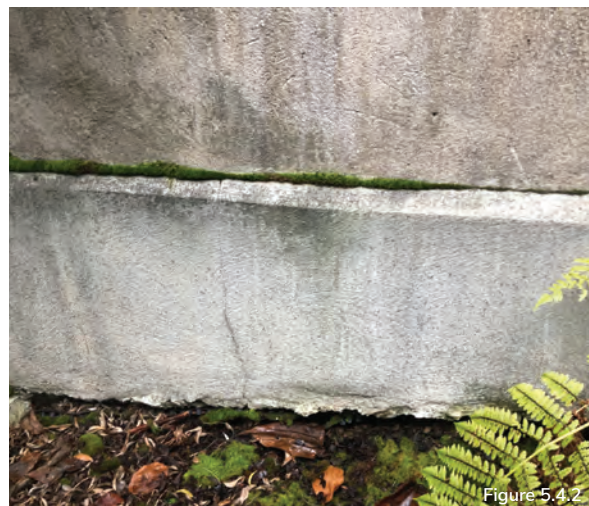
Figure 5.4.2

During a walkthrough, areas of organic growth and superficial cracking were observed (figure 5.4.1-2).

- All hairline cracking should be treated with an injection grout. Larger cracks and spalls along the wing wall caps should be repaired with a concrete patch. All patching of grout should match the adjacent concrete in color, texture and composition.

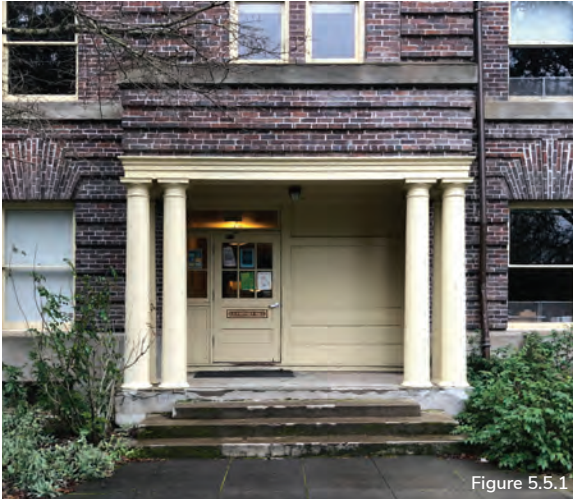
Figure 5.5.1

Generally, the historic exterior doors on the building have been maintained and are functionally adequate (figure 5.5.1). Some have experienced slight aesthetic deterioration which is expected on elements of this age. At exterior basement entries, character compromising doors were installed at some point during previous renovations (figure 5.5.2).

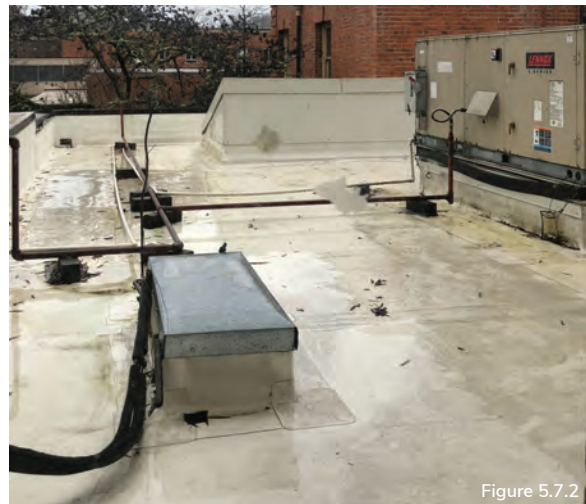
Figure 5.7.2

The existing roofing consists of TPO membrane at low-slope conditions (figure 5.7.2) and wood shingle roofing at the remaining areas. Both types of roofing were fully replaced in 2009 and are generally in good condition with about half of their expected lifespan remaining.

The skylights over the first floor office suite (figure 5.7.2) were added during a 1999 renovation and generally appear in good condition with no reports of issues.

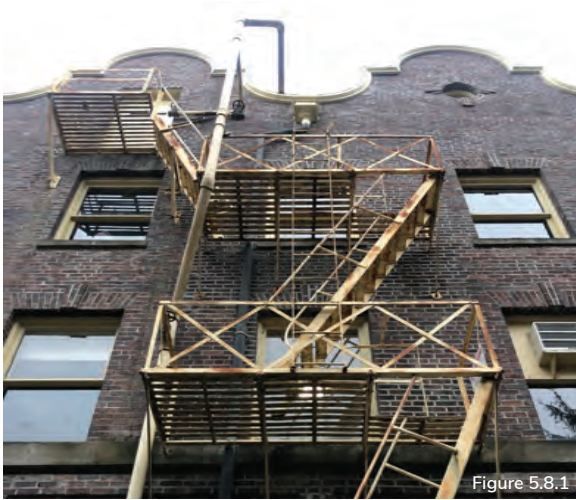
Figure 5.8.1

The historic fire escapes at the north and south facades of the building have aged and deteriorated substantially (figure 5.8.1). There are also instances of deformation near the ground level.
