CHAPMAN HALL

HISTORIC ASSESSMENT

University of Oregon
Campus Planning
Campus Planning, Design and Construction

May 2015 (updated January 2016)

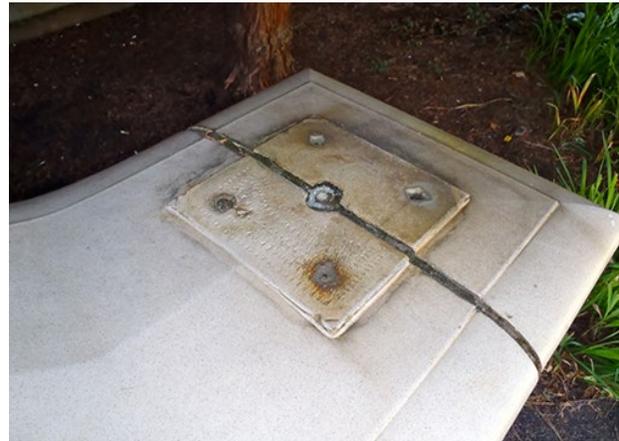
- If a historic entrance feature is completely missing, like the lamp posts at the west entrance, design and construct a new feature. It may be based on historical, pictorial, and physical documentation; or be a new design that is compatible with the historic character of the building and site.

West Entry lamp scars. 2011.

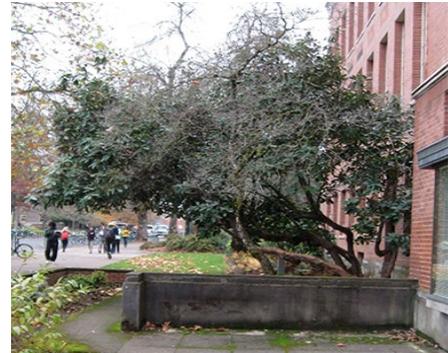
c. **2007:** Two of the four original stone benches were temporarily removed so that the sculpted legs could temporarily support the new Women's Quad honorary benches (the original bench tops are in storage). Once new legs are cast, the original bench components will be returned to their original location.

Location of removed stone benches & Rhododendron (east side). 2011.

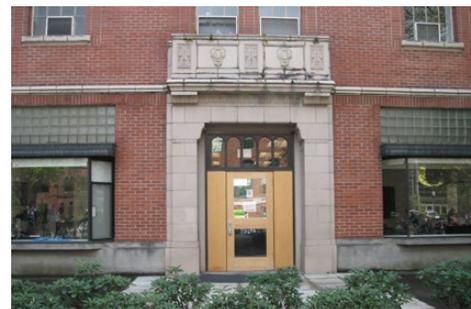
Modified existing entry. March 2015.

The original exterior Primary First Floor Entry vestibule was removed by relocating the Primary First Floor Entry door to be flush with the exterior wall. Original drawings indicate side lites and terracotta detailing on the two walls framing the exterior vestibule. The windows served as bookstore display cases (refer to drawings below). A single-panel oak door with side panels replaced the original double-door entrance. Original bronze hardware was removed. The original transom windows were salvaged and relocated above the new door.

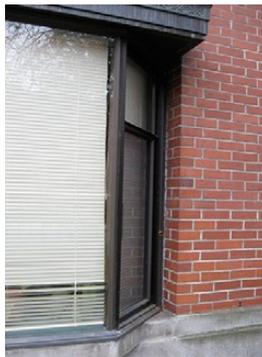
Date Unknown: Single-unit operable windows with interior screens were installed on the west facing portion of the two bay windows.

Operable window unit installed in west portion of bay window. 2011.

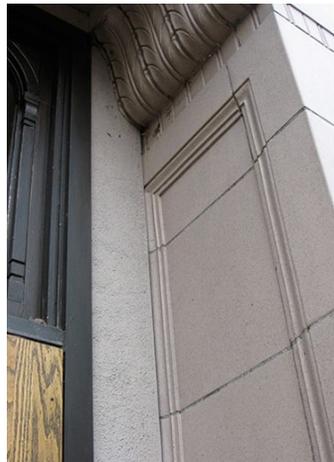
Existing original terracotta detailing, with concrete wall framing the relocated door. 2011.

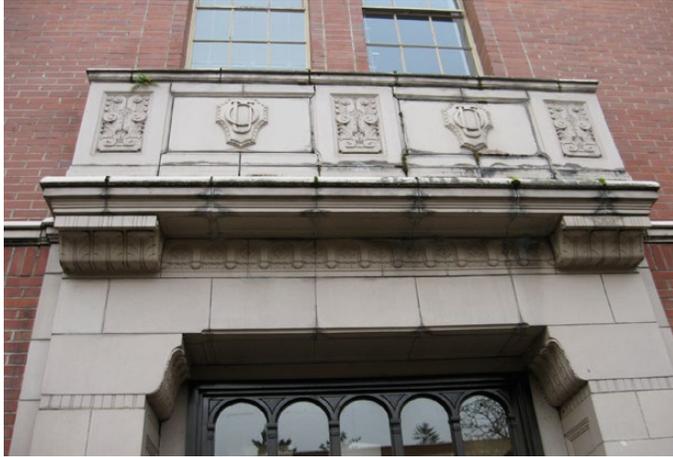
Terracotta detailing consistent with original drawings. Indicates that the original vestibule likely had terracotta detailing as shown on drawing (see p. 25 and 27). 2011.

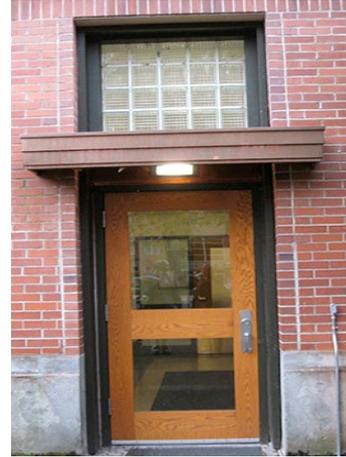
Secondary North Entrance added in 1966, with 2010 awning and door. 2011.

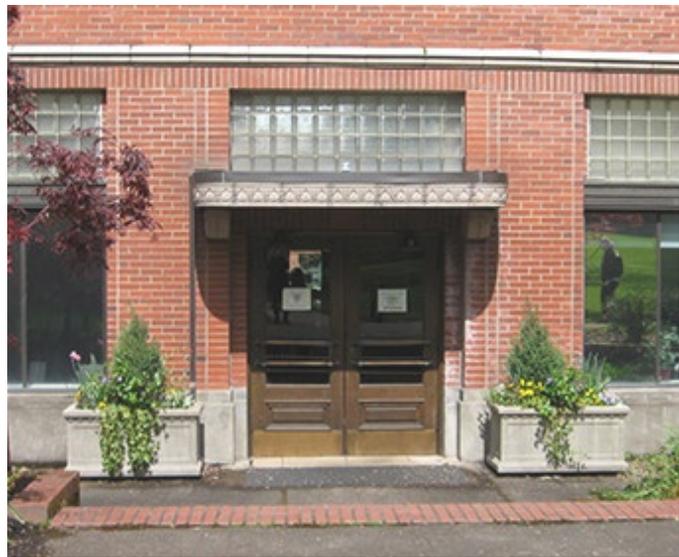
South Entry with original door and hardware and new awning April 2015.

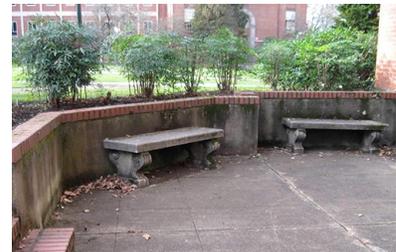
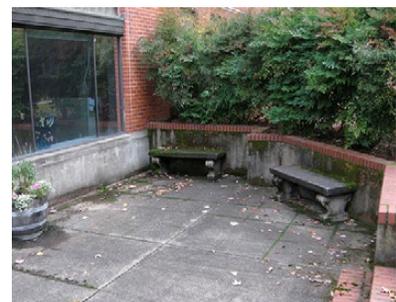
Date Unknown: Various potted plants were added in the court. Also, it appears that two cast stone benches were added, creating a total of four benches. Original drawing indicates only two benches

Four benches in South Court, originally only two. 2011.

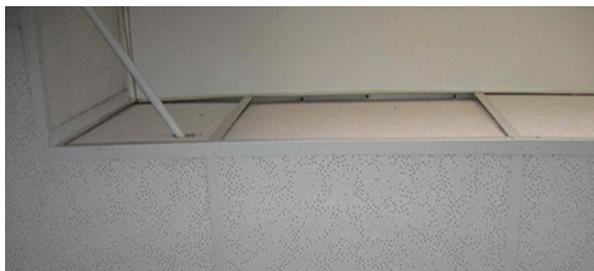
1966 dropped ceiling w/ perimeter soffit exposing original plastered ceiling above.

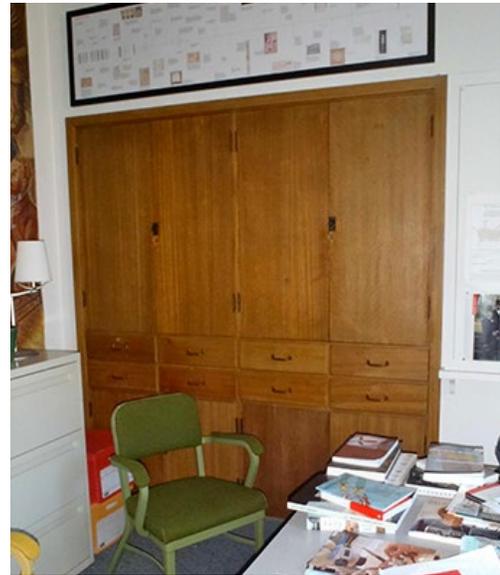
Built-in cabinet matches original Ellis Lawrence drawings. 2011.

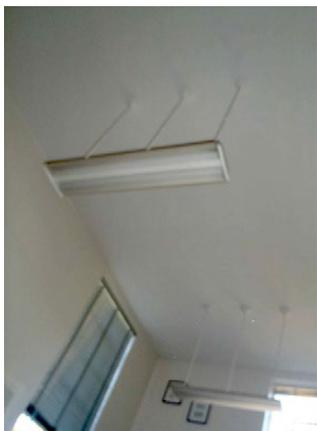
Existing lighting. 2011.

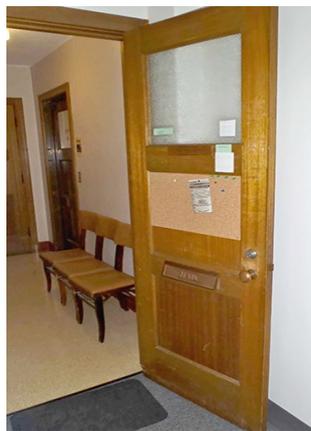
Original door and mail slot. 2011.

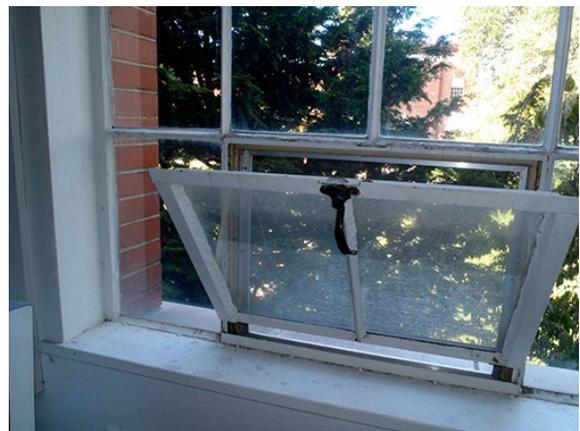
Steel frame hopper window opening. 2011.

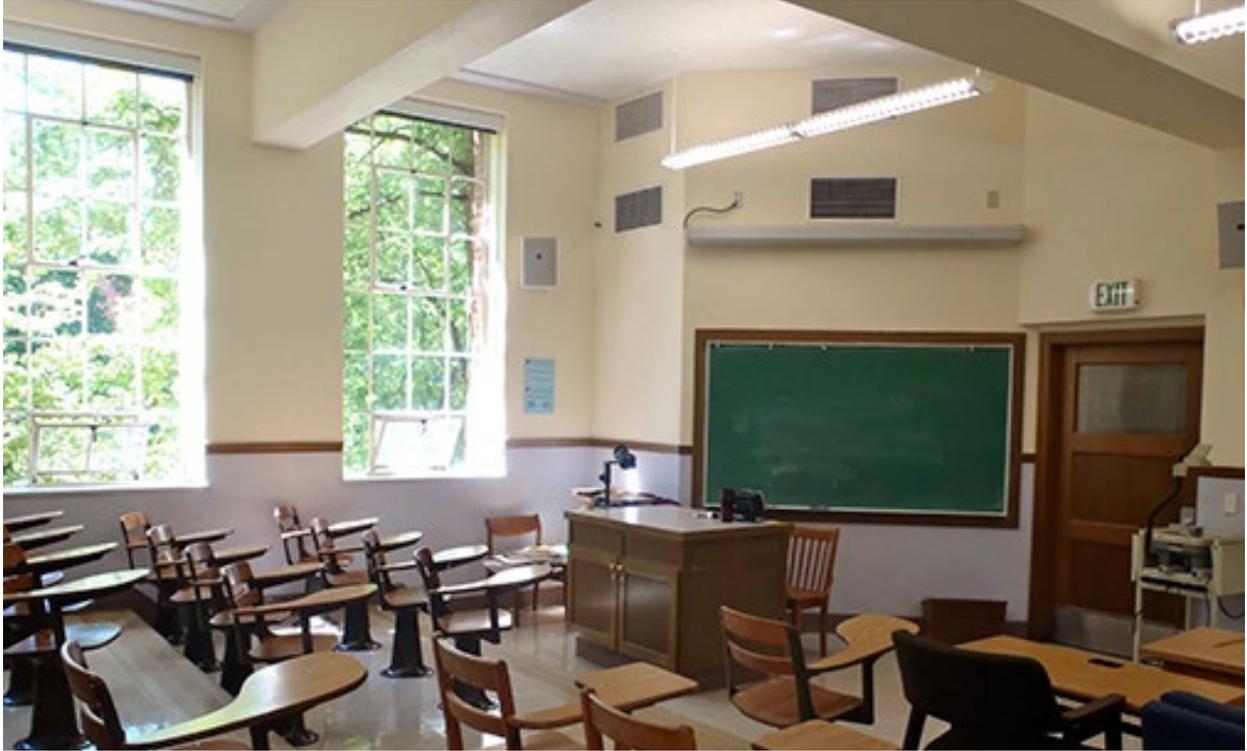
View of classroom (looking southwest). 2011.

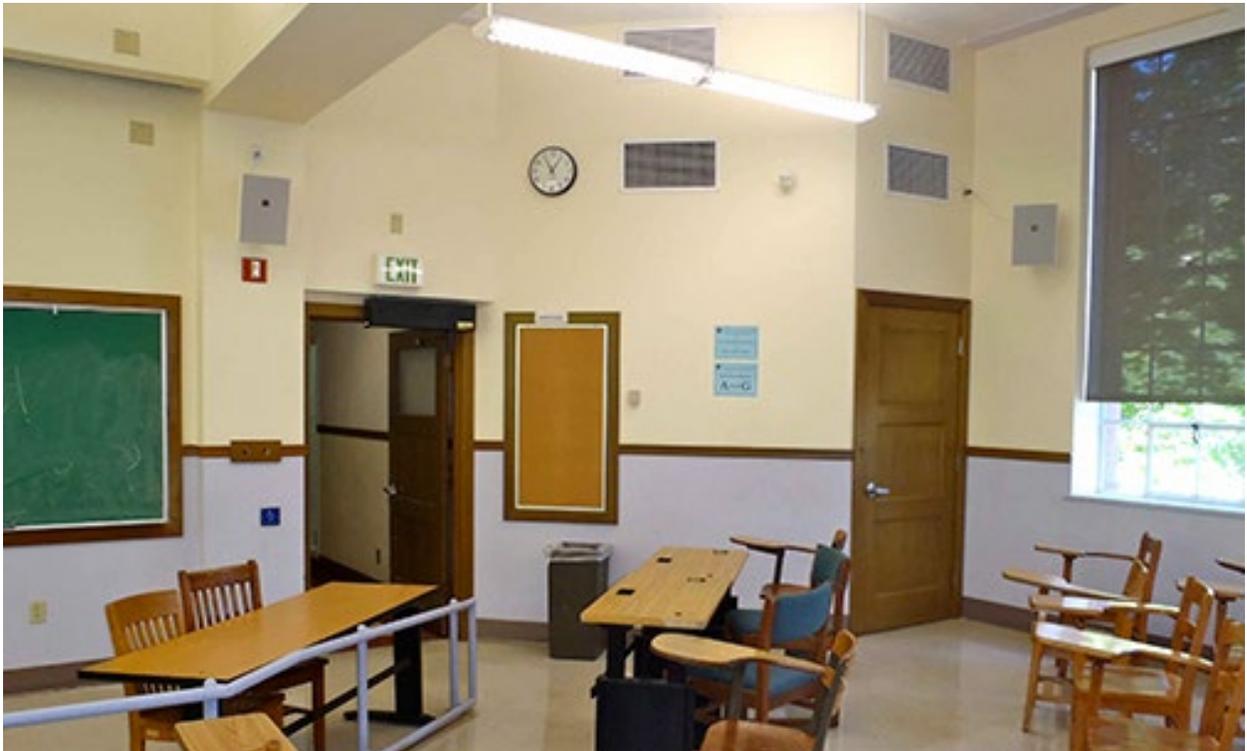
A storage room (Room 207a) was added in the northwest corner of the room, and the adjacent office (Room 206) was expanded into the original southwest corner of the Lecture Hall to maintain symmetry. Original linoleum tile flooring and an original 6" raised platform in the front of the classroom were removed. Original composite base moulding was replaced with 4" rubber baseboard. The original plastered ceiling was covered by 10' suspended ceiling 2'x4' tile. Original pendant light fixtures were replaced with fluorescent fixtures.

View of storage room addition, ADA door, and fixed seating (looking northwest). 2011.

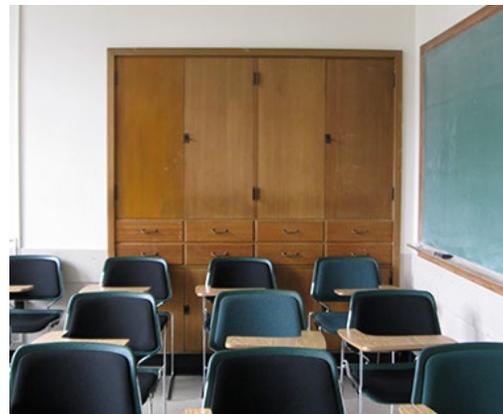
Built-in cabinets in room 202 match original Ellis Lawrence Drawings. March 2015

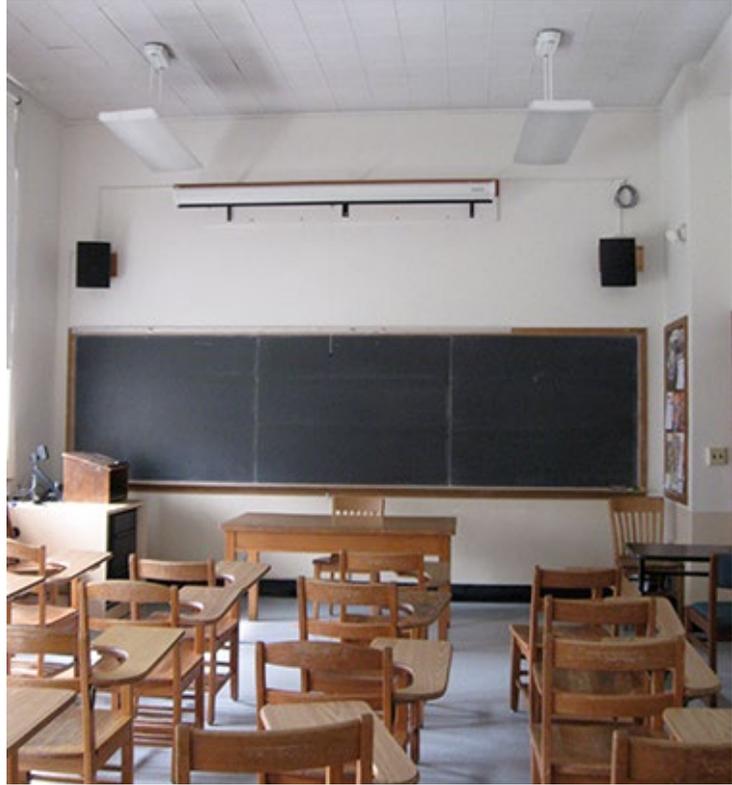
Western interior wall of Room 204. March 2015.

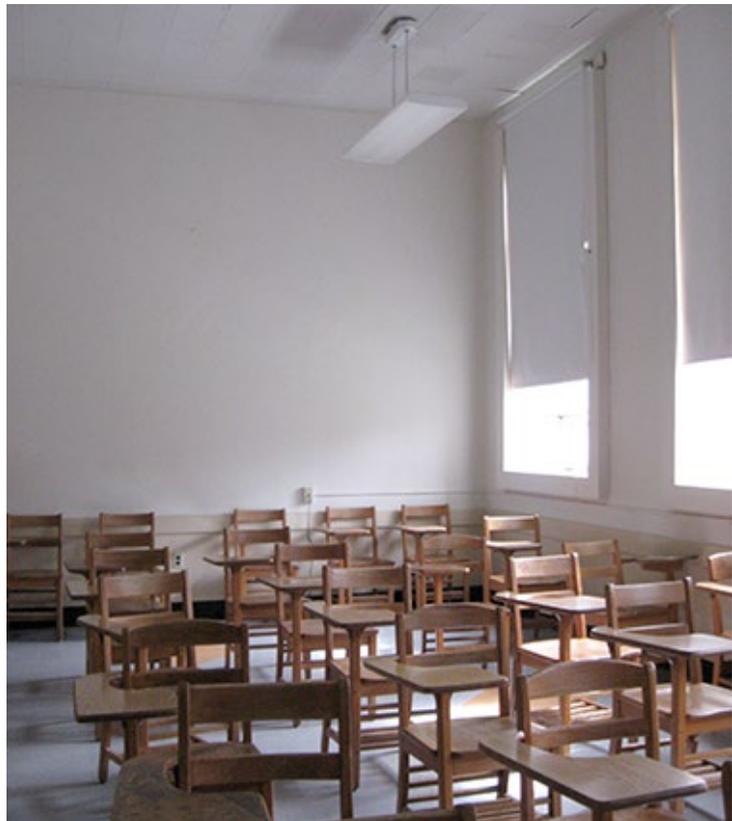
Southeastern corner of Room 204. March 2015.

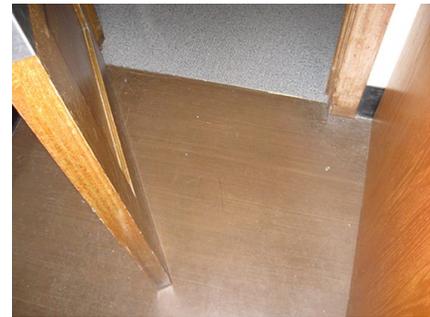
Original jasje linoleum flooring in Room 222. March 2015.

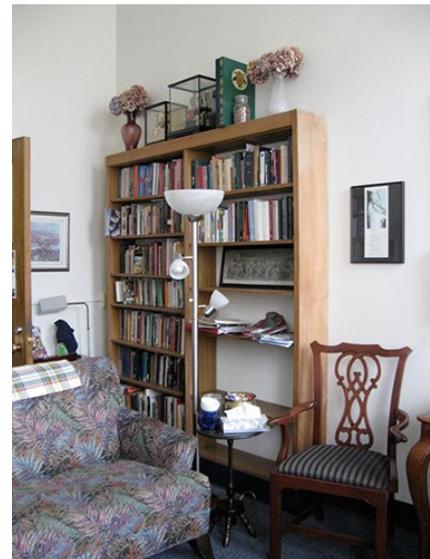
Original built-in bookcase in Room 212. The cabinet along the south wall and two sections of the bookcase indicated in the original 1938 drawings are no longer existing. March 2015.

Date unknown: Original jasper linoleum flooring replaced with carpeting in most offices, with the exception of Room 222 which still has the original flooring. The original built-in cabinet and two sections of the built-in bookcases were removed in Room 212.

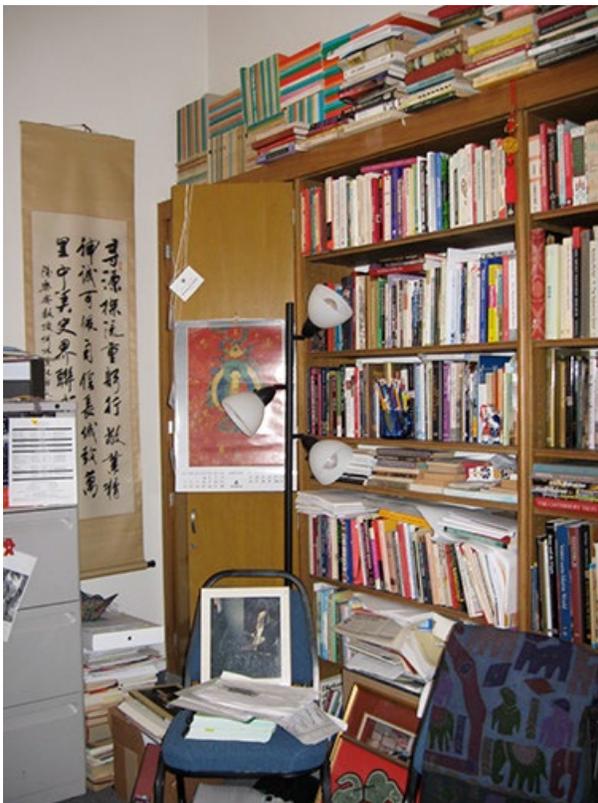
Original built-in bookcases in Room 221. March 2015.

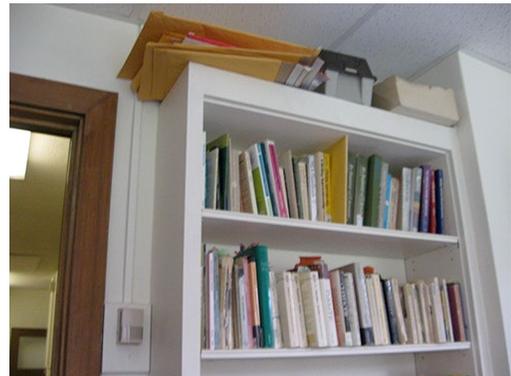
2001 Room 207 Remodel: During the 2001 remodel of the second floor auditorium, what was originally Office No. 8 (now Room 206), was expanded to the east into the auditorium space. During this remodel, the ceiling height of Room 206 was lowered. In the original plans by Ellis Lawrence, a built-in bookcase along the north wall of Room 206 is indicated. It is uncertain whether the existing bookcase in the same location is original or not, or to what extent it has been altered. The shelves match the original bookcases in Rooms 221, 222, and 212, but the trim around the case differs in appearance. It has also been painted white.

Built-in bookcase in location of original built-in bookcase. Shelves appear to be original, but painted. Trim around the case appears to have been altered. March 2015.

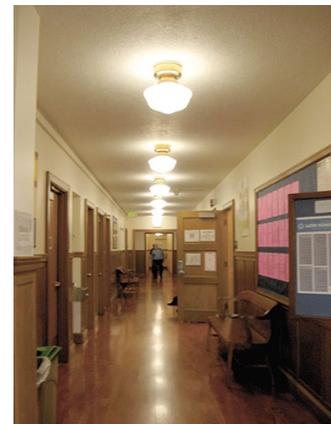
View looking east through corridor. March 2015.

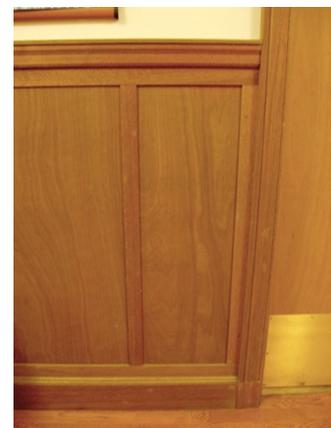
Detail of third floor corridor finishes. March 2015.

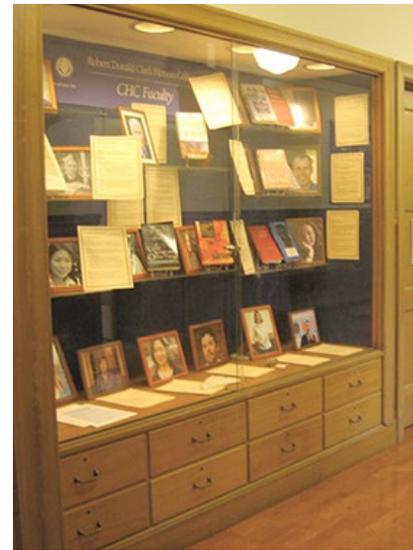
Existing third floor corridor display case. March 2015.

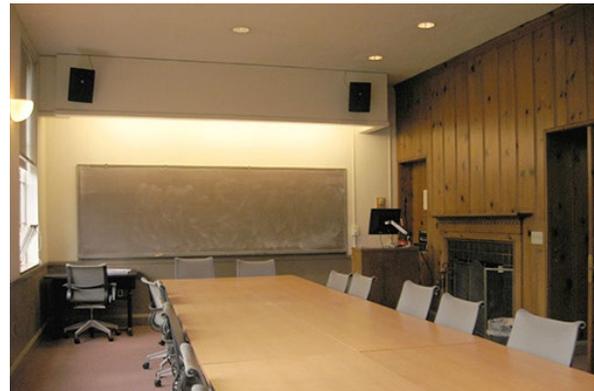
Existing conditions of Room 303, looking west. March 2015.

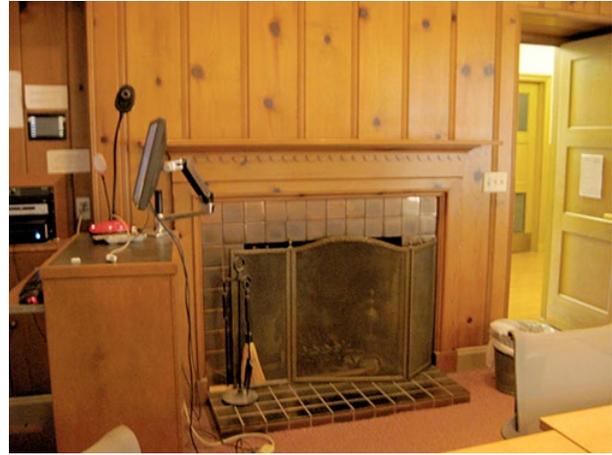
Original fireplace with wood mantel and knotty pine paneling. March 2015.

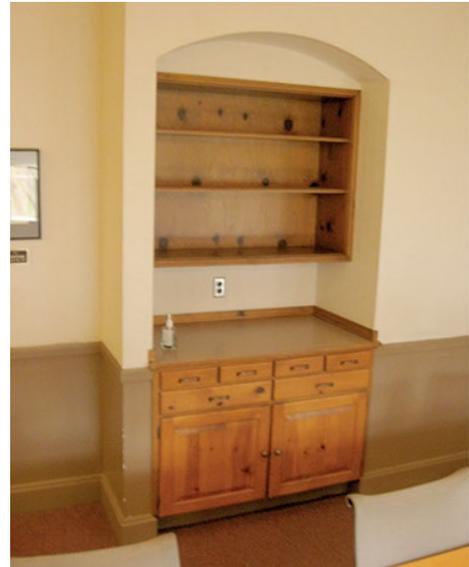
- original built-in hidden closet of shelves in Living Room just west of the entry
- original built-in buffet cabinet and counter in Dining Room has had the bottom cabinet faces replaced. Replacements slightly differ from original Ellis Lawrence drawings. Instead of four cabinet faces over the buffet cabinets, there are now two larger ones. The plywood laminate top to the buffet cabinet was also replaced

1989 Honors College Remodel: Living and Dining Rooms were reconfigured into a conference room. New carpet flooring was installed. A new screen valance was constructed along west wall. New wooden base trim was added. The four cabinet fronts to the built-in buffet cabinet were replaced with two larger cabinet fronts. The plywood laminate top of the buffet cabinet was also replaced. All existing paneling was refinished.

Original built-in buffet counter and cabinet and open shelving above. March 2015.

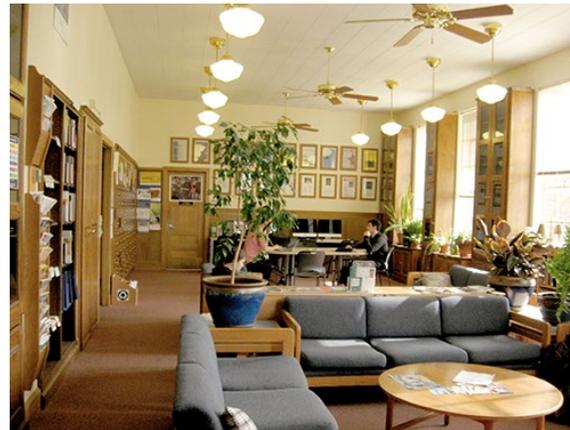
View of Honors College Library looking east. March 2015.

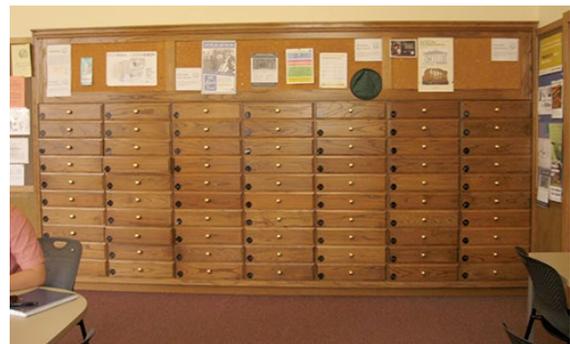
Original built-in sewing drawer cabinet. Top four rows of drawers converted into shelving in 1981 and later into what is now a corkboard. March 2015.

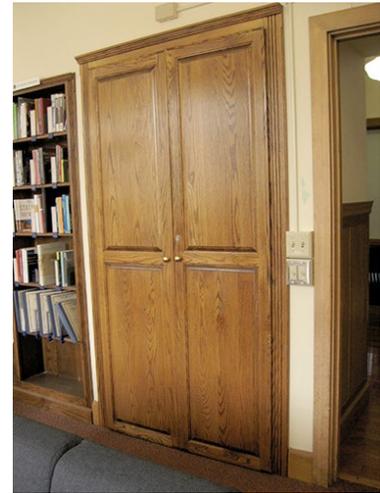
This built-in cabinet on the north wall was originally a smaller section of built-in sewing drawers. March 2015.

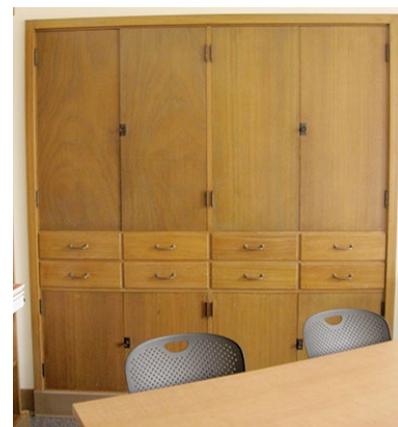
Built-in cabinets in Room 320A match original Ellis Lawrence Drawings. March 2015.

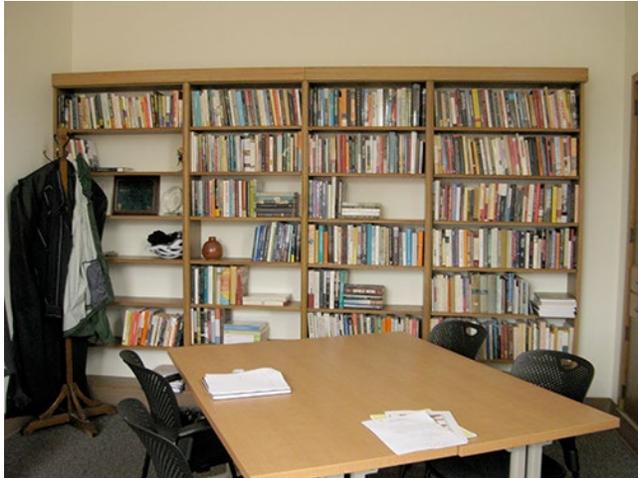
Original built-in bookcase in Room 320A. Currently about 1 foot shorter than indicated in original Ellis Lawrence drawings. March 2015.

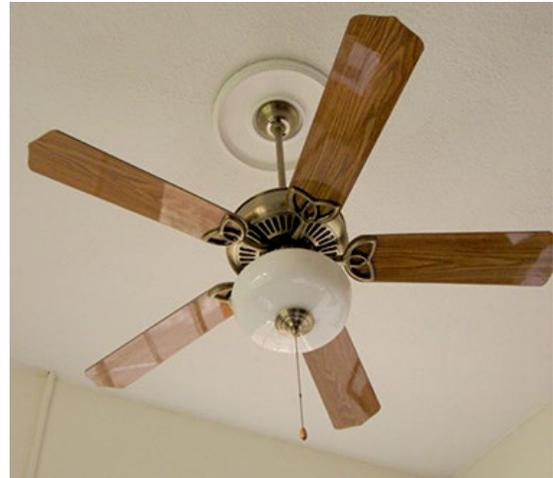
Existing lighting in Room 320A and 320B. March 2015.

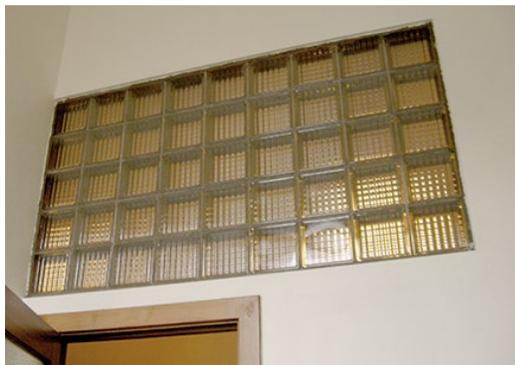
Original glass block panel above door of Room 320B. March 2015.

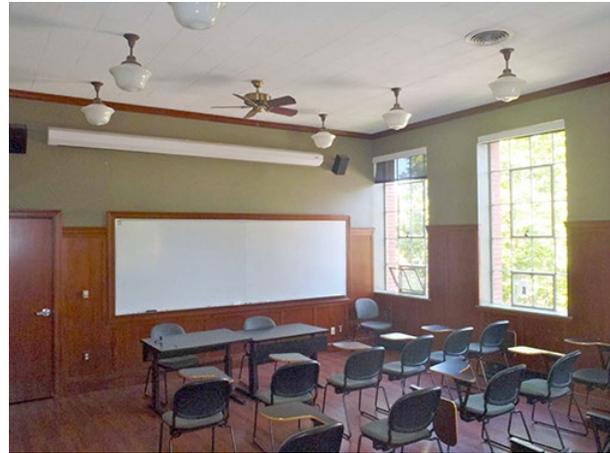
Classroom - Room 307 (facing northwest). 2011.

2005 Room 307 Remodel: New interior finishes and ceilings were added. New light fixtures were added and closely resemble the original light fixtures as seen in historic photographs of the cooperative book store.

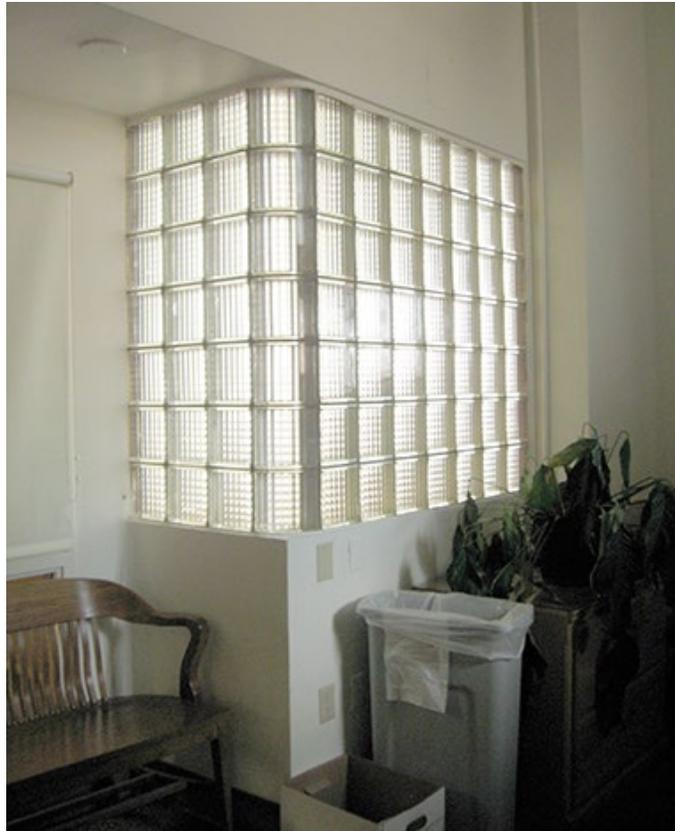
Original glass block wall in Room 320. March 2015.
