Gerlinger Hall

Preliminary Historic Assessment

University of Oregon
Campus Planning, Design and Construction - January 2014 (updated January 2016)

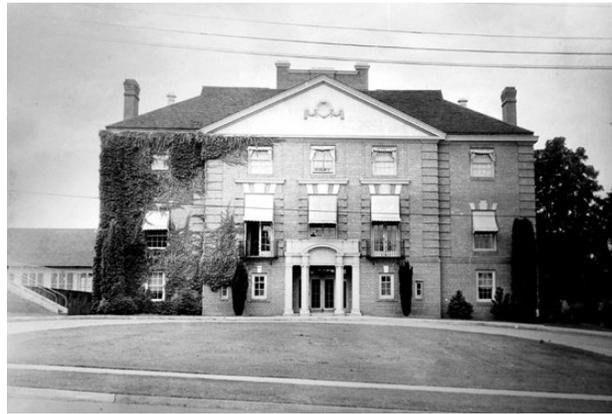
1925 East facade

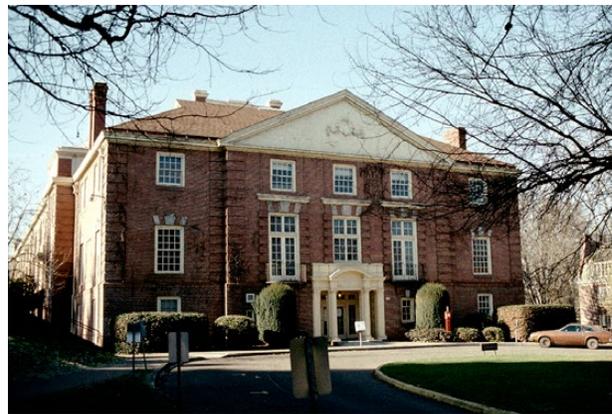
Post 1988 East facade

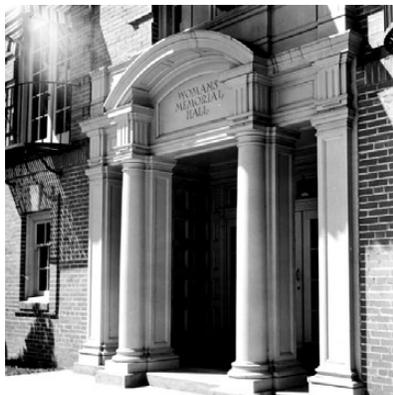
East entrance with original concrete step date unknown

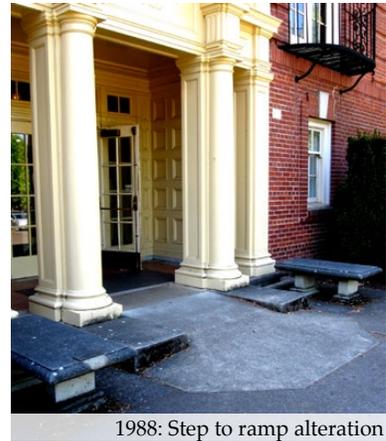
1988: Step to ramp alteration

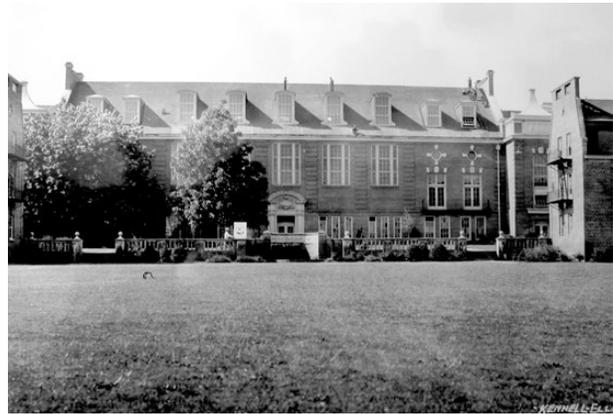
Pre-1932 North facade

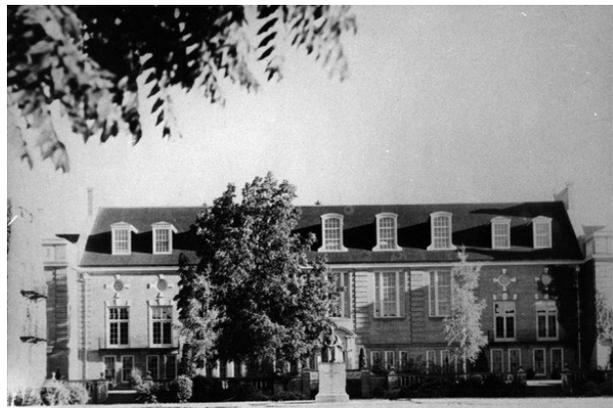
Post 1932 North facade

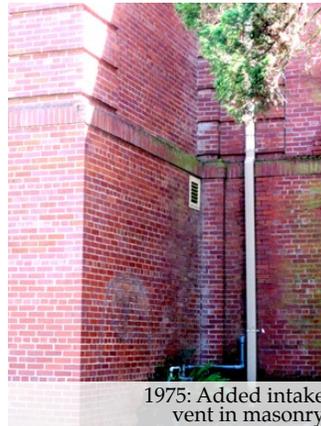
1975: Louvers added into first floor windows and intake vent into masonry east of the main entrance as part of the Locker Room Remodel Project.

1975: Added intake vent in masonry

3. Assess current roofing material - consider cedar shingles.
4. Remove all unnecessary louvered vents on the north facade and replace with original sashes, if existing, or compatible new sashes (coordinate removal of vents with Student Recreation Center project).

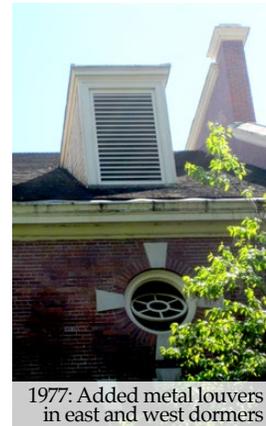
1977: Full-length metal louvers installed into existing window frames of dormers on east and west ends. Tunnel ventilator added at northwest corner.

1977: Added metal louvers in east and west dormers

5. Re-side dormers with cedar shingles with clear finish.
6. Assess need for louvered vents in dormers on north and south facades and possibly replace with original sashes, if existing, or compatible new sashes.

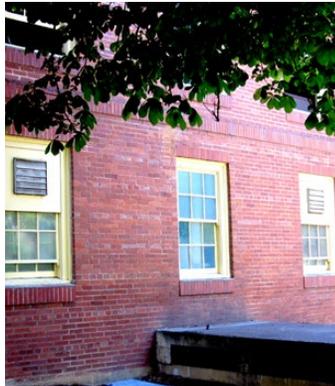
1977: Added tunnel vent

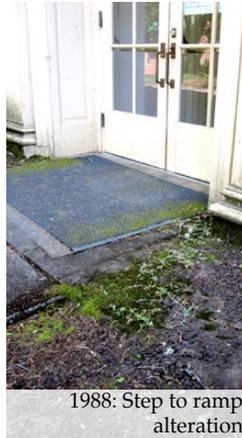
1982-83: Fans added to pool room windows likely as part of the Pool Restoration Project.

1984: Added vents in pool room windows

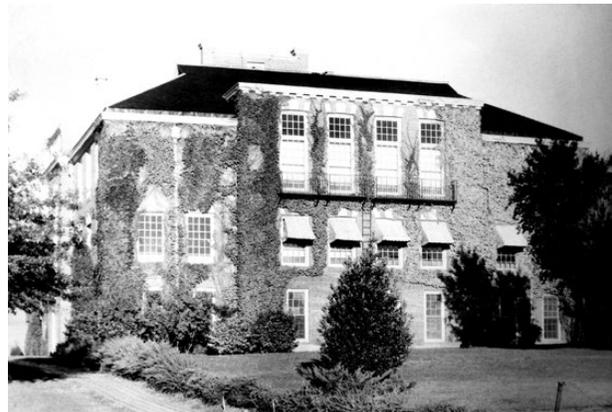
1925 West facade (with awnings)

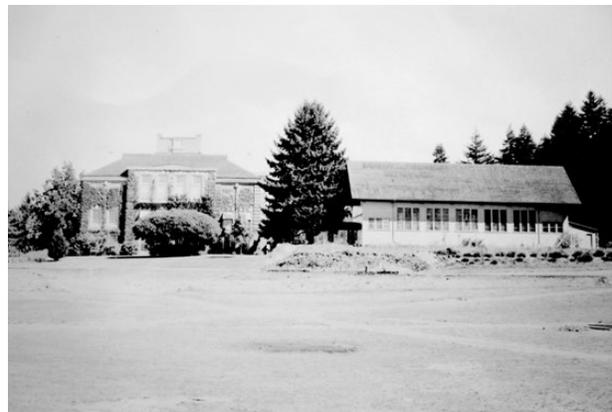
Post 1935: Removal of awnings shown on some of the second floor windows. It is likely the awnings were never replaced as foliage and new campus buildings provided necessary shade for the facade.

1935 West facade with original outdoor gym (with awnings)

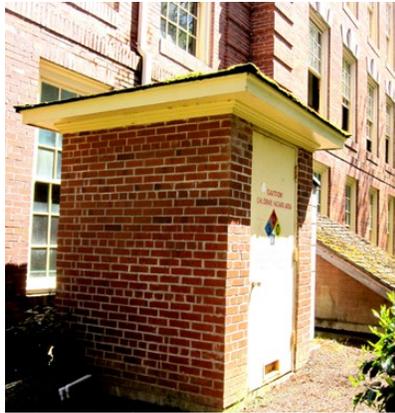
1963: Detached pool chlorinator building constructed at the southwest corner of the building.

1963: Added pool chlorinator building

9. Remove pump shed.
10. Assess reuse of chlorinator building and/or remove.
11. Repair hardware scars on masonry from iron balcony and ladder on the west facade.

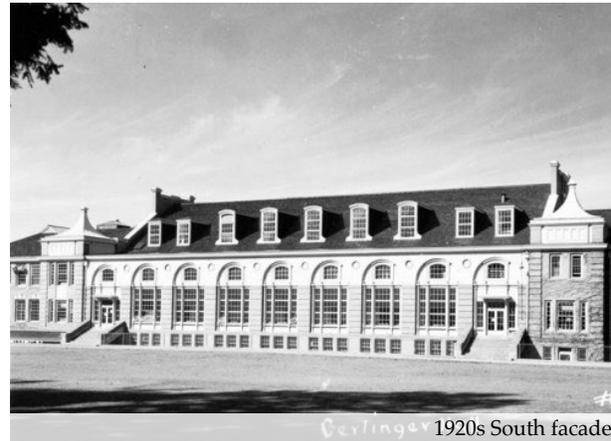
Gerlinger 1920s South facade

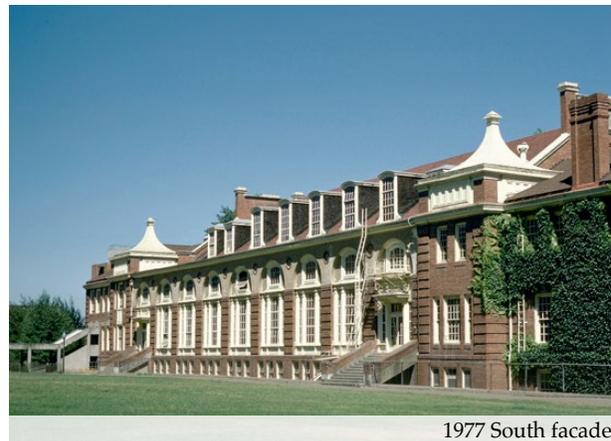
1977: Original horizontal pivot windows and frames removed and full-length metal louvers installed in dormer on east end. Fire escape and ladders (not original - unknown date of installation) removed. Accessible door replaced an original window, and remaining window openings on first floor of east tower infilled with brick as part of the Life Safety Remodel Project.

1977 South facade

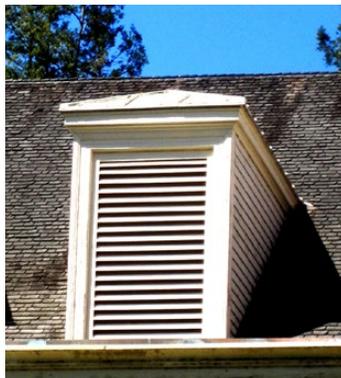
1977: Louvers installed in dormer on east end

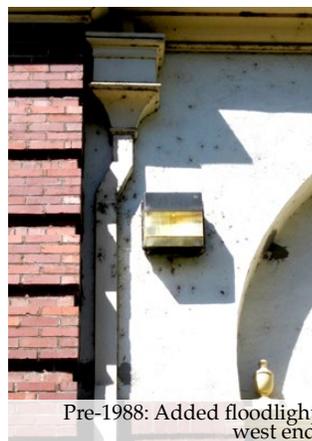
Pre-1988: Added floodlight west end

1. Remove all unnecessary exterior conduit and building-mounted flood lights. If required, replace with compatible fixtures.
2. Retain original materials and compatible light fixture at main east entrance.

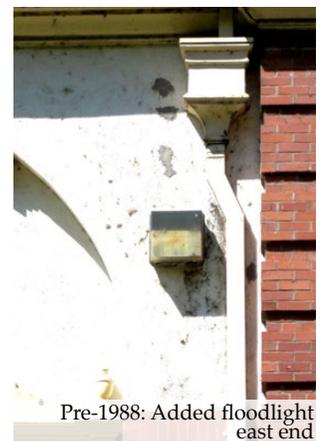
Pre-1988: Added floodlight east end

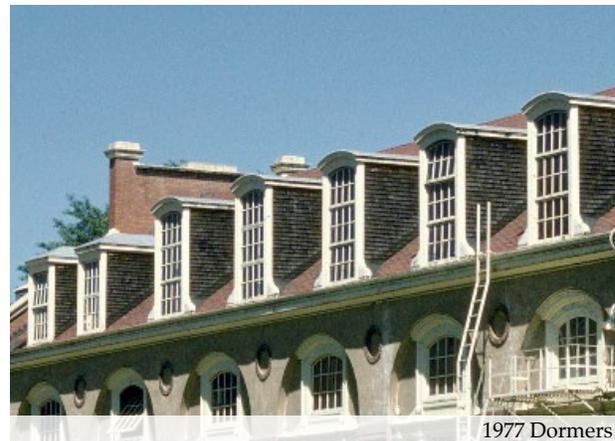
1977: Original horizontal pivot windows and frames removed and full-length metal louvers installed in dormer on east end of south facade and dormers on east and west ends of north facade. Second dormer on the west end of the north facade framed in. Sprinkler system added within the dormers. All changes were part of the Life Safety Remodel.

1977 Dormers

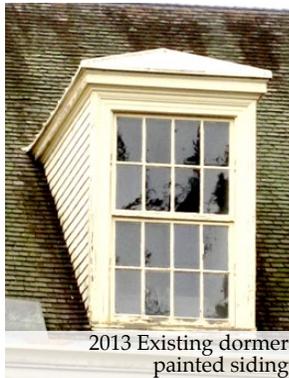
Post 1977: Original exterior, unpainted cedar siding, painted cream.

2013 Existing dormer painted siding

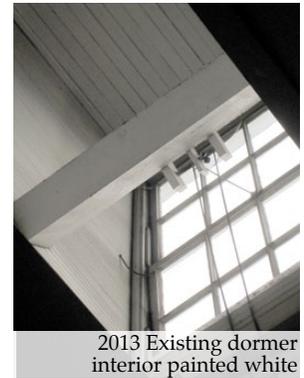
Date Unknown: Unpainted fir panelling within the interior of the far west dormer on the south facade painted white. It is likely this was for reflective purposes in an effort to get more natural light to the otherwise dark stairwell.

2013 Existing dormer interior painted white

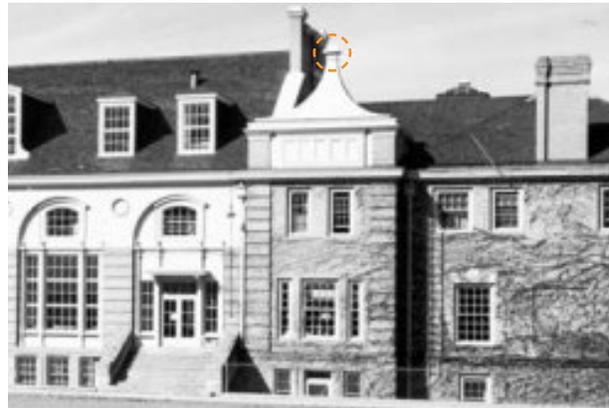
1920s Southeast Tower *Note: Iron sphere not incorporated*
