# Friendly Hall

## Preliminary Historic Assessment

University of Oregon  
Campus Planning  
Campus Planning and Facilities Management

October 2022

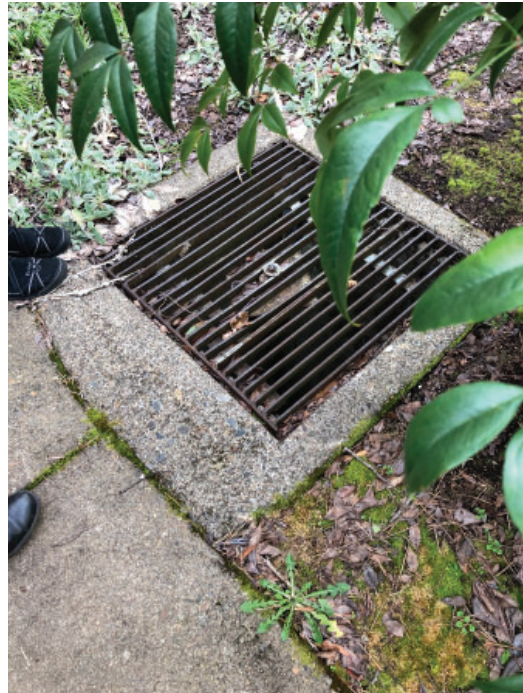
Storm drain inlet location in landscape, not original.

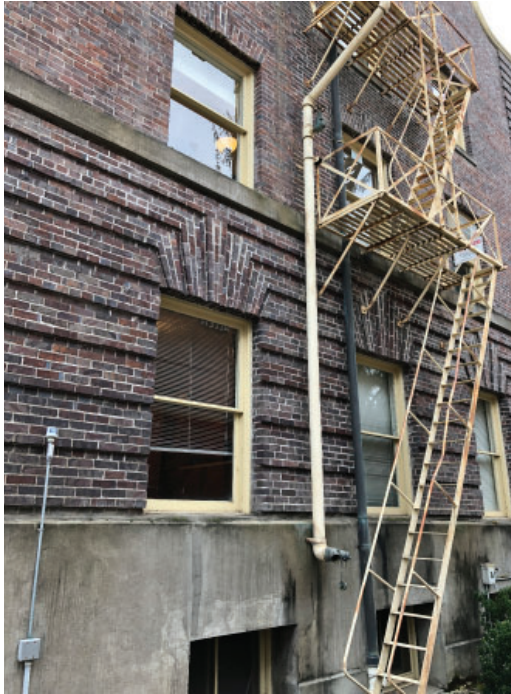
Fire escapes are not original, further research needed to determine date added. Fire sprinkler standpipes are not original.

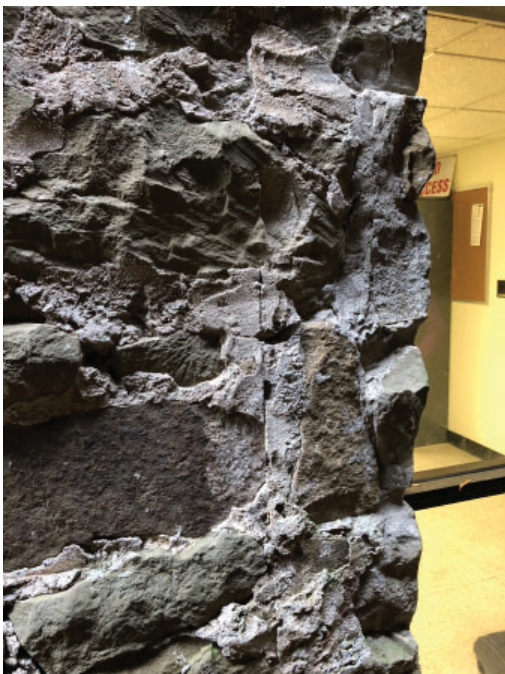
Original stone foundation throughout  
basement level.

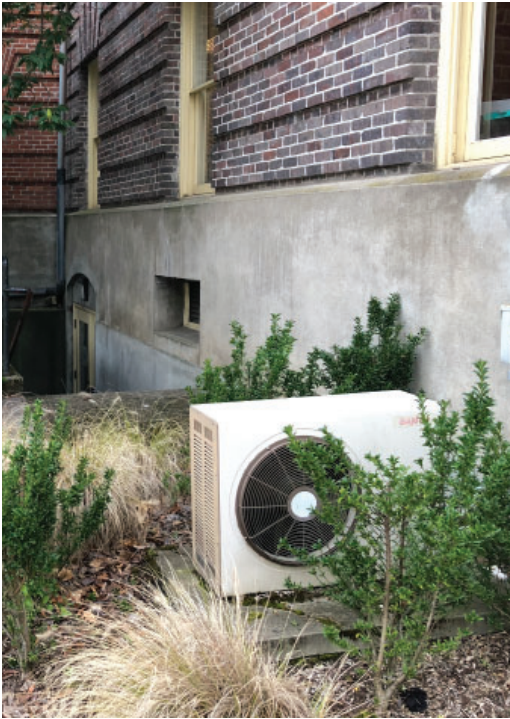
Mechanical systems added to exterior facade in exposed location.

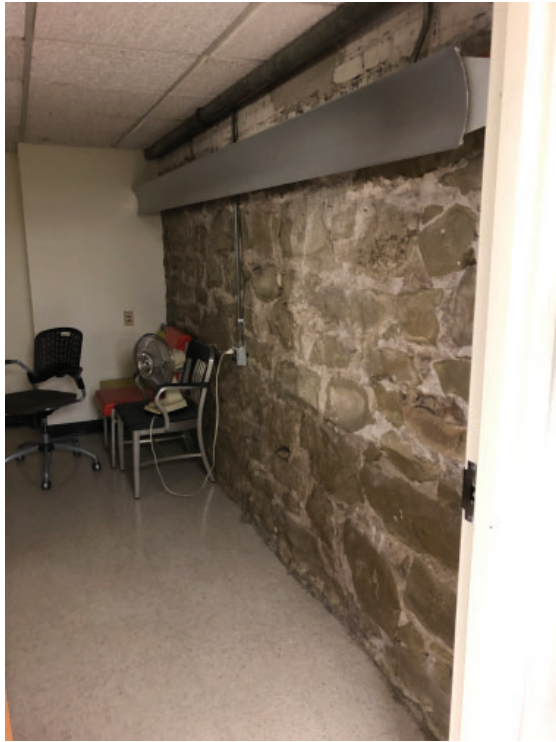
Room 26 (Original Stone Foundation)

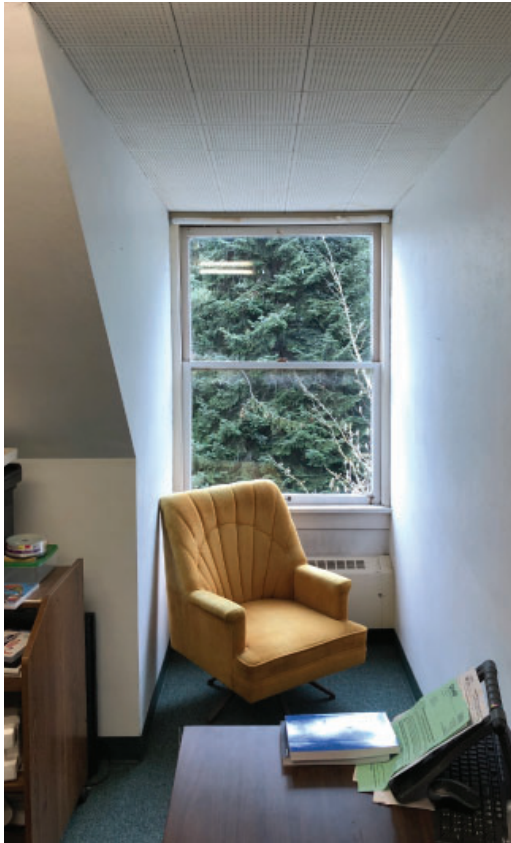
Room 424 (Dormer Window)

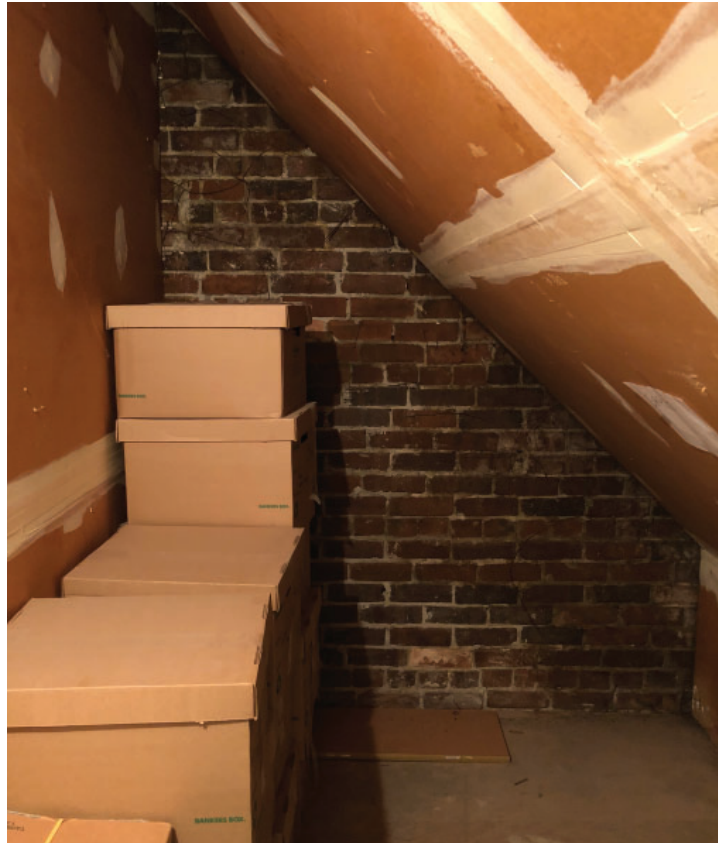
Room 420 (Exposed Brick)

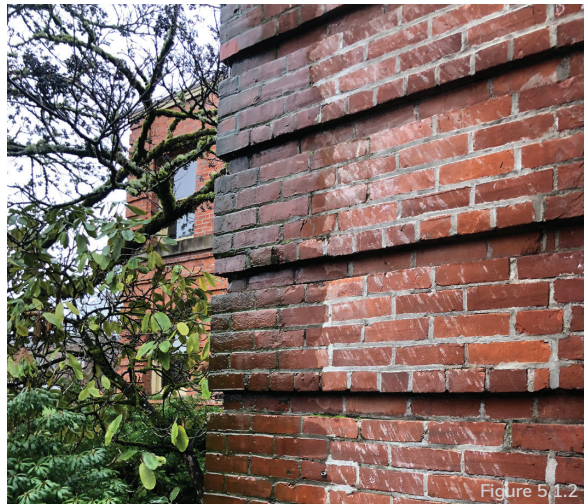
Figure 5.1.2

The exterior walls of Friendly Hall indicate the original structure and its two major additions. All three major constructs use an American or Common bond. A dark brick is used on the original portion (figure 5.1.1), while the additions are clad with a red brick (figure 5.1.2). The 1914 addition on the east also has a different coursing pattern than the other two constructs (figure 5.1.3). The face brick is embellished with quoins, jack arches, and rusticated reveals on the first floor.

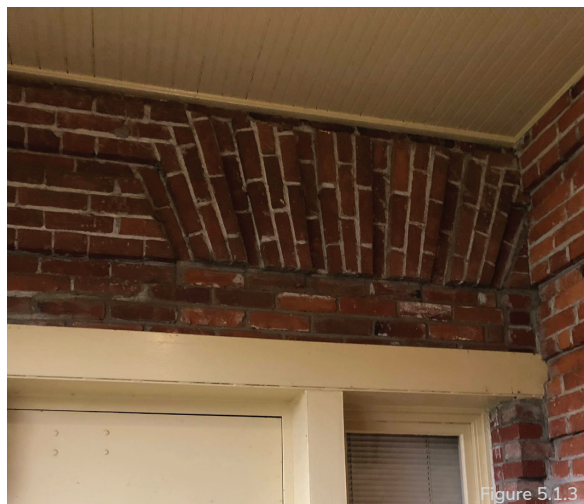
Figure 5.1.3

Mortar joints are generally intact and in good condition. There are some areas of previous repointing that are an inadequate match to the historic mortar color and texture (figure 5.1.3) which should be replaced.

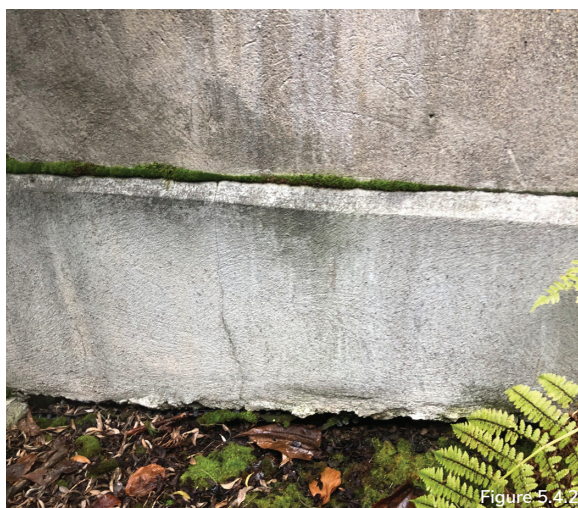
Figure 5.4.2

During a walkthrough, areas of organic growth and superficial cracking were observed (figure 5.4.1-2).

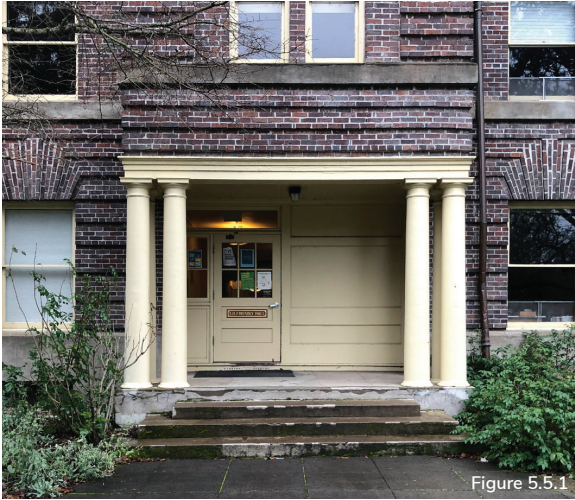
Figure 5.5.1

Generally, the historic exterior doors on the building have been maintained and are functionally adequate (figure 5.5.1). Some have experienced slight aesthetic deterioration which is expected on elements of this age. At exterior basement entries, character compromising doors were installed at some point during previous renovations (figure 5.5.2).

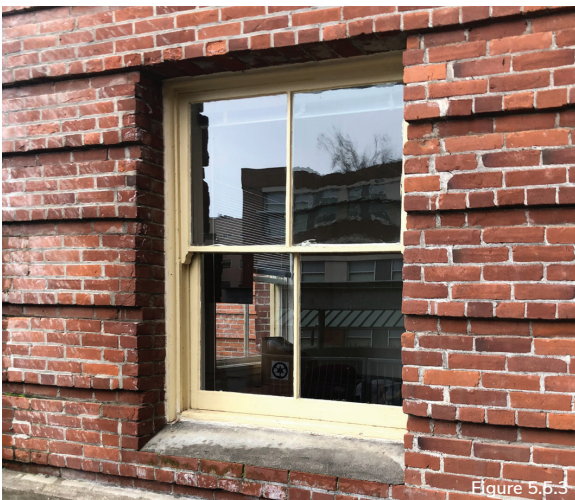
Figure 5.5.3

The exterior windows on Friendly Hall are generally in good condition (figure 5.5.3). A restoration of all exterior windows was performed by Soderstrom Architects in 2009 so areas of paint or wood deterioration are limited. However, the existing single pane vision glass does not provide adequate environmental performance.

- Exterior windows should be cleaned and repaired as necessary.
- Low emissivity film will be added to reduce heat transfer without compromising the appearance of the historic windows.

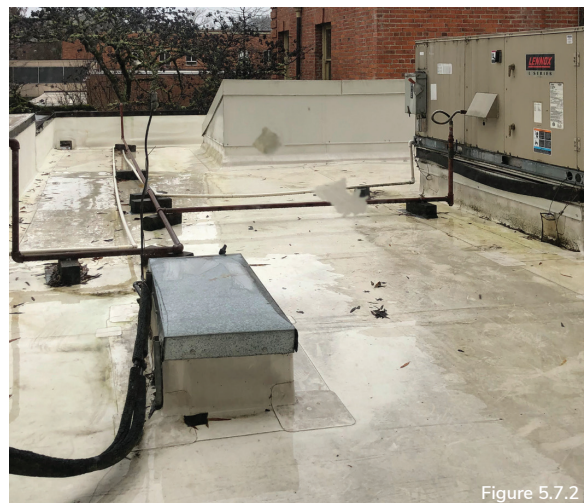
Figure 5.7.2

The existing roofing consists of TPO membrane at low-slope conditions (figure 5.7.2) and wood shingle roofing at the remaining areas. Both types of roofing were fully replaced in 2009 and are generally in good condition with about half of their expected lifespan remaining.

The skylights over the first floor office suite (figure 5.7.2) were added during a 1999 renovation and generally appear in good condition with no reports of issues.

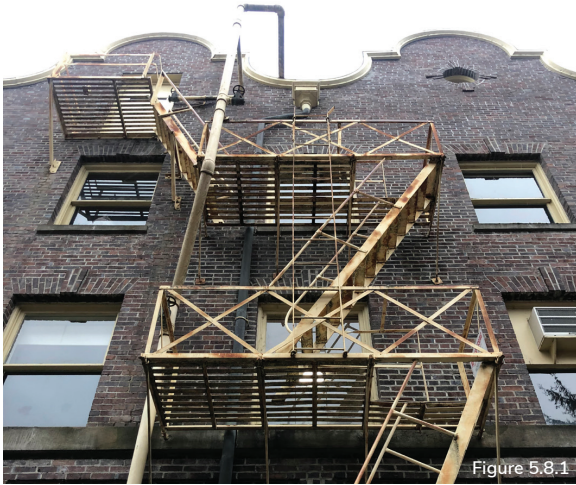
Figure 5.8.1

The historic fire escapes at the north and south facades of the building have aged and deteriorated substantially (figure 5.8.1). There are also instances of deformation near the ground level.

- Existing window openings that have been previously outfitted with mechanical louvers should have historically appropriate windows reinstalled.
- If removal of the fire escapes is deemed necessary, the oculus windows should be recreated to restore the historic appearance.
